# WOOD DESTROYING PESTS AND ORGANISMS INSPECTION REPORT

| 2049 | Sierra Way | San Luis Obispo | 93401-4523 | 09/04/2026 | 1 of 6 |

| General Description:<br>Single story; Single family residence; Stucco exterior; Composition shingle roof; Vacant. | Inspection Tag Posted:<br><div style="border: 1px solid black; padding: 2px; text-align: center;">GARAGE</div> |

## \*\*\*Complete Inspection Report\*\*\*

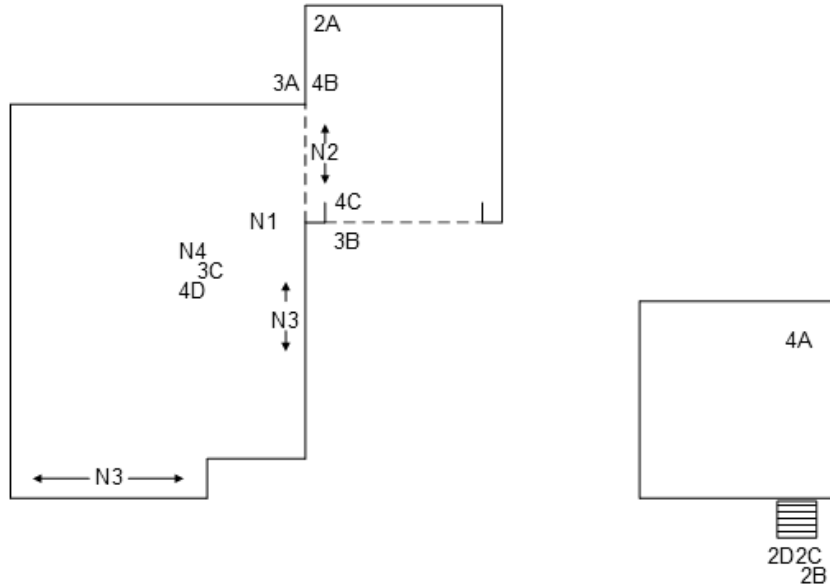
Diagram not to scale-Finding locations approximate

| Finding: | 2A | Evidence of Drywood Termite infestation was found at the interior garage and appears to extend into inaccessible areas of the structure. |
| Finding: | 2B | Evidence of Drywood Termite infestation was found at the exterior. |
| Finding: | 2C | Drywood Termite damage was found at the stair stringer. |
| Finding: | 2D | Drywood Termite damage was found at the stair treads . |

| Finding: | 3A | Fungus damage was found at the rafter end of the eave area. |
| Finding: | 3B | Fungus damage was found at the exterior garage jamb and header jamb. |
| Finding: | 3C | Minor fungus infection and/or damage was found at the subfloor below the bathroom. The original moisture source has been corrected. The area was dry (below 20% moisture content) and there is no structural weakness. |

| Recommendation: | | Seal the structure and fumigate with a gas lethal to Drywood Termites (Sulfuryl Fluoride). All occupants and pets must vacate the structure until the fumigation is complete. This company will exercise reasonable caution, but cannot be held responsible for damage to plants, TV antennas or roofing due to the fumigation. Further terms and instructions will be supplied upon request or upon scheduling of the fumigation. Information may also be obtained from the fumigation page on our website at <a href="http://www.keytermite.com">www.keytermite.com</a><br><b>***Fumigations are guaranteed for 5 years from the date completed***</b> |
| Recommendation: | | Cut the damaged portion of the stair stringer and install a pressure treated pad as needed. |
| Recommendation: | | Remove and replace the damaged portion of the stair treads as needed. |

| Recommendation: | | Replace the fungus damaged portions of the rafter end as needed. |
| Recommendation: | | Replace the damaged portions of the door jamb as necessary. |
| Recommendation: | | Remove the surface growth with a wire brush. Chemically treat the infection with disodium octaborate tetrahydrate or copper naphthenate. Periodic inspection is recommended to ensure condition is controlled. |
