# WOOD DESTROYING PESTS AND ORGANISMS INSPECTION REPORT

| Building No.<br>4428 | Street<br>Shorthorn Ct. | City<br>Chico | ZIP<br>95973 | Date of Inspection<br>04/09/2026 | Number of Pages<br>4 |
| GENERAL DESCRIPTION:<br>One story, single family residence, slab foundation, cement fiber board exterior, composition roofing, garage, detached garage, vacant/furnished | | | | Inspection Tag Posted:<br>Garage<br>Other Tags Posted: | |

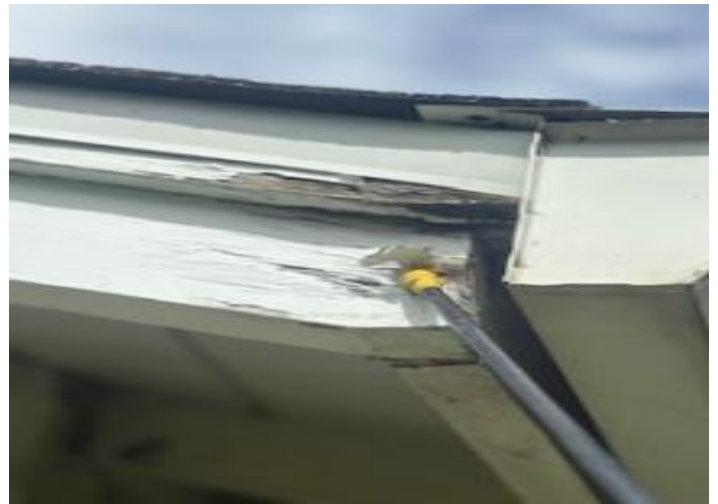
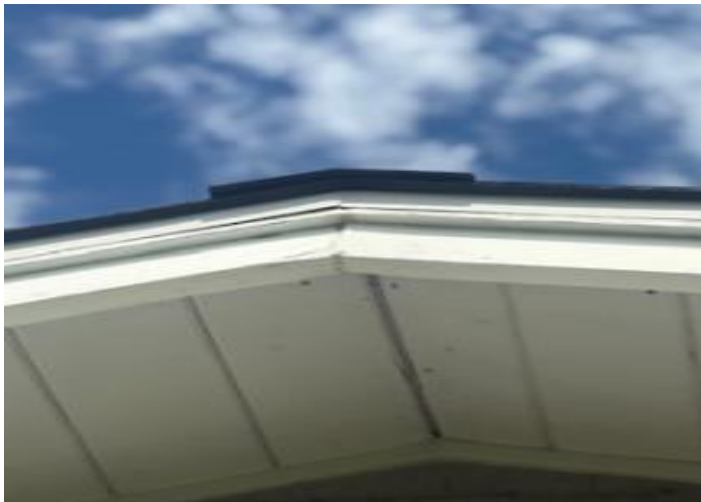
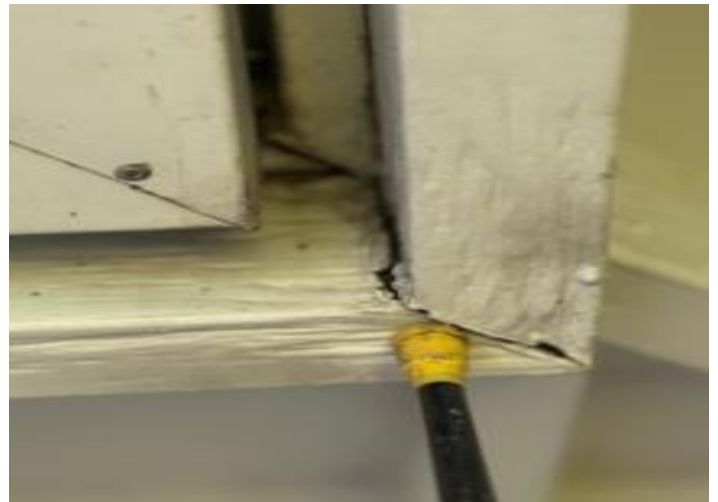
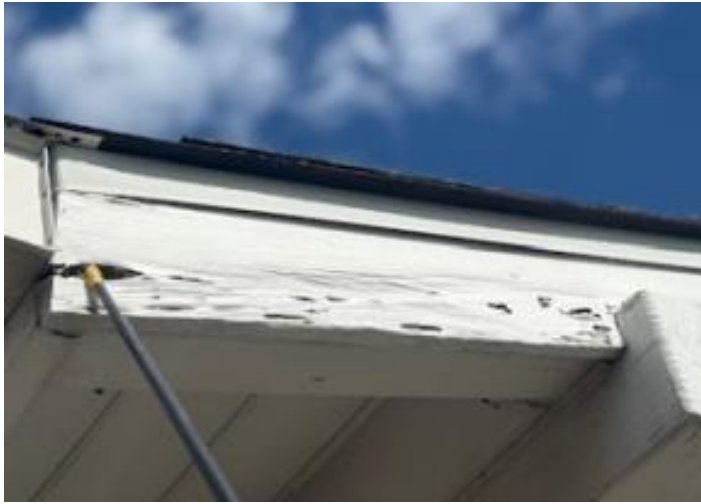
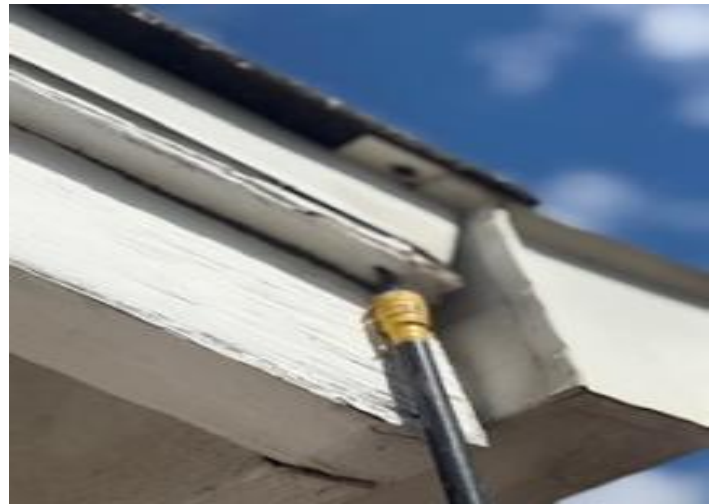
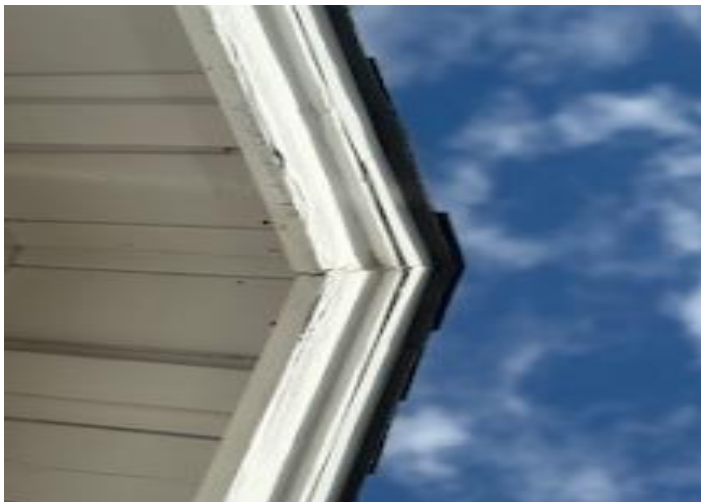
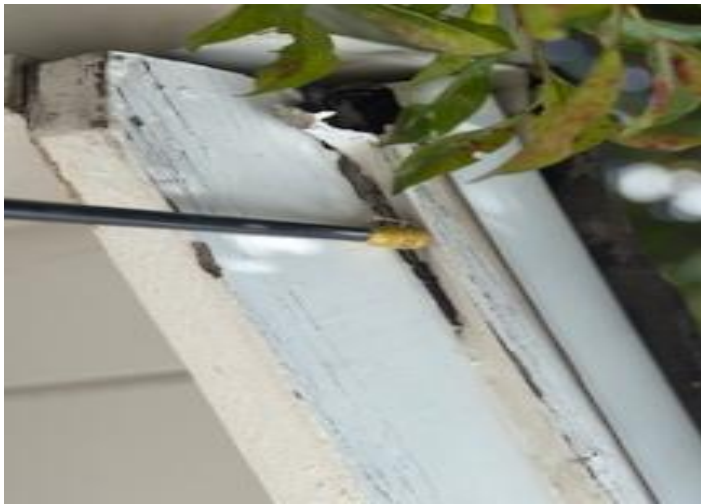
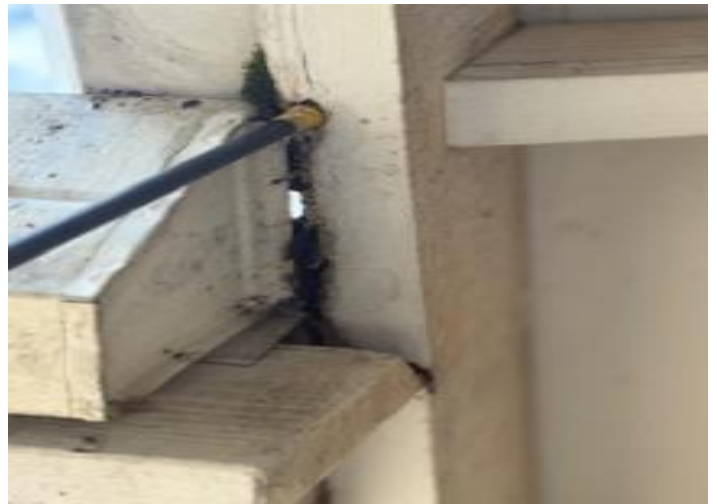
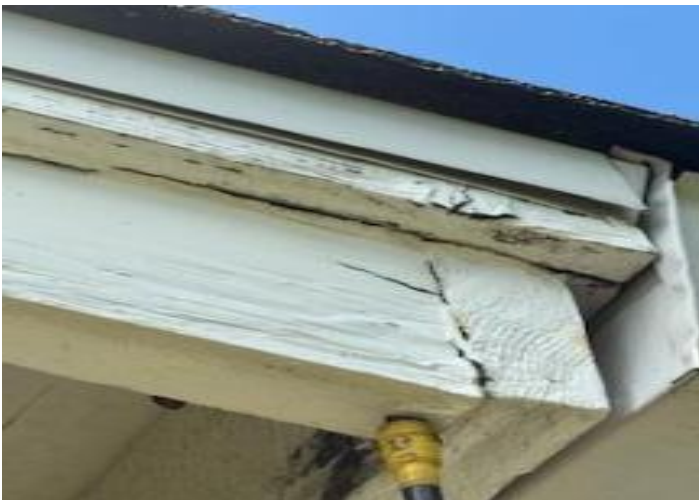
11A

FINDINGS - excessive moisture damage, fungus and/or dry rot noted to fascia, barge rafters and shingle molding at various locations

RECOMMENDATION - Cut back or cut out infected and or damaged wood members. Fill in, replace or repair as needed. Prime paint only

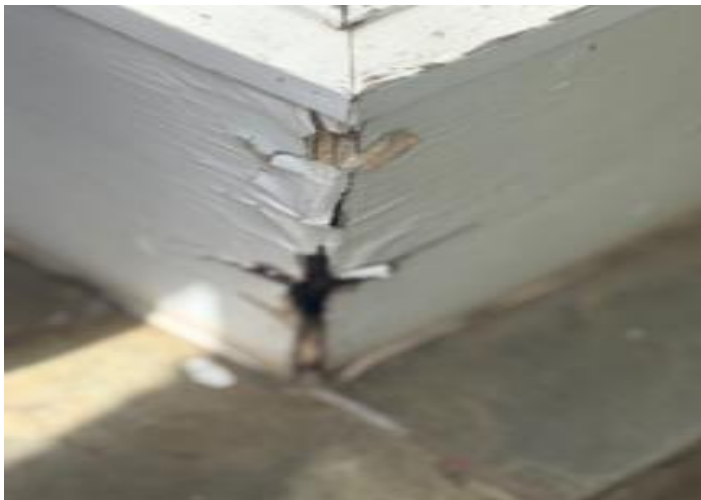
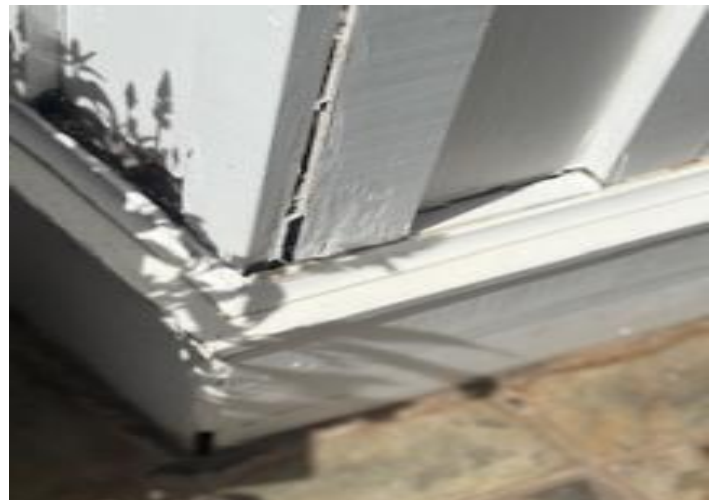
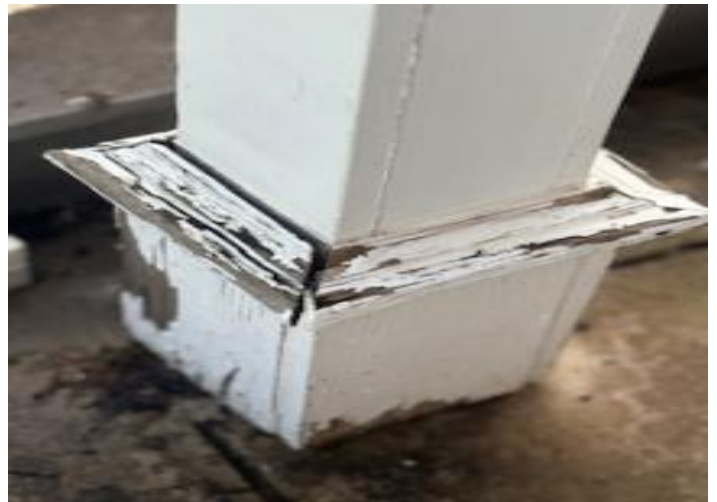
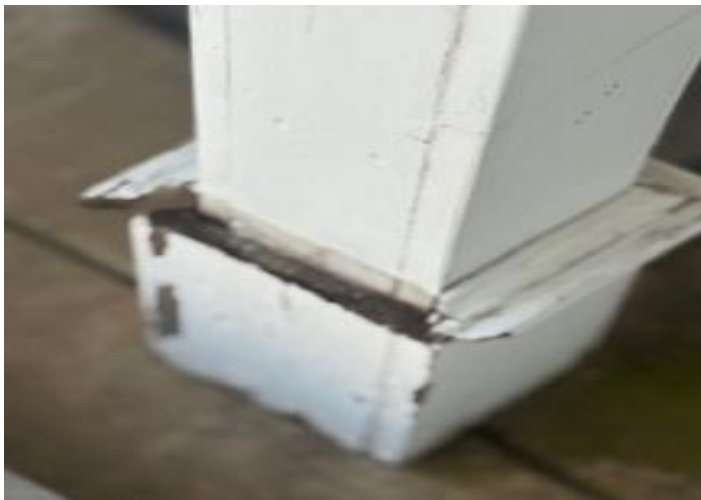
4A

FINDINGS - excessive moisture damage, fungus and/or dry rot noted to porch post trim at various locations

RECOMMENDATION -.Cut out excessive moisture damages to wood members (dry rot and/or fungus), treat with state approved fungicide and repair as needed. (Prime Paint Only) if hidden damages are revealed during repairs, a supplemental report will be submitted

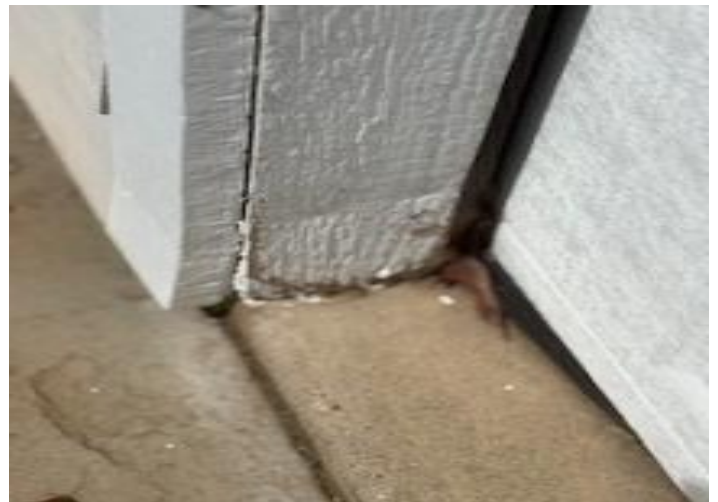
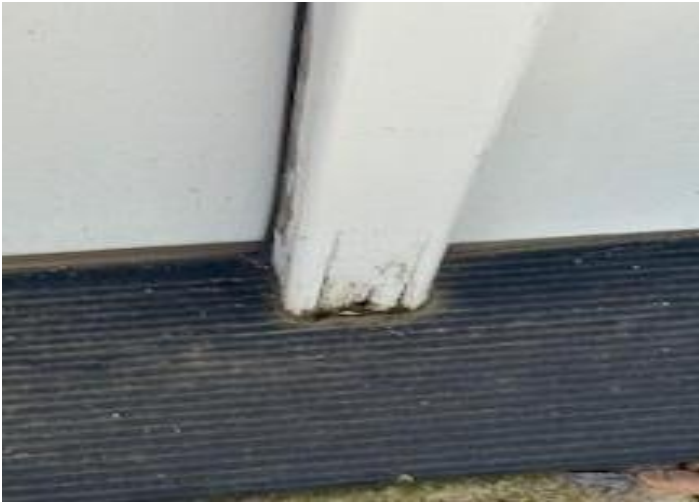
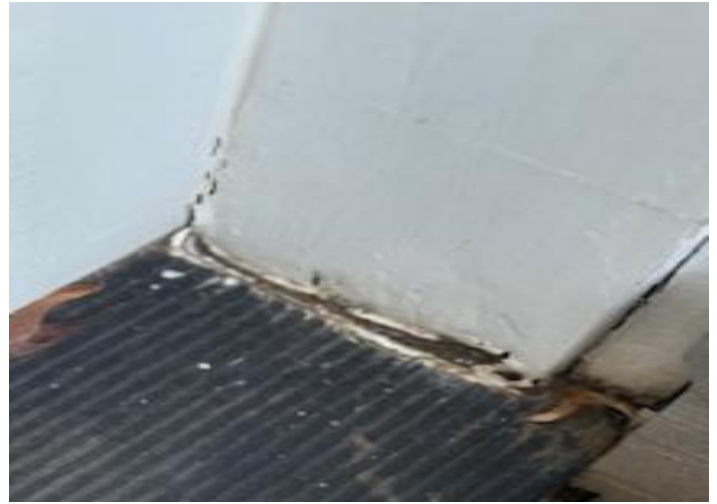
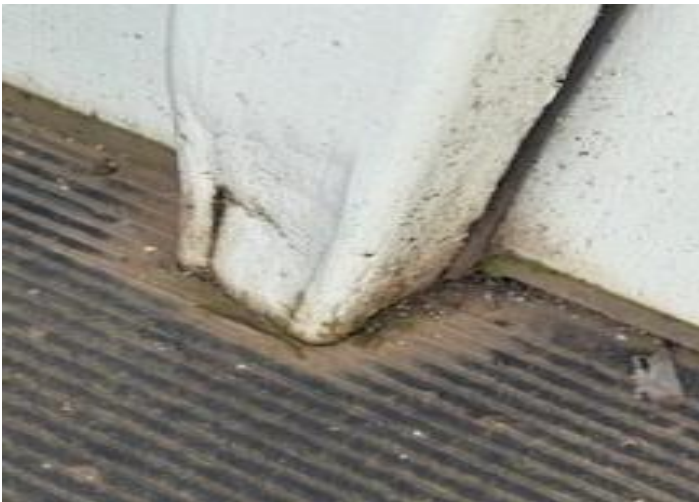
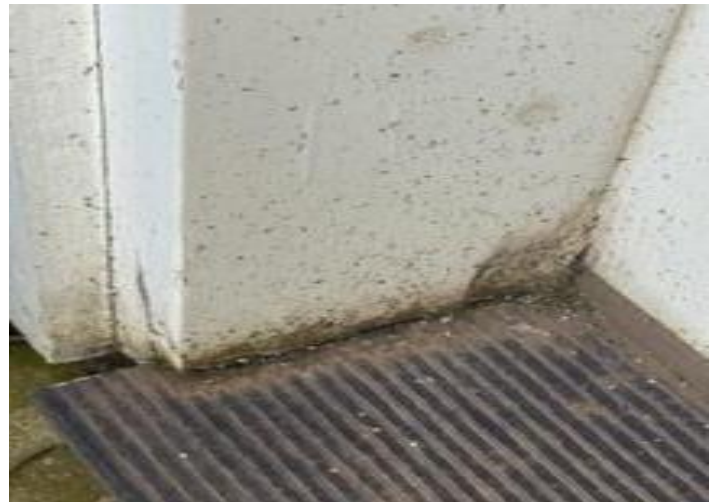
11C

FINDINGS - excessive moisture damage, fungus and/or dry rot noted to door casings and door trim at various locations

RECOMMENDATION - Cut out excessive moisture damages to wood members (dry rot and/or fungus), treat with state approved fungicide and repair as needed. (Prime Paint Only) if hidden damages are revealed during repairs, a supplemental report will be submitted

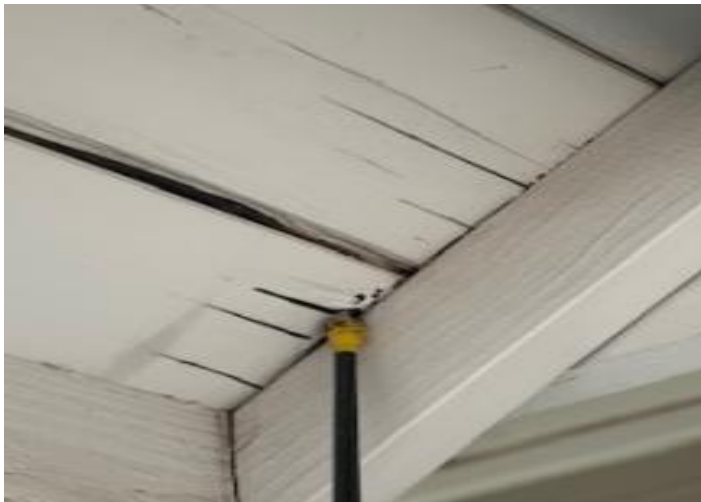
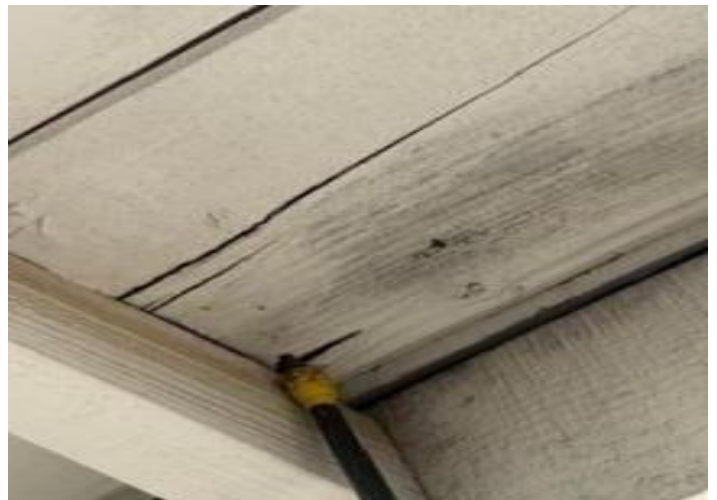
4B

FINDINGS - excessive moisture damage, fungus and/or dry rot noted to porch awning eave boards at various locations

RECOMMENDATION -Pull back roofing directly over damaged eve sheeting/roof sheeting, Cut out damage and/or repair as needed. Prime paint only. Re-install roofing if in good condition, replace as needed. If hidden damages are uncovered during repairs, a supplemental report will be submitted.

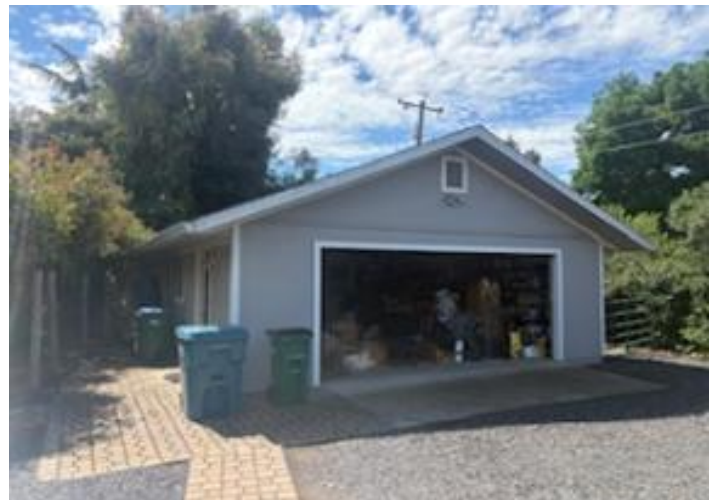
FINDINGS - excessive moisture condition, chipped/peeling paint and/or bare/exposed wood noted to detached garage exterior at various locations

RECOMMENDATION - Other trades to seal/paint as needed.
