Jun 3rd, 2025

222 North Lassen Street, Willows, CA, 95988

Home Inspection Report

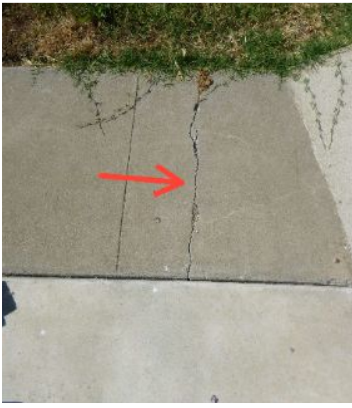
Cracks noted

Marginal

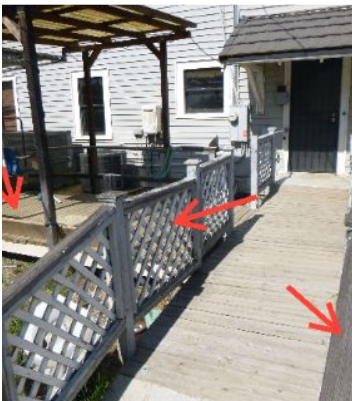
The back deck needs to be repaired

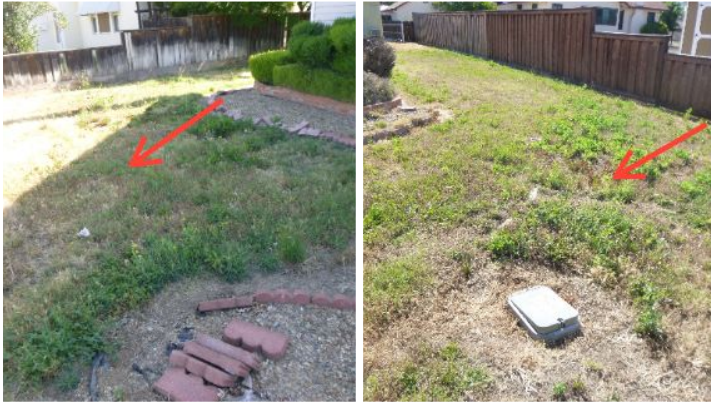
Marginal

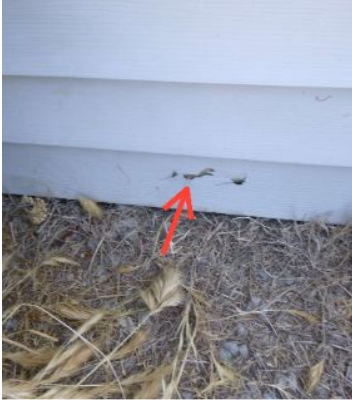
Marginal

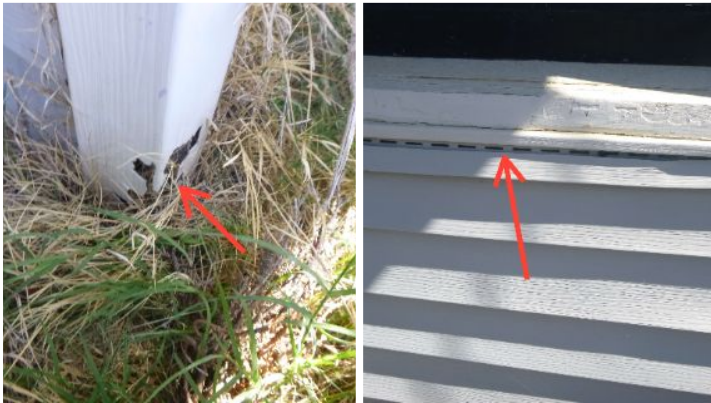
Small holes in the bottom and loose

Marginal

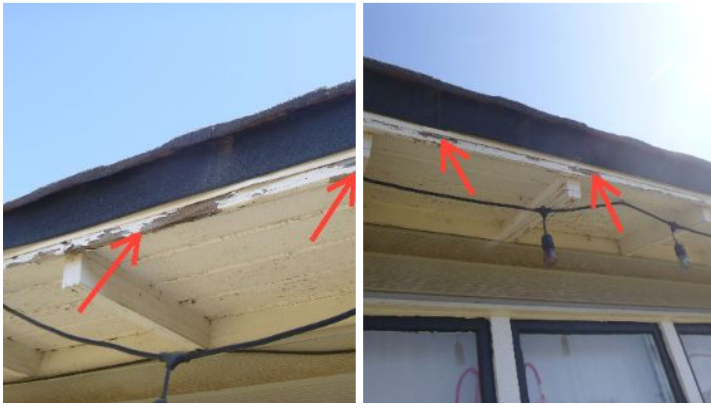
Marginal

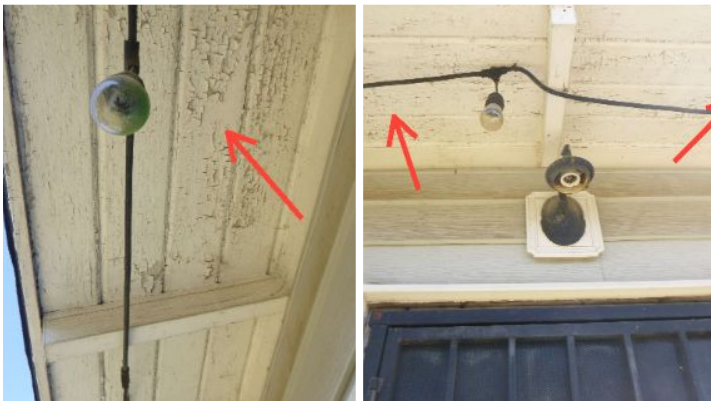
Paint peeling

Marginal

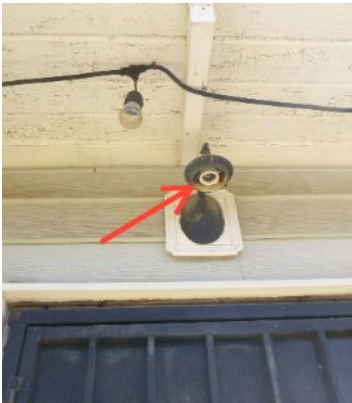
The front light cover is missing

Marginal

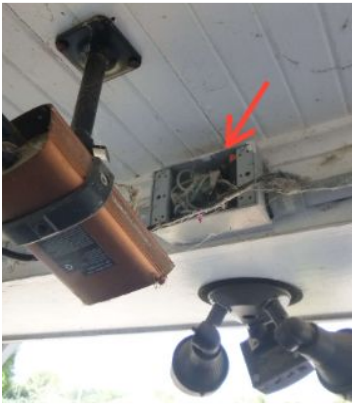
One cover is missing

Marginal

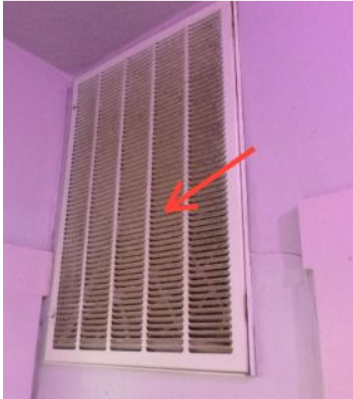
The filter is dirty and needs to be replaced

Defective

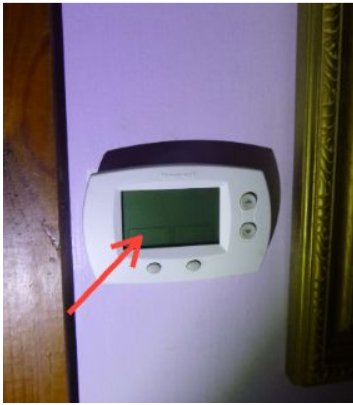
The thermostat is not working

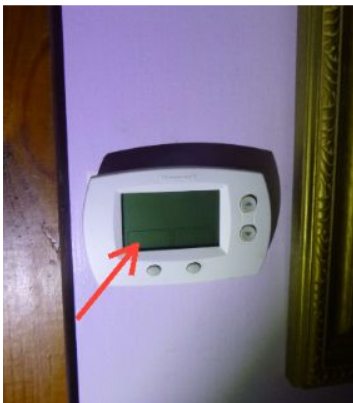
The thermostat was not working

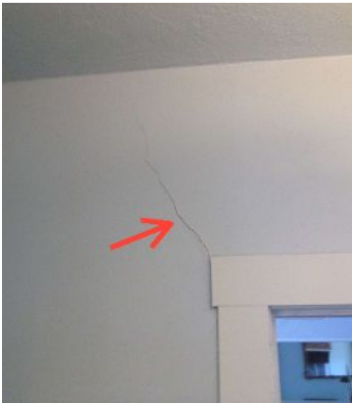
Cracks present

Marginal

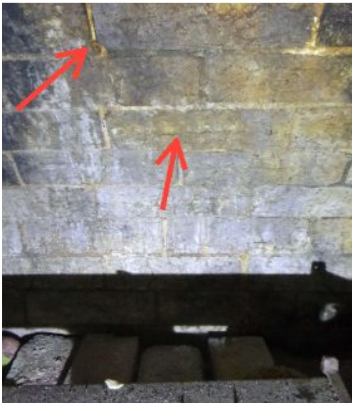
Open joints in the fire box. The fireplace should be removed

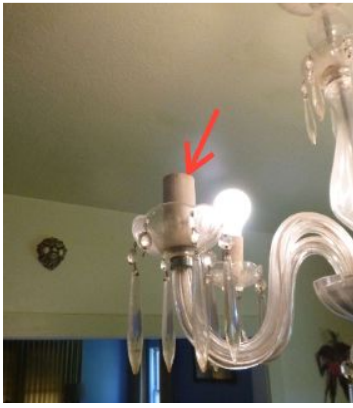
Light bulb missing

Marginal

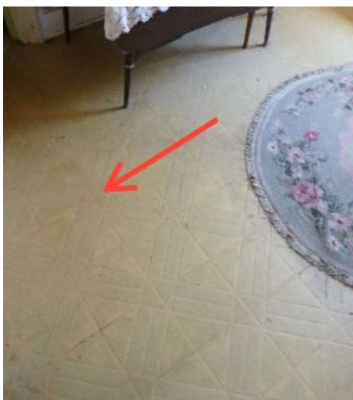
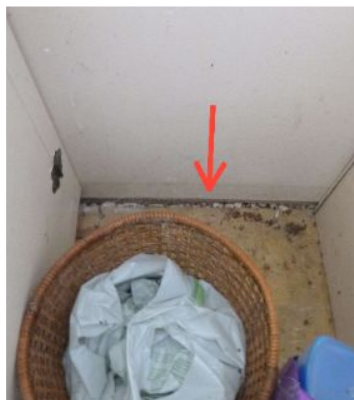
Worn and missing base board

Marginal

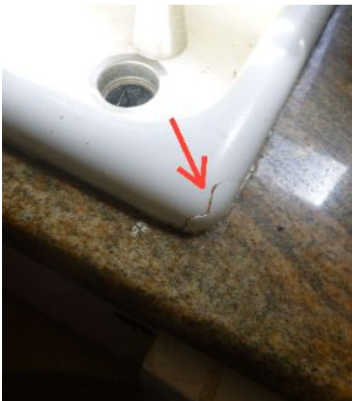
The corner is cracked

Marginal

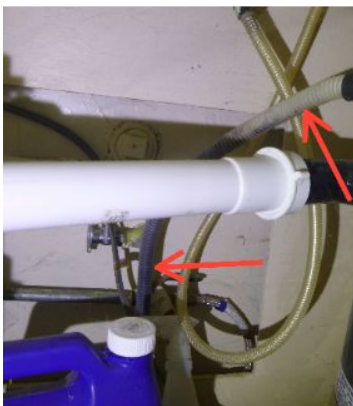
The drain needs to have a high loop

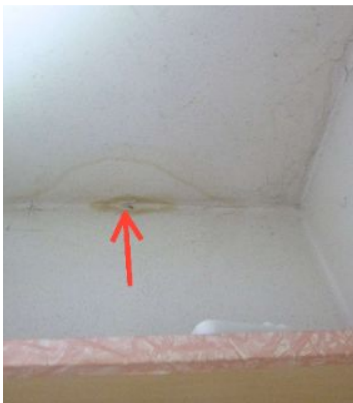
Water stains noted in the closet. These appear to be old

Marginal

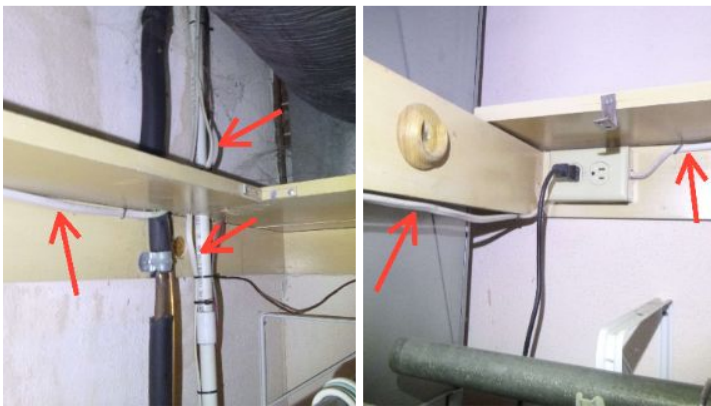
The wires in the closet need to be protected

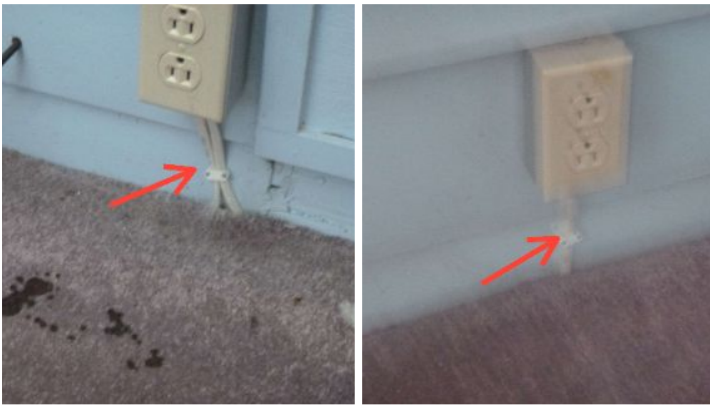
One missing plug cover. The light cover is missing

Marginal

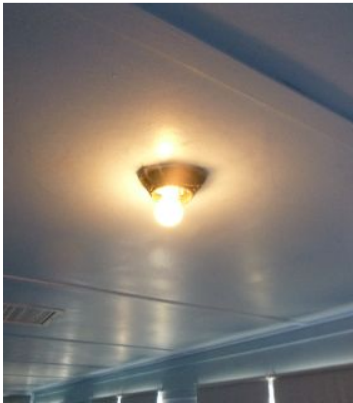
The light cover is missing

Marginal

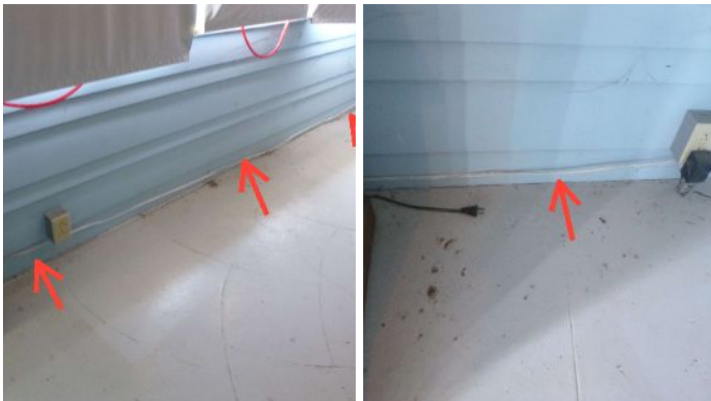
The plug wires need to be protected

Defective

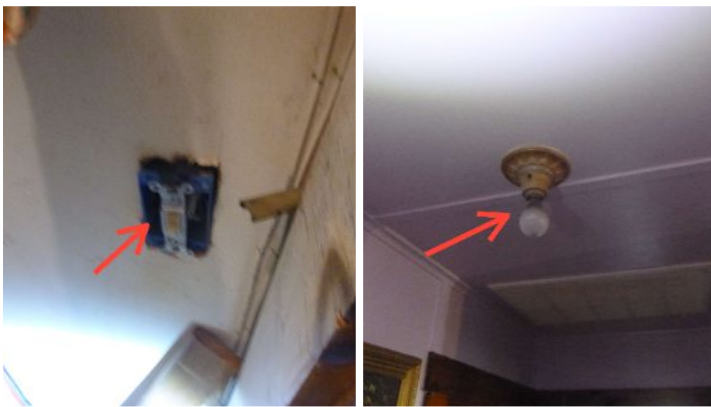
Missing switch cover and one light is out

Marginal

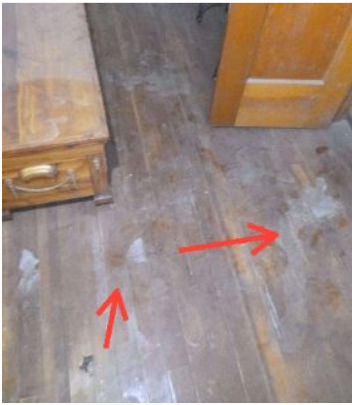
Worn wood floor finish

Marginal

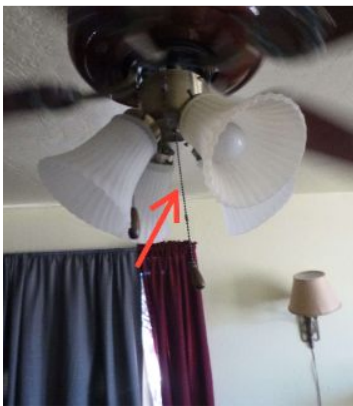
Bulbs out

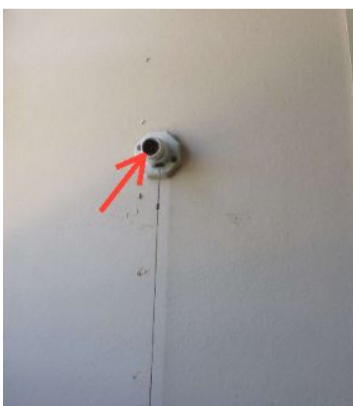
Missing bulb in the closet

Marginal

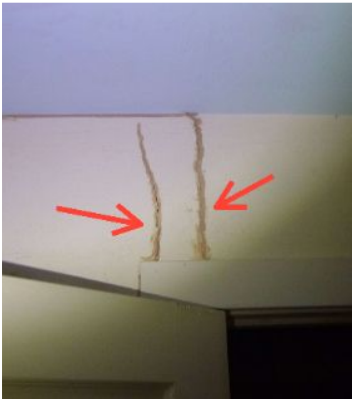
Cracks present

Marginal

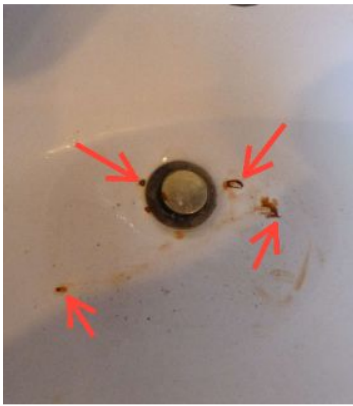
Stains noted

Marginal

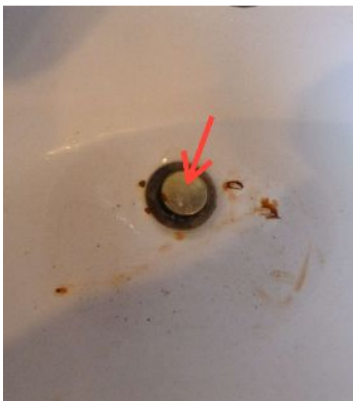
29.10 FAUCETS/TRAPS

The sink stopper is not working

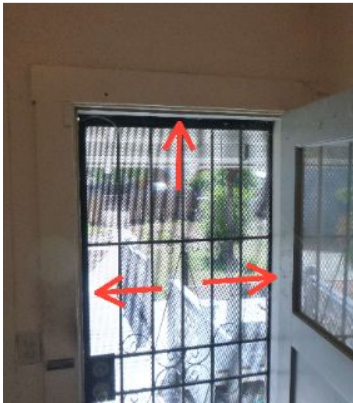
The door needs weather stripping

Defective

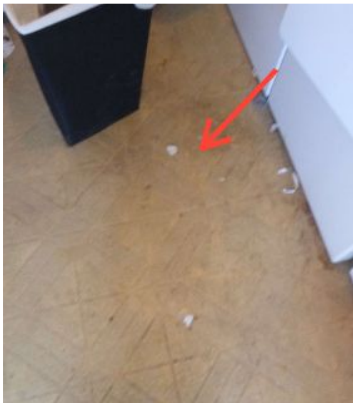
Worn

Marginal

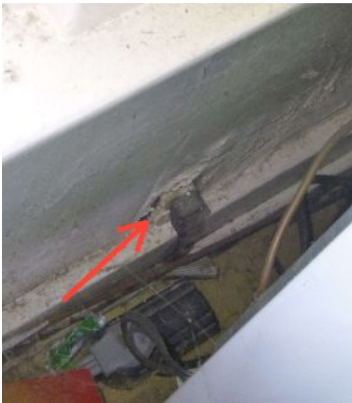
Plug cover missing behind the refrigerator

Marginal

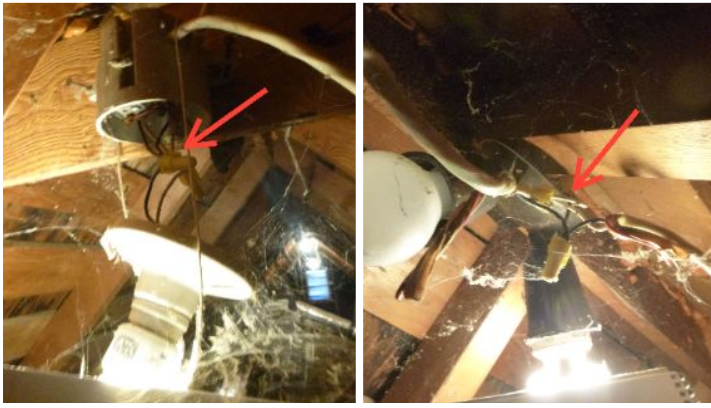
The lights need to be installed properly

Defective

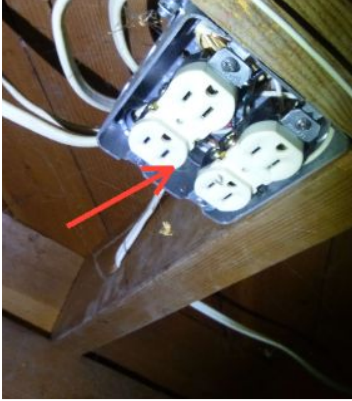
One plu box is missing the cover

Marginal

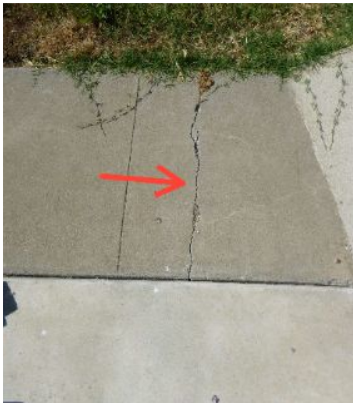
Cracks noted

Marginal

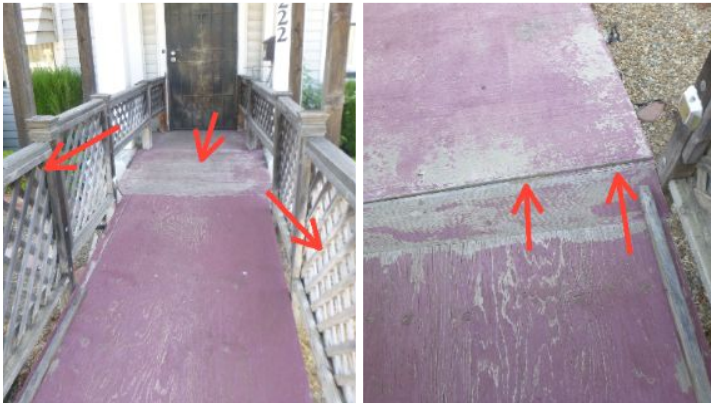
1.3 STEPS/STOOPS

The front wood ramp needs to be re painted and has a trip hazard

Defective

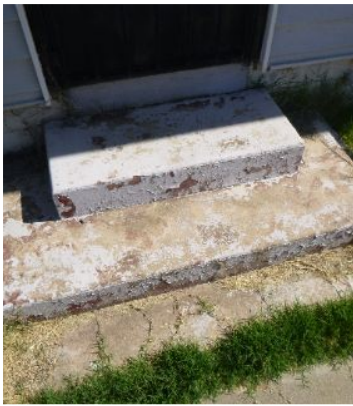
Paint peeling

Defective

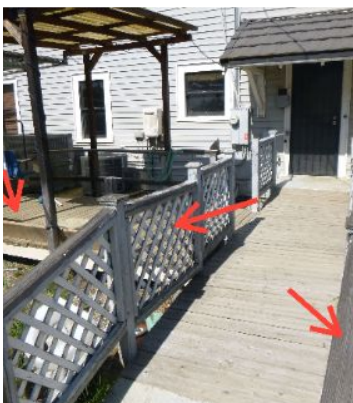
1.4 DECK

The back deck needs to be repaired

Defective

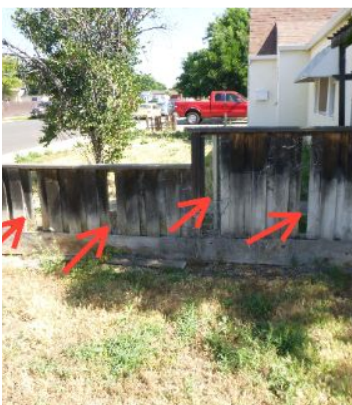
1.7 FENCES

The fence is in need of repair

Defective

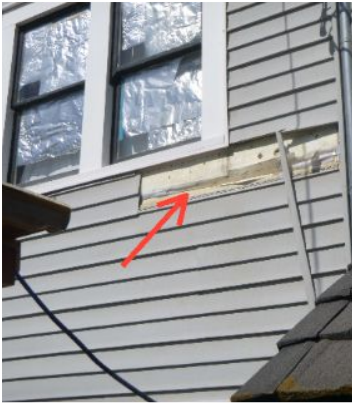
2.2 BALANCE OF THE HOUSE

Missing pieces in the back

Defective

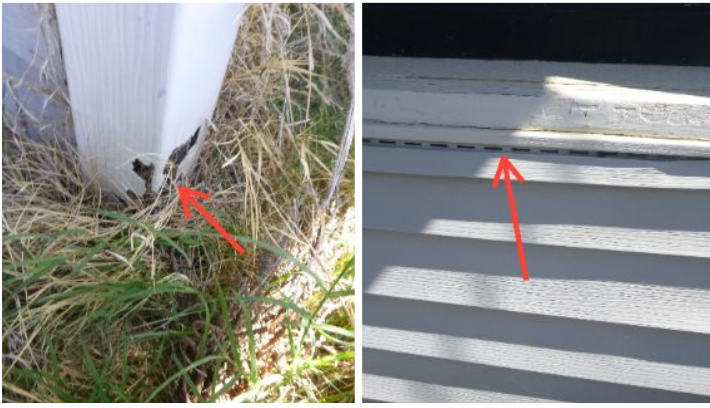
2.3 TRIM

Small holes in the bottom and loose

Marginal

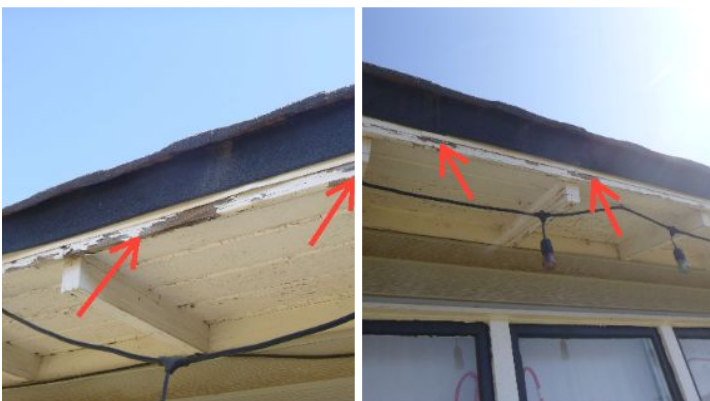
Paint peeling

Marginal

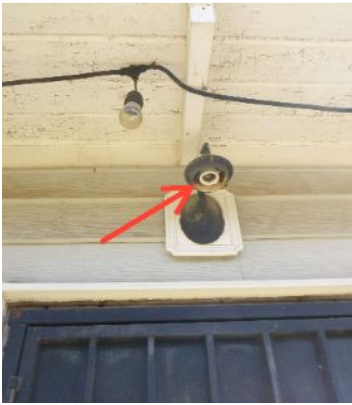
The front light cover is missing

Marginal

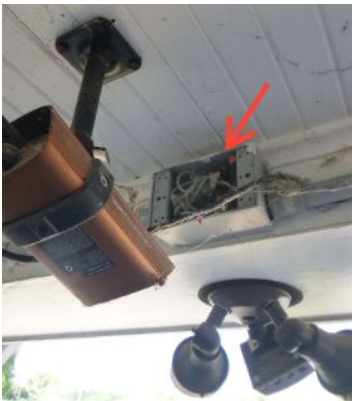
2.10 EXTERIOR ELECTRIC OUTLETS

One cover is missing

Marginal

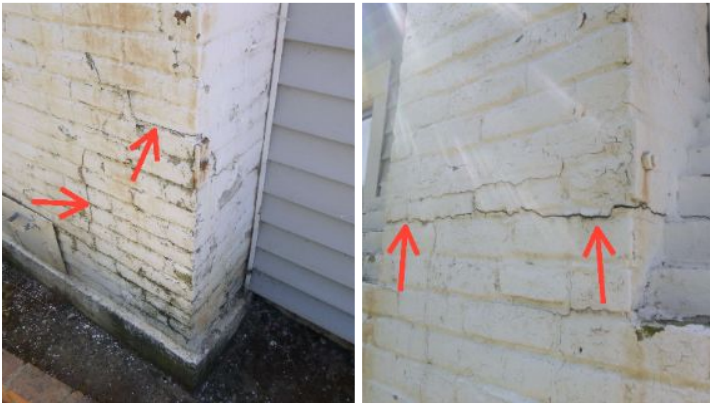
3.9 CHIMNEY

The box is cracked down low. The chimney is cracked at the sholder. The fire place should be removed and rebuilt

Defective

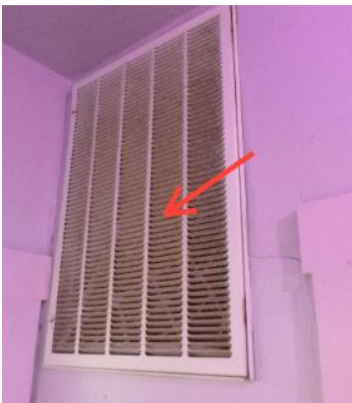
7.13 BLOWER FAN/FILTERS

The filter is dirty and needs to be replaced

Defective

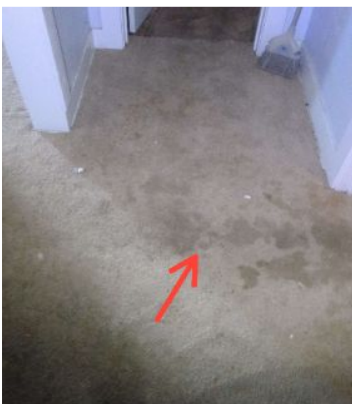
11.2 FLOOR

Damaged carpet

Defective

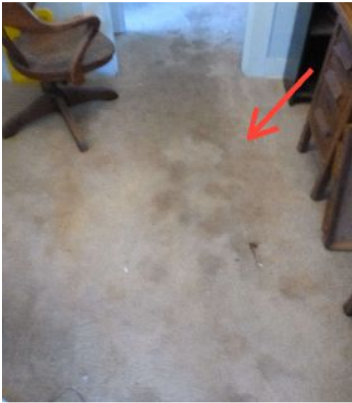
12.2 FLOOR

Damaged carpet

Defective

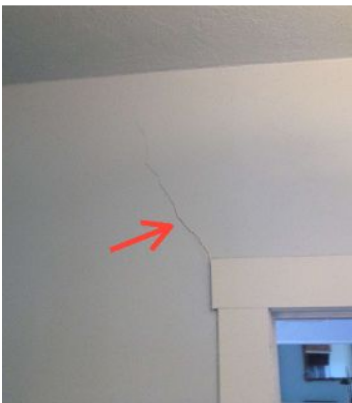
12.3 WALLS

Cracks present

Marginal

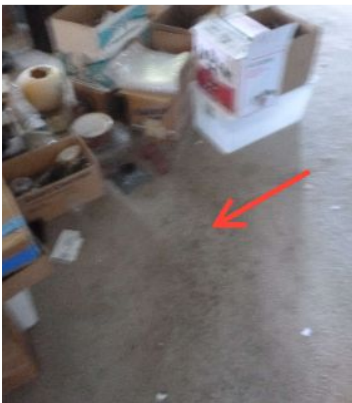
13. Living Room

Damaged carpet

Defective

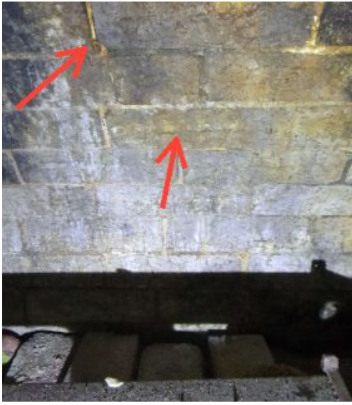
14.1 FIRE PLACE

Defective

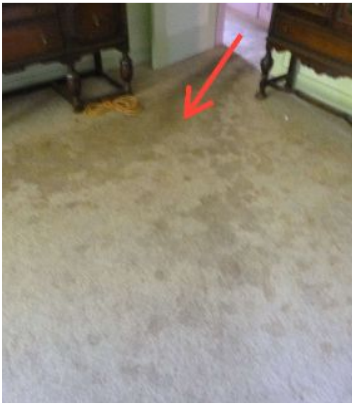
15.2 FLOOR

Damaged carpet

Defective

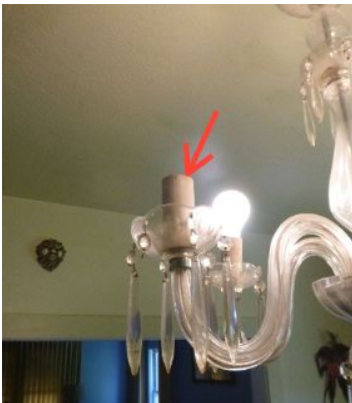
15.7 ELECTRICAL

Light bulb missing

Marginal

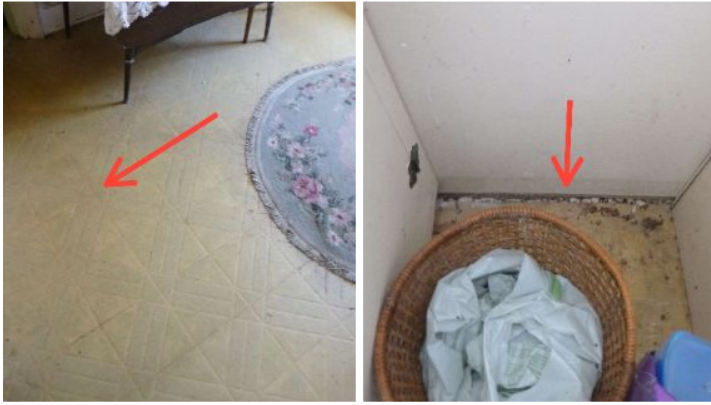
17.2 FLOOR

Worn and missing base board

Marginal

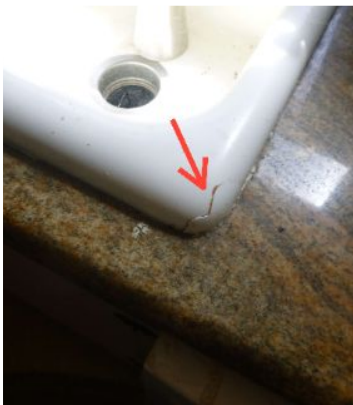
17.8 SINK

The corner is cracked

Marginal

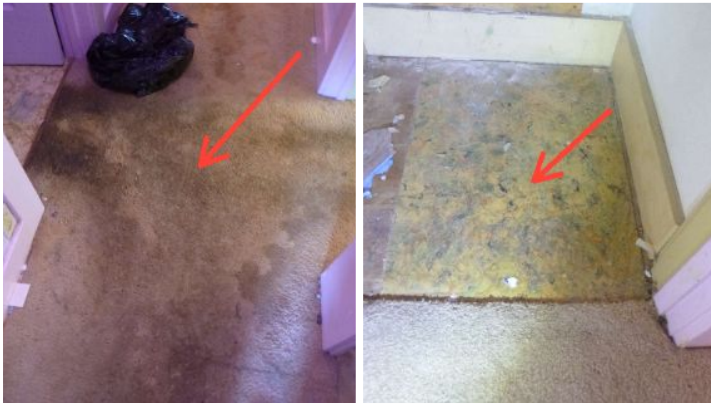
18.2 FLOOR

Damaged carpet. The old linoleum in the closet possibly contains asbestos. Most of the old floorings have asbestos. This is not a problem if left alone

Defective

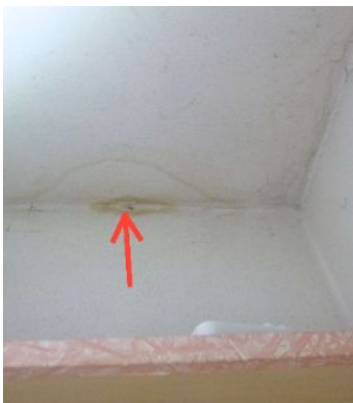
18.4 CEILING

Water stains noted in the closet. These appear to be old

Marginal

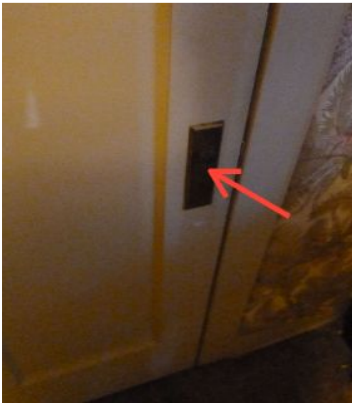
The closet knob is missing

Defective

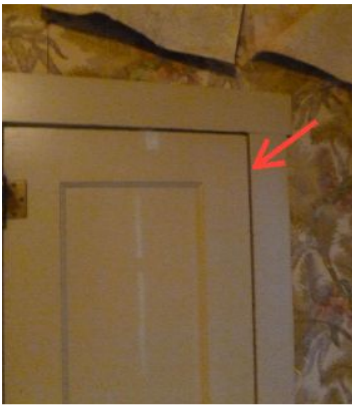
The door hits the jamb

Marginal

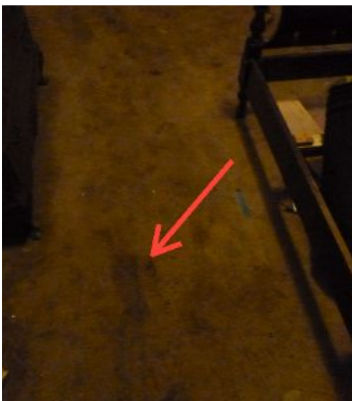
19.2 FLOOR

Damaged carpet

Defective

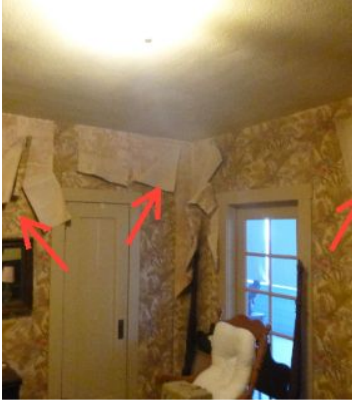
19.3 WALLS

Cracks present The wall paper is falling off

Defective

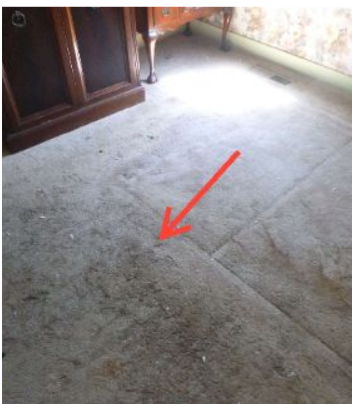
20.2 FLOOR

Damaged carpet

Defective

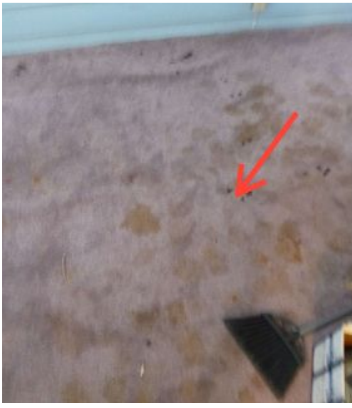
21.2 FLOOR

Damaged carpet

Defective

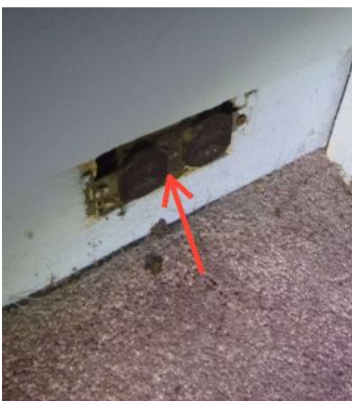
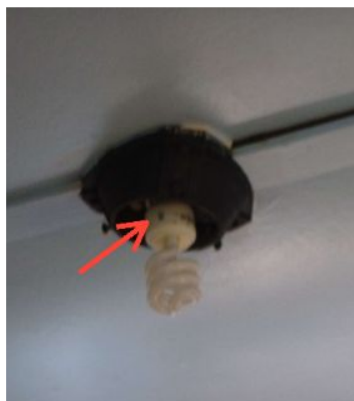
One missing plug cover. The light cover is missing

Marginal

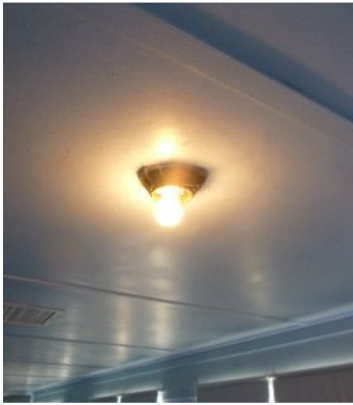
The light cover is missing

Marginal

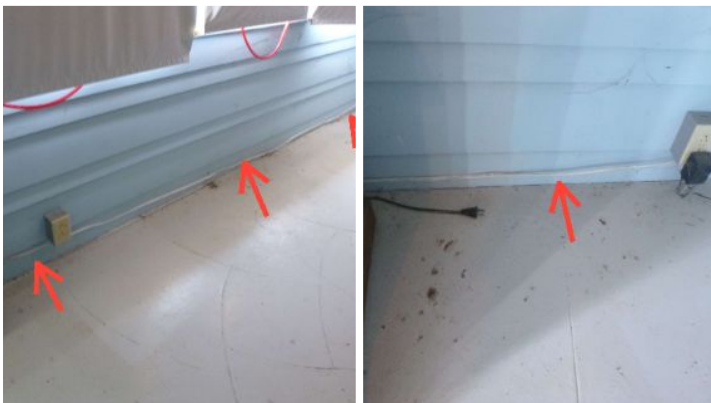
The plug wires need to be protected

Defective

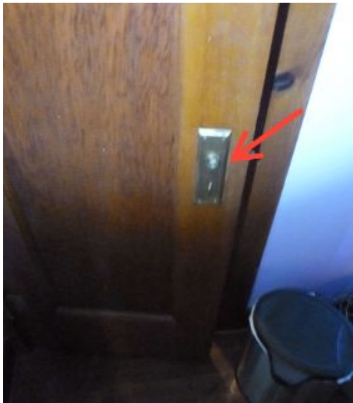
The door knob is missing

Defective

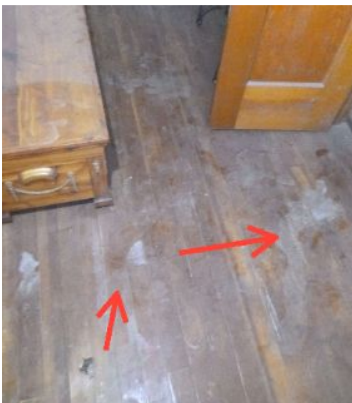
Worn wood floor finish

Marginal

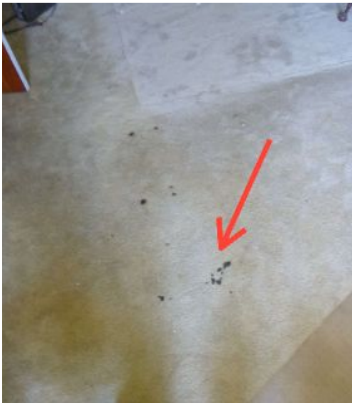
26.2 FLOOR

Damaged carpet

Defective

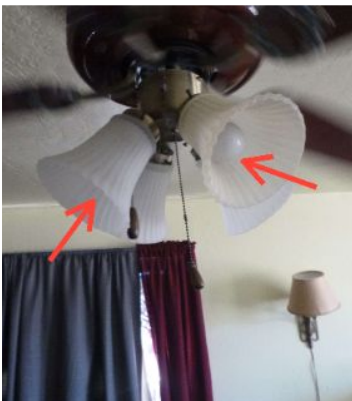
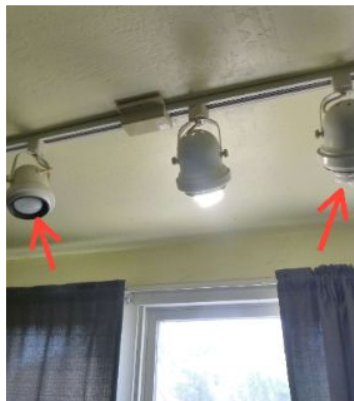
Bulbs out

Marginal

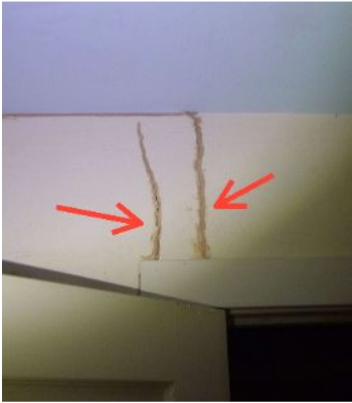
28.3 WALLS

Cracks present

Marginal

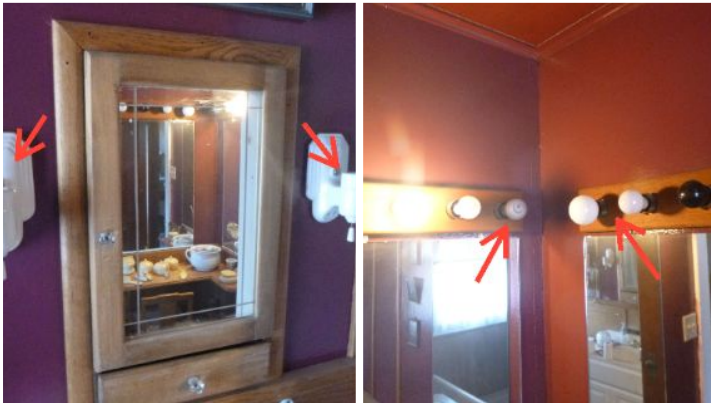
29.7 ELECTRICAL

Bulbs missing and out

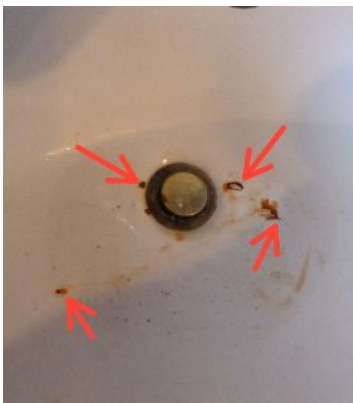
29.9 SINK/BASIN

Stains noted

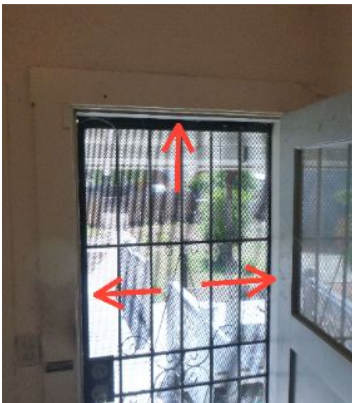
The door needs weather stripping

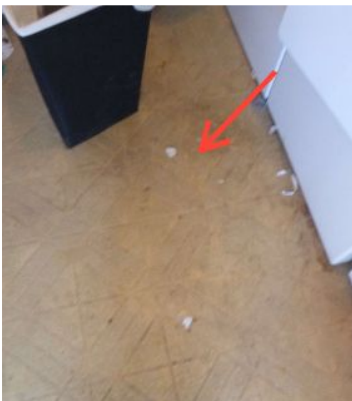
30.2 FLOOR

Worn

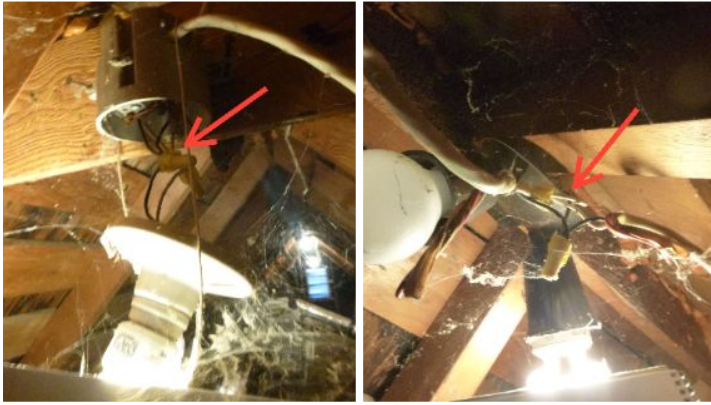
The lights need to be installed properly

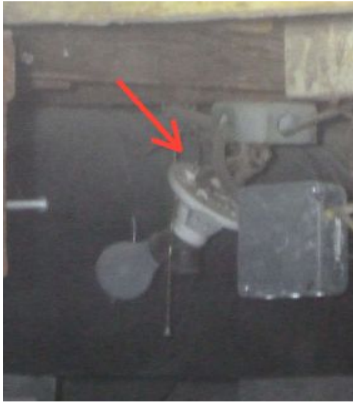
Inadequate ventilation. One Sq. Ft. of venting is required for each 150 Sq. Ft. of floor space

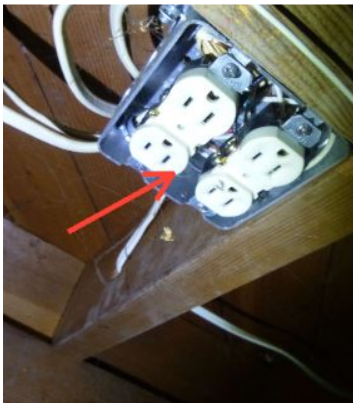
One plu box is missing the cover
