Real Estate Inspection Report

305 Canyon Highlands Drive
Oroville, CA 95966

Prepared For: Chris Heebink
Inspected On Wed, Mar 25, 2026 at 11:00 AM

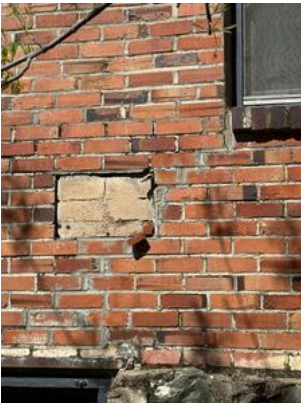
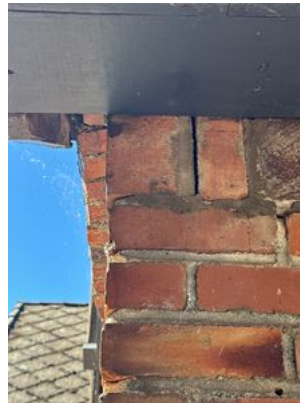
Comment 11

Damaged siding at east elevation.

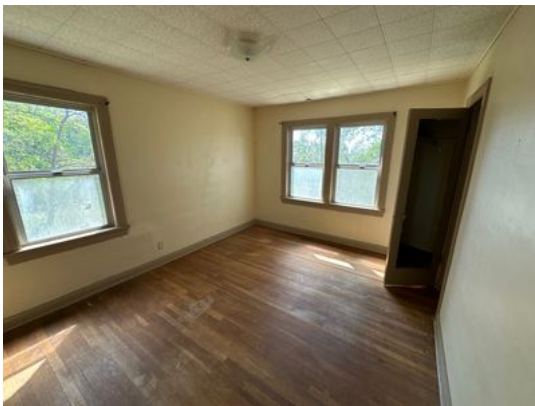
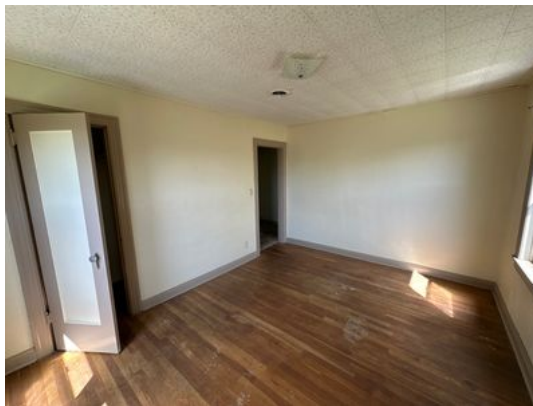
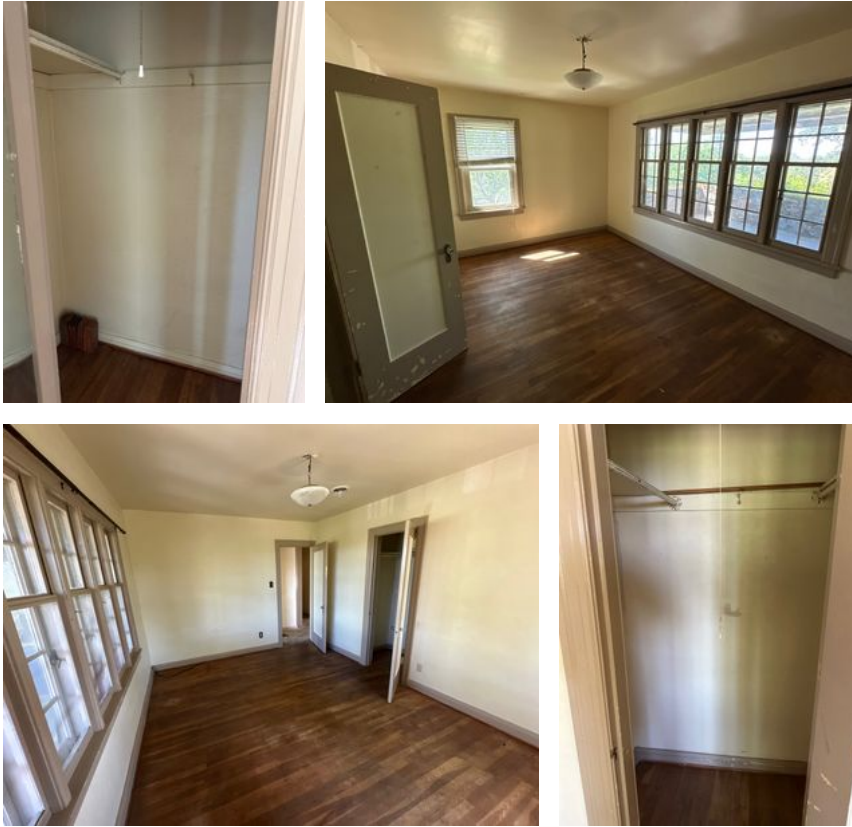
Comment 19

Damaged ceiling, wall in guest bedroom, recommend review for repair.

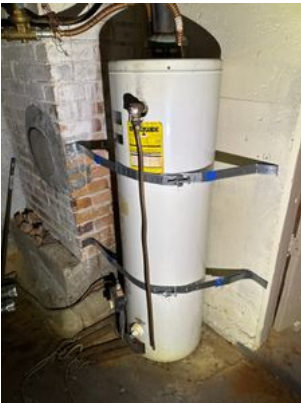
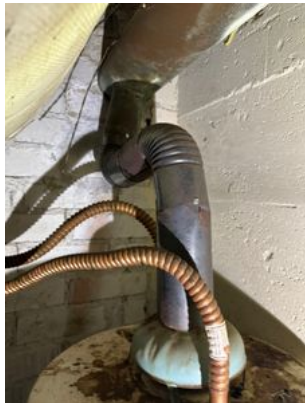
Comment 30

Improper venting at water heater, reverse slope. Recommend review for repair.

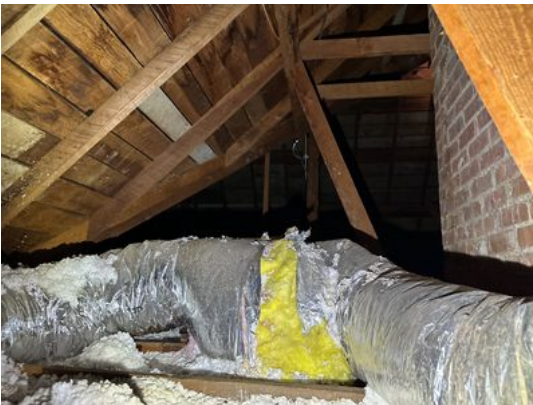
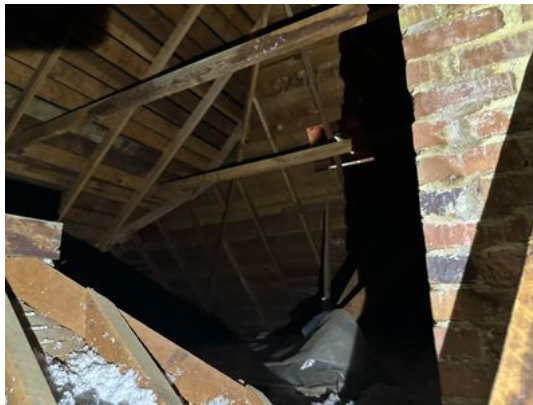
Attic areas.

Damage to sheathing, roof joists in area of chimney. Recommend review for repair.

Knob and tube present, noted.

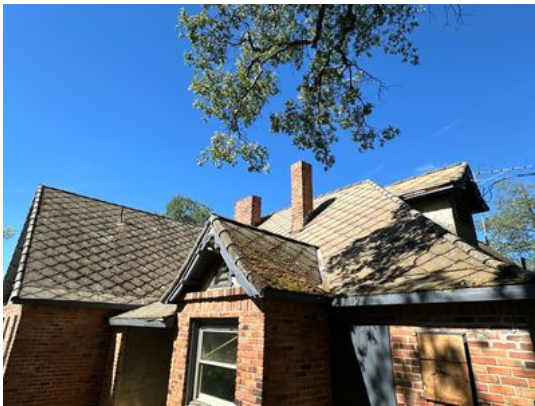
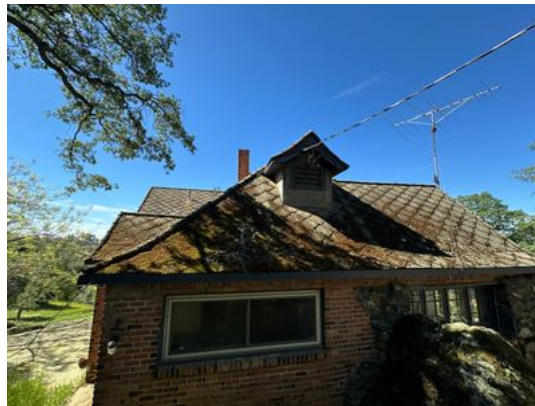
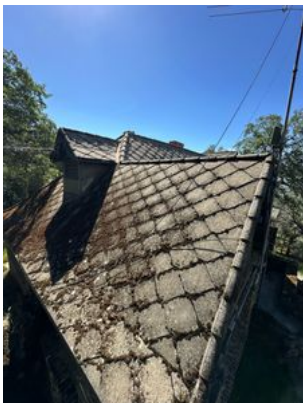
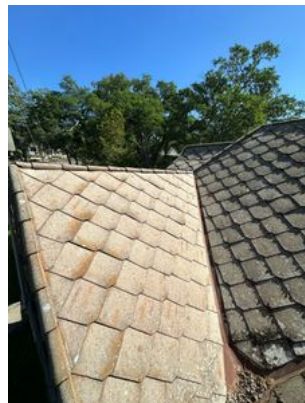
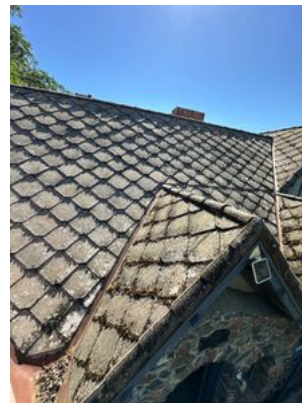
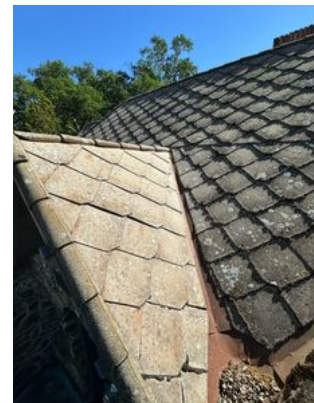
Roof areas.

Moss on roof. This can lead to the premature failure of the roof and subsequent leaks. Recommend treating moss during its growing season (wet months) with a moss killer. For information on various moss treatment products and their pros and cons, visit <http://bryophytes.science.oregonstate.edu/page24.htm>

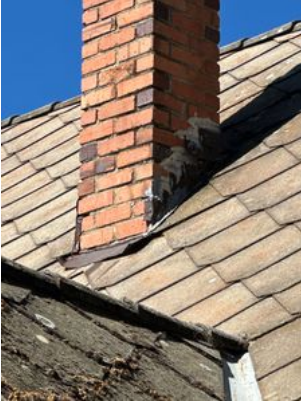
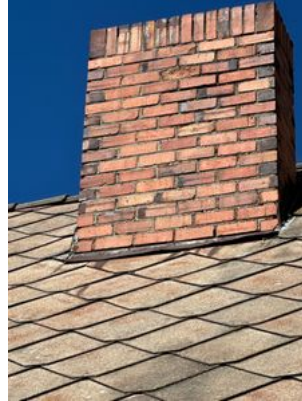
Flashings at chimney are rusted. Rain caps and spark arrestors not present. Recommend review for repair.

Recommend inspection by a roofing contractor.
