A-OK Home Inspection Service
(530) 321-5355
aokinspections.com

Real Estate Inspection Report

27 Inglewood Dr, Oroville,
CA 95966

Inspected On Sat, Feb 28, 2026 at 10:30 AM

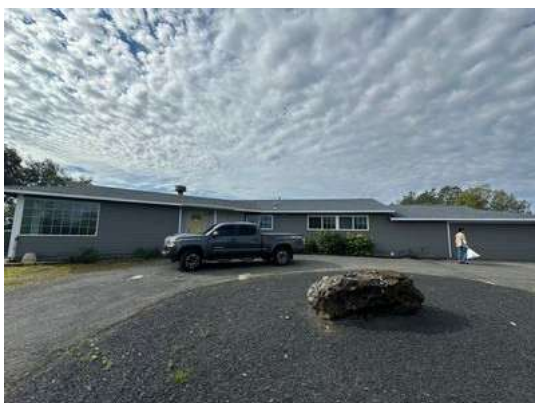
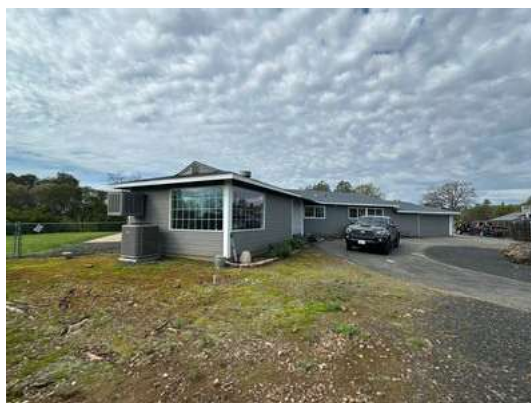
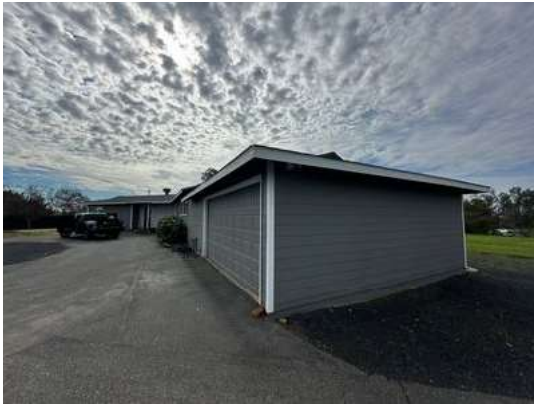
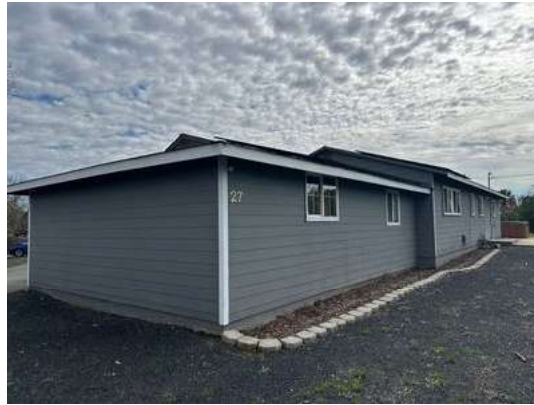
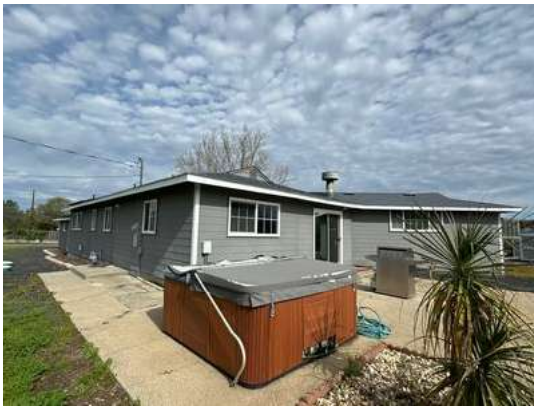
Broken living room fixed window. Broken garage window.

Window(s) noted with a moisture barrier breach. Northeast elevation, southwest elevation bathroom, southwest elevation guest bedroom, southwest living room fixed.

Damaged siding along ground level, southwest elevation. Recommend review for repair.

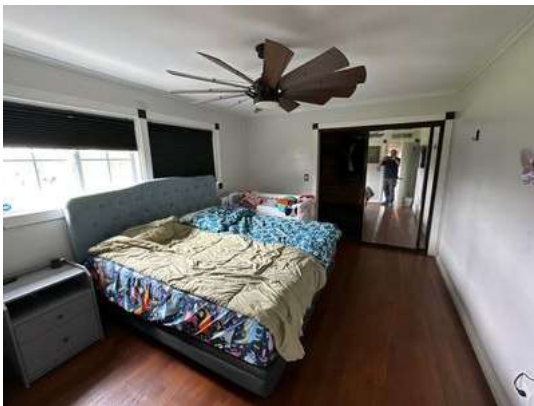
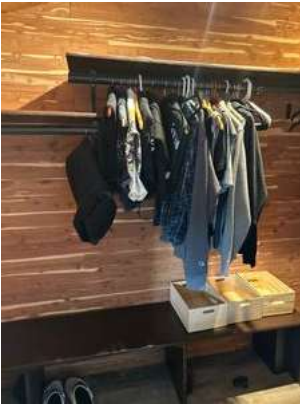
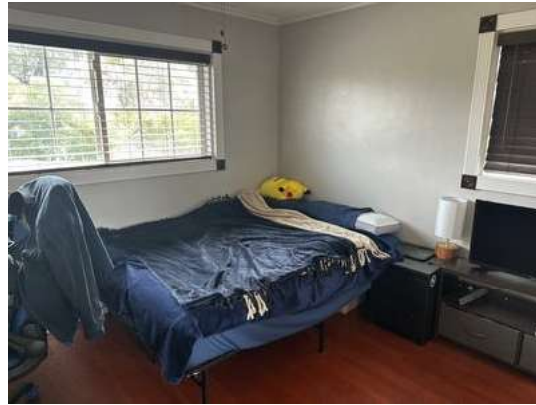
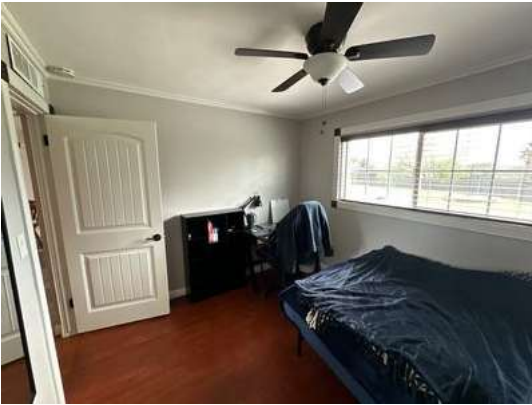
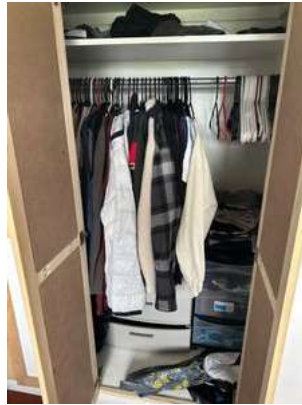
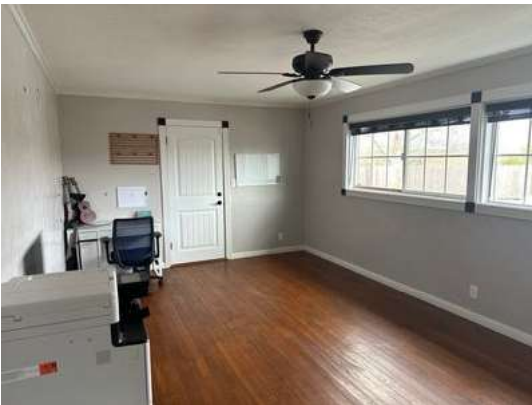
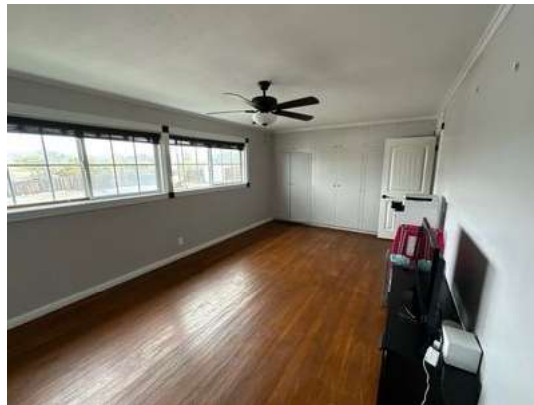
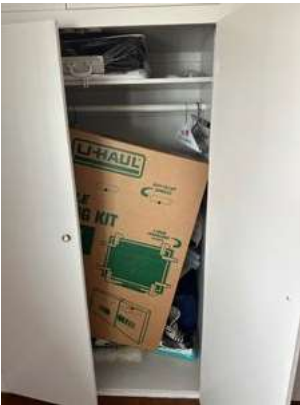
Smoke detector missing from guest bedroom.

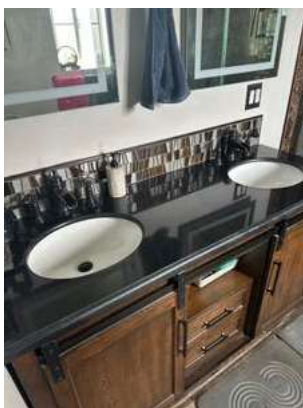
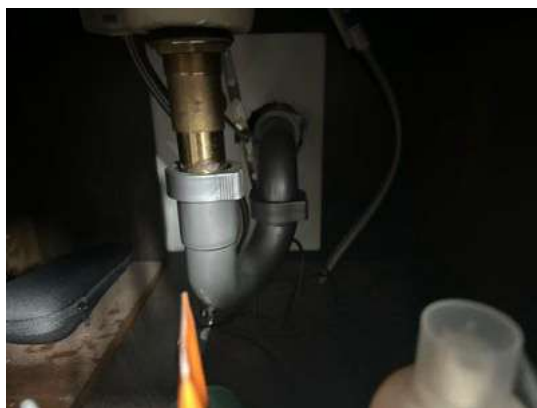
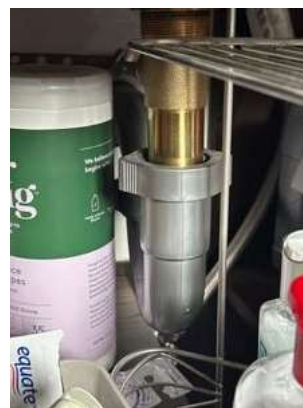
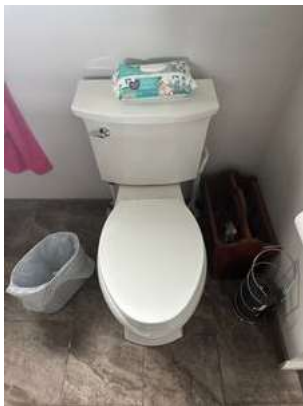
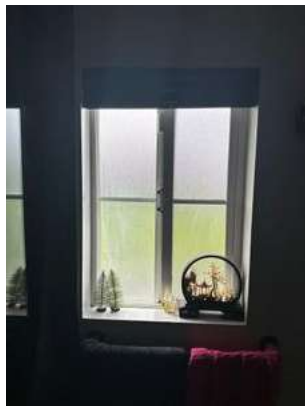
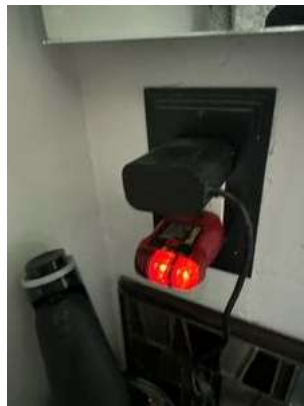
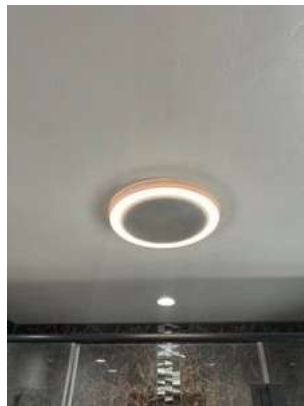
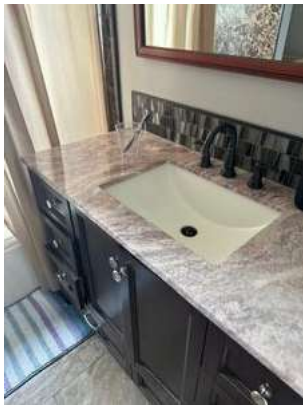
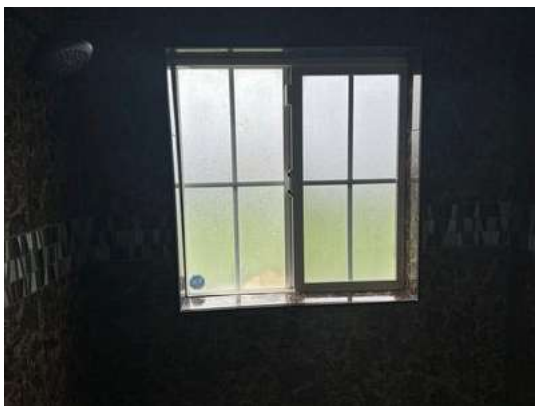
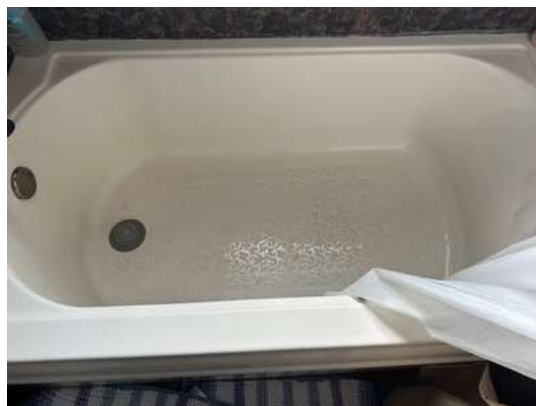
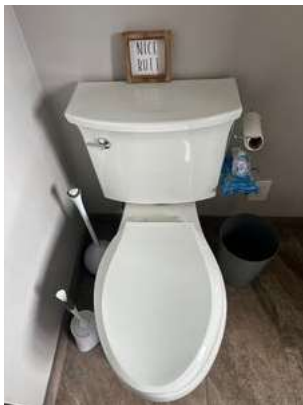
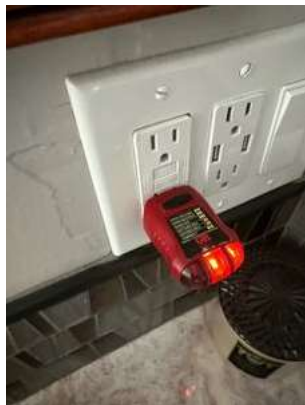
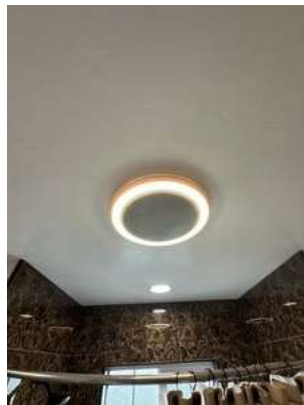
It's rather common for corrosion to gather on valves & fittings under the sink in bathrooms as well as the toilet shut off valves. Overall corrosion is generally considered a maintenance type of item, unless active leaking is present.

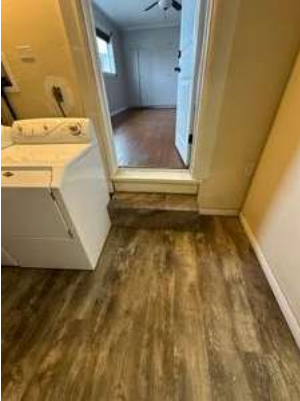
Comment 14

Irregular steps at laundry room. 7 1/4" max Riser height recommended.

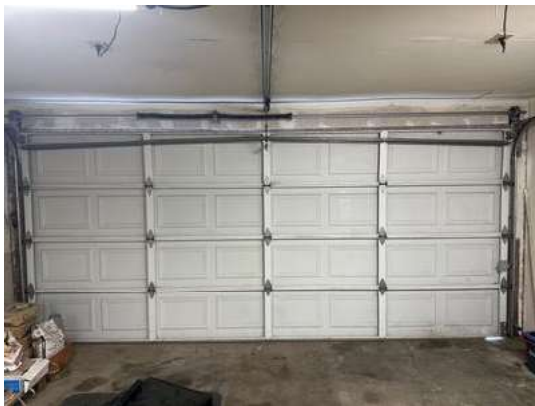
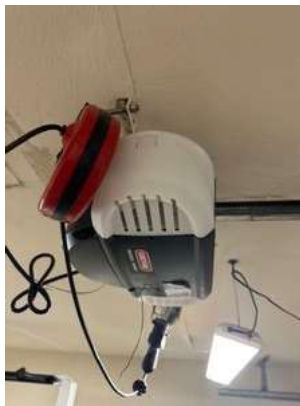
Comment 16

Unable to open garage door, error light on eye beam. Recommend review for repair.

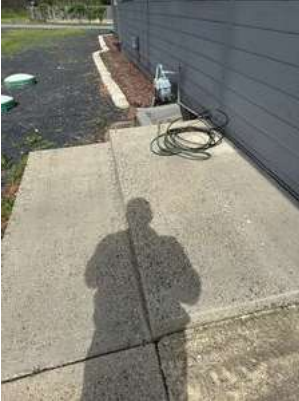
Comment 20

Exposed anchor bolts at side concrete pad. Potential trip hazard noted. Recommend removing.

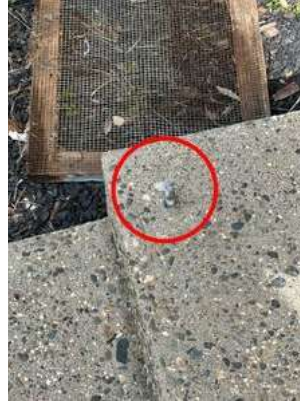
Comment 21

Predictable settling cracks on concrete walkway surfaces noted.

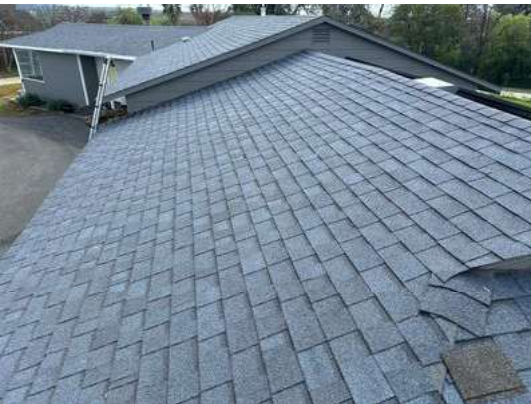
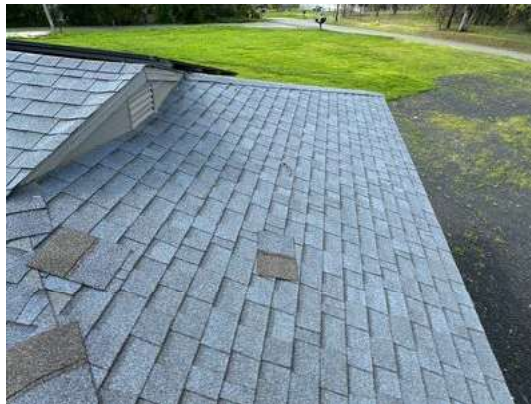
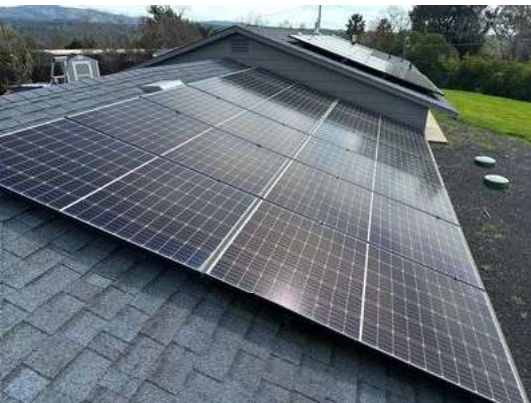
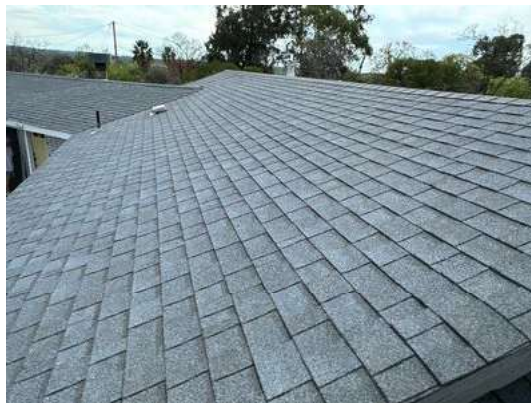
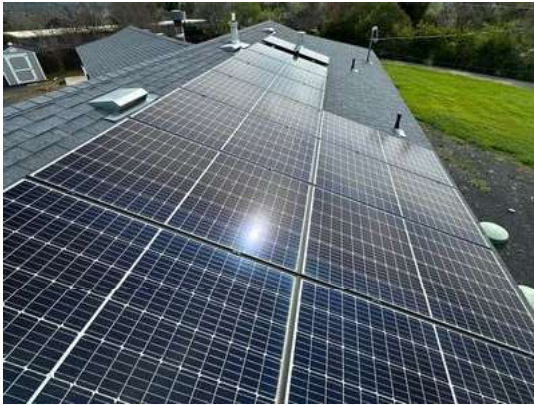
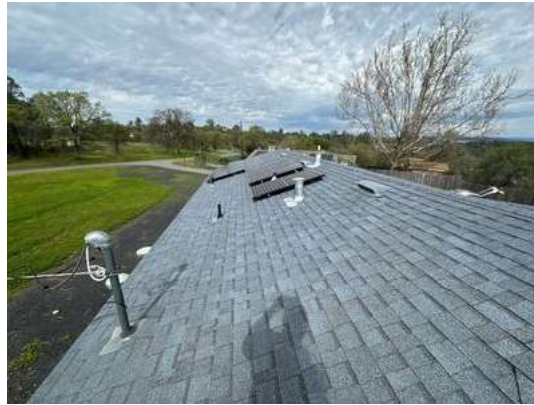
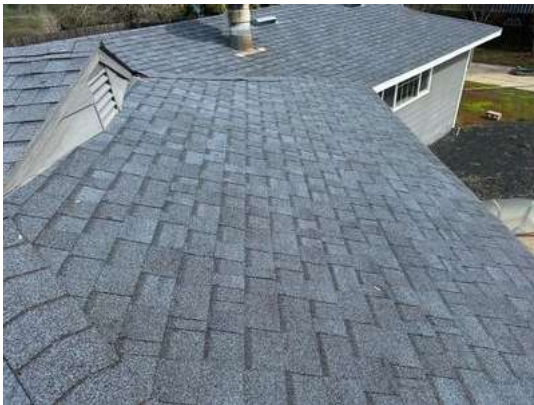
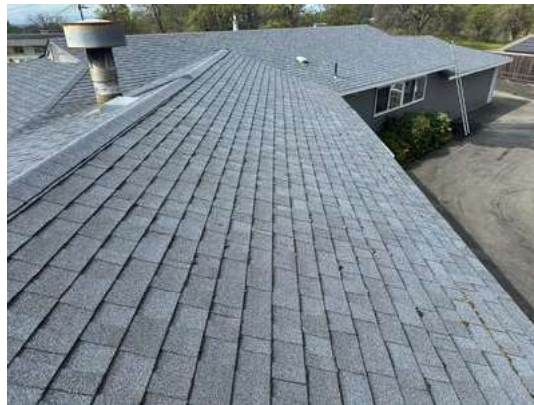
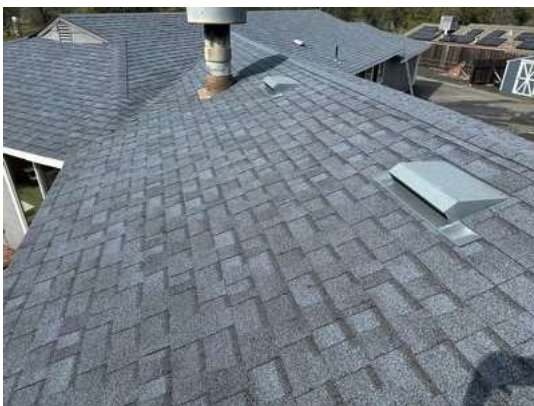
Roof areas.

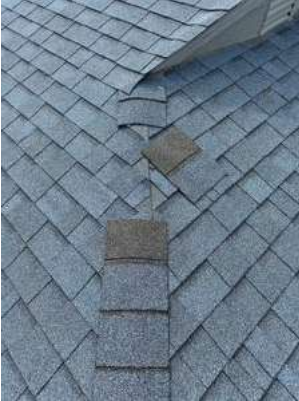
Shingles missing along ridge at garage.

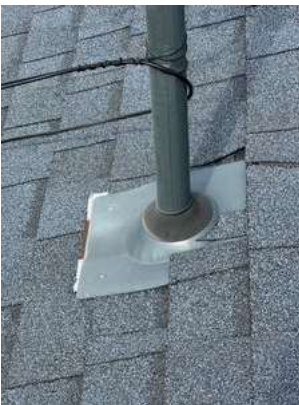
Comment 29

Electrical service drop boot flashing lifting. Recommend review, repair to prevent moisture intrusion.

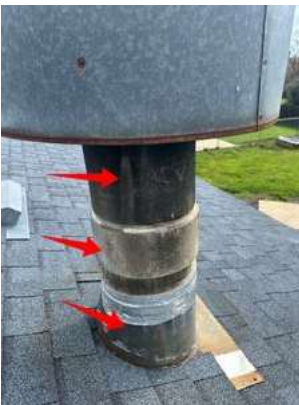
Possible asbestos materials observed. The materials appeared to be in serviceable condition at the time of inspection. Asbestos materials are considered safe by the EPA if they are not disturbed, torn, ripped, or damaged. No torn, ripped, or damaged materials were observed. If client has any concerns regarding asbestos materials, an asbestos testing lab should be consulted for further review to ensure safety. Fireplace chimney noted.

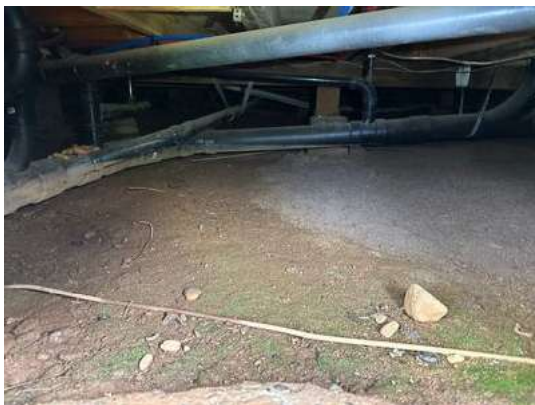
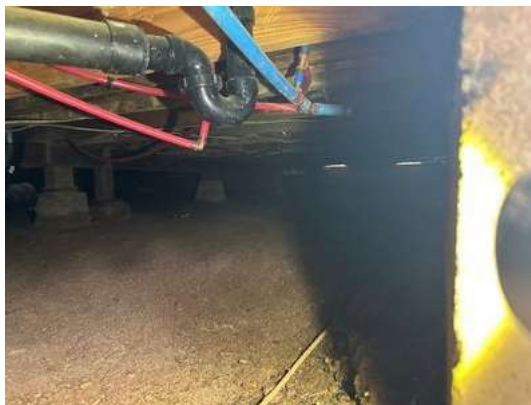
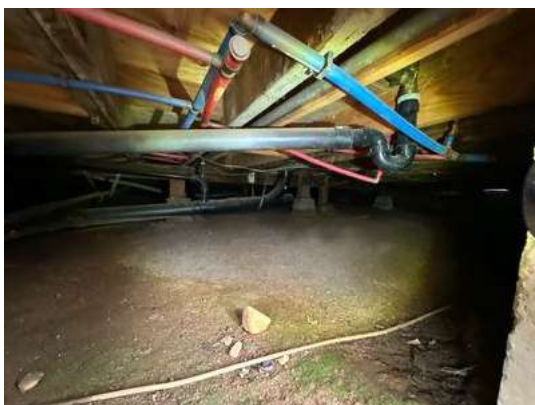
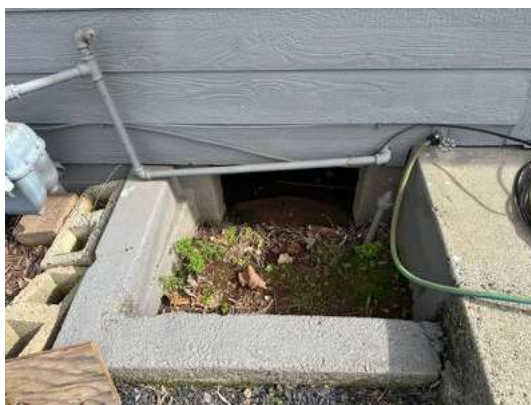
Foundation / Crawlspace areas.

Moisture/ mud in crawlspace, presumably from recent rains. Did not enter crawlspace.
