Accurate Inspection Team LLC
Property Inspection Report

336 Rosemont Blvd, San Gabriel, CA 91775
Inspection prepared for: Kingman Family Trust & Mary Vega Trustee
Real Estate Agent: Pete Whan - Pete Whan & Associates

Date of Inspection: 1/28/2026 Time: 10:00 am
Age of Home: 1941 Size: 1,484 sqft
Weather: Sunny & Warm

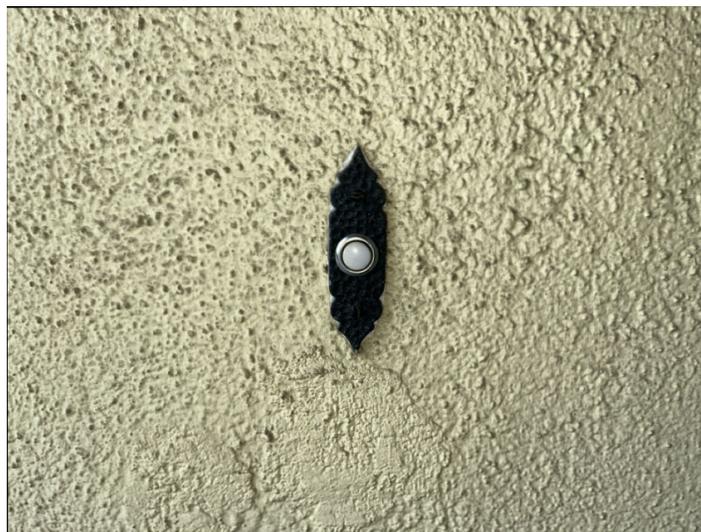
5. Door Bell

Observations: **door bell did not operate**

door bell did not operate

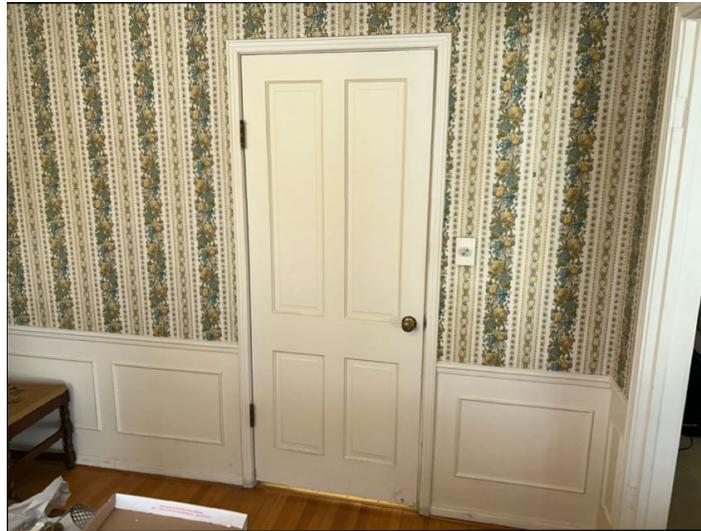
6. Interior Doors

Observations: functional, worn hardware, **hardware sticks, door did not latch**

hardware sticks, door did not latch

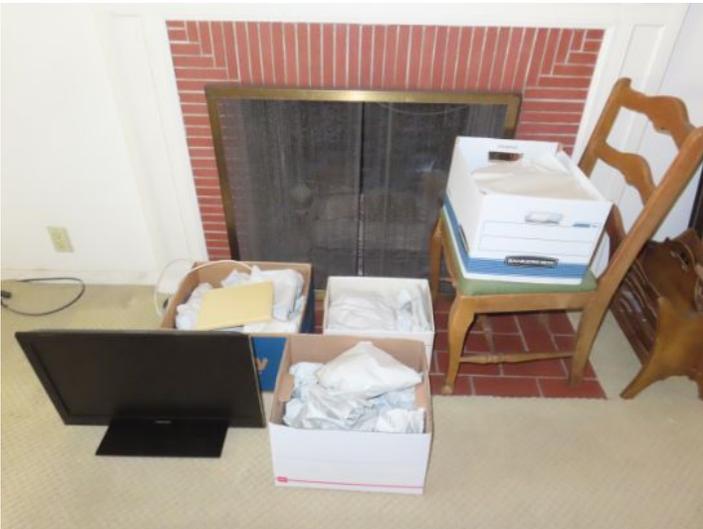
could not fully inspect due to personal items

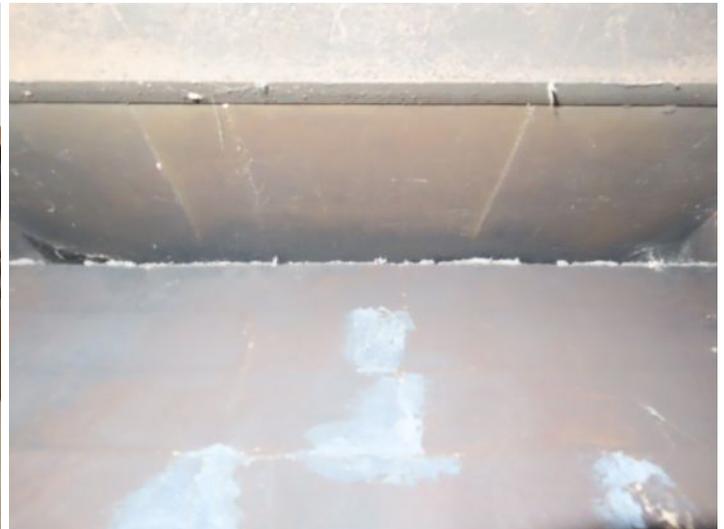
Observations: limited inspection, gas only, patching present, could not fully inspect due to personal items, **recommend cleaning, no damper door not visible**

no damper door not visible

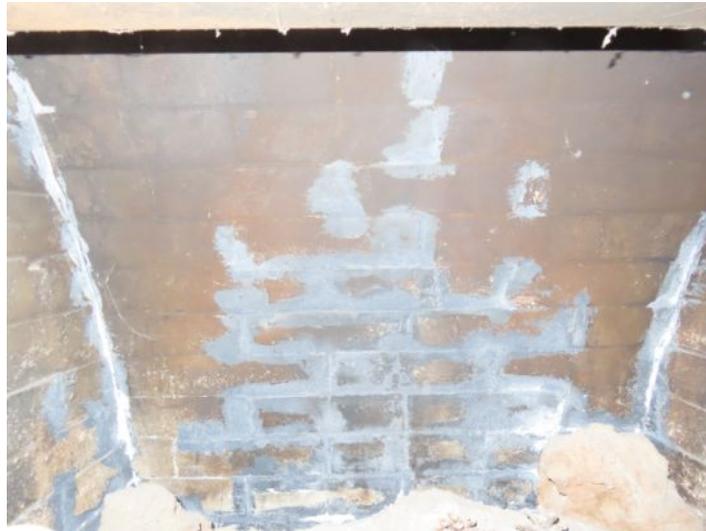
patching present

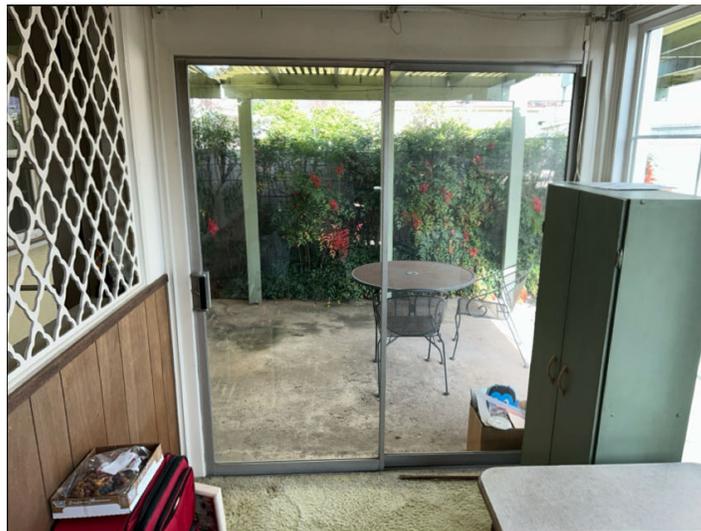
10. Interior Sliding Doors

Observations: **did not operate, stuck in closed position**

did not operate, stuck in closed position

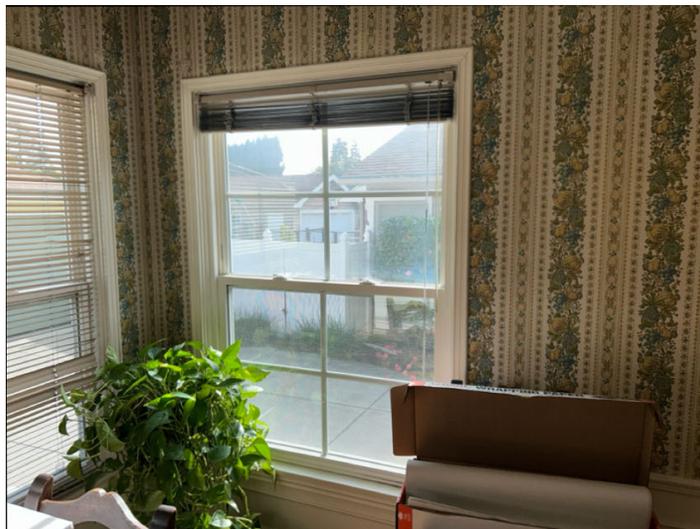
Observations: functional, worn hardware, dirty tracks, recommend cleaning tracks, **condensation present between the glass**

condensation present between the glass

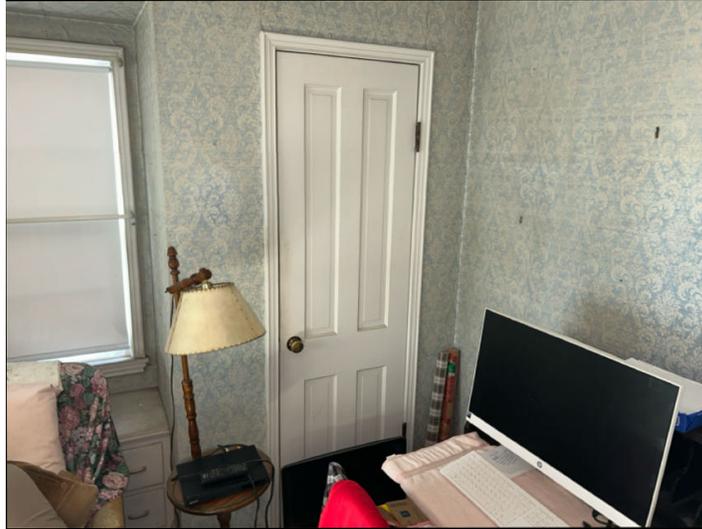
5. Bedroom Closets

not accessible due to personal items

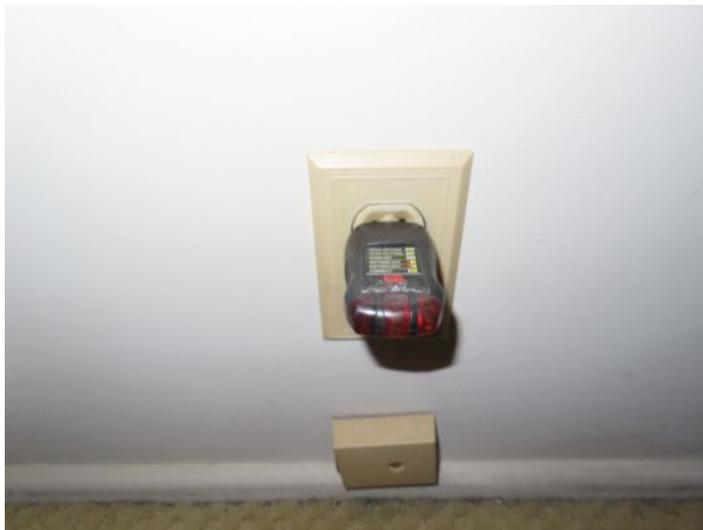
7. Bedroom Electrical

Observations: functional, worn switches & outlets, 3 prong outlets are not grounded, 2 prong outlets present, **dead outlet at the 2 prong outlet**

dead outlet at the 2 prong outlet

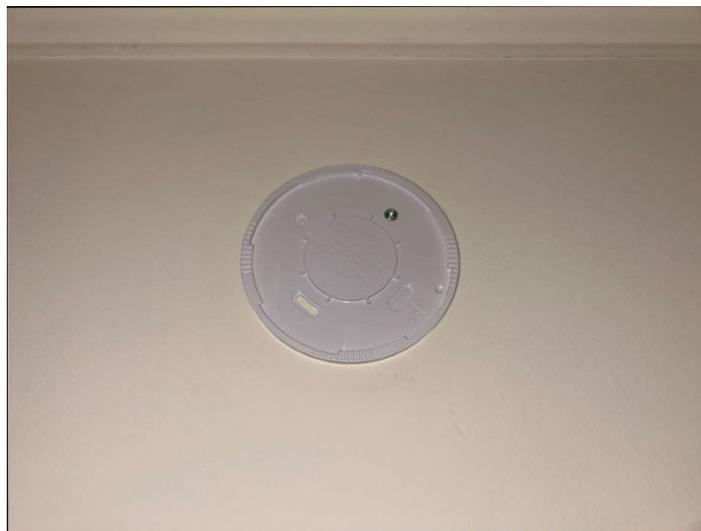
9. Bedroom Smoke Detectors

Observations: operated, **missing in #1 and #3 bedroom**

missing in bedroom

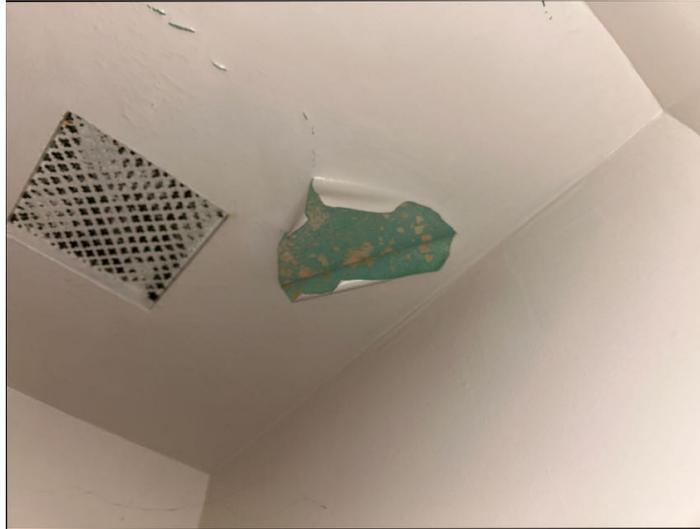
Observations: cracking small, **blistered and peeling paint in the shower**

blistered and peeling paint in the shower

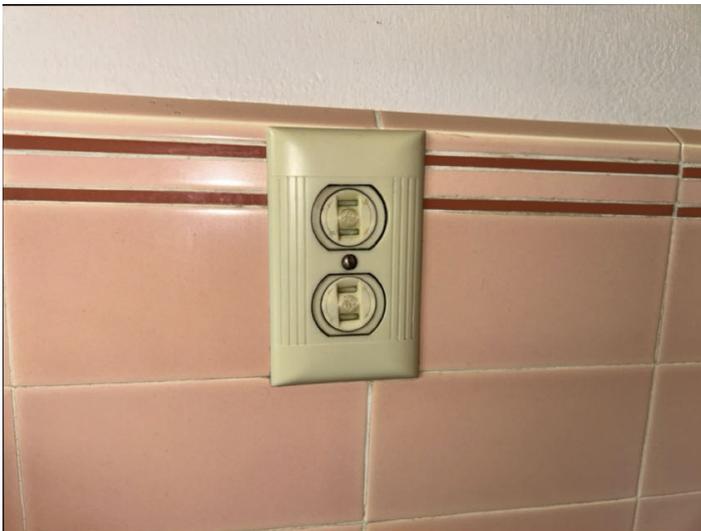
2 prong outlets present

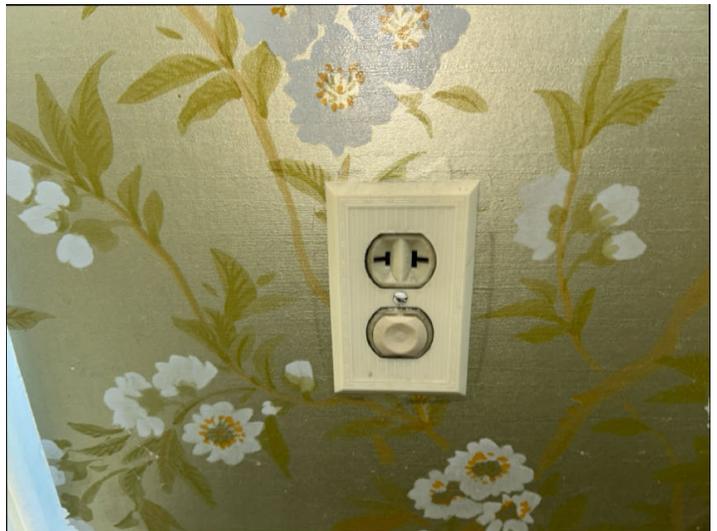
2 prong outlets present

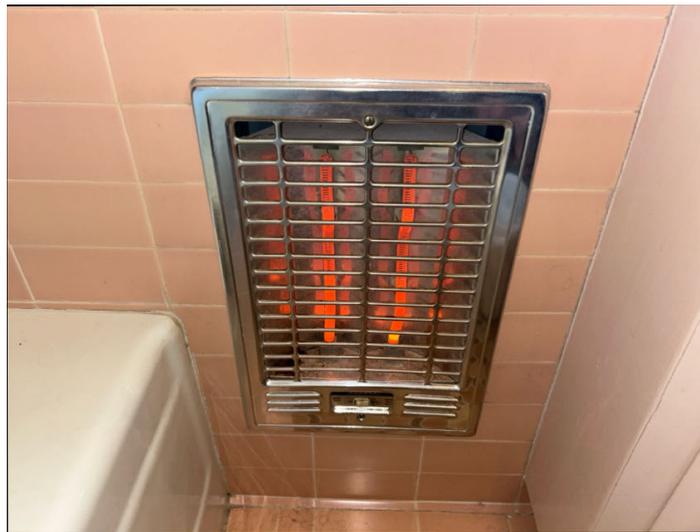
11. Bathroom Heating

Observations: electric wall heater operated, **recommend removal of electric wall heater**

recommend removal of electric wall heater

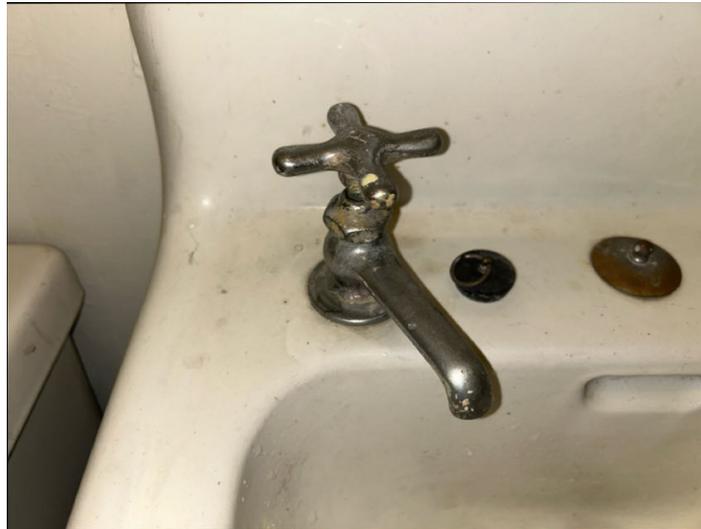
18. Bathroom Sinks

Observations: functional, worn fixtures & surface, **faucet leaks while operating**

faucet leaks while operating

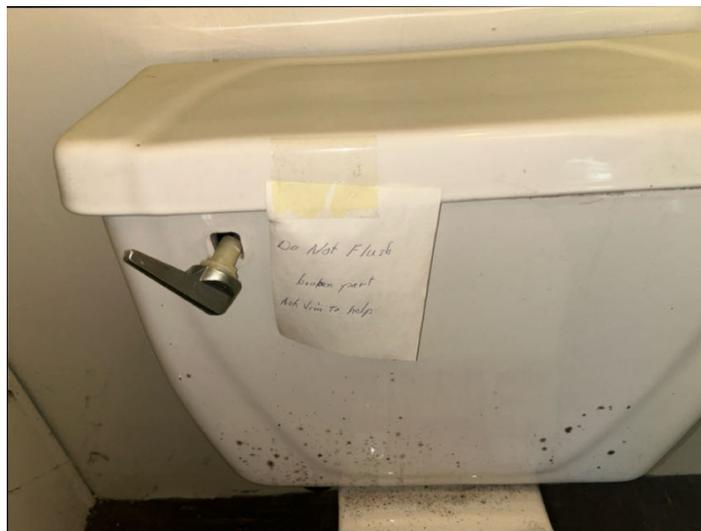
19. Bathroom Toilets

did not test toilet

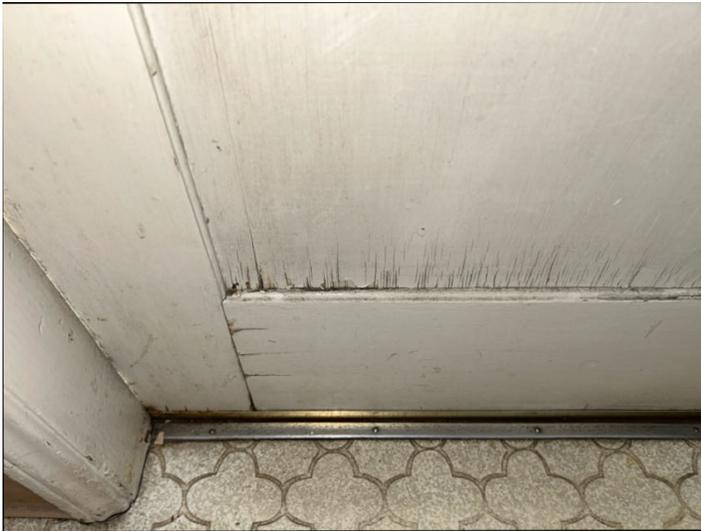
weathered

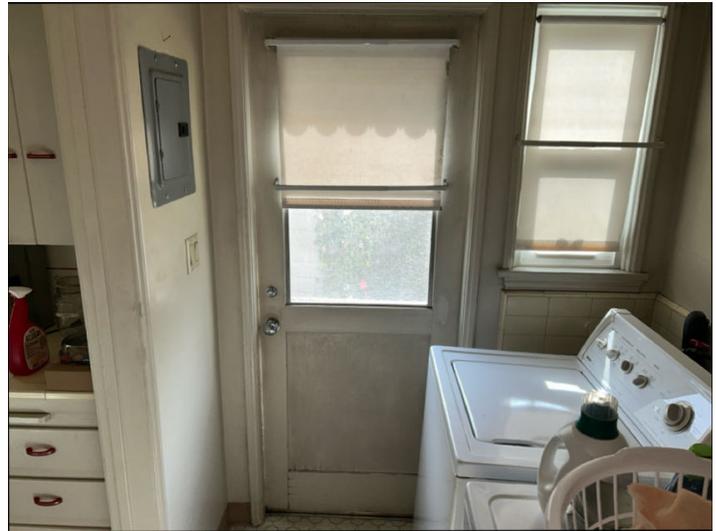
not square in the jamb

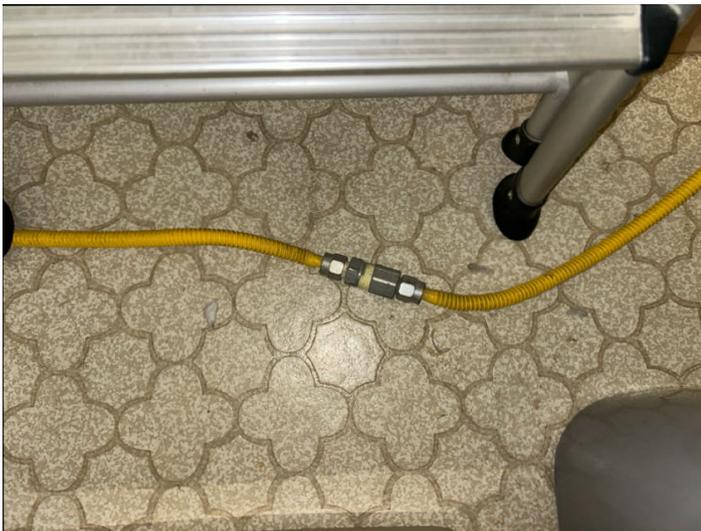
10. Laundry Gas Valves

Observations: functional, could not fully inspect, **unsecured gas line, irregular installation, using 2 flex gas lines, recommend further evaluation**

irregular installation, using 2 flex gas lines, recommend further evaluation

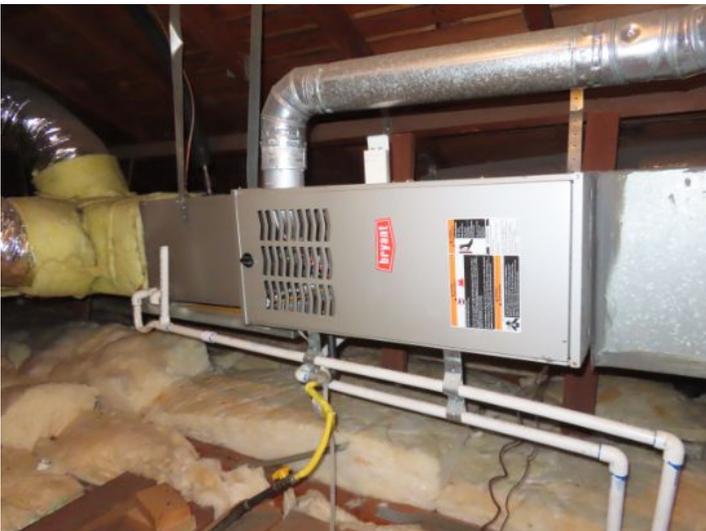
1. Heater Condition

Observations: operated, **recommend a licensed heating and A/C contractor for service, rusted drip pan, signs of leaking at the secondary condensation line**

operated

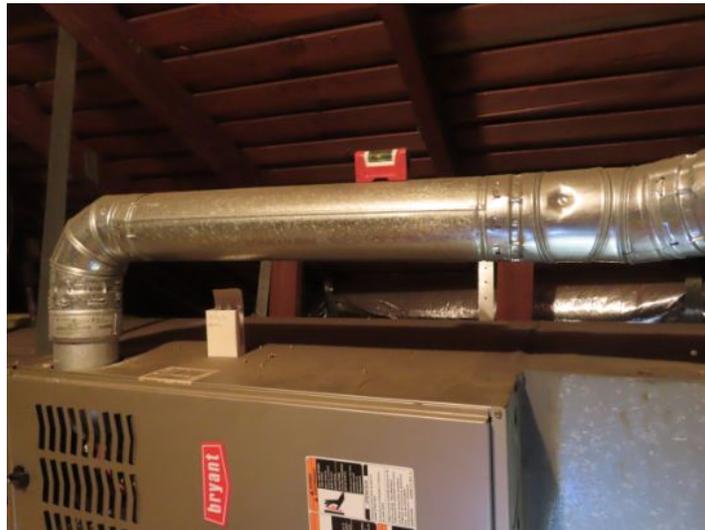
5. Heater Venting

Observations: vents at less than 90 degree angle

vents at less than 90 degree angle

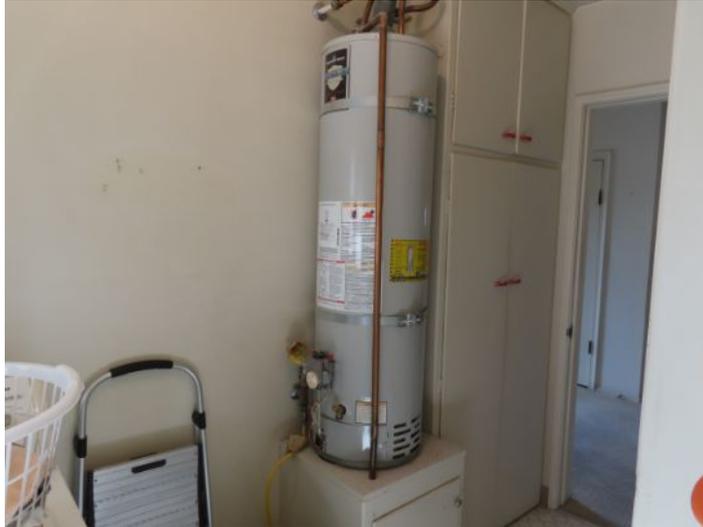
Observations: operated, older water heater, The date of manufacture is 2007

The date of manufacture is 2007

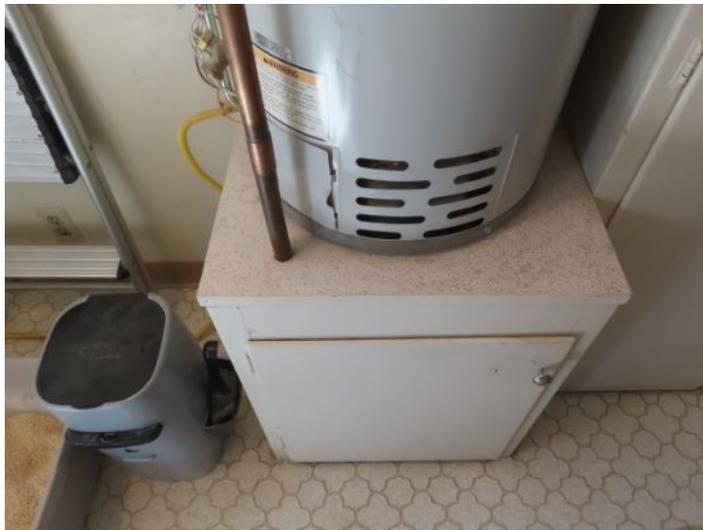
Observations: functional, **recommend a drip pan**

recommend a drip pan

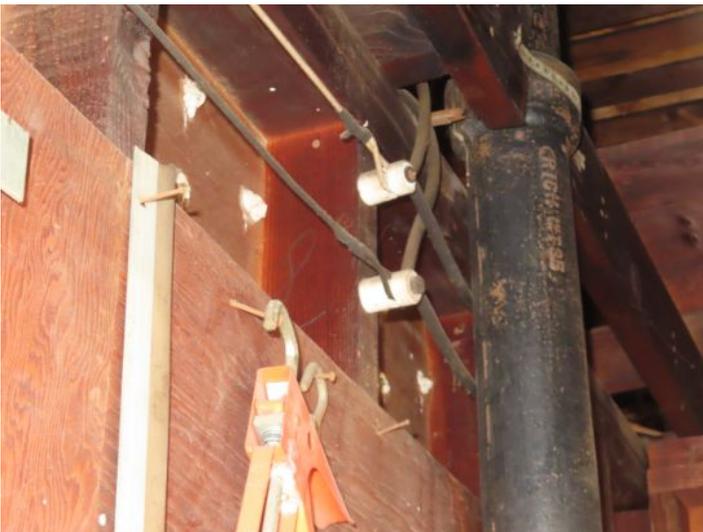
Observations: could not access some electrical areas due to personal items , worn outlets, **recommend upgrading knob & tub wiring, knob and tube present**

knob and tube present

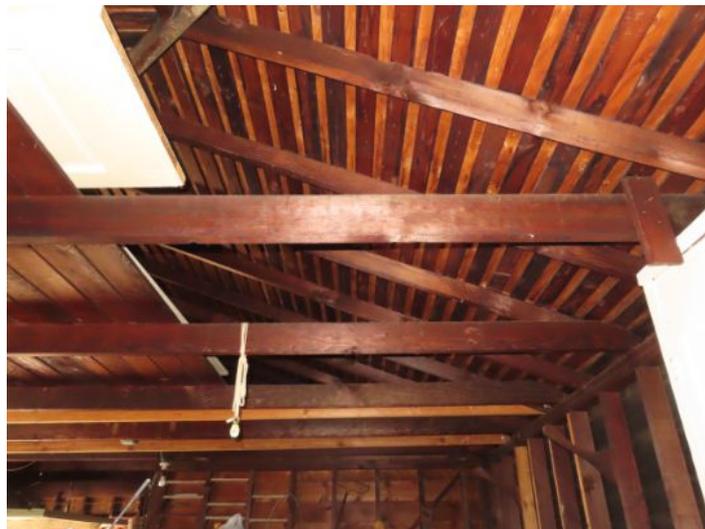
Observations: not for heavy storage, ceiling is drywall and paneling in areas, limited inspection, small cracks

not for heavy storage

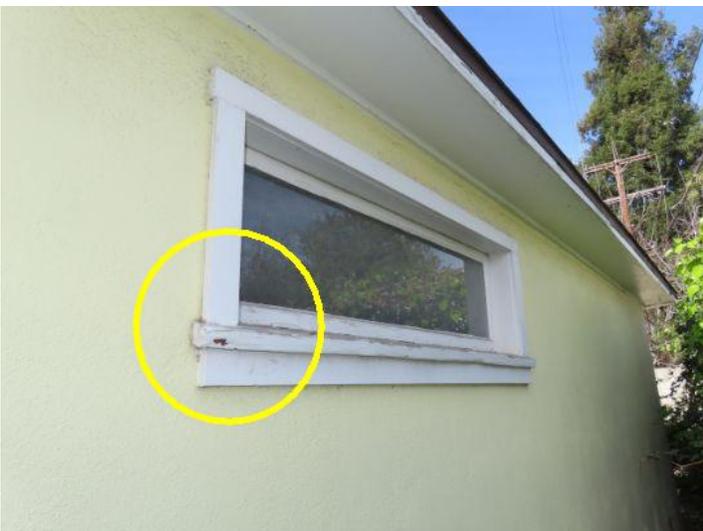
Observations: functional, worn hardware, dirty tracks, **did not latch or lock, deteriorated wood window frames**

deteriorated wood window frames

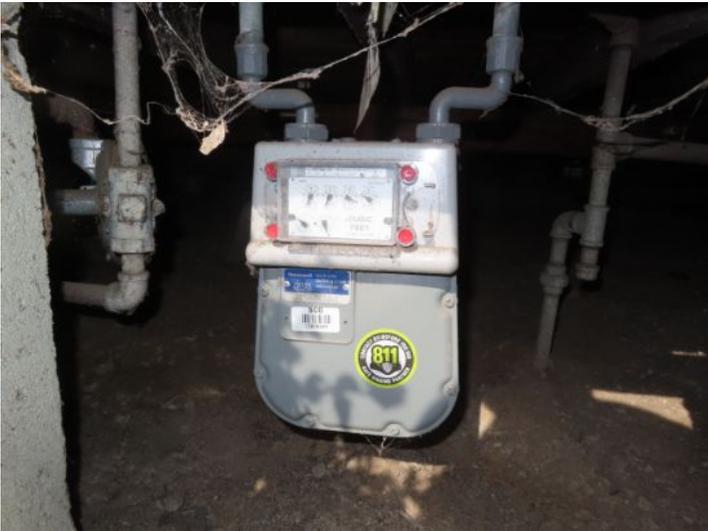
Observations: natural gas, no seismic shut off present, recommend a seismic shut off, can not determine if gas pipe is protected in the ground

natural gas

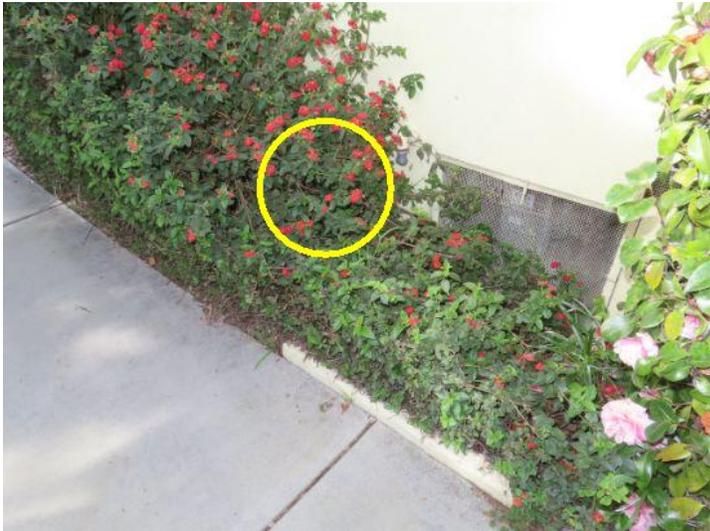
main gas shut off, behind shrubs

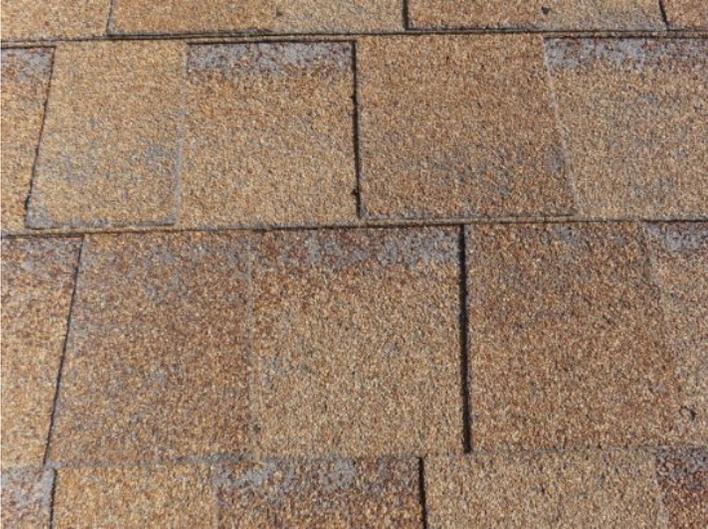
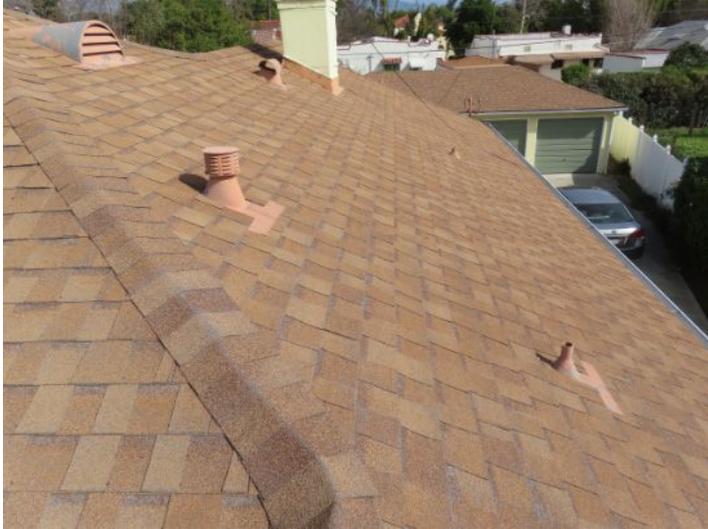
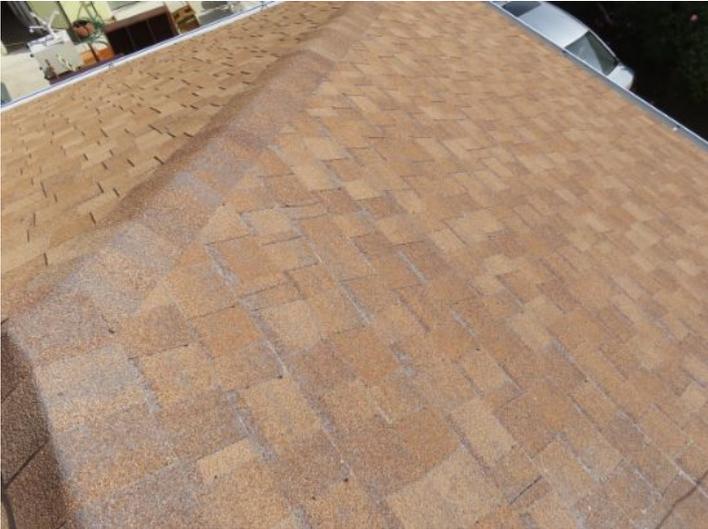
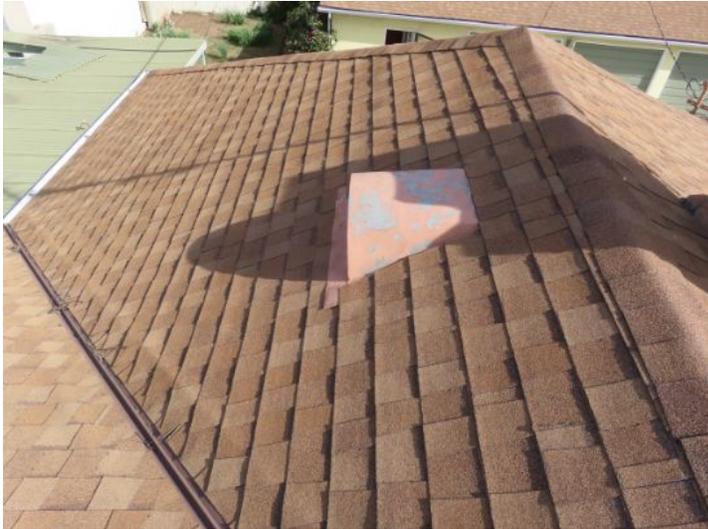
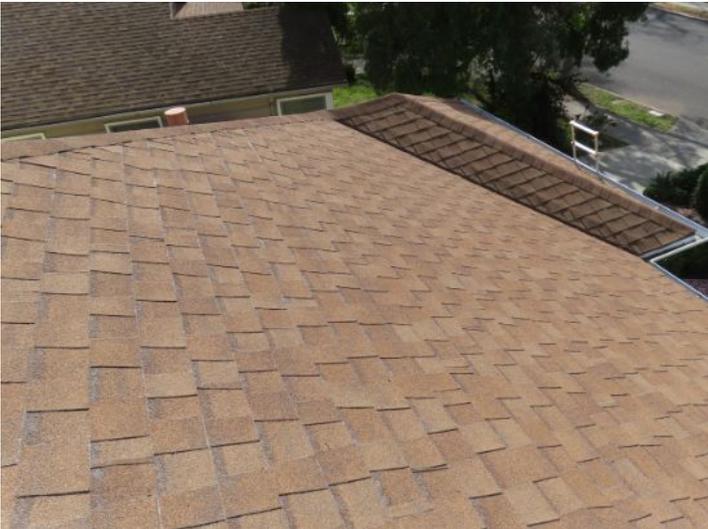
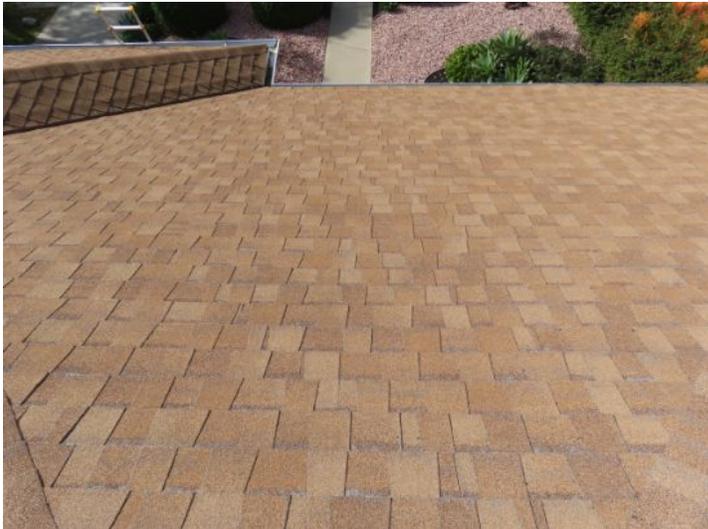
Roof Type: Asphalt Shingles
Observations: showing signs of wear

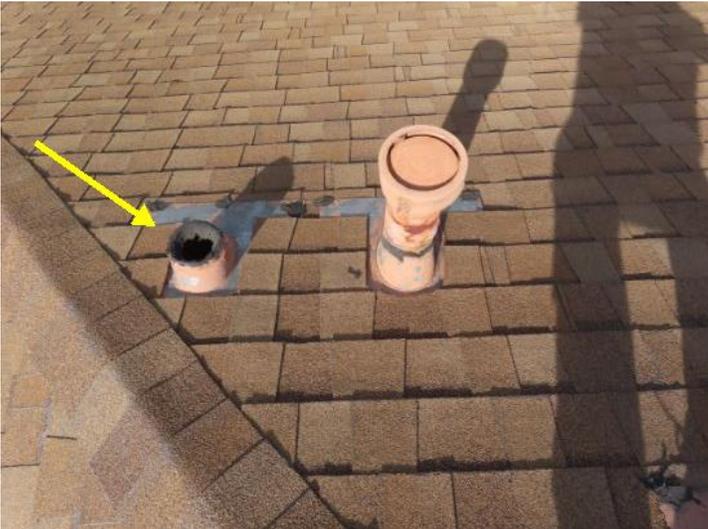
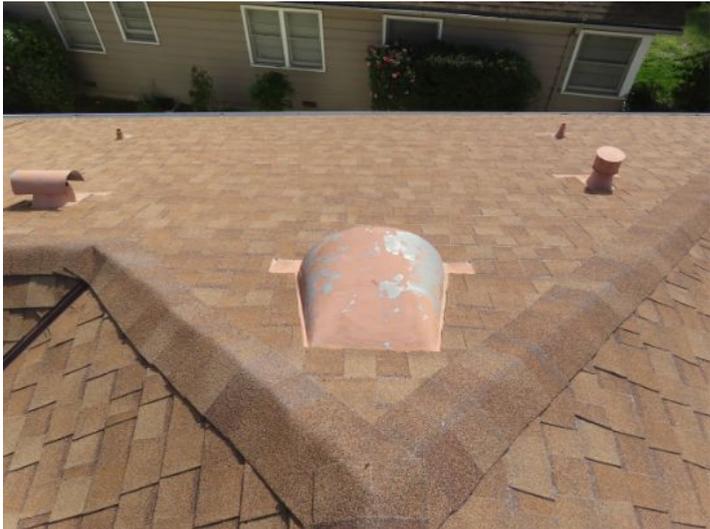
Observations: functional, plumbing vent pipe does not extend to the proper height

plumbing vent pipe does not extend to the proper height

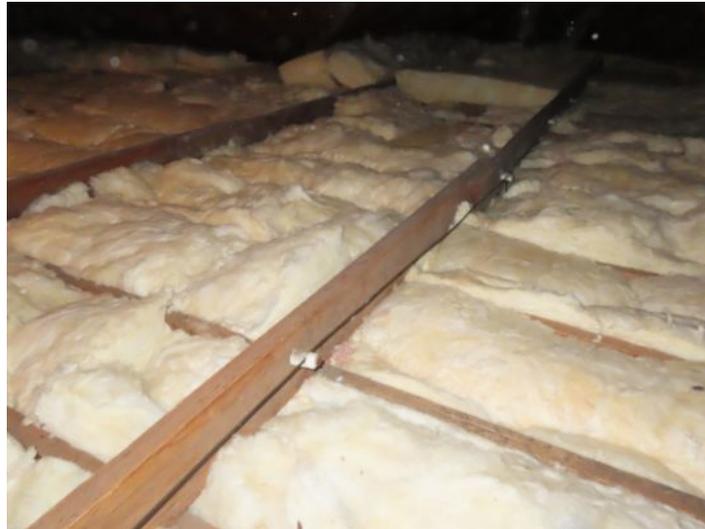
knob and tube present, recommend licensed electrician to evaluate all areas of structure

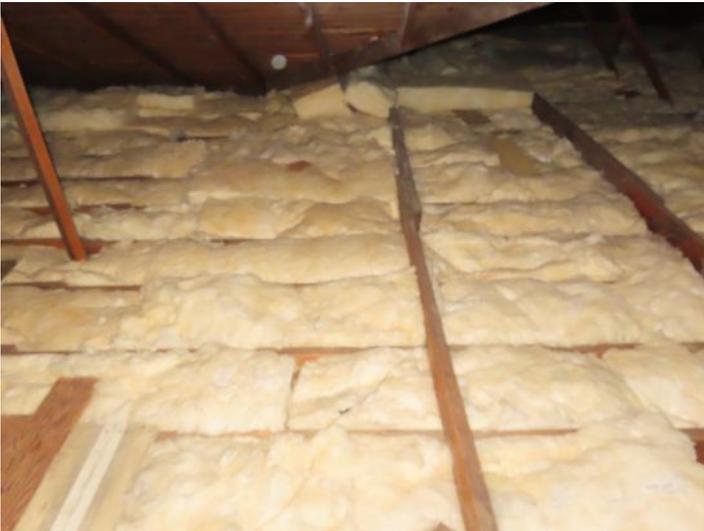
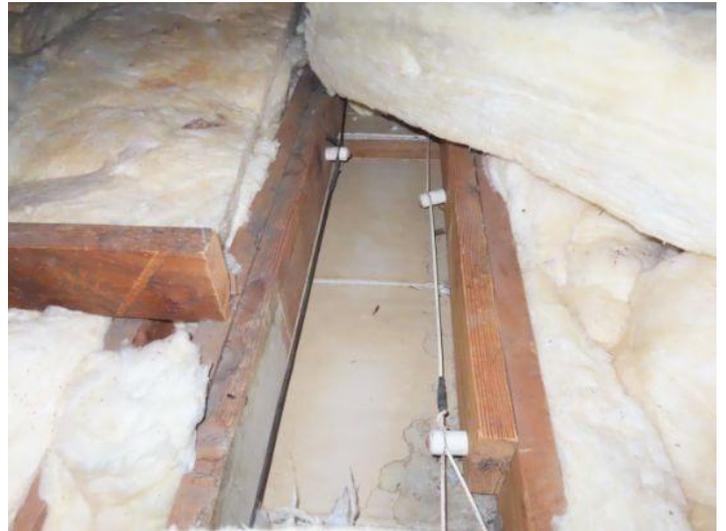
Observations: insulation covering knob and tube wiring

insulation covering knob and tube wiring

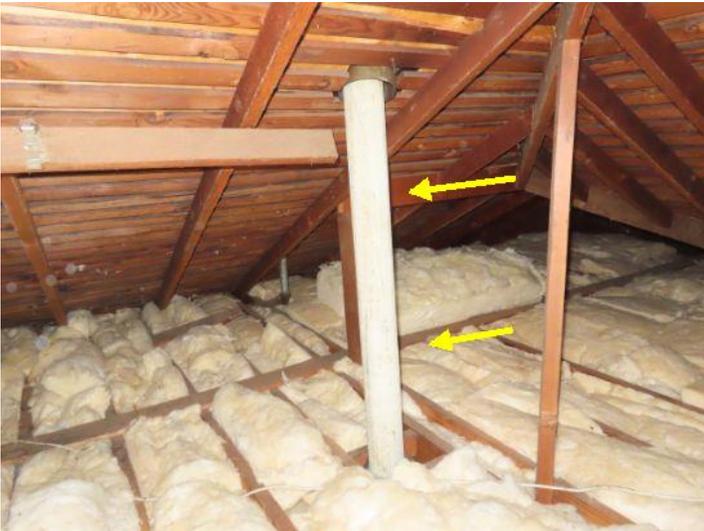
Observations: could not access all areas, stains in areas, evidence of past leaking, **old asbestos transite pipe present, recommend removal**

old asbestos transite pipe present, recommend removal

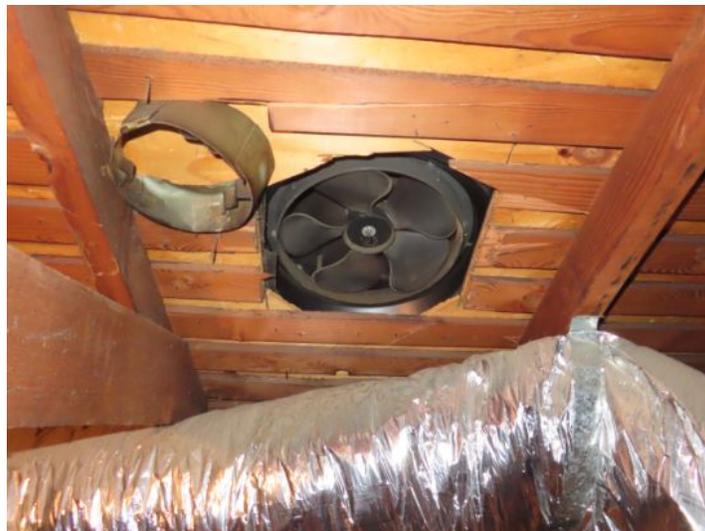
Observations: functional, attic fan present and operated, limited inspection only

attic fan present and operated, limited inspection only

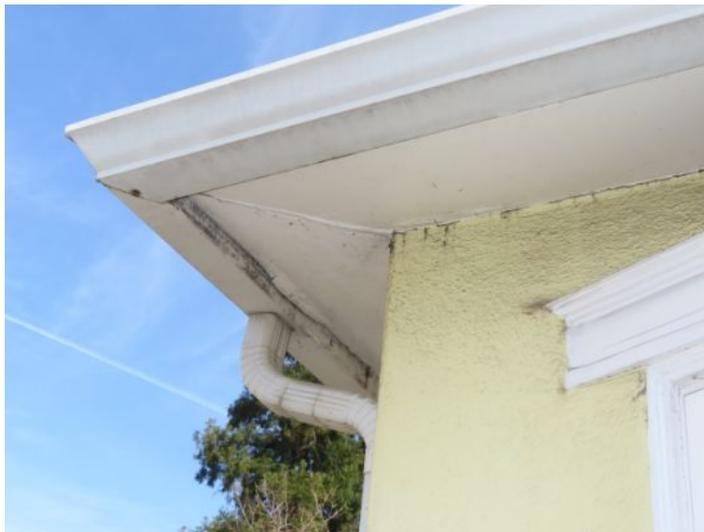
Observations: could not access some attic vents, **no lower vents visible**

no lower vents visible

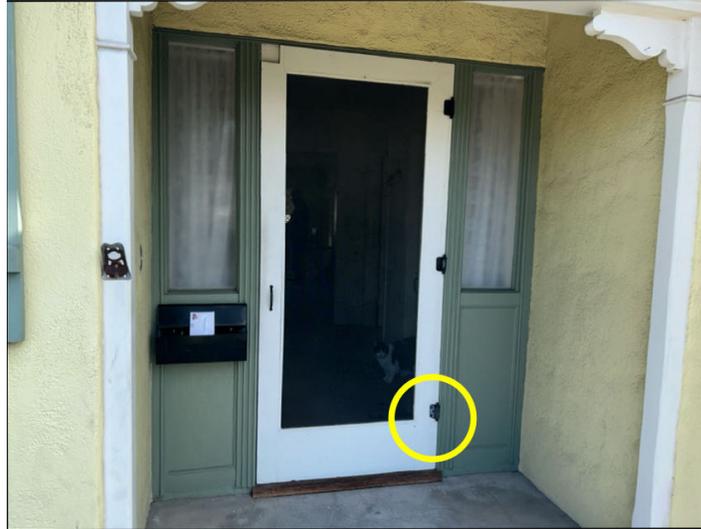
Observations: functional, worn hardware, exterior screen door sticks at the hinge side

exterior screen door sticks at the hinge side

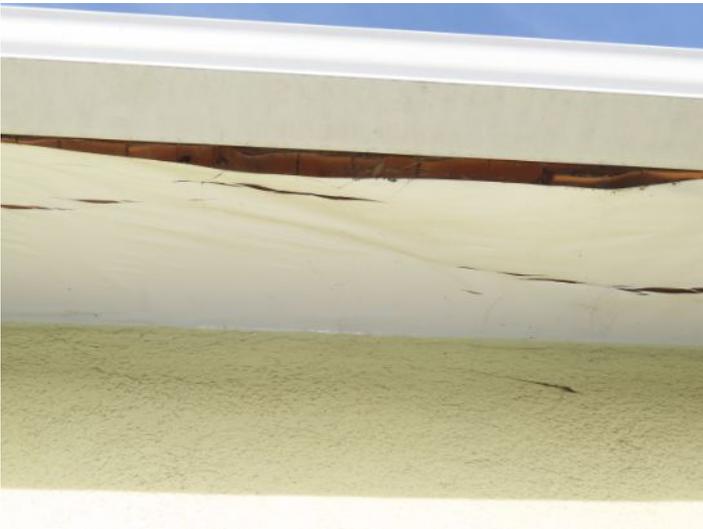
Observations: stained, weathered, leaking at the eaves, recommend further evaluation by a licensed roofing contractor, deteriorated wood, consult termite report all wood areas

leaking at the eaves

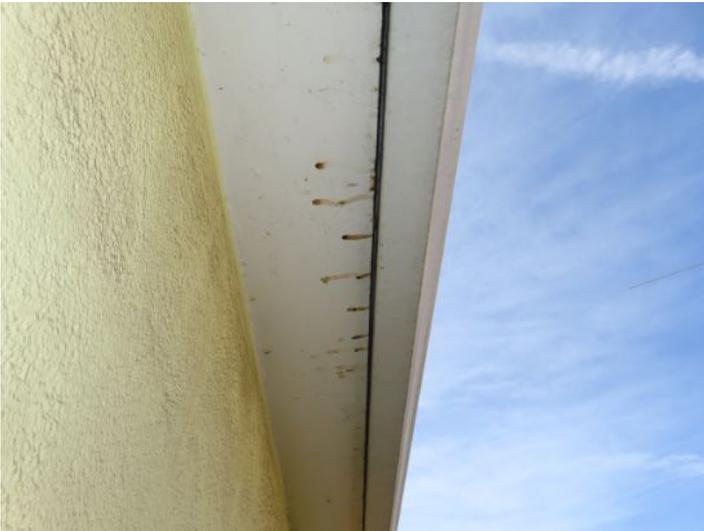
leaking at the eaves

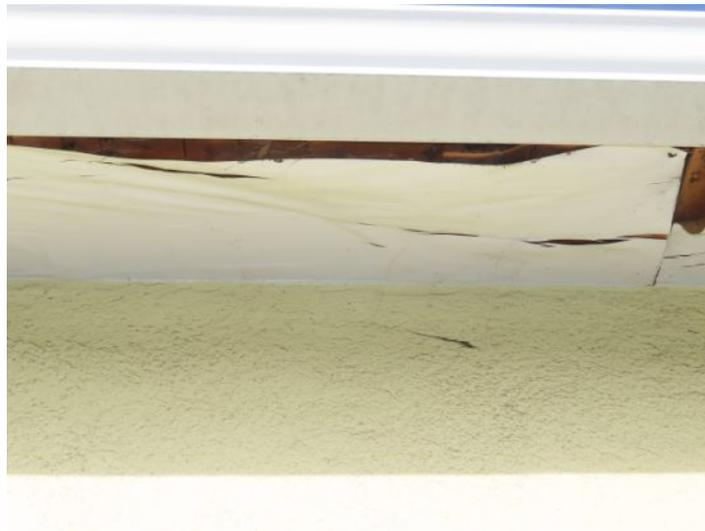
Observations: weathered, **peeling in areas**

peeling in areas

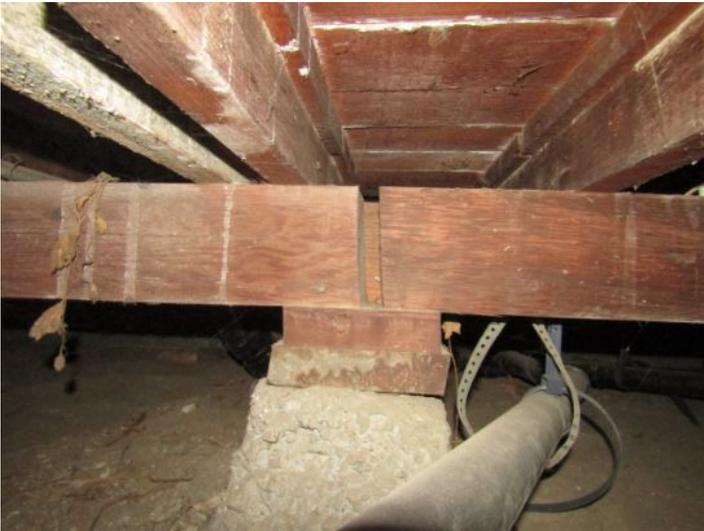
Observations: good, recommend T-Straps at the post and girders, could not access all areas

recommend T-Straps at the post and girders

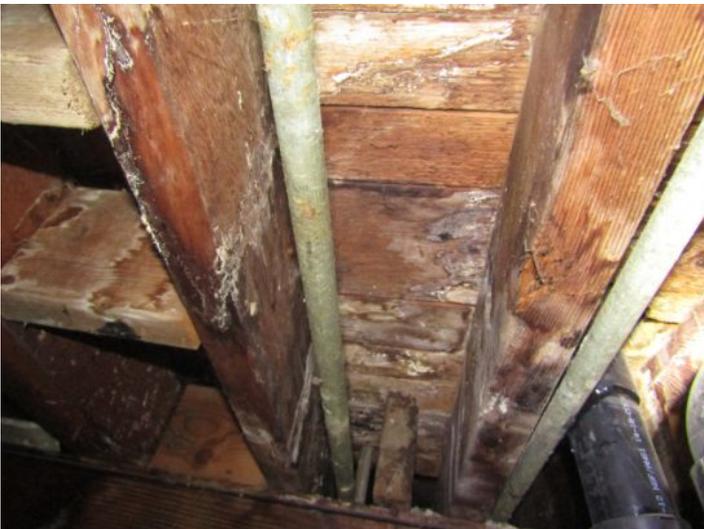
Observations: could not access all areas, stained in areas, **deteriorated wood in areas, consult termite report on all wood area**

deteriorated wood in areas

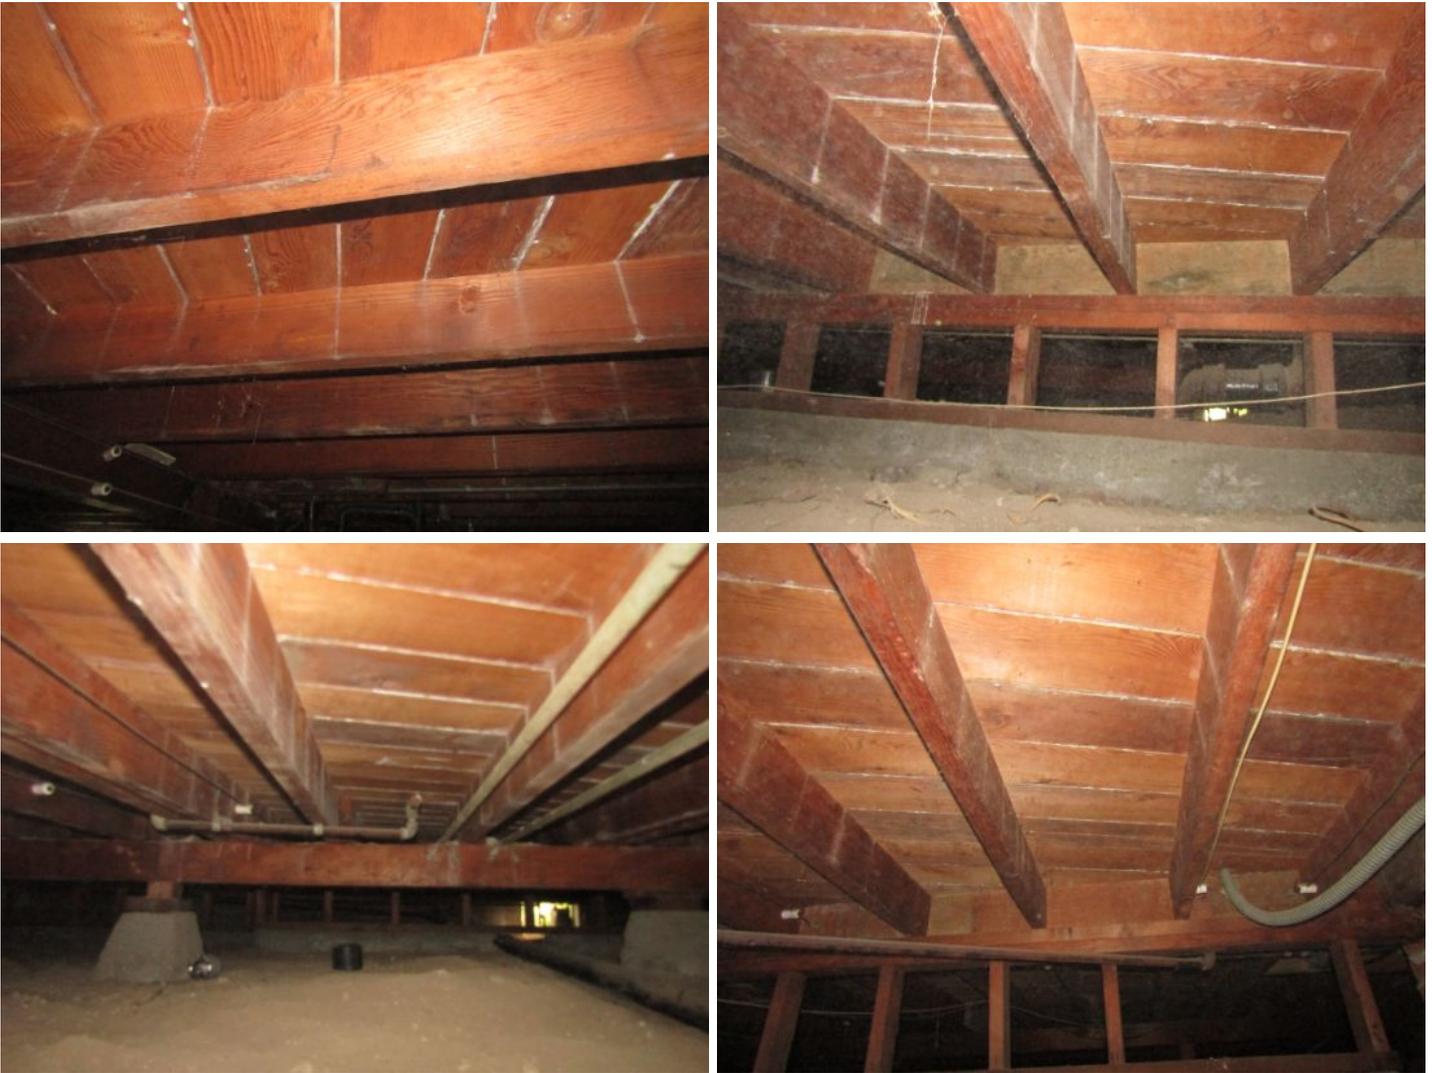
stained in areas

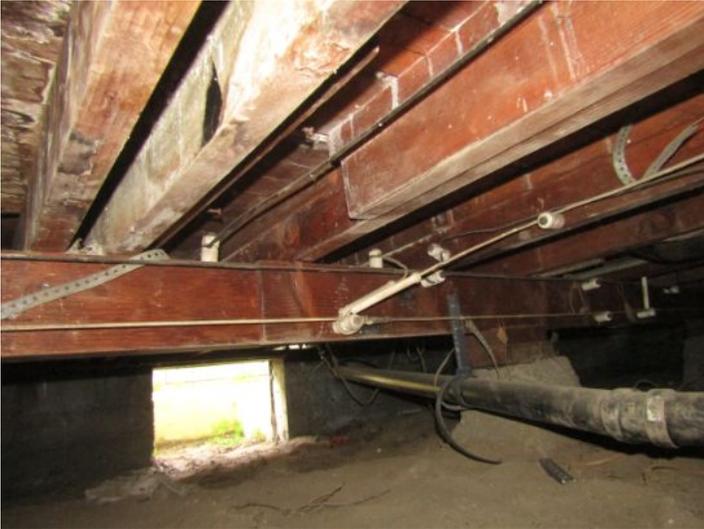
Observations: some electrical not accessible, could not access all areas, **knob and tube present, recommend upgrading knob & tube wiring**

knob and tube present

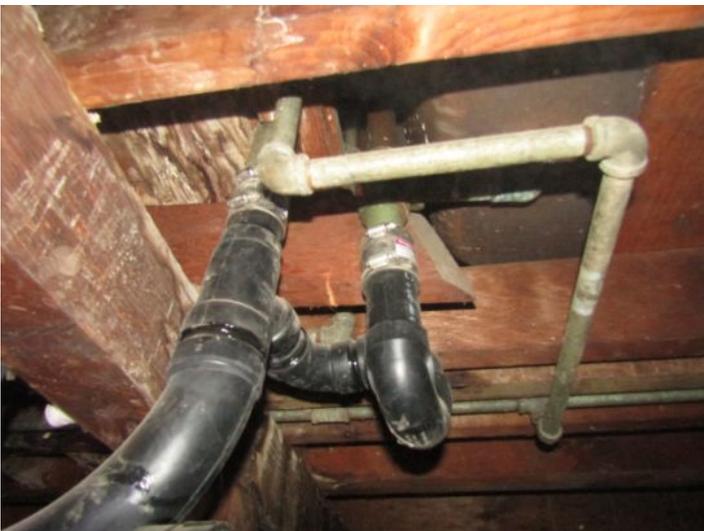
Observations: could not access all areas, some plumbing is not accessible, **visible leaking under the hall bathroom bathtub**

visible leaking under the hall bathroom bathtub

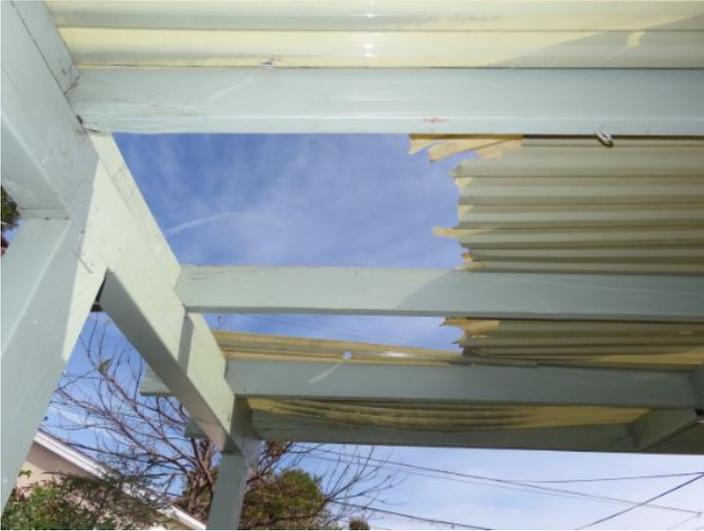
Observations: functional, weathered, **damaged and missing**

damaged and missing

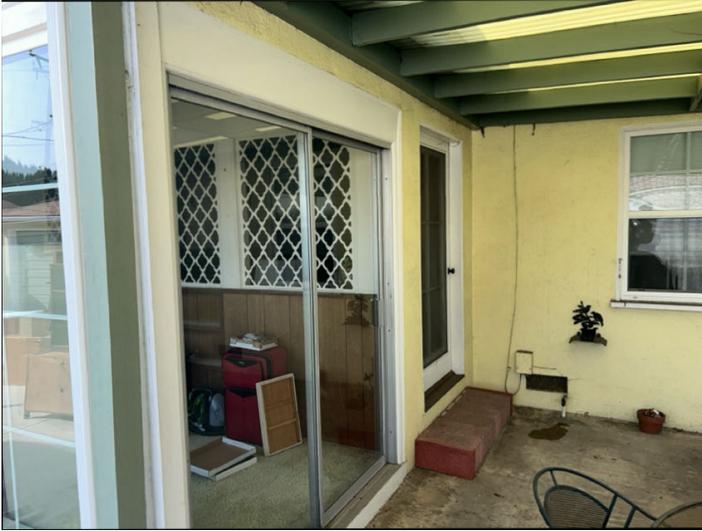
Observations: worn outlets, no light present at the exterior door, **exposed wires going from the house to the garage, 3 prong outlets are not grounded**

no light present at the exterior door

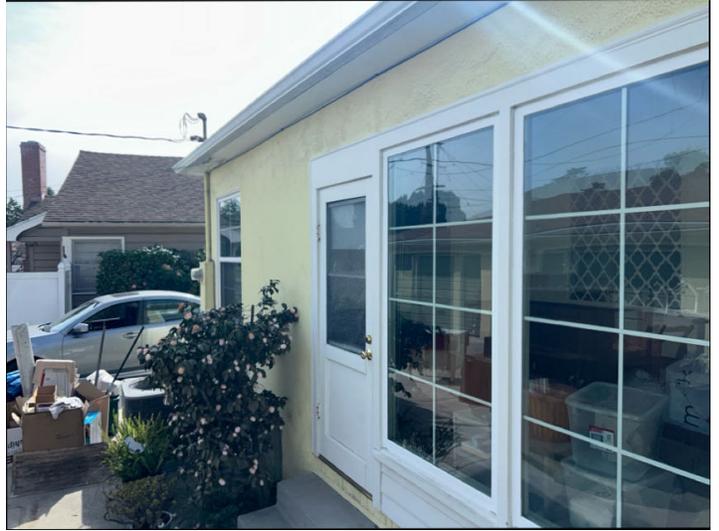
no light present at the exterior door

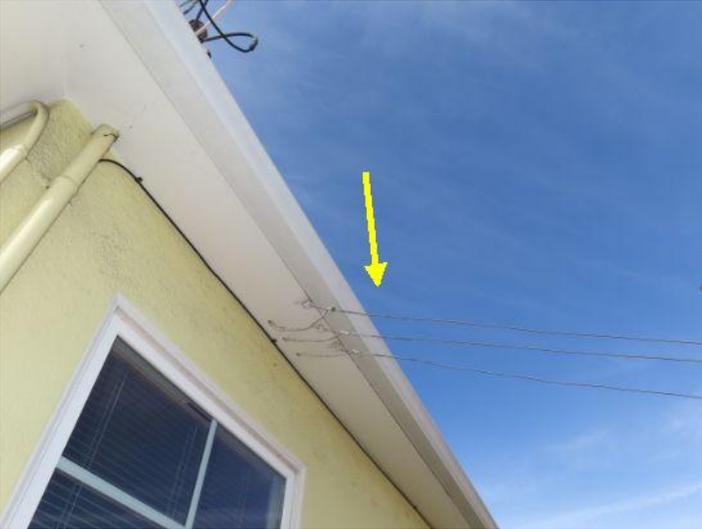
exposed wires going from the house to the garage
