Accurate Inspection Team LLC
Property Inspection Report

336 Rosemont Blvd, San Gabriel, CA 91775
Inspection prepared for: Kingman Family Trust & Mary Vega Trustee
Real Estate Agent: Pete Whan - Pete Whan & Associates

Date of Inspection: 1/28/2026 Time: 10:00 am
Age of Home: 1941 Size: 1,484 sqft
Weather: Sunny & Warm

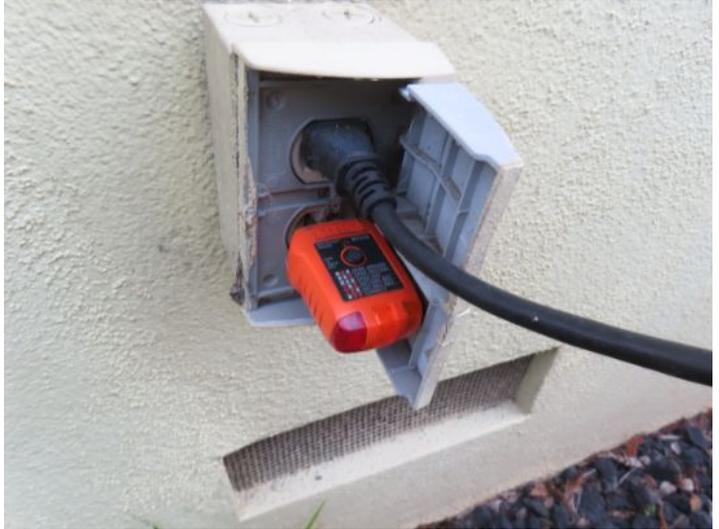
3 prong outlets are not grounded

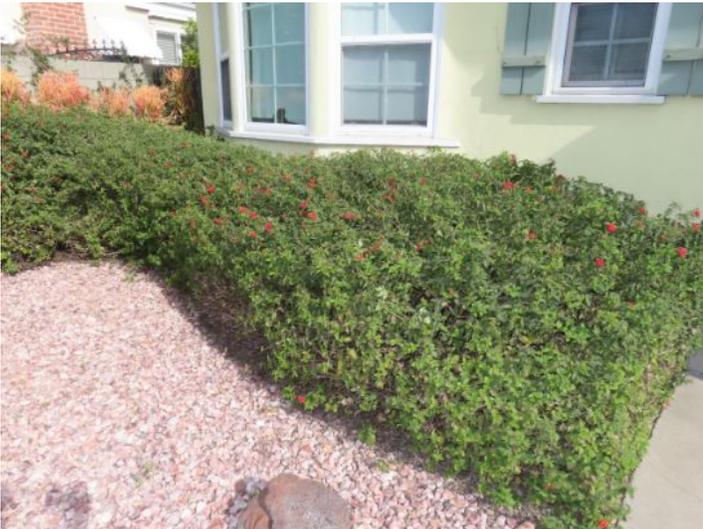
Observations: no drains visible, recommend trimming all shrubs that are touching the structure

recommend trimming all shrubs that are touching the structure

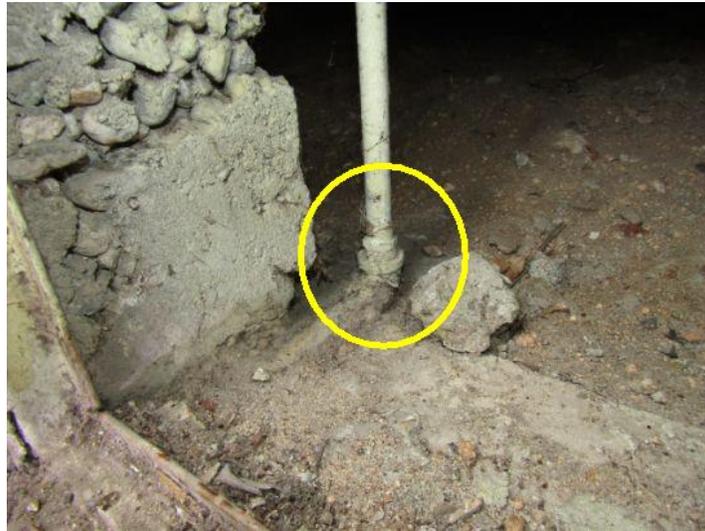
Observations: worn fixtures, copper to galvanized missing proper connections

copper to galvanized missing proper connections

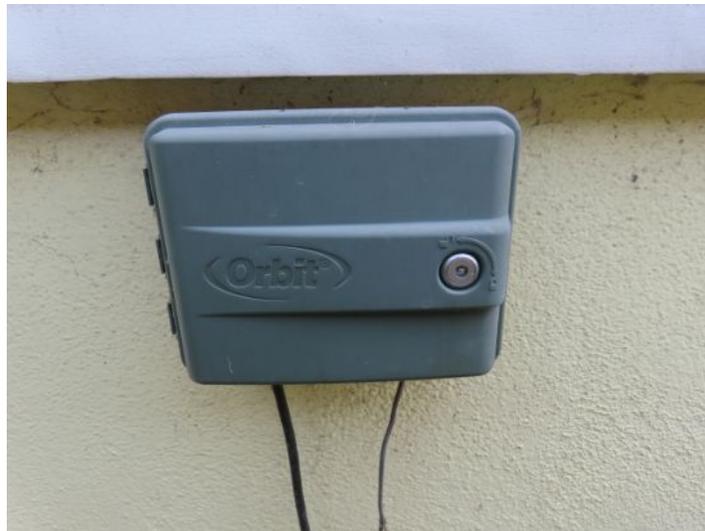
Observations: on timers, not tested by the inspector, consult the owner on the operation of the system

on timers, not tested by the inspector

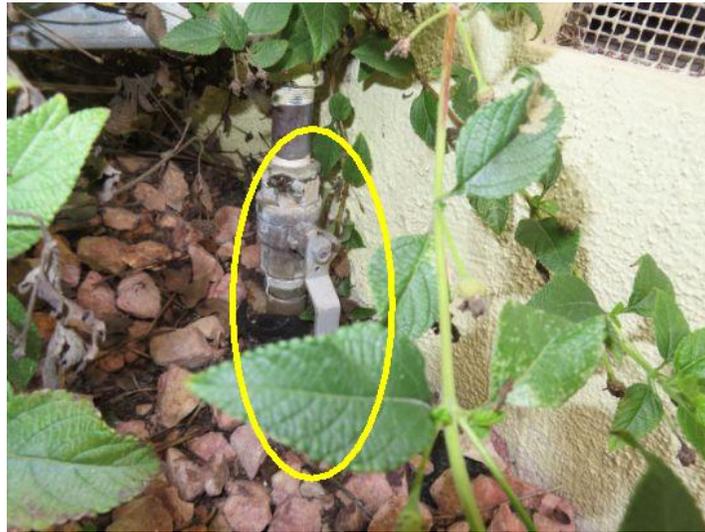
15. Main Water Shut Off Valve

Location: front of structure, front walk way
Observations: functional, worn valve

main water shut off
