Mitch Fredericks Home Inspections

13614 Dall Lane

Inspected on Wed, Mar 11 2026 at 2:19PM

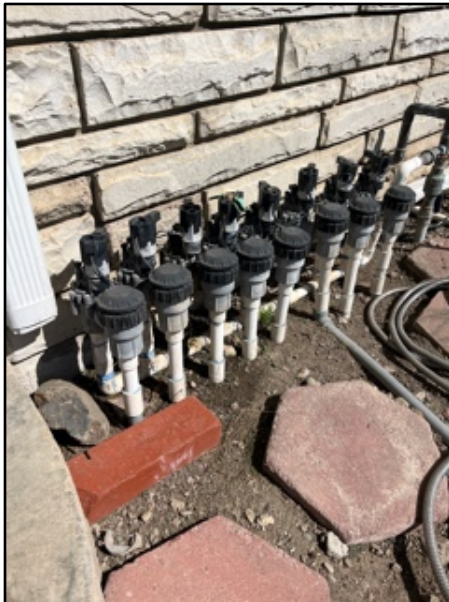
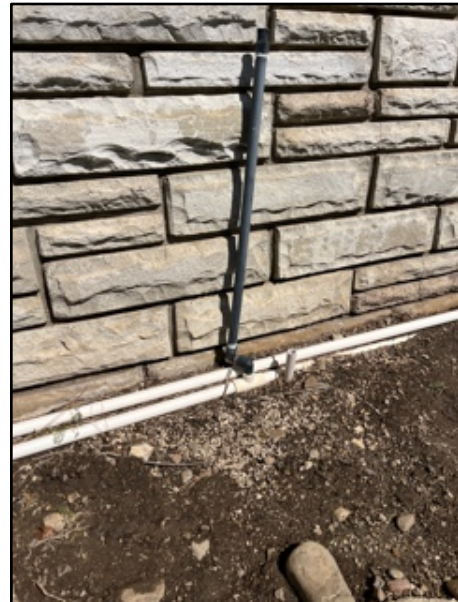
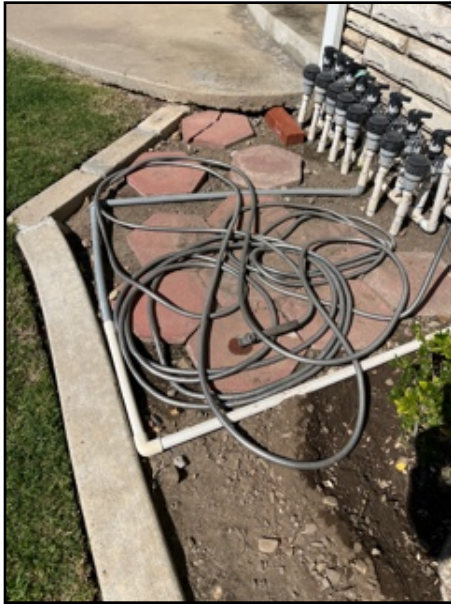
The front yard sprinkler valves are free of leaks.
Most of the PVC piping is above ground and can be damaged or broken.

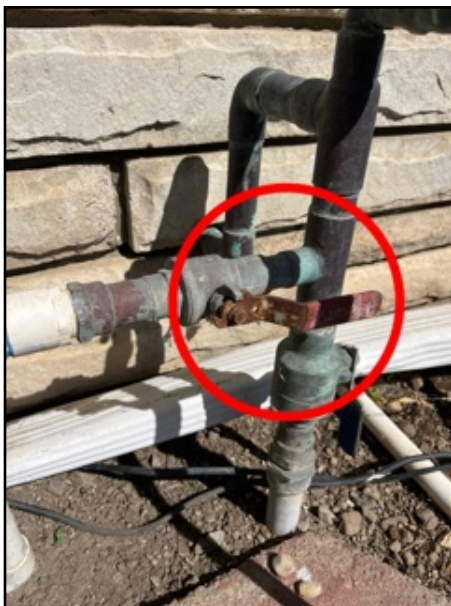
Figure 3-1

The irrigation has its own separate water shut off.

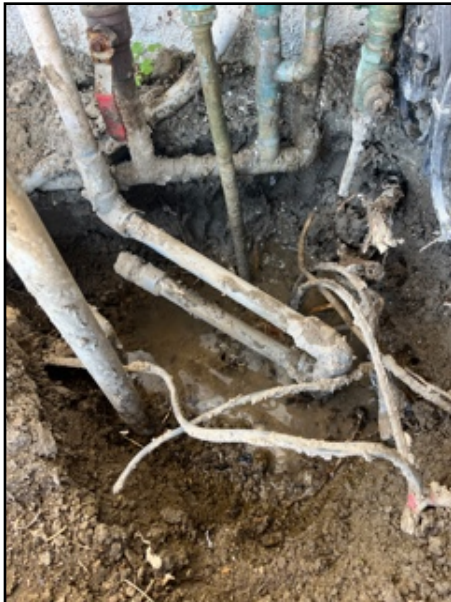
The backyard sprinkler valves appear to be free of leaks. The pool fill valve is presently leaking and is in need of repair.

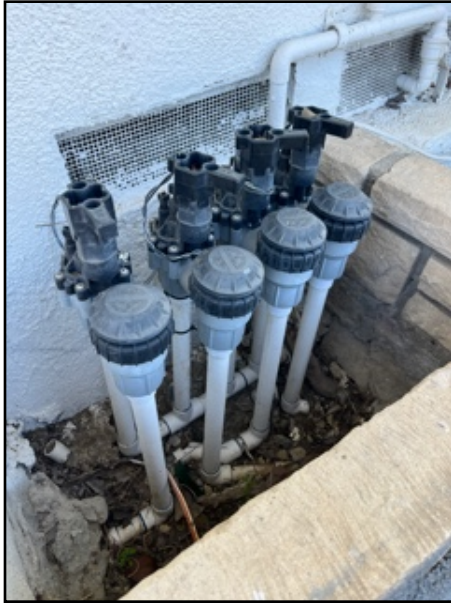
Figure 5-1

The left side yard sprinkler valves are free of leaks.

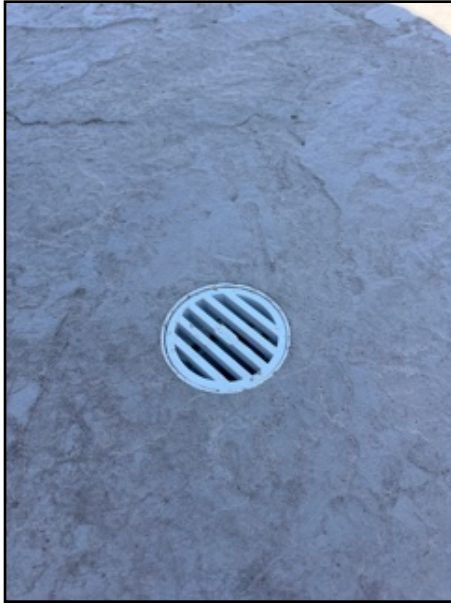
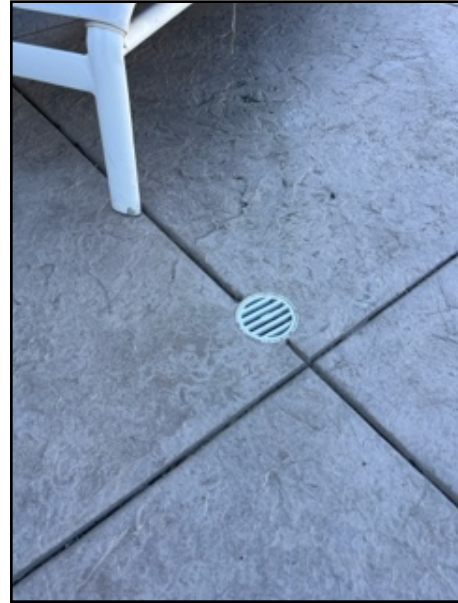
The backyard patio around the pool has drains.

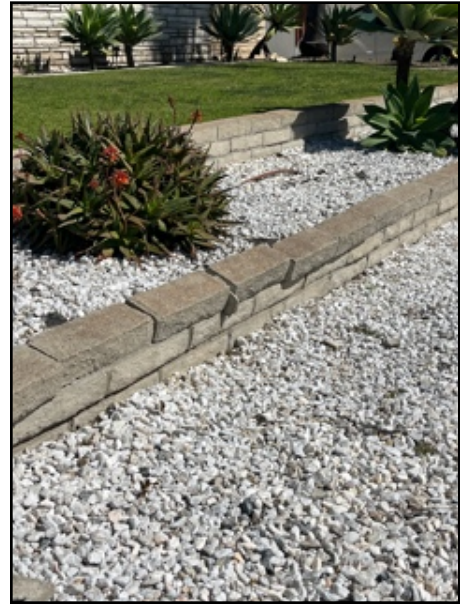
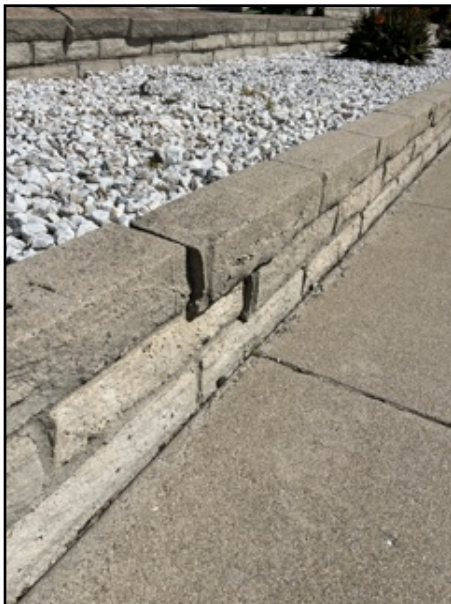
The front planter, retaining walls show cracks between the blocks, and the wall leans slightly.

Repairs can be made to the block wall.

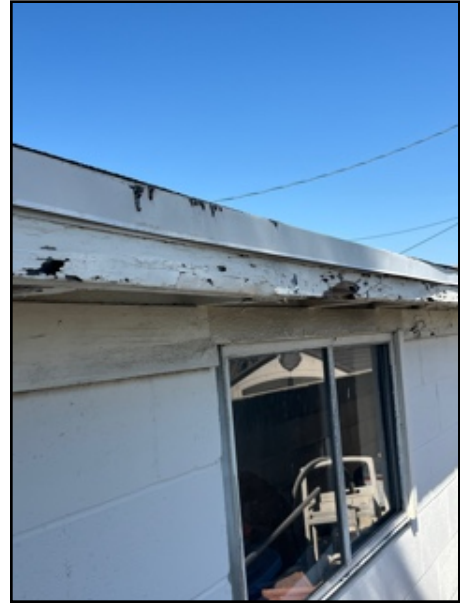
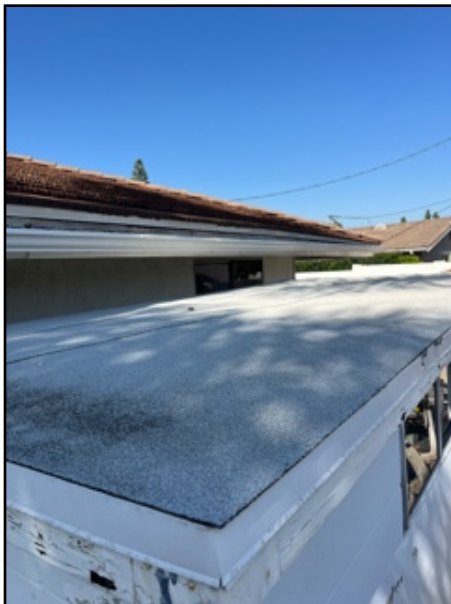
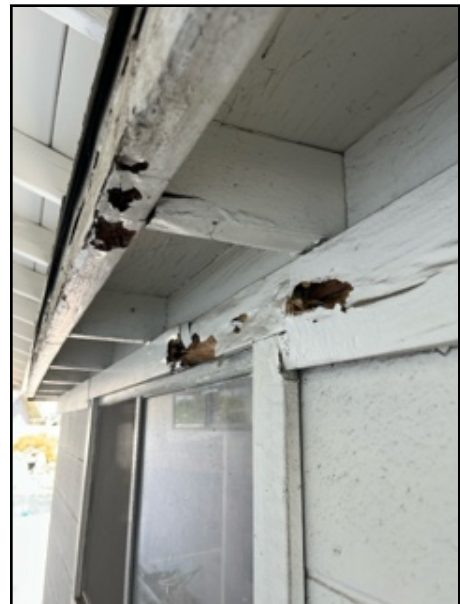
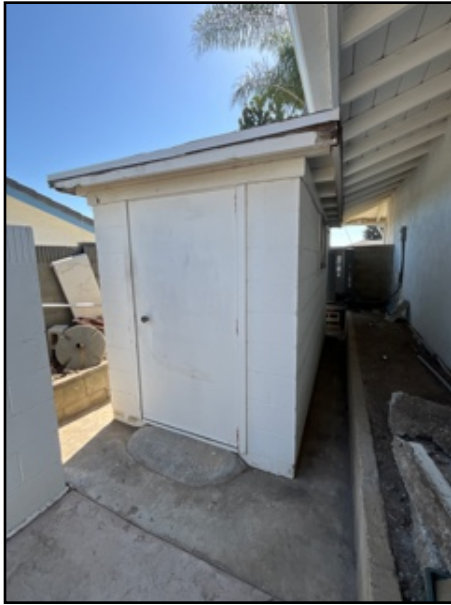
The right side storage shed shows termite damage and wood rot.

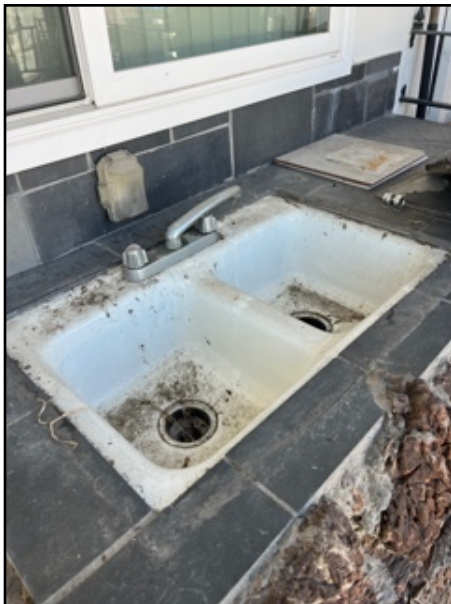
Figure 9-1

Comment 9:
The backyard wet bar sink is not in use.

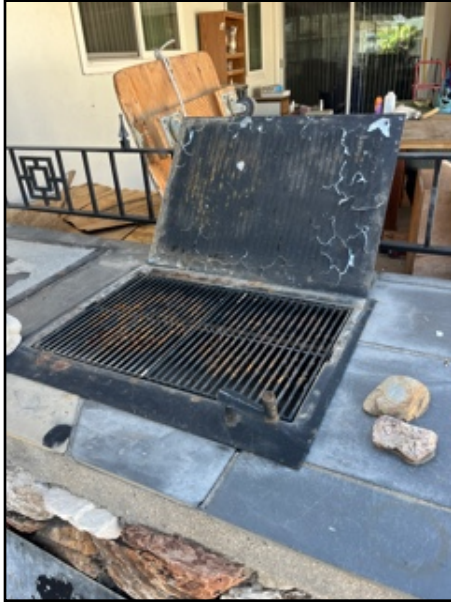
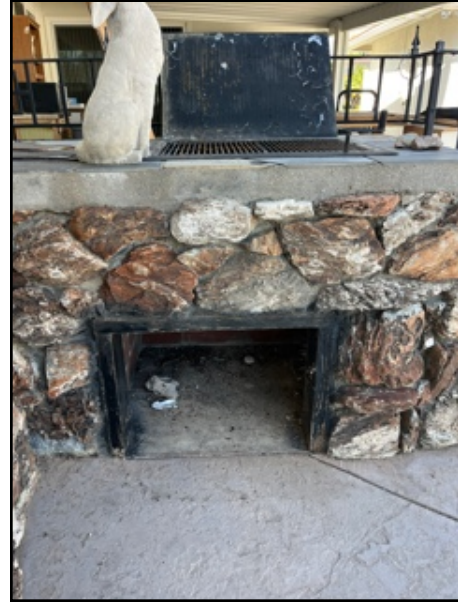
The backyard barbecue appears to be bricketts/coals.
No visible propane or gas line below.

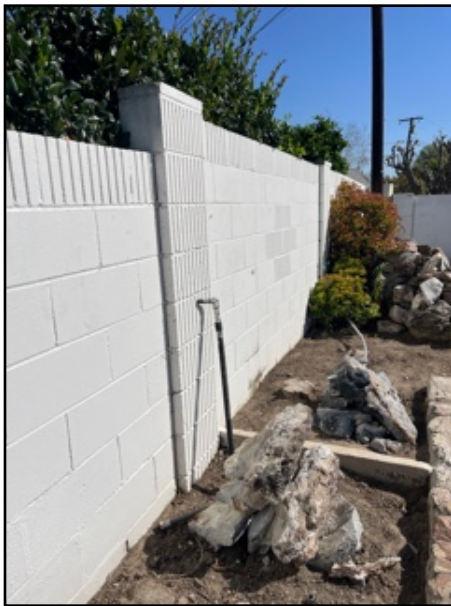
The rear block wall shows settling cracks.
The right side block wall shows outlines of settling between the blocks.

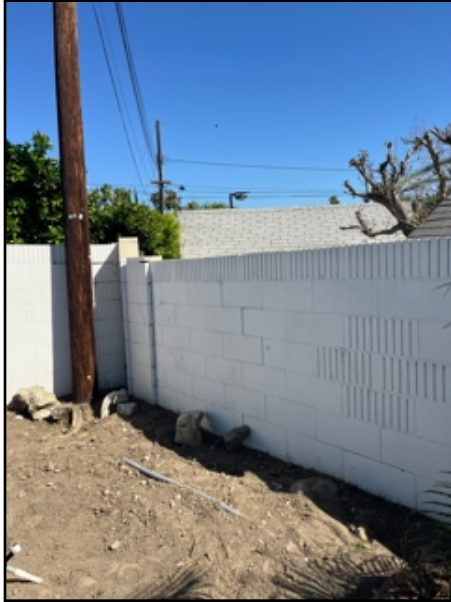
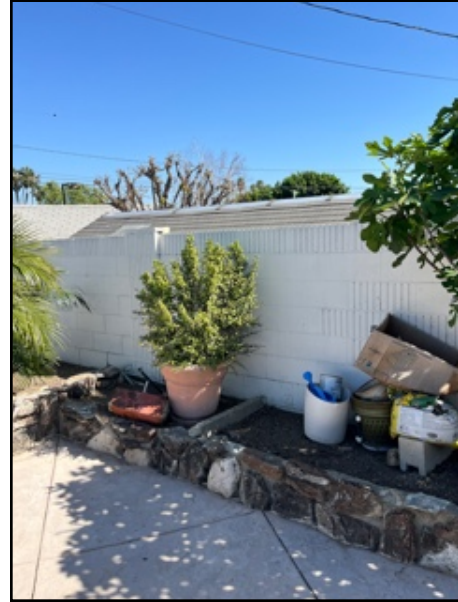
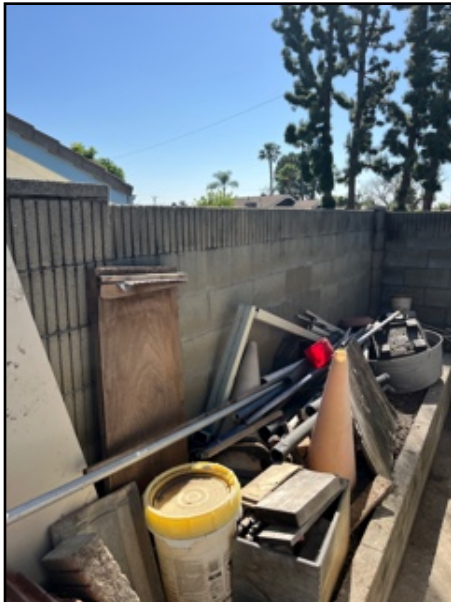
The right side block wall appears to in overall good condition. The wall is not painted white all the way to the front of the house.

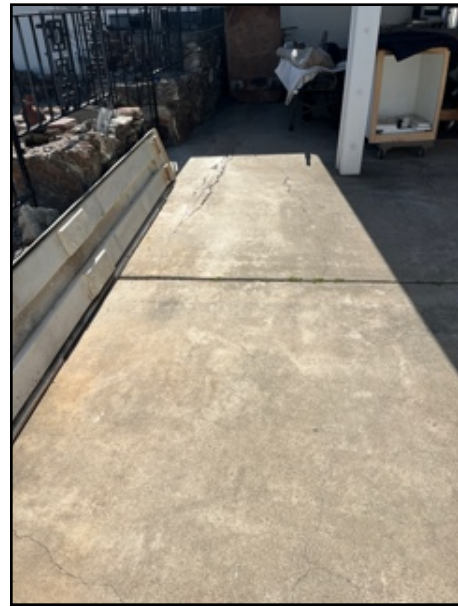
The backyard concrete patio shows settling cracks.

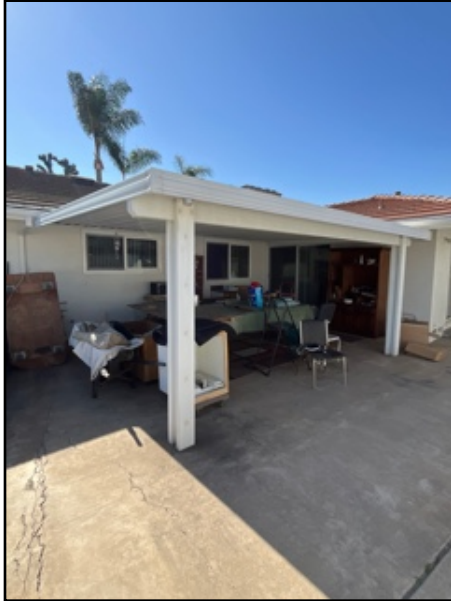
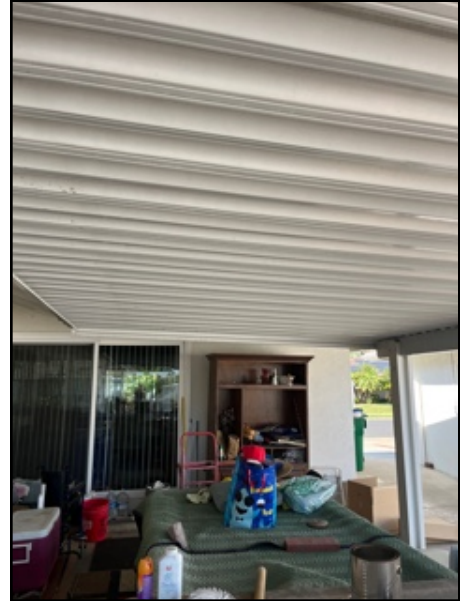
The aluminum patio cover appears to be tight and sound.

The patio cover roof attaches to the house, and there is damage in the eaves because of leaks.

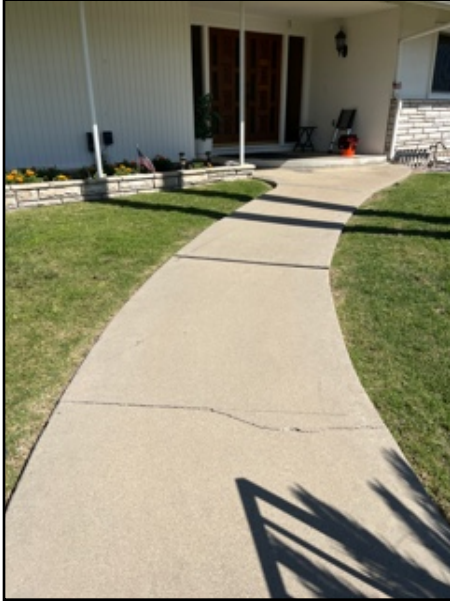
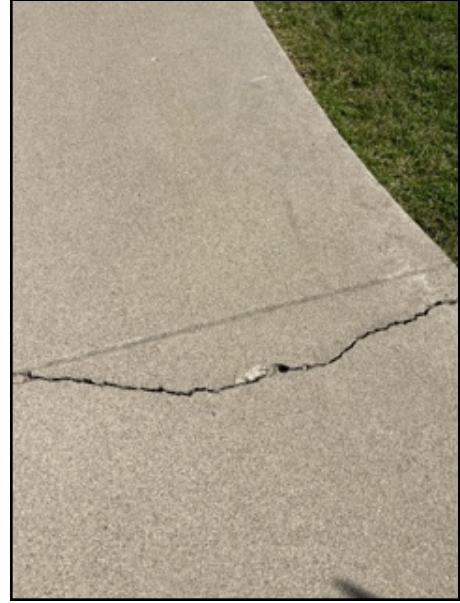
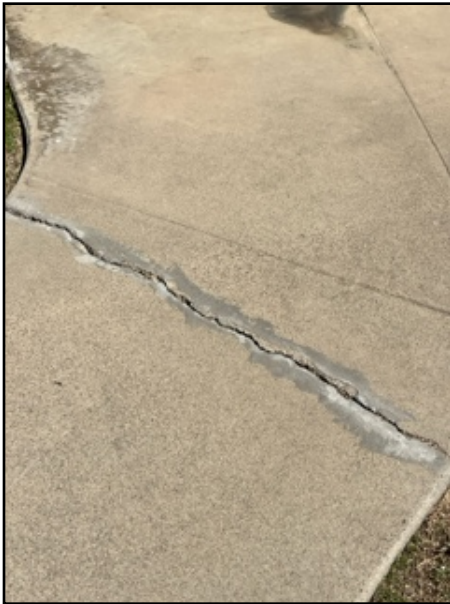
The front concrete walkway, shows settling cracks.

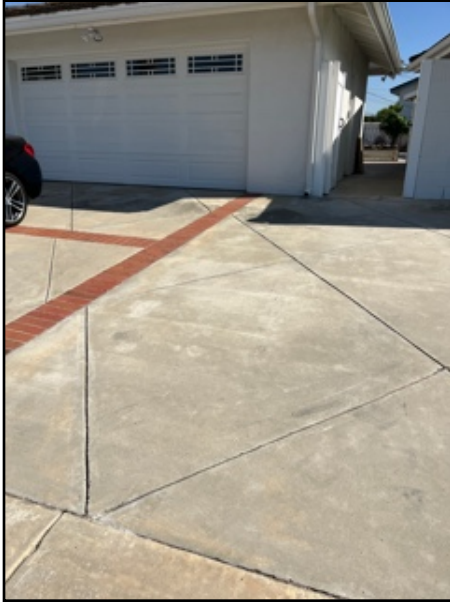
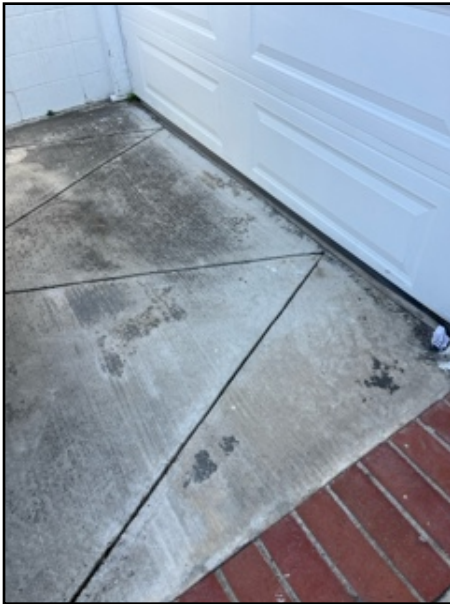
The brick flatwork and the concrete appear to be in good condition at the left side driveway.

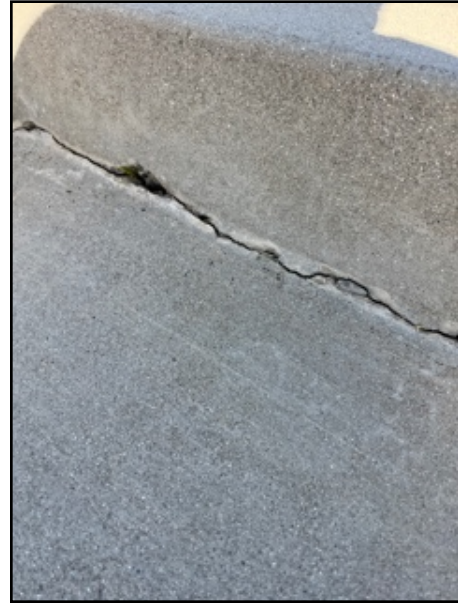
Figure 18-2

The front concrete steps show settling cracks.

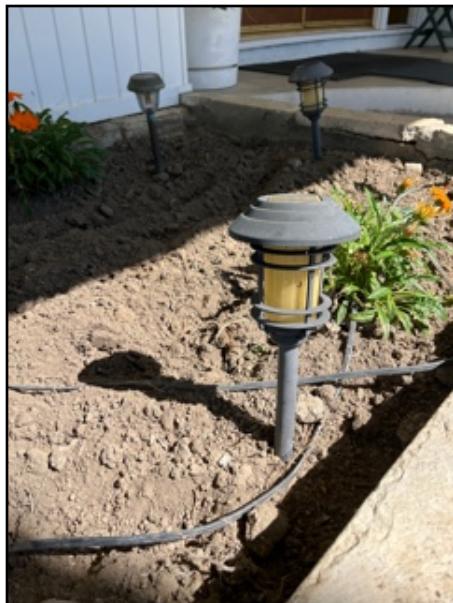
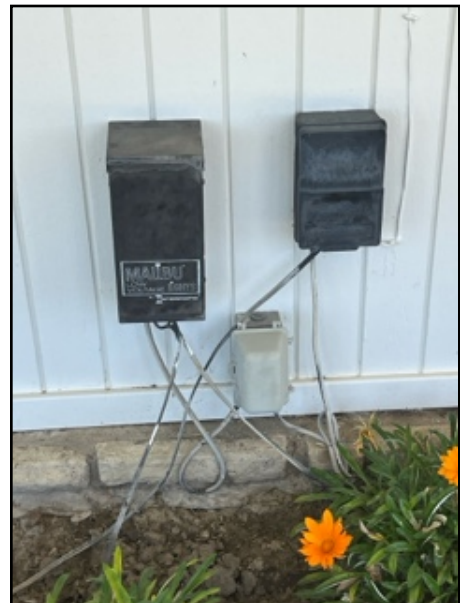
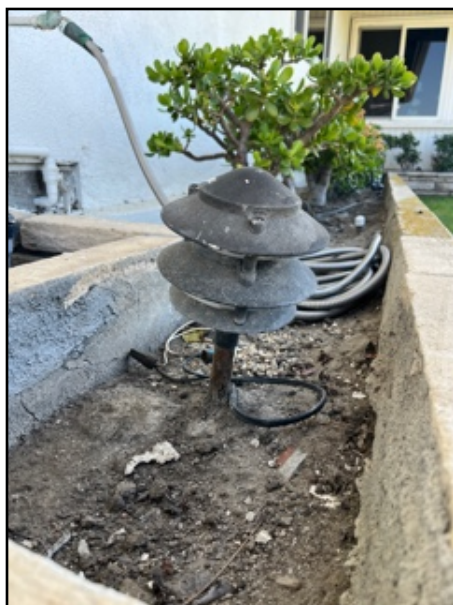
The Malibu style of lights can be very temperamental and will need ongoing maintenance. There are timer boxes for the lights in the front yard.

Many of the lights are solar, and they also can be very temperamental.

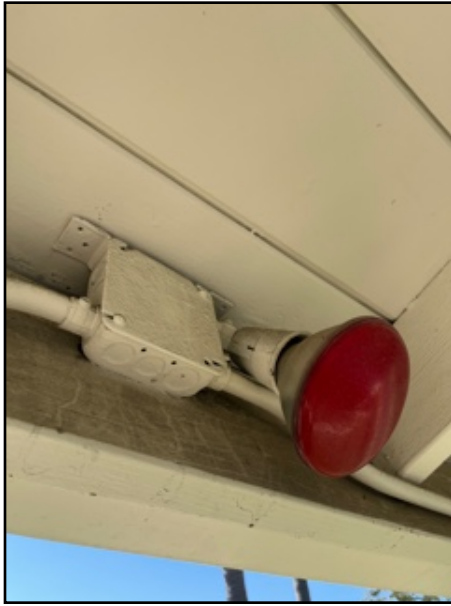
Figure 21-1

The outlet does not have a weather resistant cover plate. This is located in the eaves at the front right corner.

At the left side of the house, there is also outlets that do not have weather resistant cover plates.

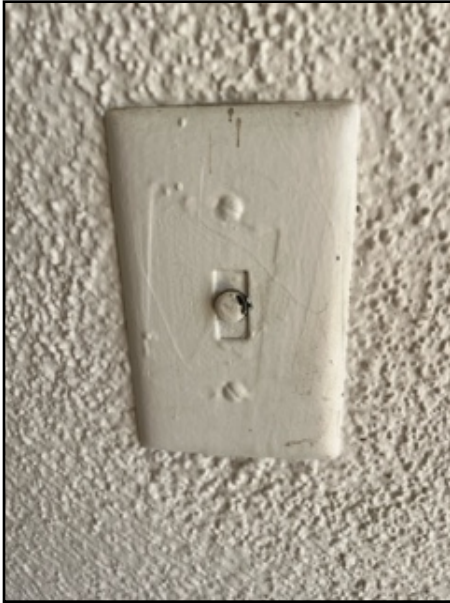
Figure 23-1

Comment 23:
The doorbell chime only dings.

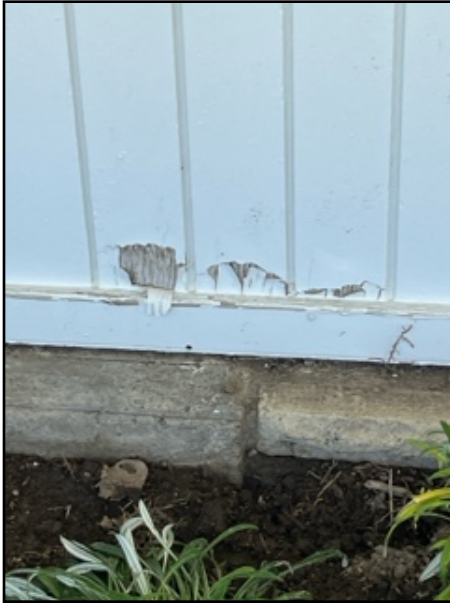
Figure 28-1

The front wood siding shows paint peeling exposing bare wood.

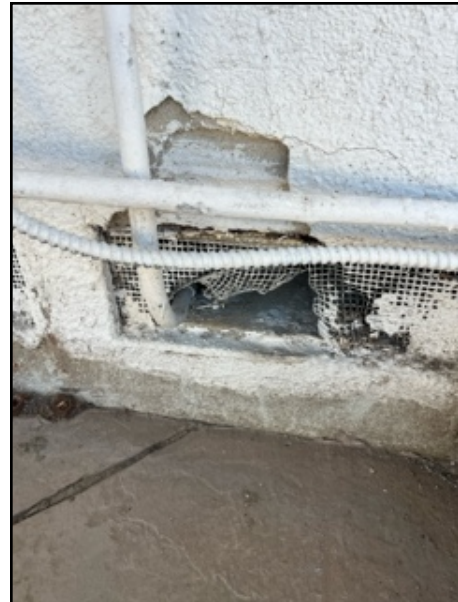
Figure 30-2

The stucco on the house at the rear shows flaking and crumbling. Repairs are needed at this time.

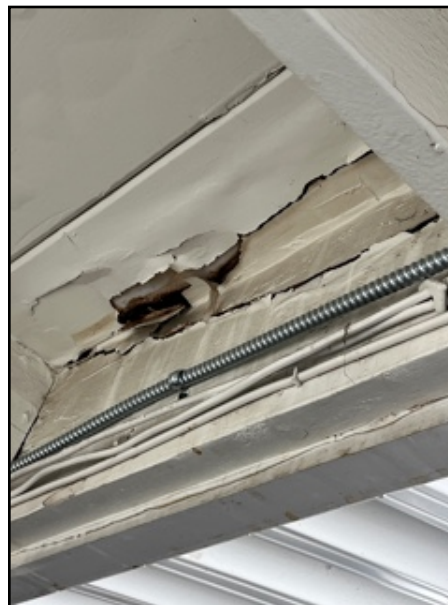
Figure 31-2

The ease at the rear of the house show wood damage and rocked because of the installation of the patio cover.

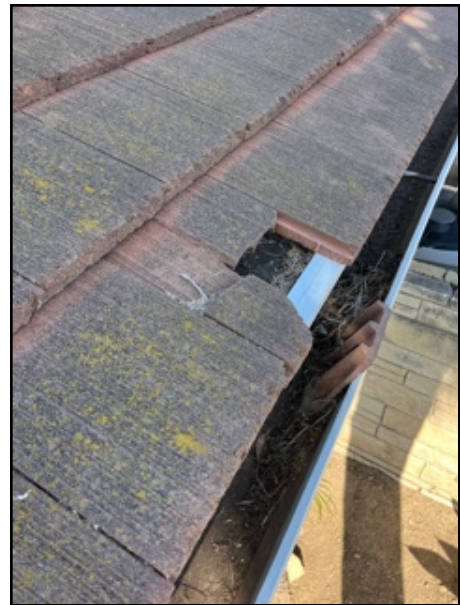
Figure 33-2

The front right corner tile is broken.

There is a second broken tile at the right side front corner.

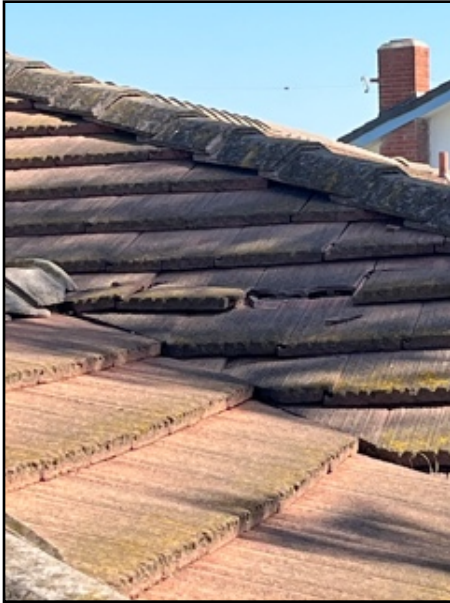
Figure 34-1

There are several broken tiles at the left side of the house near the valley area.

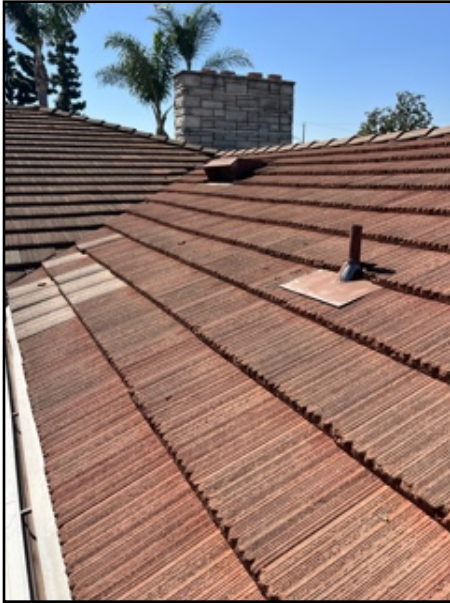
Figure 35-1

Comment 35:
The rear roof shows broken roof tiles.

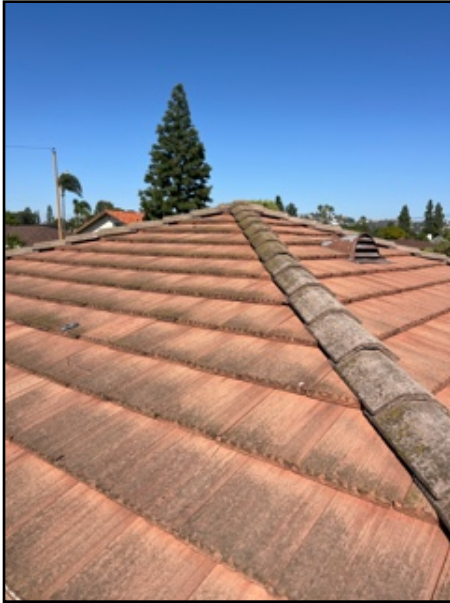
Figure 36-1

The garage roof also shows broken roof tiles.

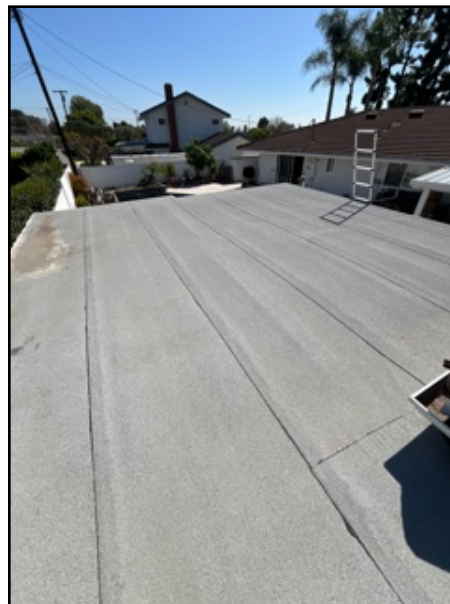
Figure 37-2

The flat roof over the garage/rear storage and room appears to be in overall good condition. There are water marks, indicating rainwater is pooling on this roof. Repairs are needed at this time.

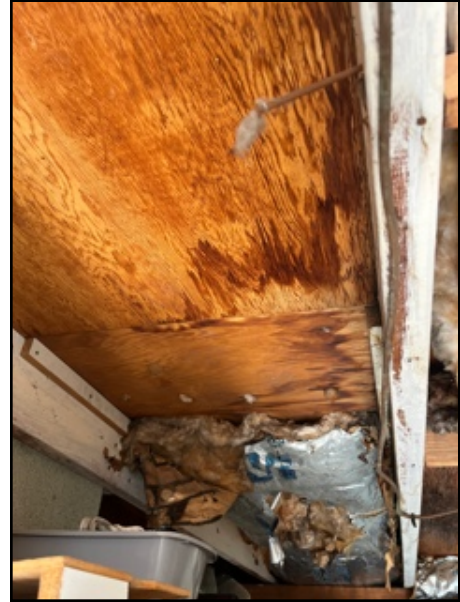
Figure 38-2

In the storage room behind the garage, the ceiling/plywood shows water stains from the flat roof.

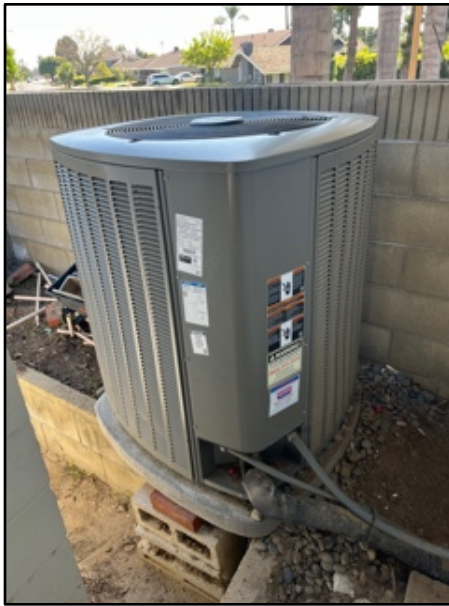
Figure 39-1

The outside condenser was installed in 2022. The unit uses the R410 A Freon. The condenser does not fit in the planter and has to have blocks stacked to support it from hanging over the edge.

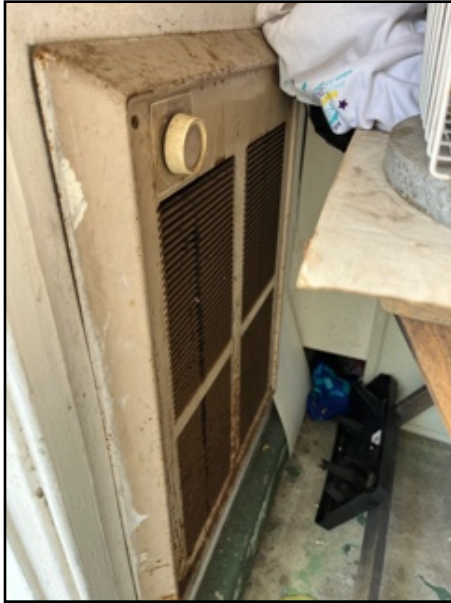
Figure 42-1

The electric heater in the garage does not operate.

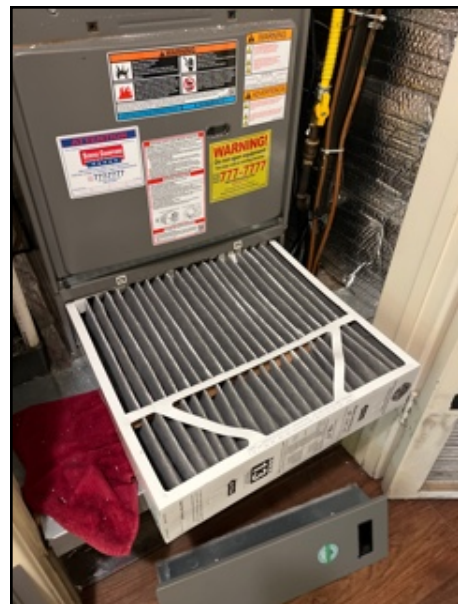
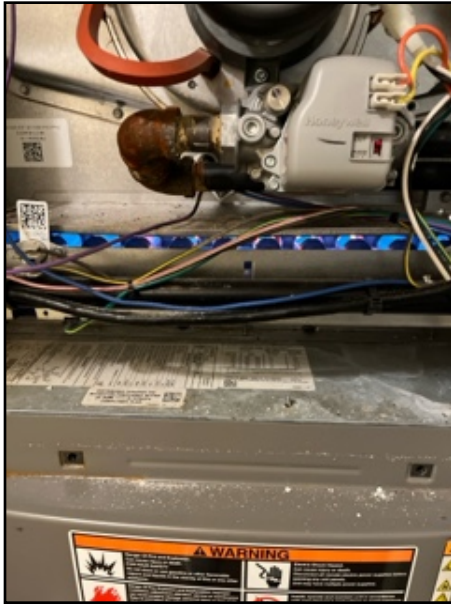
The furnace responds to the thermostat control. The burners ignite, and the blower motor is quiet at the time of the inspection.

The filter is dirty and should be replaced.

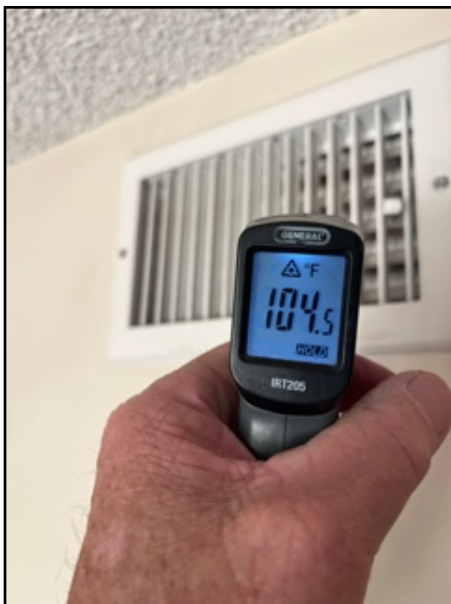
Figure 44-1

The heated air is blowing out at 104°.

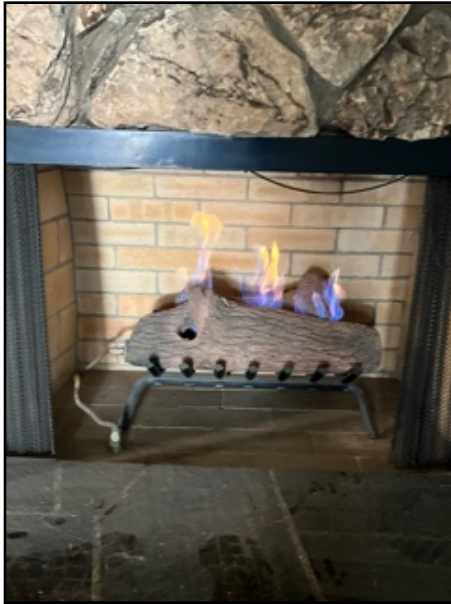
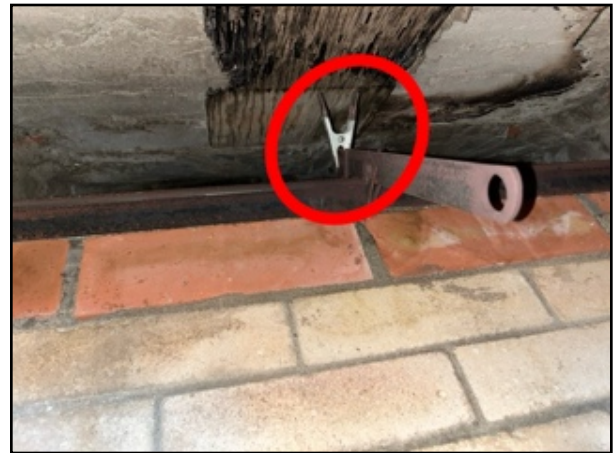
The family room fireplace damper has a C clamp attached. This is recommended by the Gas company.

The fireplace gas burner ignites.

The fireplace has a mesh screen.

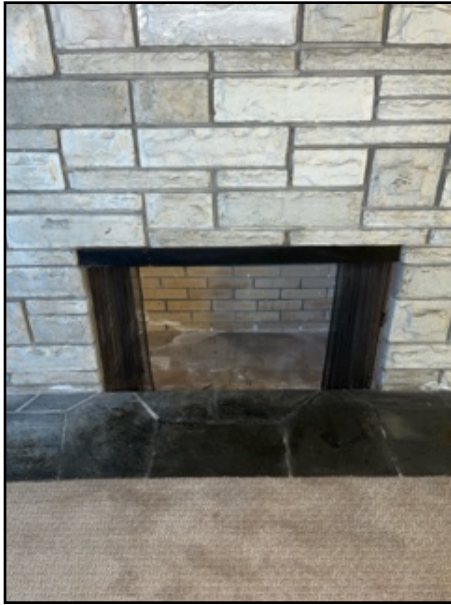
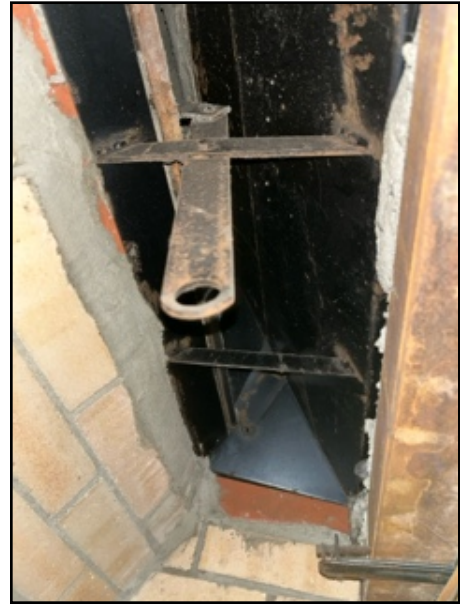
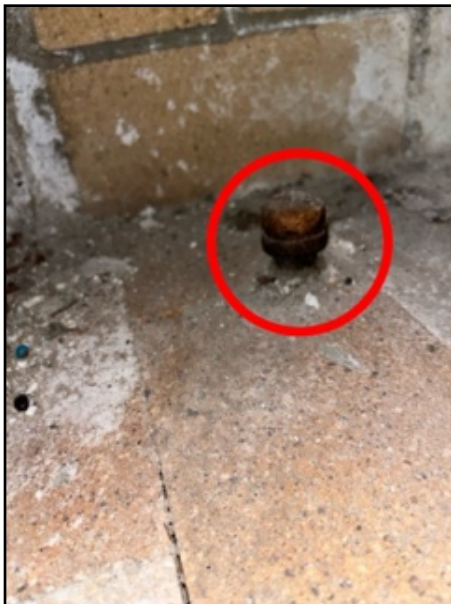
The fireplace has a mesh screen.

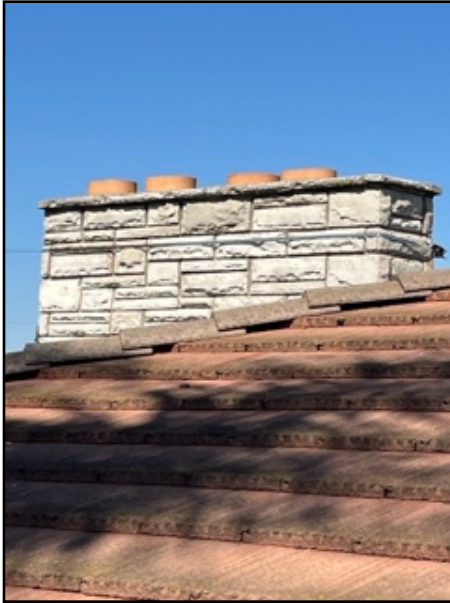
Figure 47-1

The chimney does not have spark arrestors installed.

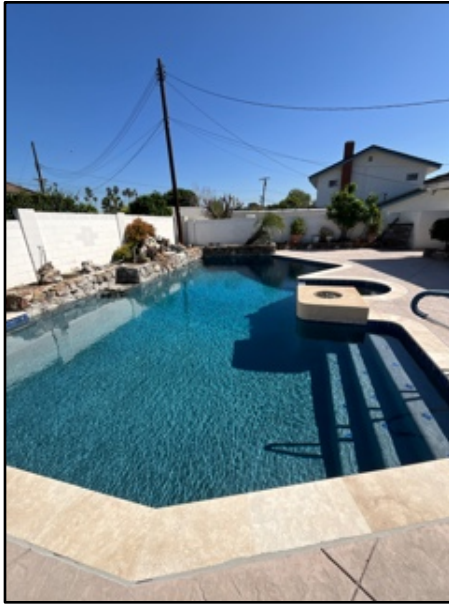
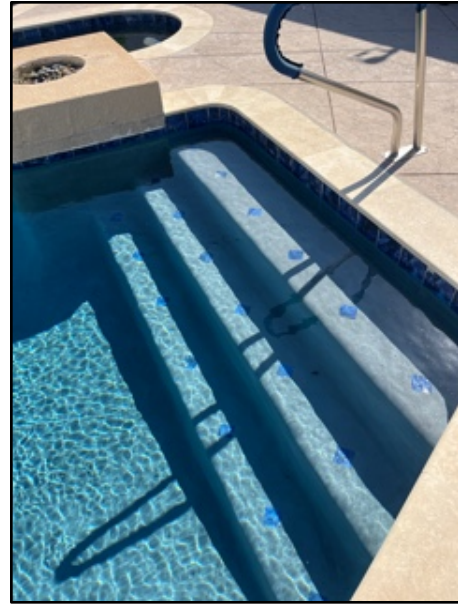
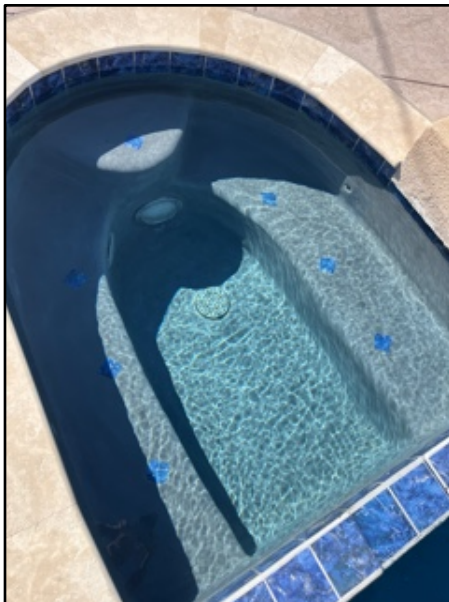
The pool plaster and tile appear to be in good condition.

The plaster and tile in the spa appears to be in good condition.

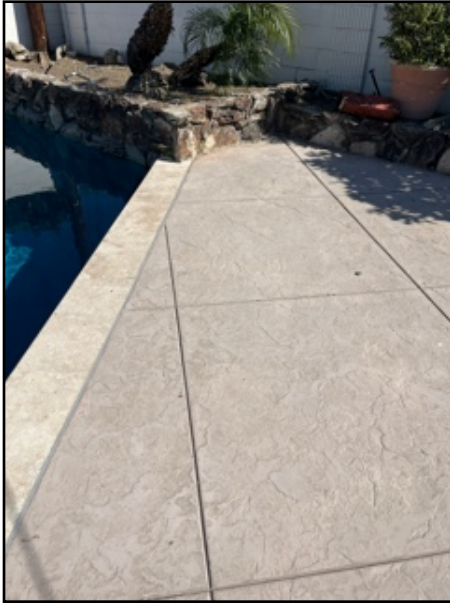
The concrete deck and the coping curb are well sealed.

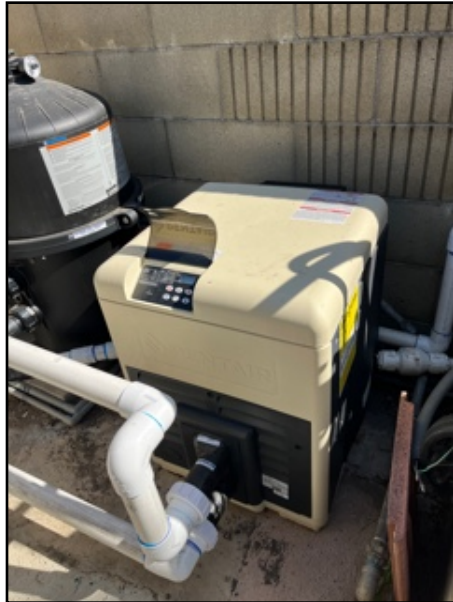
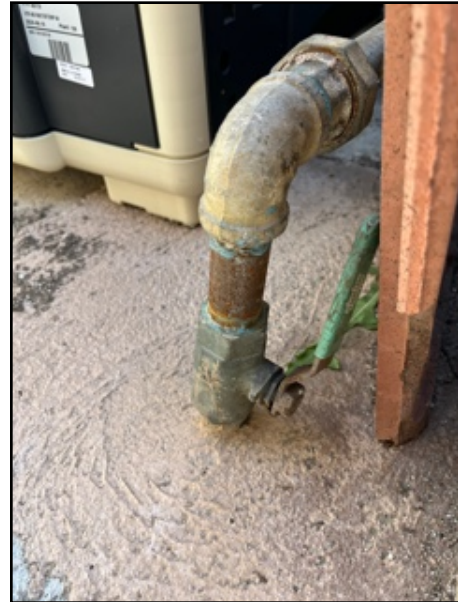
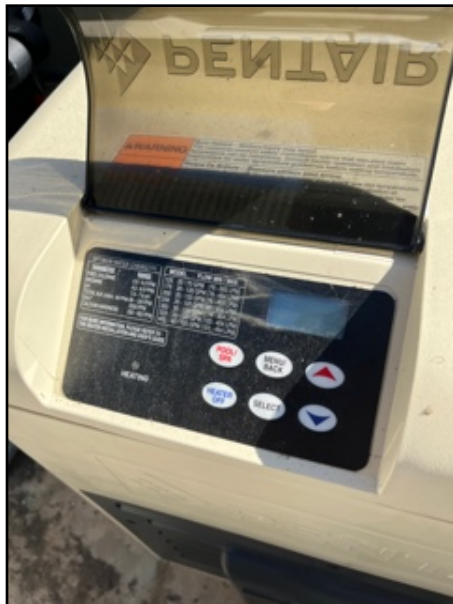
I was unable to get the heater to respond to the touchpad.
Have the sellers demonstrate that the heater is operating.

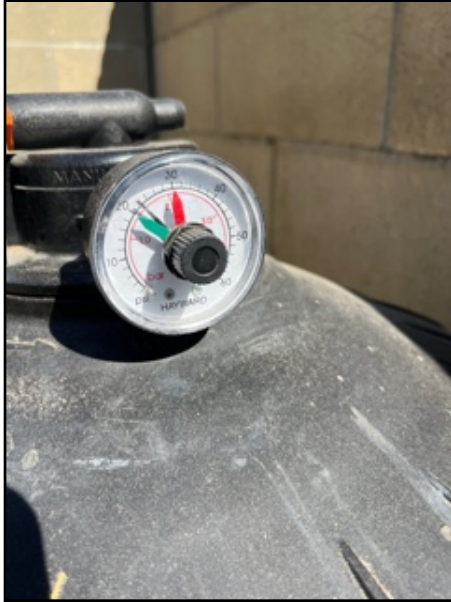
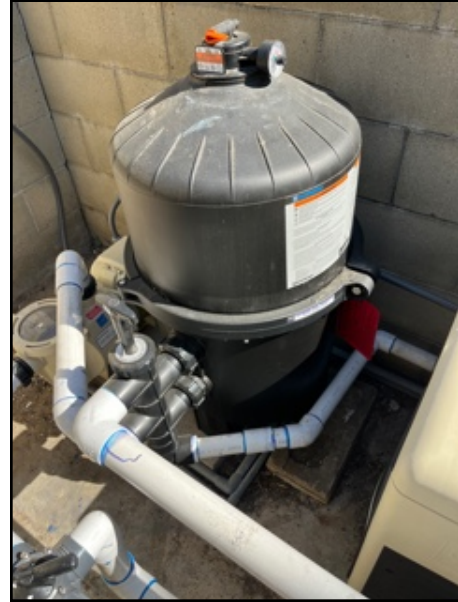
Comment 52:
The filter pressure is good at 20 psi.
No visible leaks from the filter.

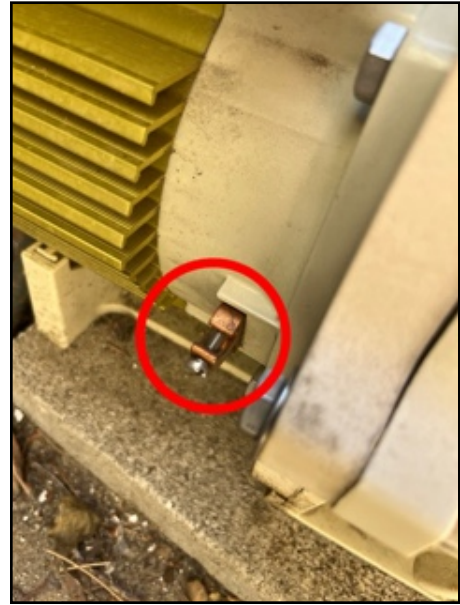
Figure 53-2

Comment 53:
The pump motor is quiet and free of leaks.
There is not a ground wire attached to the pump motor or the heater.

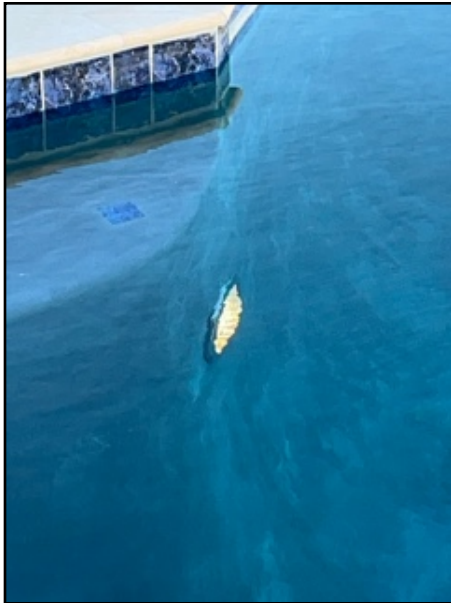
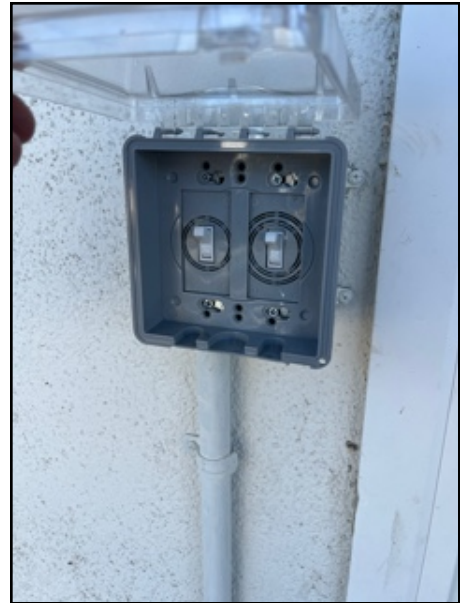
The pool light is operating from the wall switch near the master bedroom sliding glass door.

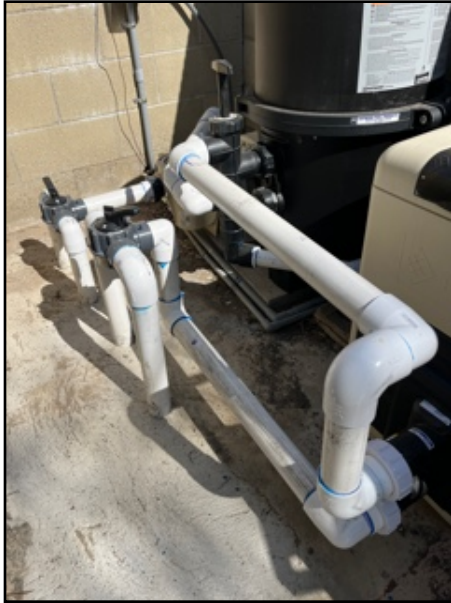
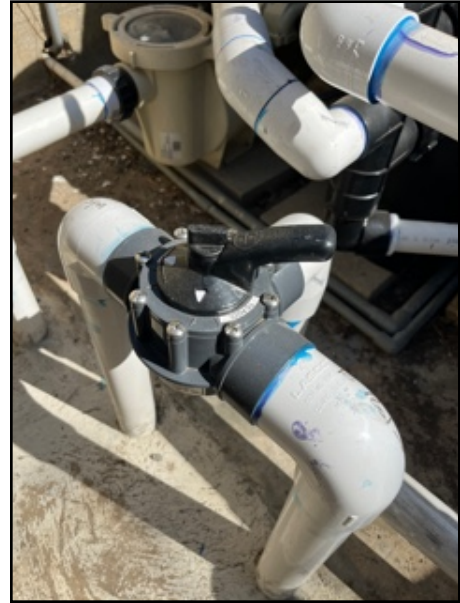
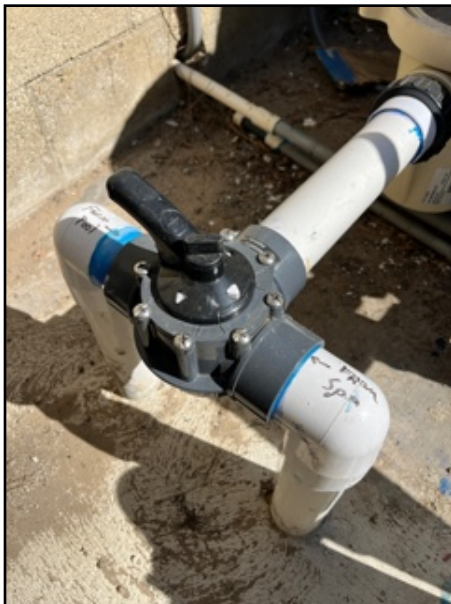
The plumbing pipes and control valves are free of leaks.

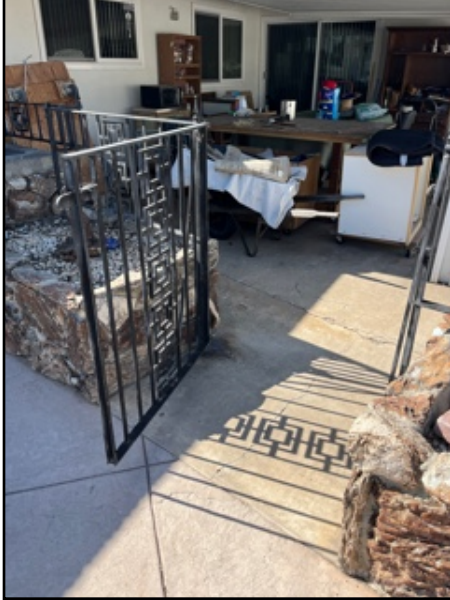
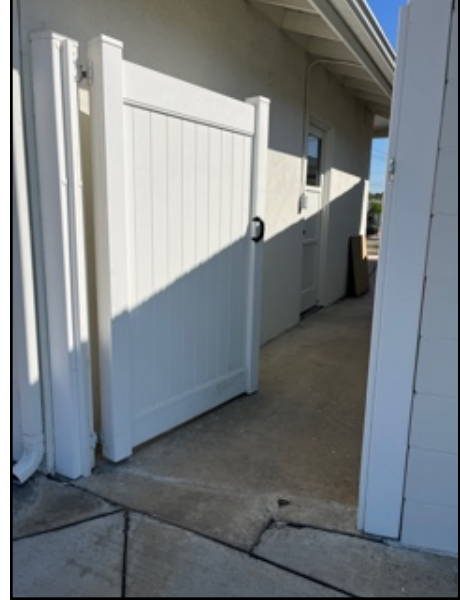
The gates going into the backyard are not self closing and latching. This does not meet the child safety codes.

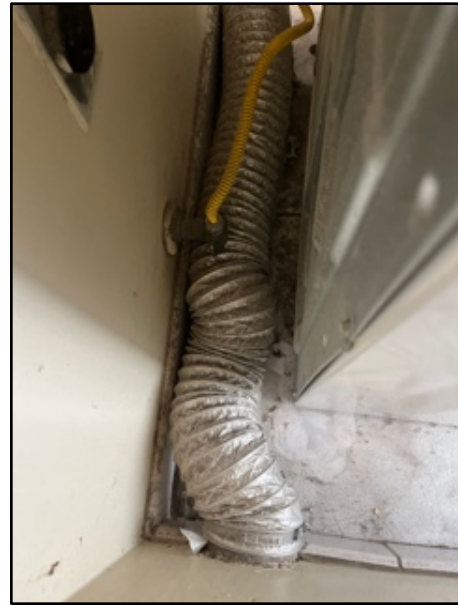
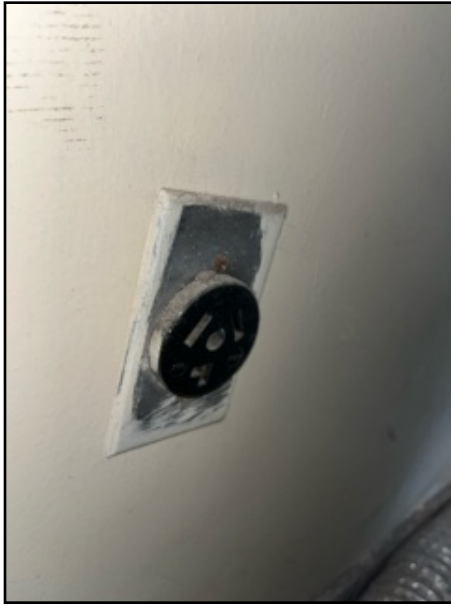
The washer hook up valves are free of leaks.

I recommend vacuuming, the dryer vent of lint and debris.

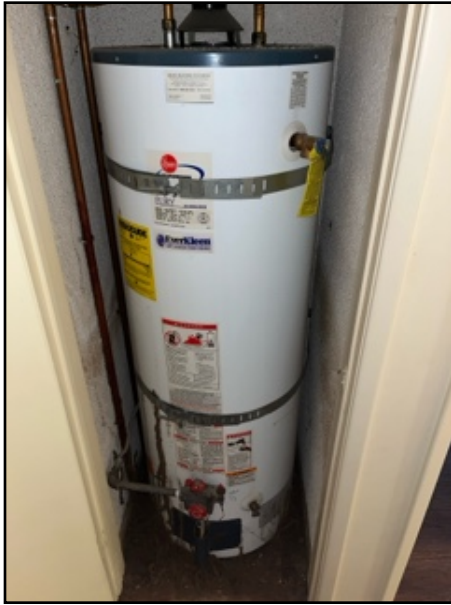
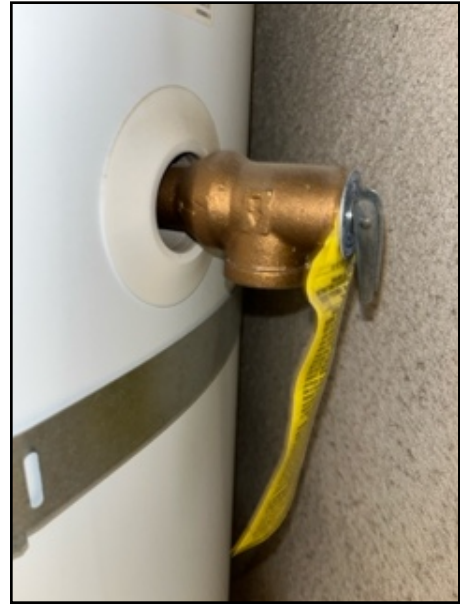
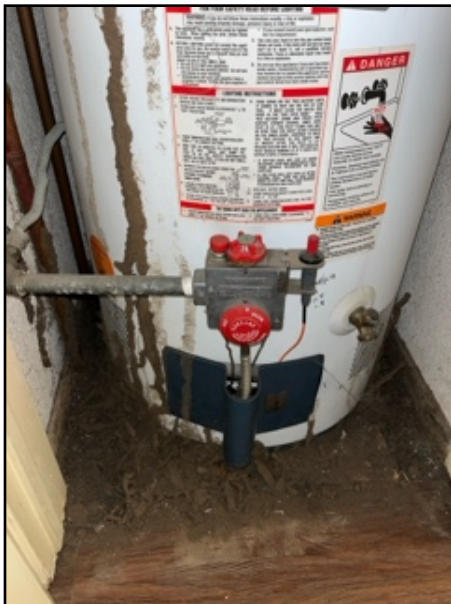
The bedroom hall water heater has two earthquake straps securely mounted.
The pressure relief valve does not have a downspout pipe
The base of the closet shows subterranean termite mud tunnels.
The gas line does not have a sediment trap.
The water heater is not sitting in an overflow pan with a drain to the exterior.
The water heater is old and nearing the end of its life.
