Mitch Fredericks Home Inspections

13614 Dall Lane

Inspected on Wed, Mar 11 2026 at 2:19PM

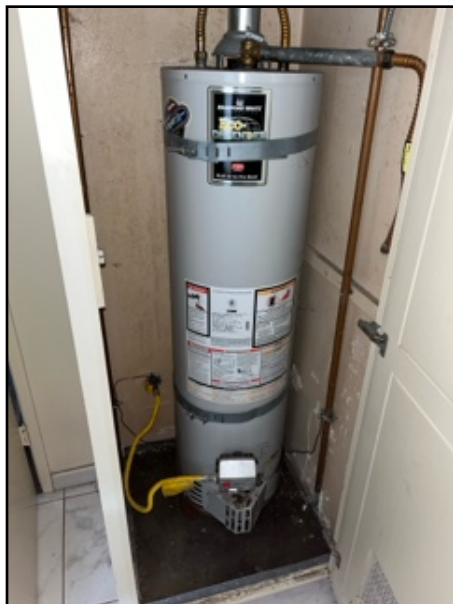
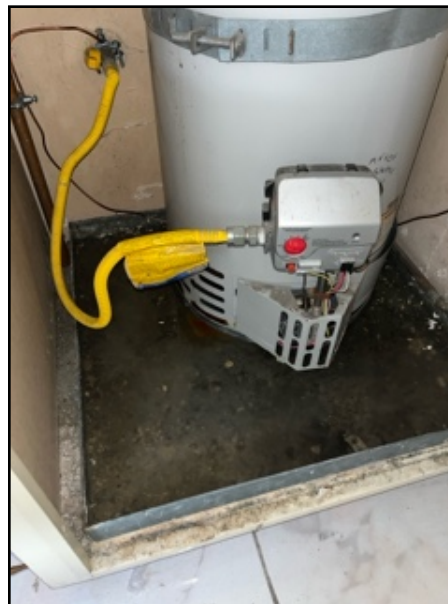
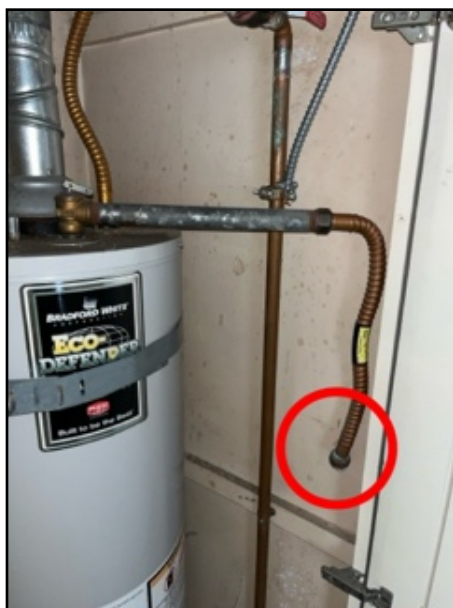
The pressure relief valve does not have a downspout to the floor.

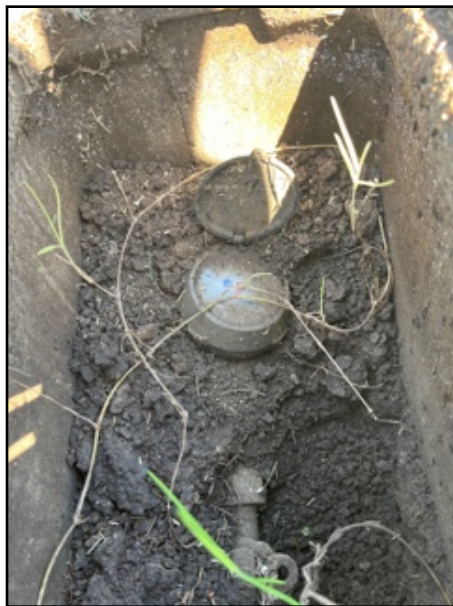
Figure 61-1

The main water meter is located near the street in a vault.

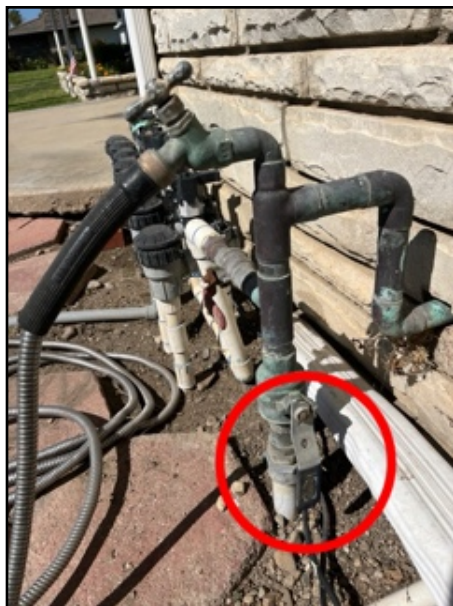
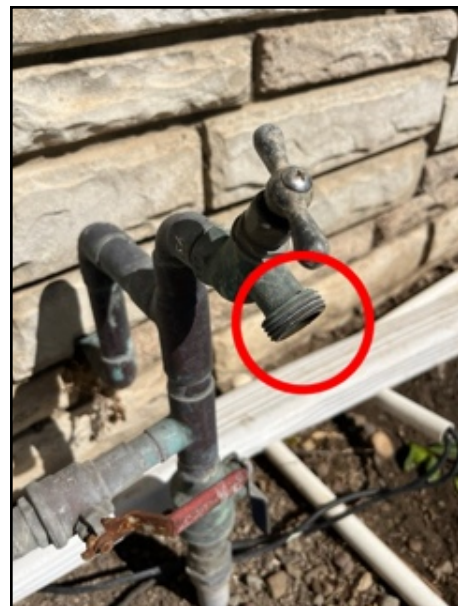
The exterior hose bib does not have an antisiphon device installed.

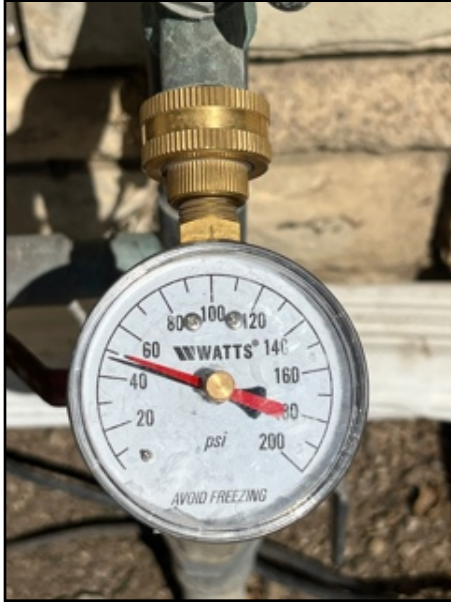
Figure 63-1

The water pressure is slightly low at 48 psi.

The water pressure should be between 60 and 75 psi.

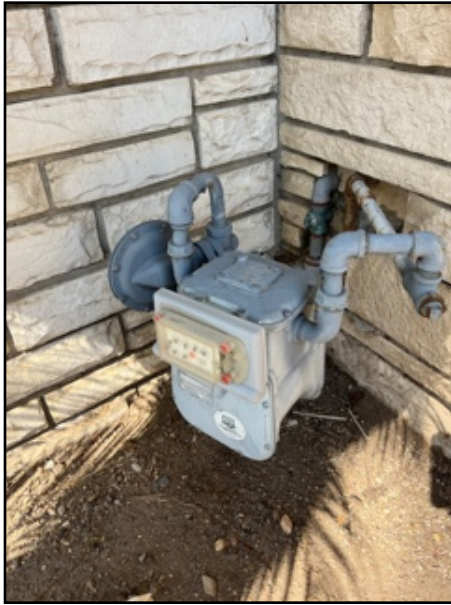
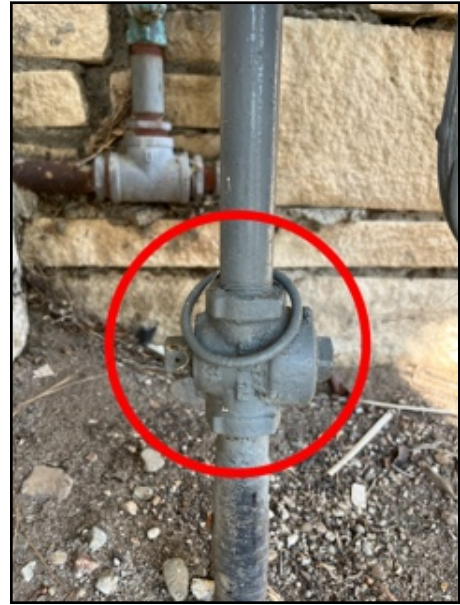
You will need a wrench to turn the gas valve.

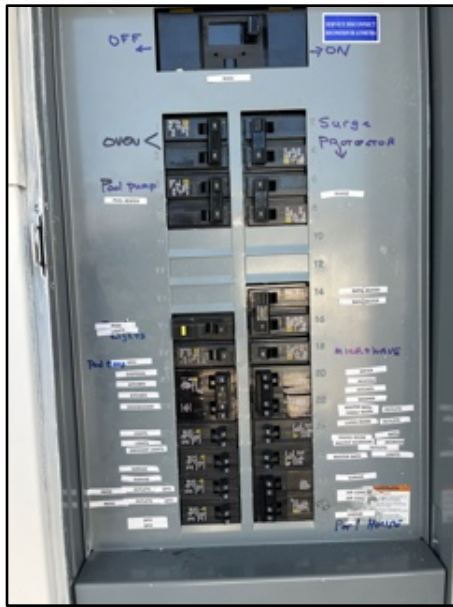
The breakers are labeled.

The main service disconnect is 200 amps.

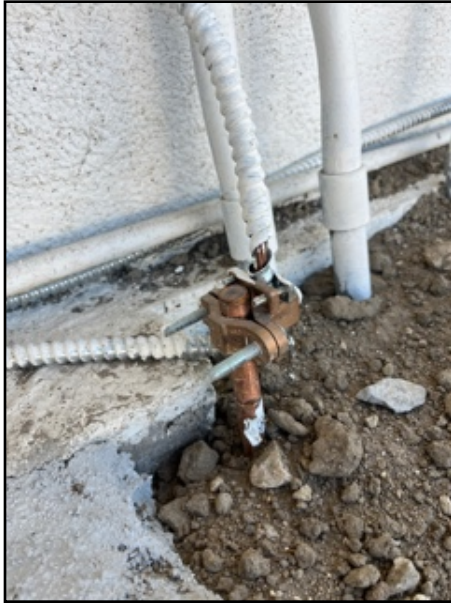
Figure 70-1

Comment 70:
The electrical panel is grounded.

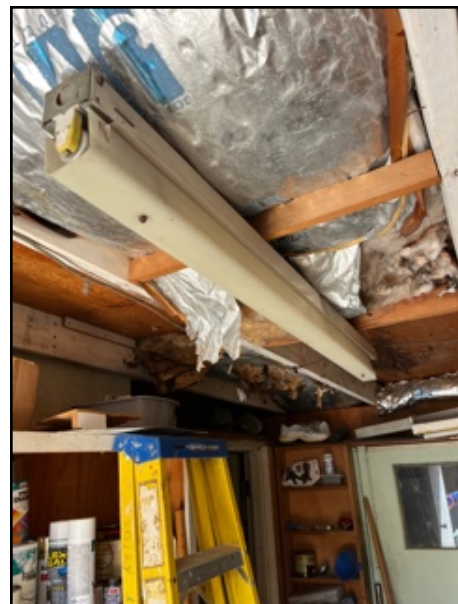
Figure 71-2

Comment 71:
At the rear of the garage, there is a storage shed that has electrical romex wiring exposed and not in conduit.
The old light fixture is in need of repair.

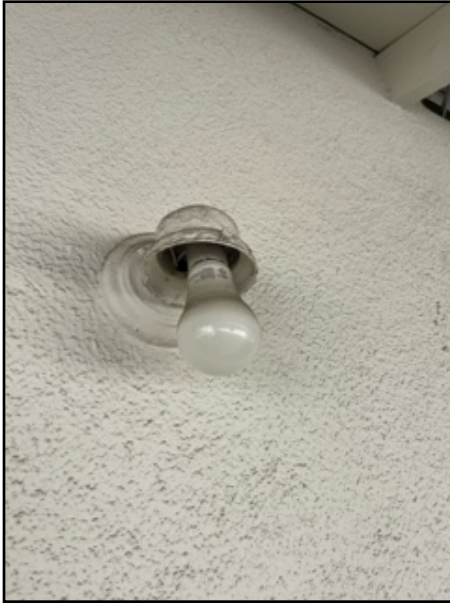
Figure 72-1

The laundry porch light does not have a glass globe.

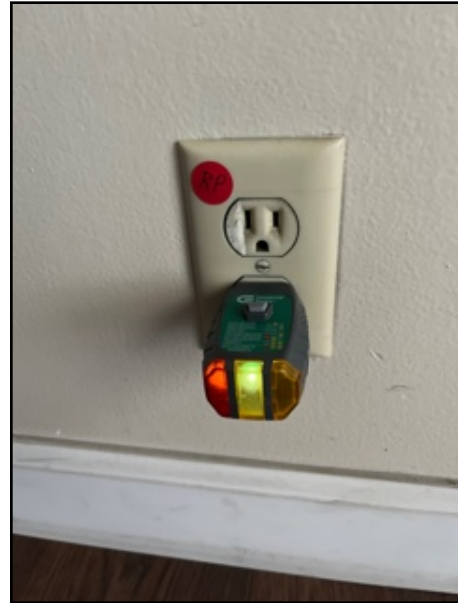
In the family room near the wet bar there are two electrical outlets that have reverse polarity. Another outlet that's close to the wet bar should be GFCI protected.

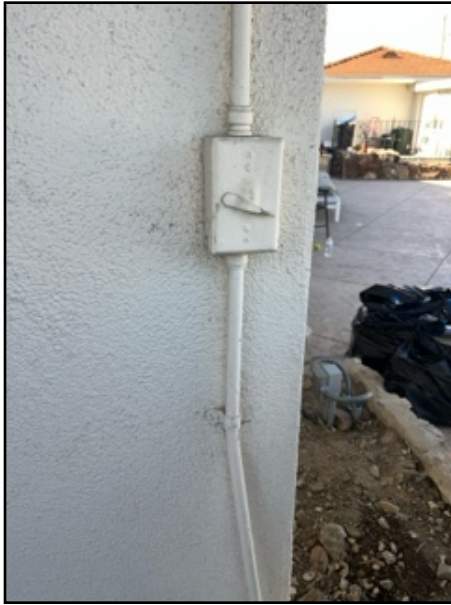
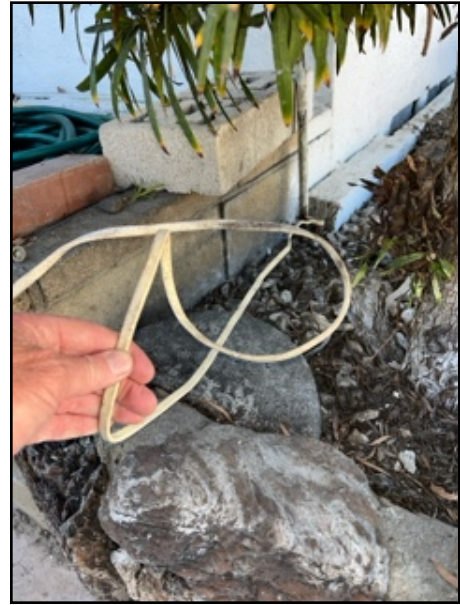
At the rear right corner of the house, there's a light switch exposing electrical wiring that is disconnected. I am uncertain what this was used for.

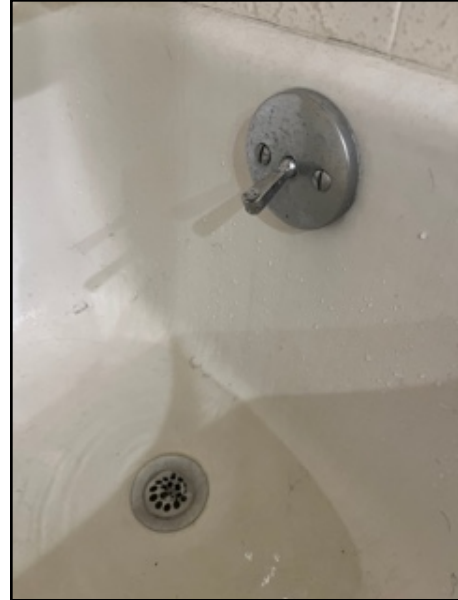
The hall bathroom tub stopper is operating. The tub drains well.

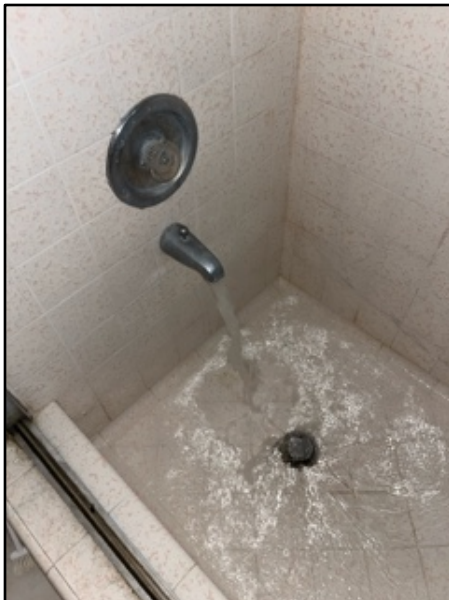
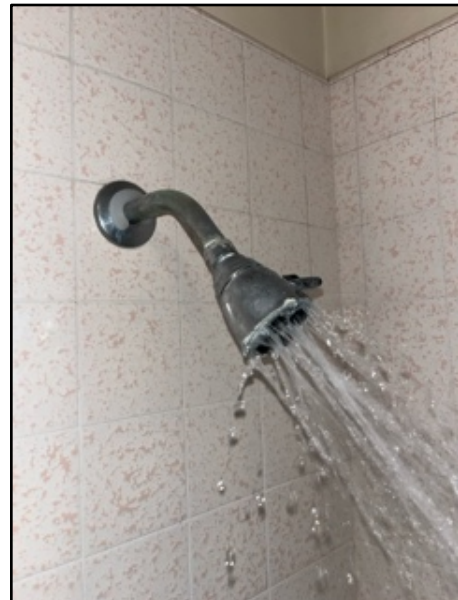
The master bathroom tub spout is operating. The tub drains well.
The showerhead appears to be leaking and may need replacement.

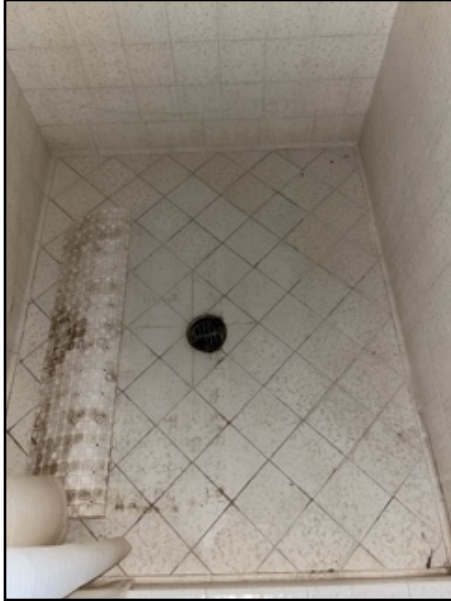
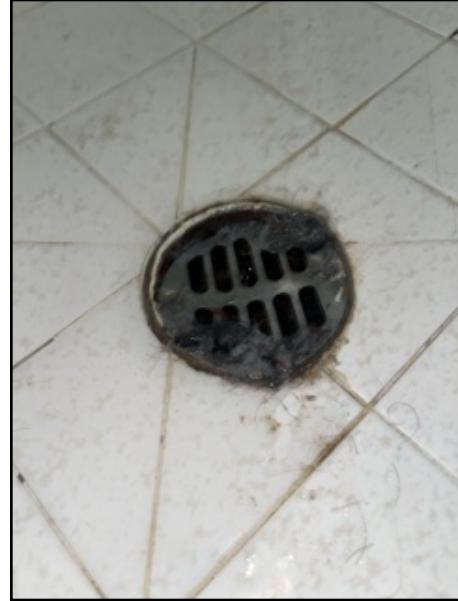
The hall bathroom shower floor tile and grout appear to be in need of cleaning and removing hair from the drain.

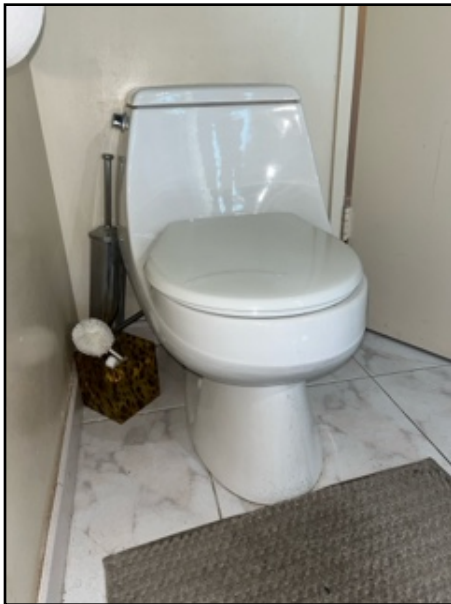
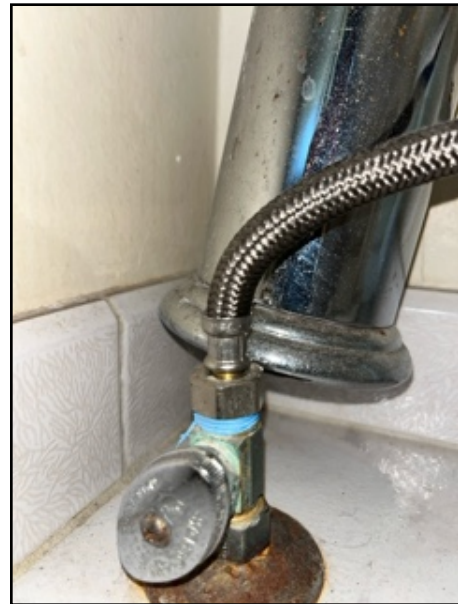
The hall bathroom toilet is securely mounted. The supply valve is free of leaks.

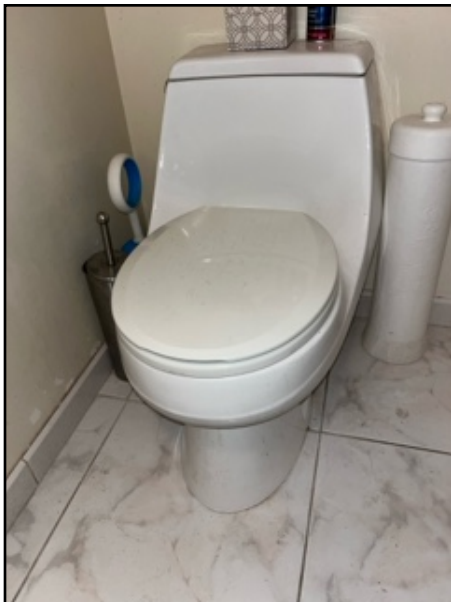
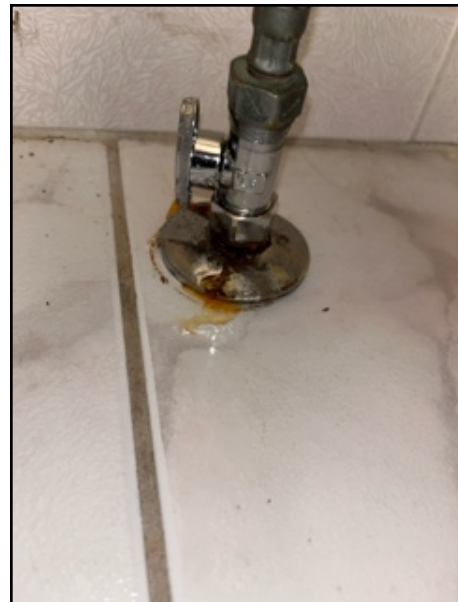
The master bathroom toilet is securely mounted. The supply valve is free of leaks.

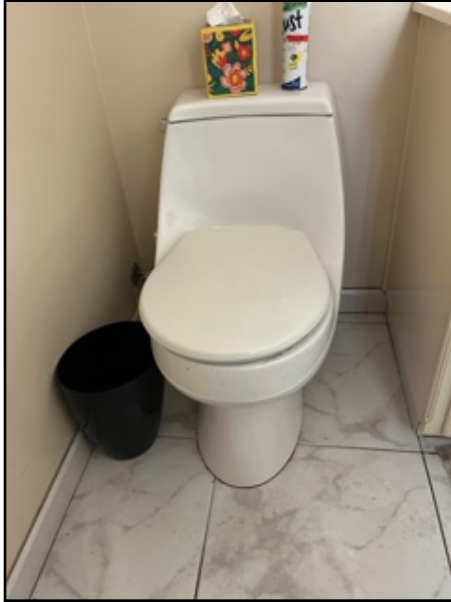
The half bathroom toilet is securely mounted and flushing properly. The supply valve is a quarter turn shut off with a steel braided hose.

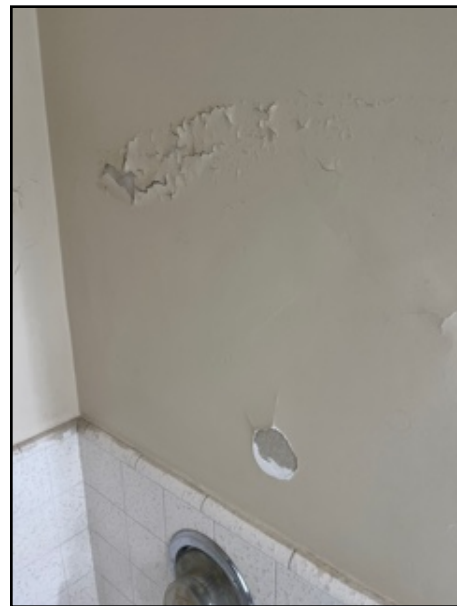
The hall bathroom plaster wall walls above the tub show paint peeling.

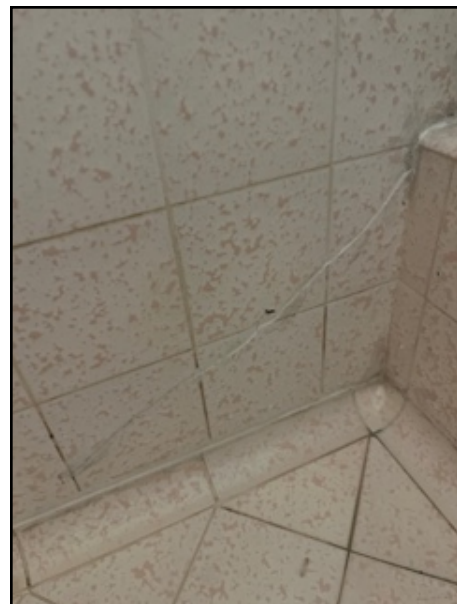
Figure 83-2

The master bathroom, shower tiles show cracks that have been sealed with caulking.

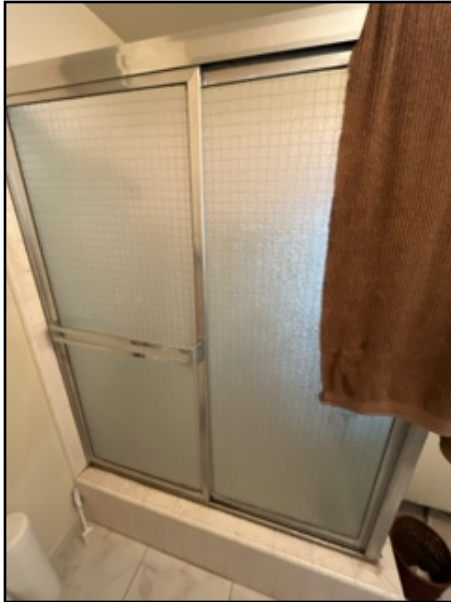
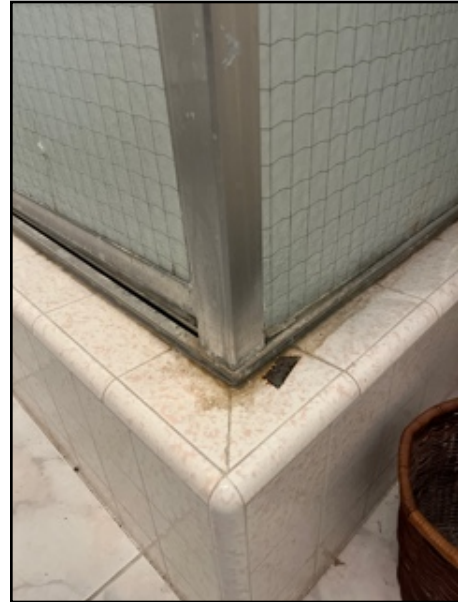
The master bathroom shower enclosure only has one door that operates.

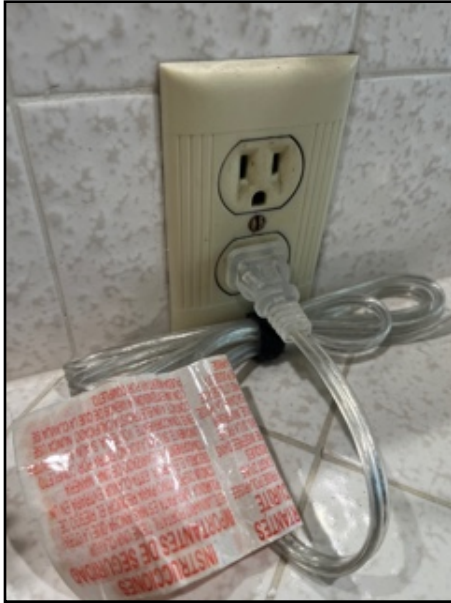
Figure 86-1

Comment 86:
The bathroom outlets are not GFCI protected.

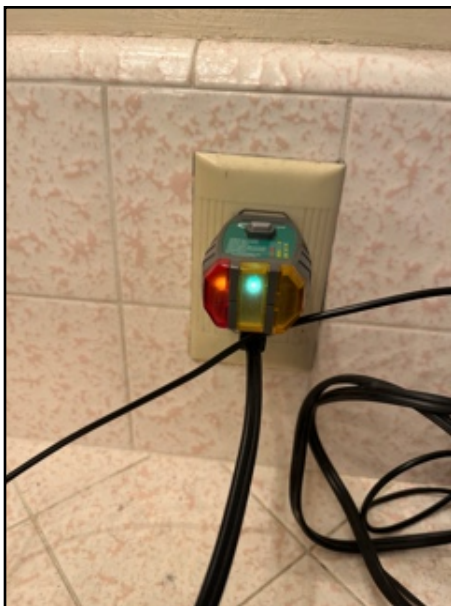
Figure 87-1

Comment 87:
The master bathroom electrical outlet has reverse polarity.

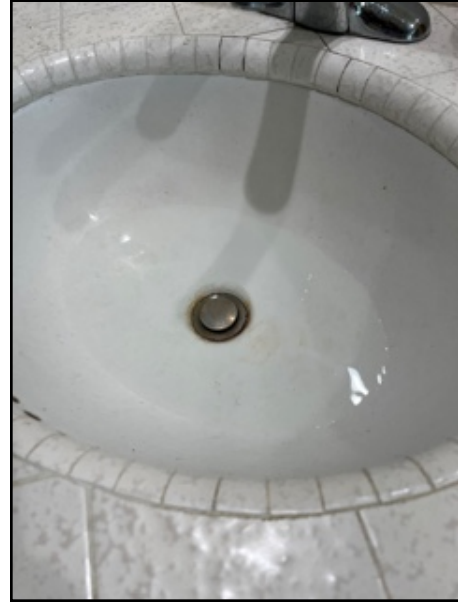
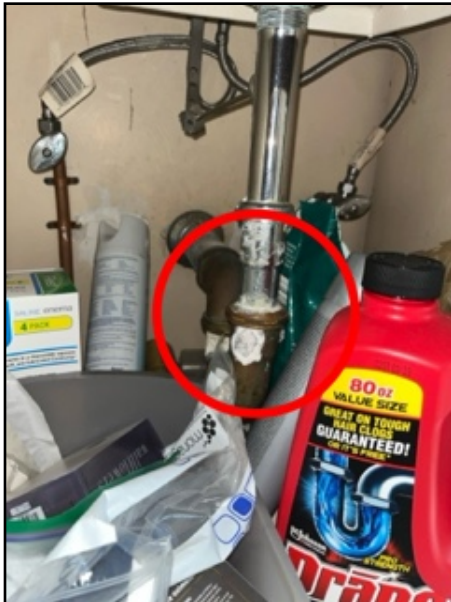
The hall bathroom left side sink drains slowly. Drano is present below the sink cabinet. The waste line pipe is heavily corroded and should be replaced.

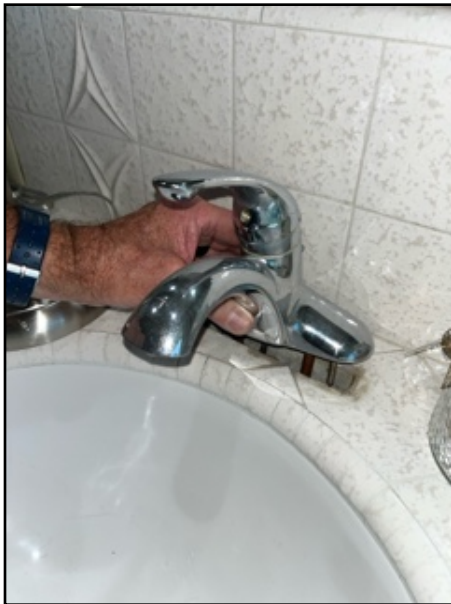
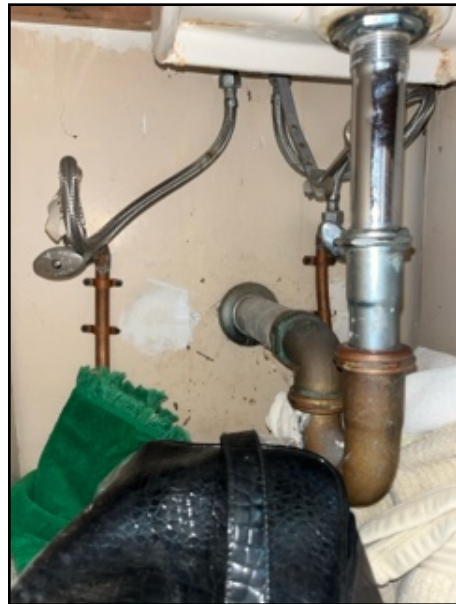
The hall bathroom right side sink faucet is not securely mounted.

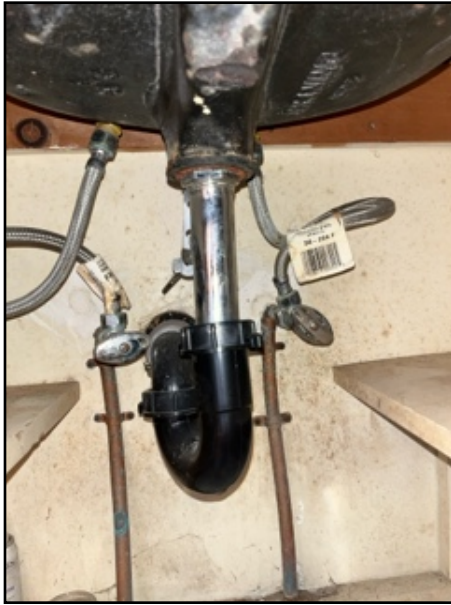
The master bathroom sink is draining slowly. The wasteline pipe appears free of leaks.

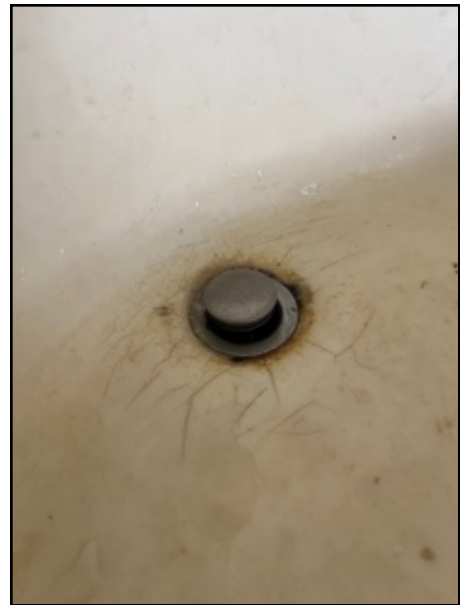
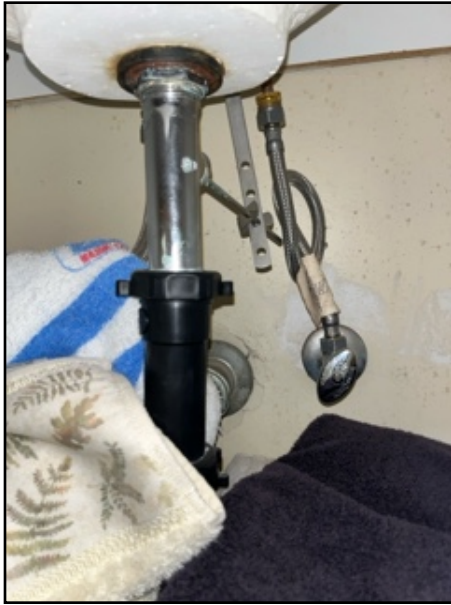
The half bathroom off of the laundry room shows cracks in the basin around the drain. Repairs are needed at this time.

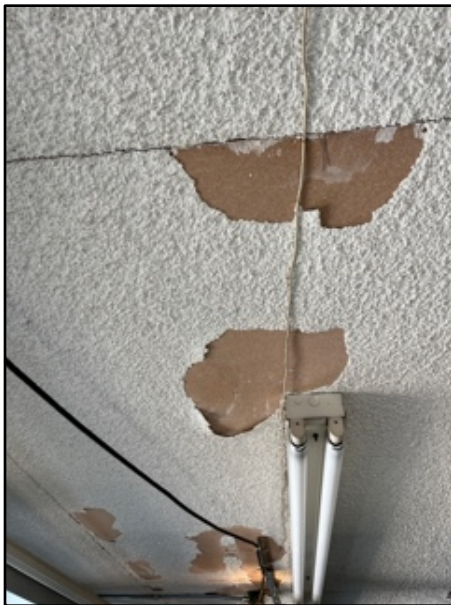
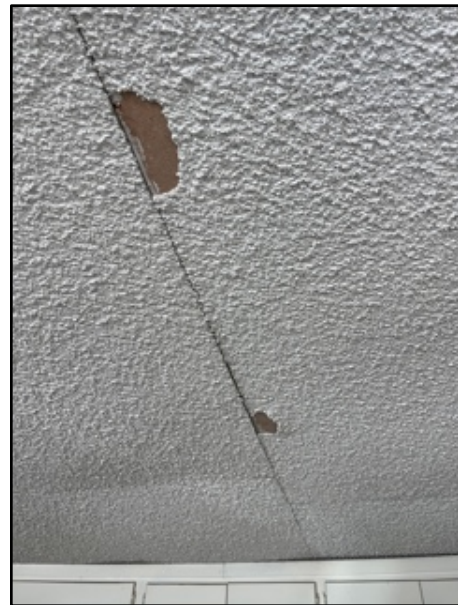
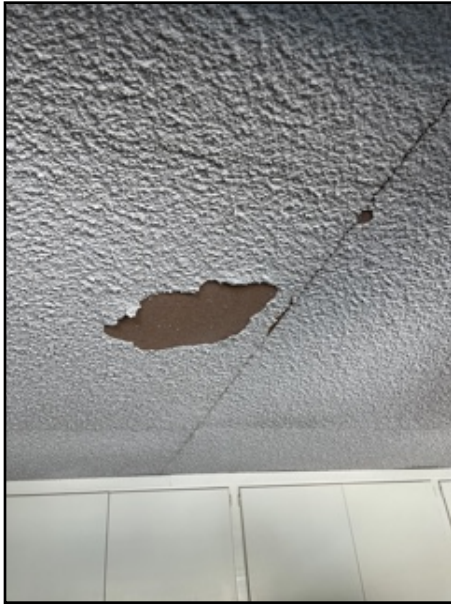
If it is confirmed that the ceiling has asbestos, it should not be disturbed.

The removal of the acoustic ceiling should be performed by a licensed trained professional.

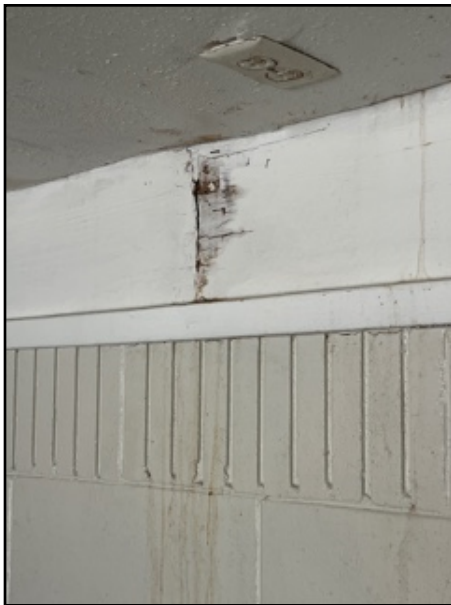
Comment 93:

Evidence of rainwater intruding into the room. The roof shows evidence of pooling water in this location.

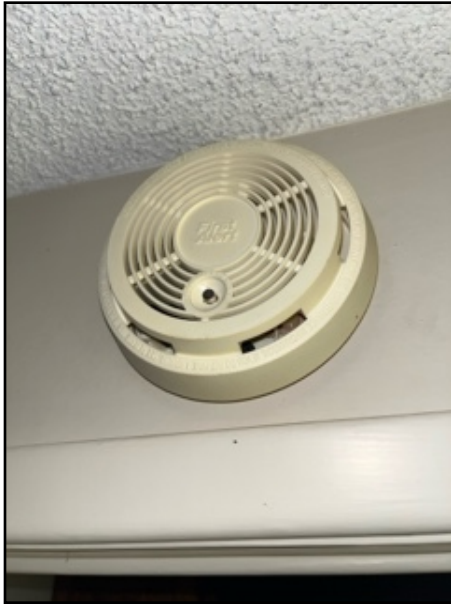
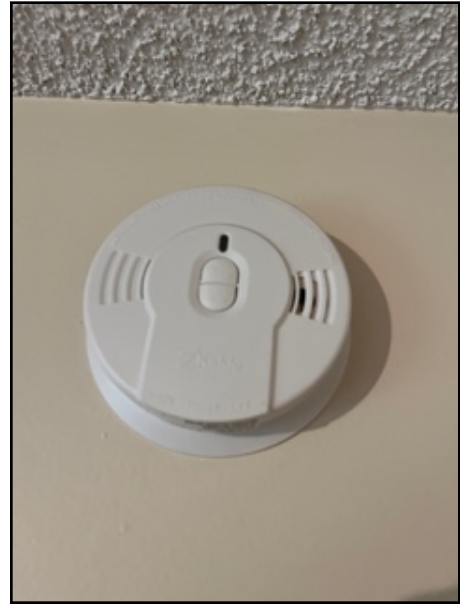
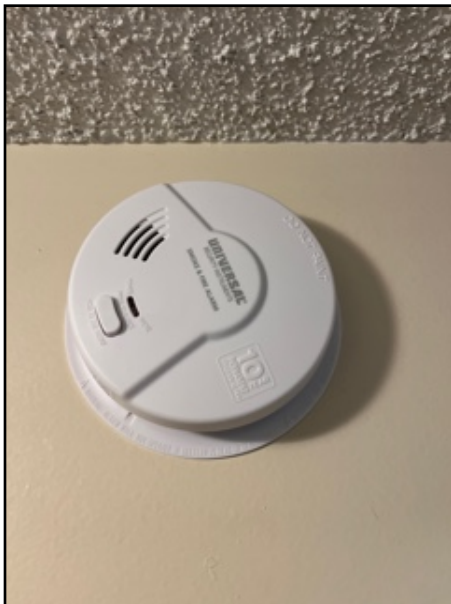
Some of the smoke detectors appear to be older than 10 years. Smoke detectors should be upgraded to the 10 year battery devices. In the hall, there is a carbon monoxide detector installed.

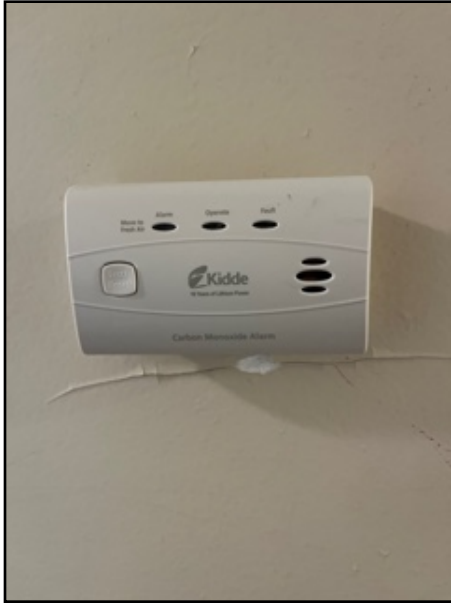
Comment 98:

Carbon monoxide detectors are installed in the bedroom halls.

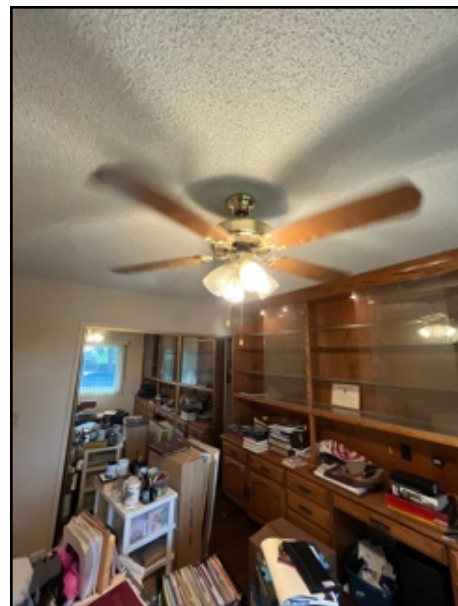
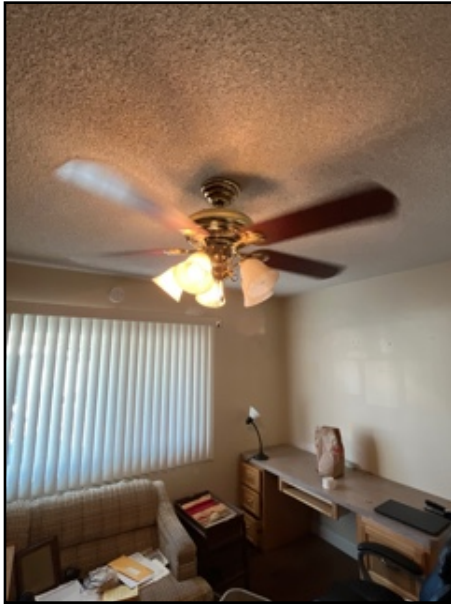
Comment 99:

The bedroom ceiling fans are operating from the pull chains.

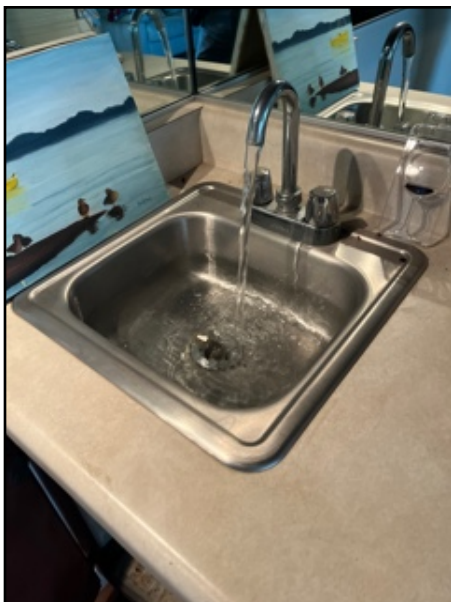
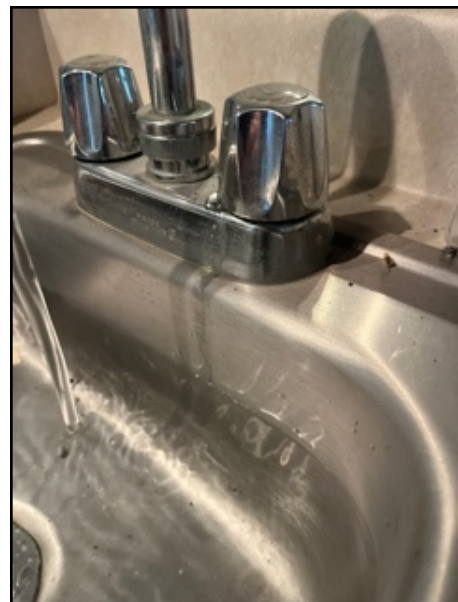
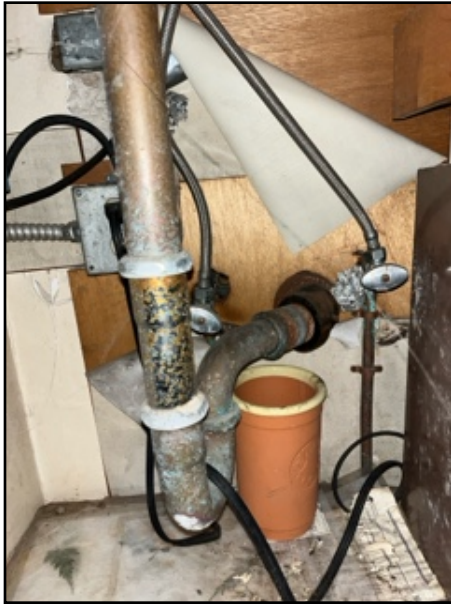
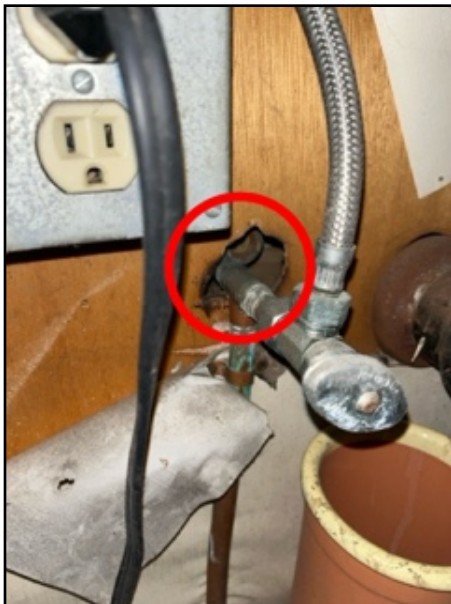
The family room wet bar is operating. Water is leaking at the control valve handles.

No visible leaks under the sink at the wasteline pipes.

Under the wet bar in the cabinet, there is rodent droppings. There are holes in the wall that should be sealed to keep rodents out.

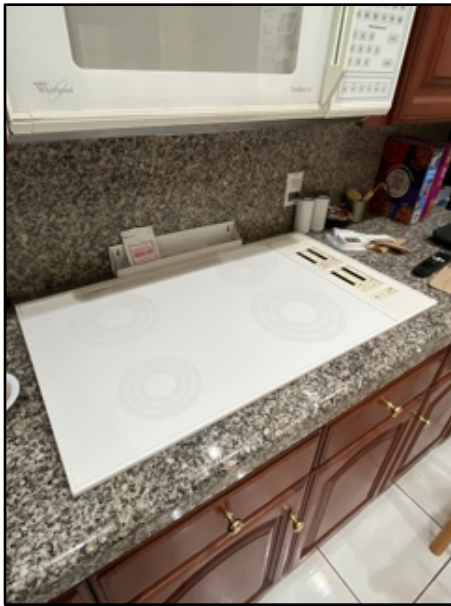
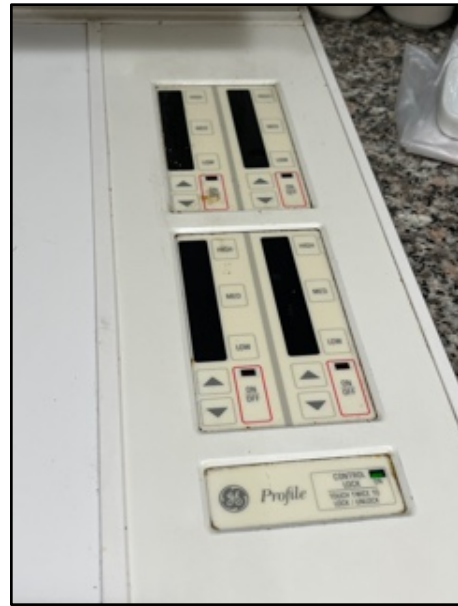
Comment 101:

The cooktop is locked, and I was unable to operate it.

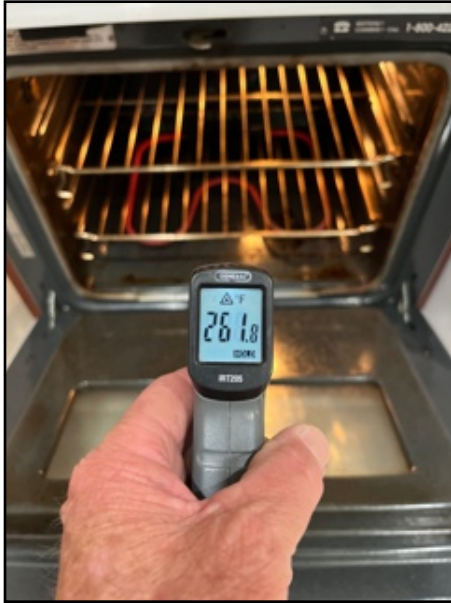
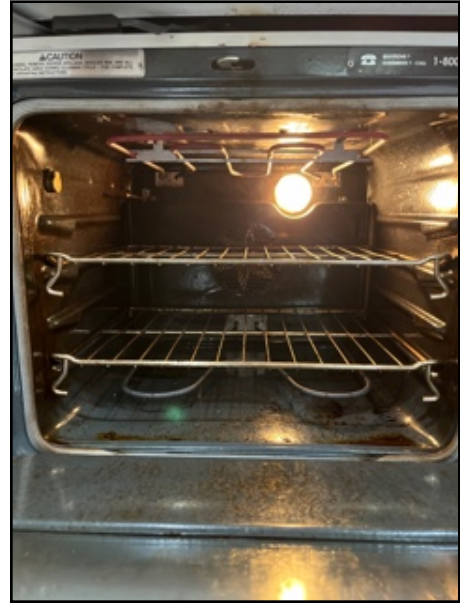
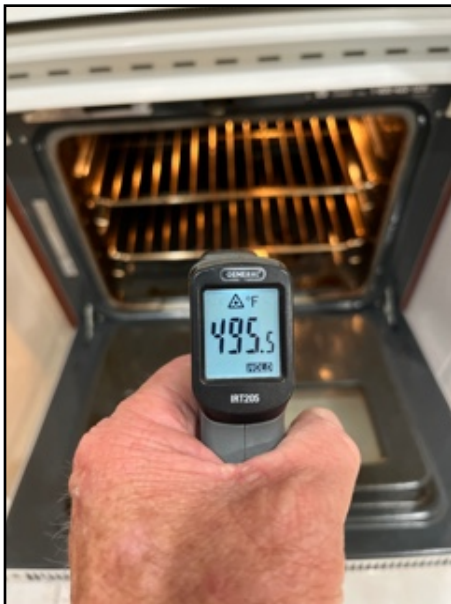
Comment 102:

The oven bake and broil both heating to appropriate temperatures.

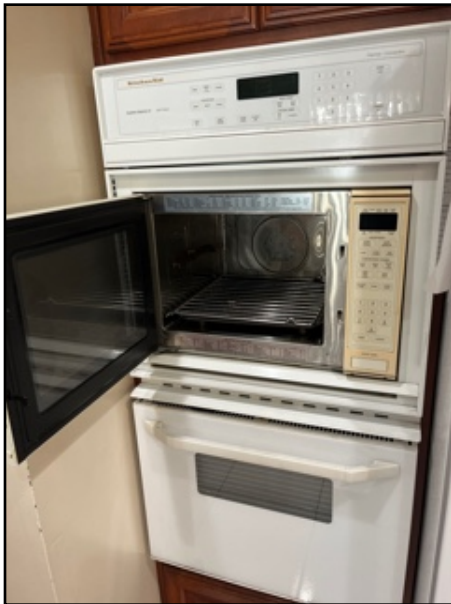
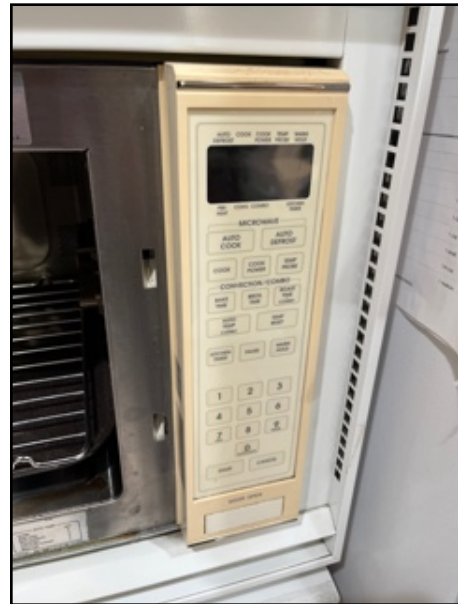
Comment 103:

The microwave built-in above the oven does not have power and does not work.

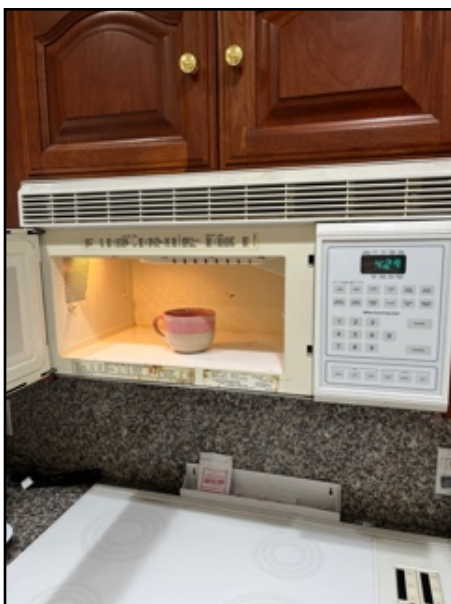
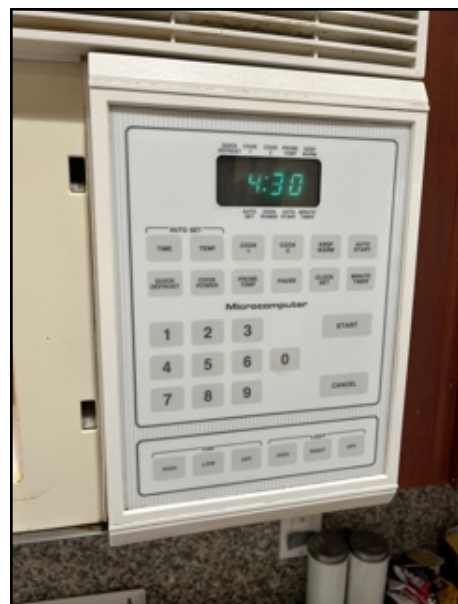
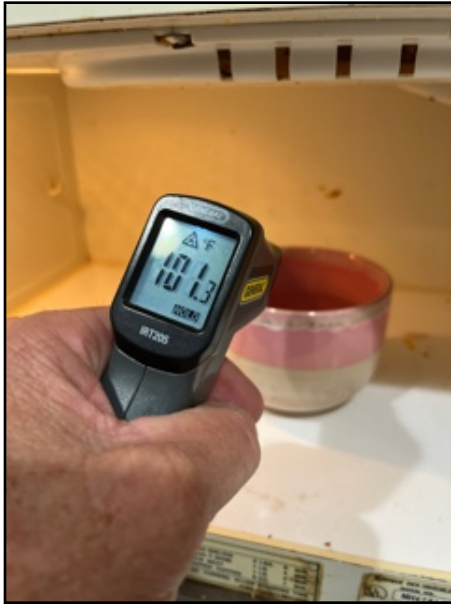
The microwave is operating and heats a cup of water in 30 seconds. No further test was conducted on the microwave.

Located over the cooktop.

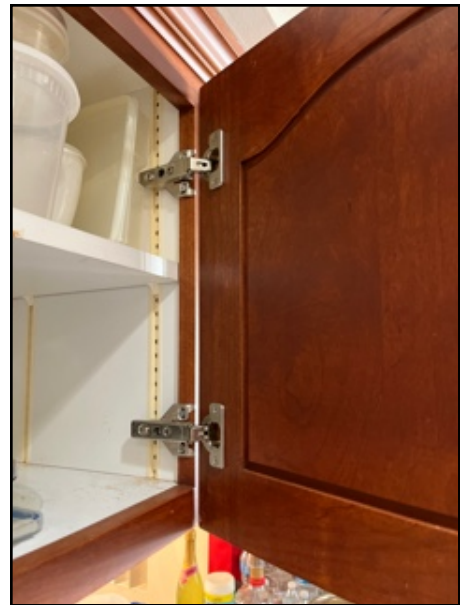
Cabinet pole knobs are missing. Adjustments are needed to the hinges.

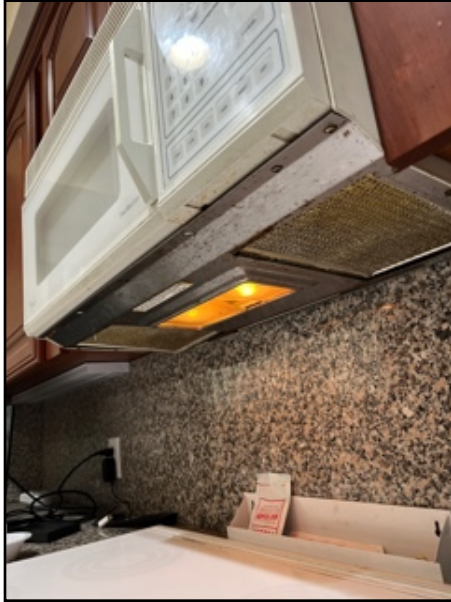
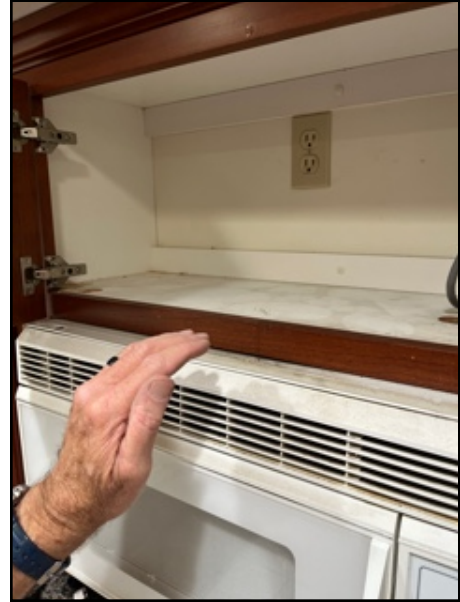
Comment 107:
The exhaust fan and light are operating.
The exhaust vents back into the room.

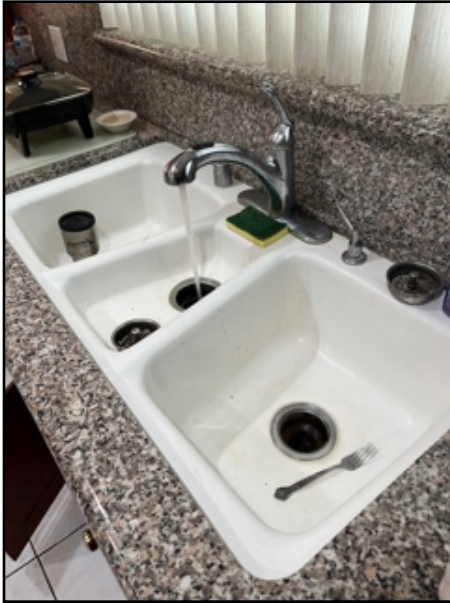
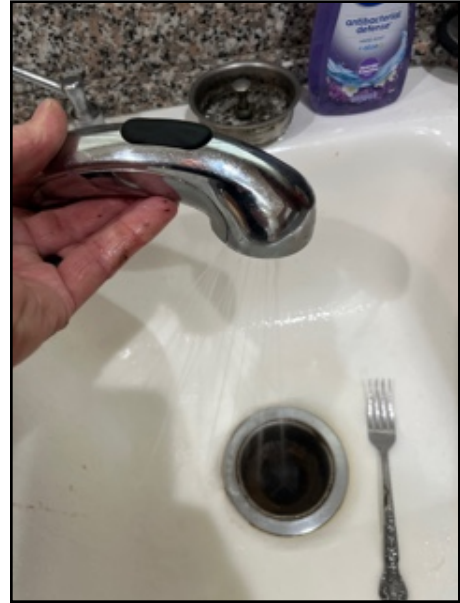
Comment 108:
The kitchen sink and spray nozzle are operating.

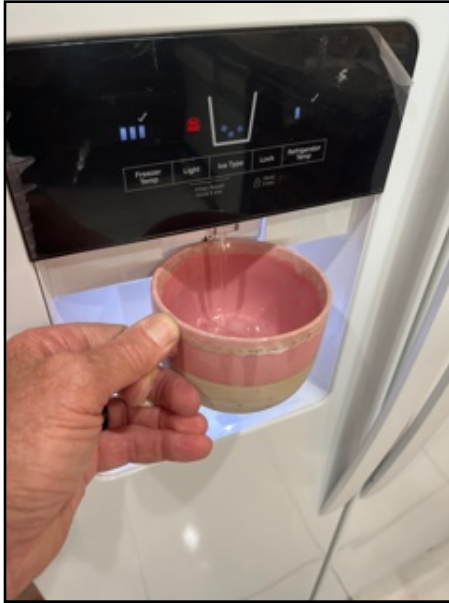
Comment 109:
The water operates from the refrigerator door.

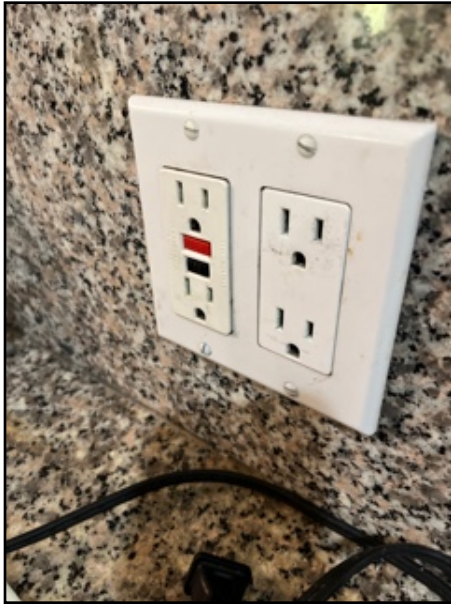
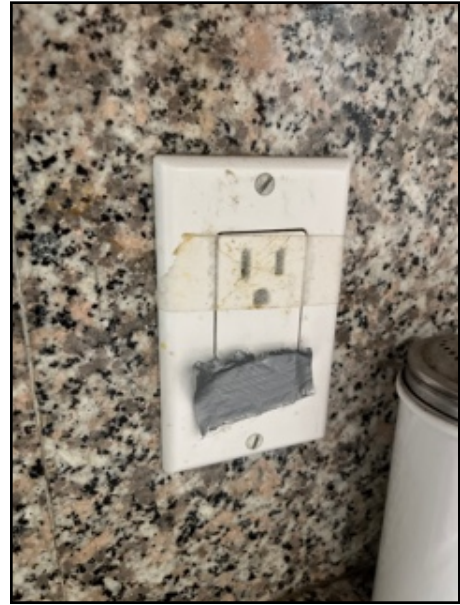
Comment 110:
The kitchen outlets are GFCI protected.
There is one outlet that has been taped over. I don't know if the outlet is safe to plug into.

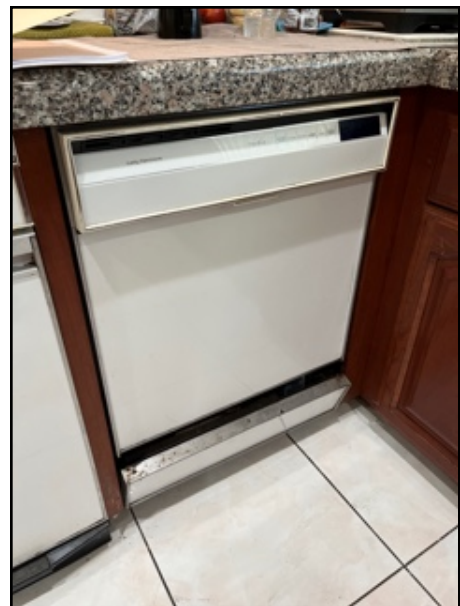
Figure 111-2

Comment 111:
The dishwasher does not operate.
I recommend replacing the dishwasher.

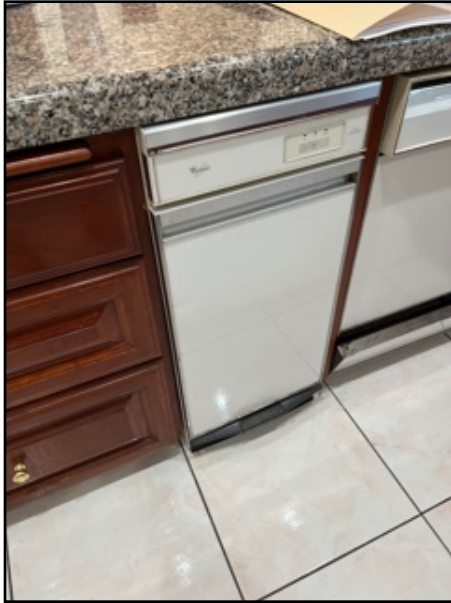
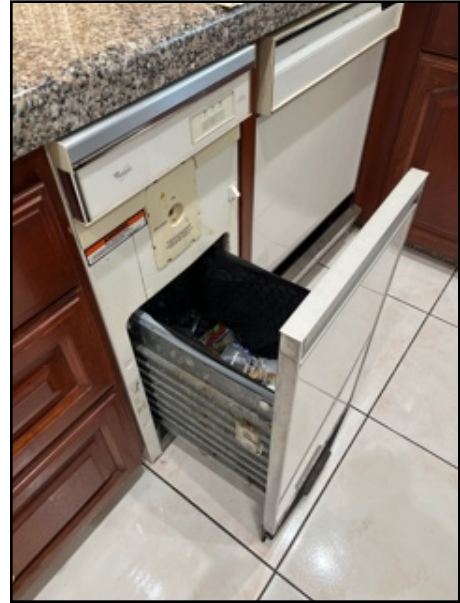
Comment 112:
The trash compactor does not operate.

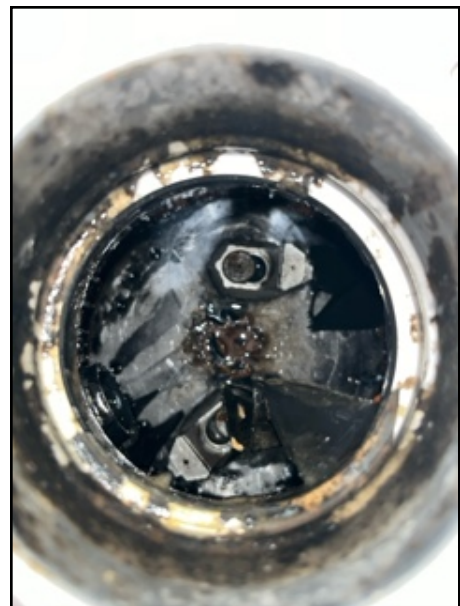
Figure 113-2

Comment 113:
The garbage disposal is noisy and should be replaced.

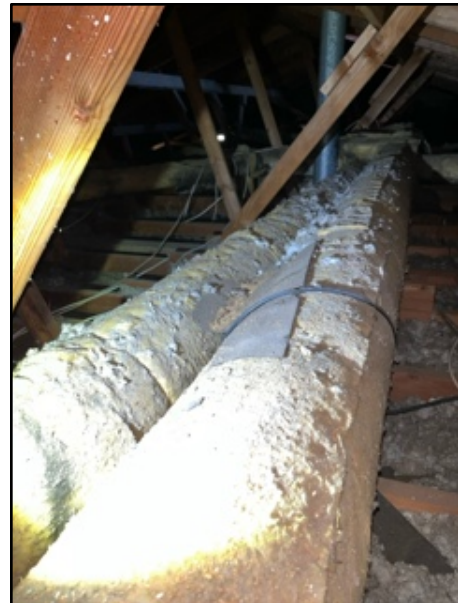
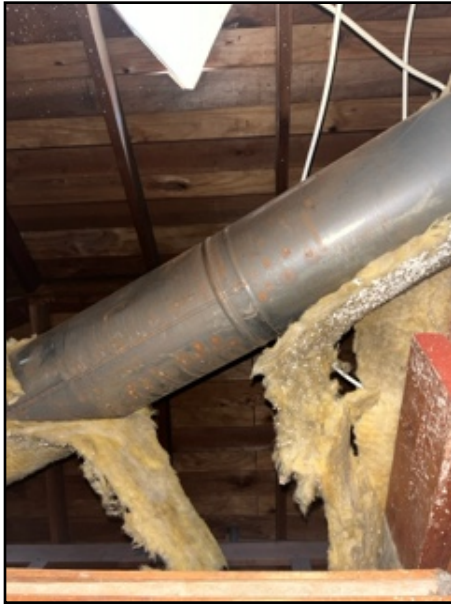
One or two of the heating ducts are missing its insulation.

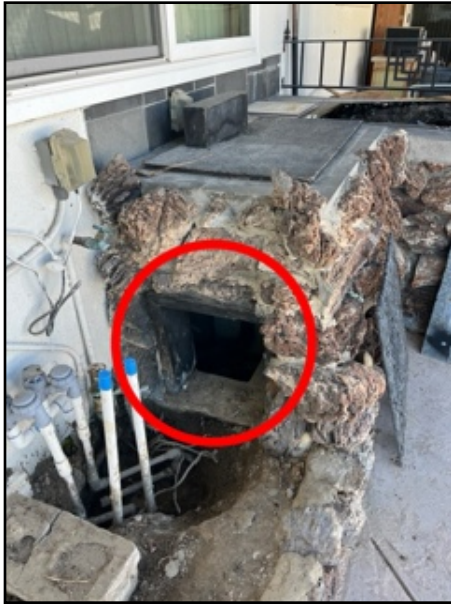
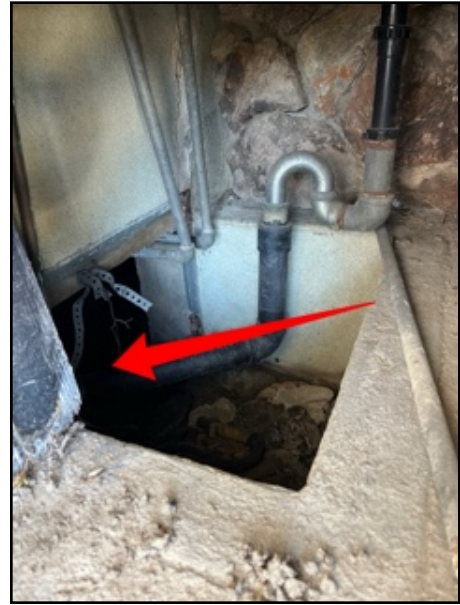
The sub area was not inspected. It would be good to have someone check the foundation, the plumbing, the shower pans, and any wood damage.
