Mitch Fredericks Home Inspections

13614 Dall Lane

Inspected on Wed, Mar 11 2026 at 2:19PM

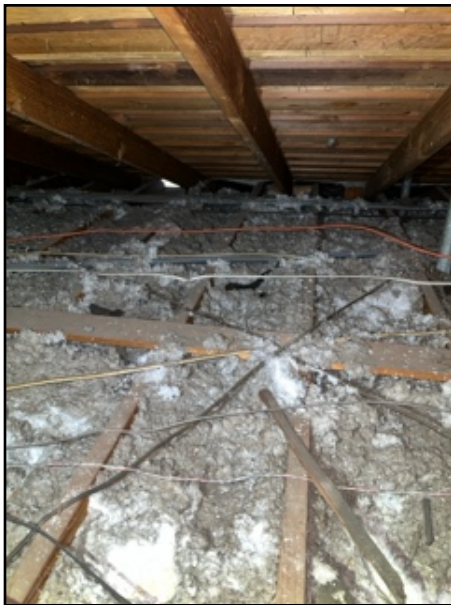
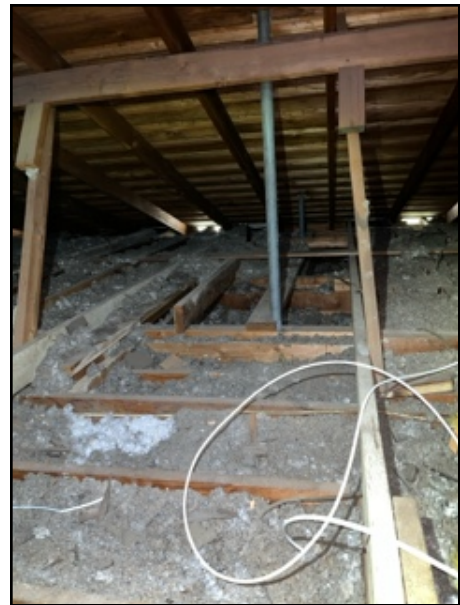
Comment 116:
The attic insulation is blown in between the joist and rafters.

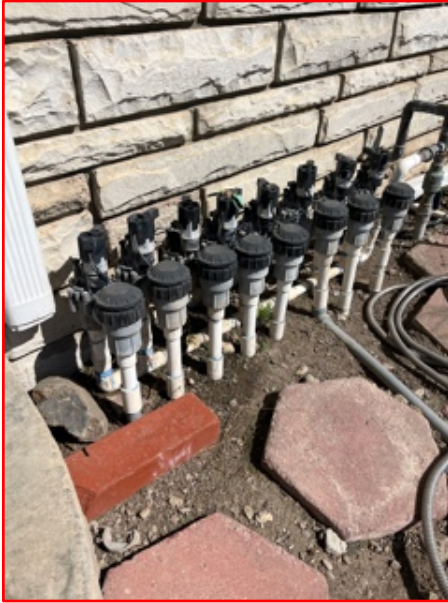
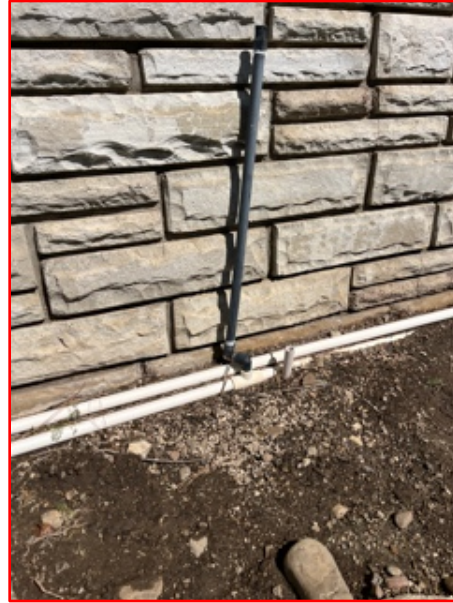
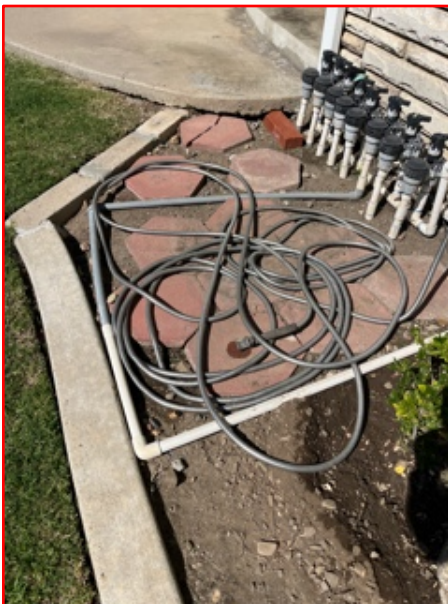
1) The front yard sprinkler valves are free of leaks.

Most of the PVC piping is above ground and can be damaged or broken.

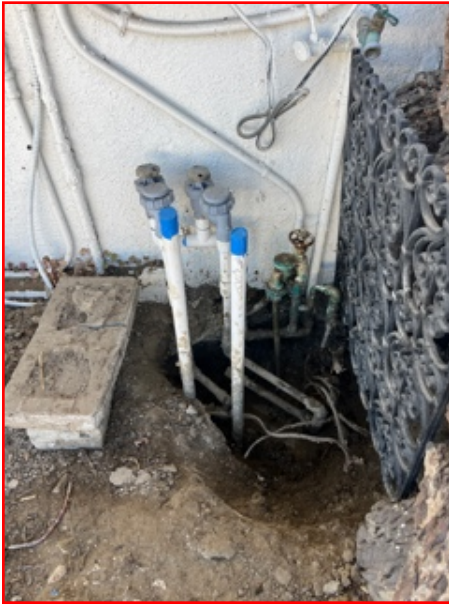
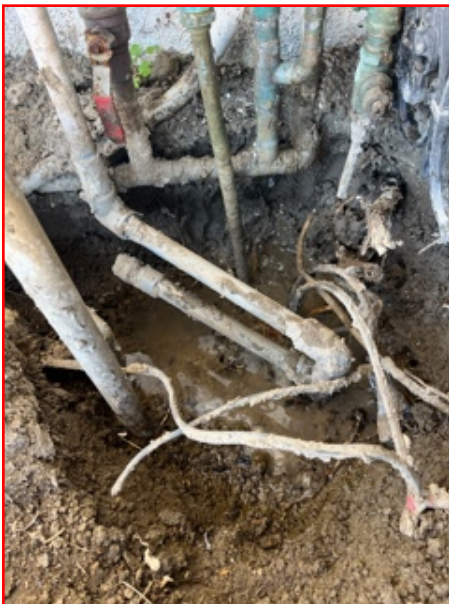
2) The backyard sprinkler valves appear to be free of leaks. The pool fill valve is presently leaking and is in need of repair.

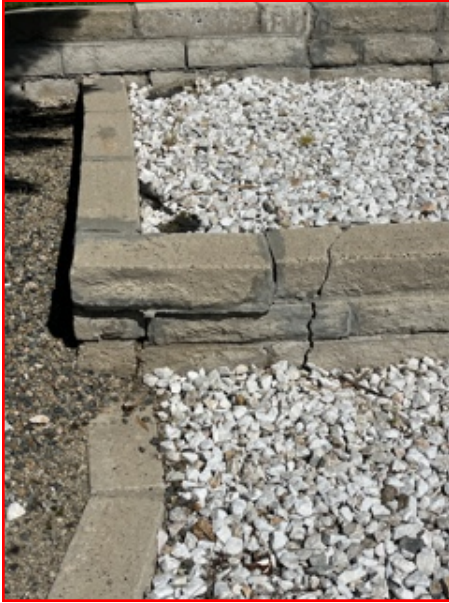
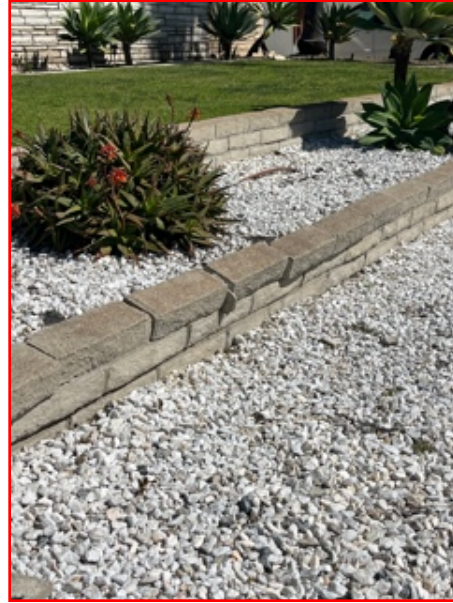
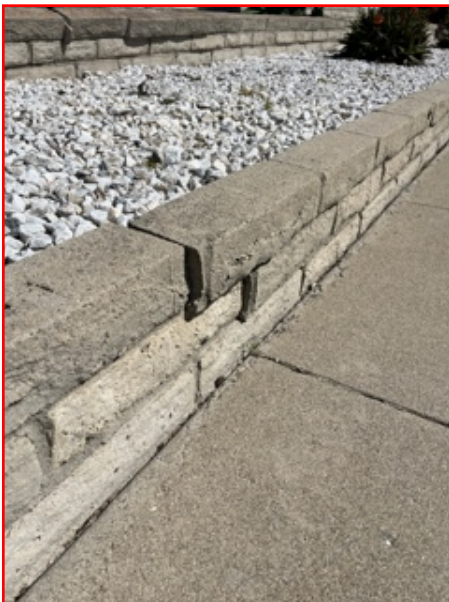
3) The front planter, retaining walls show cracks between the blocks, and the wall leans slightly.

Repairs can be made to the block wall.

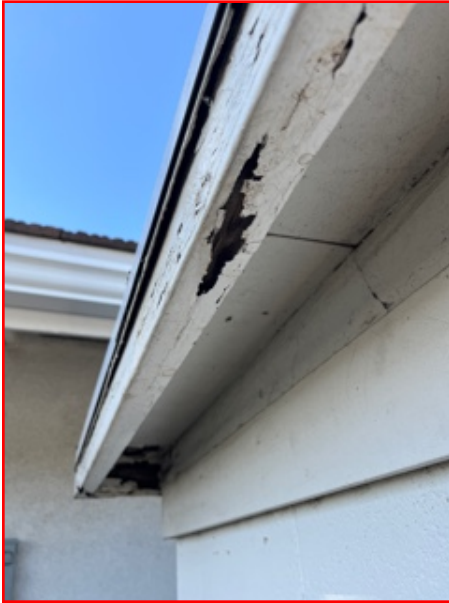
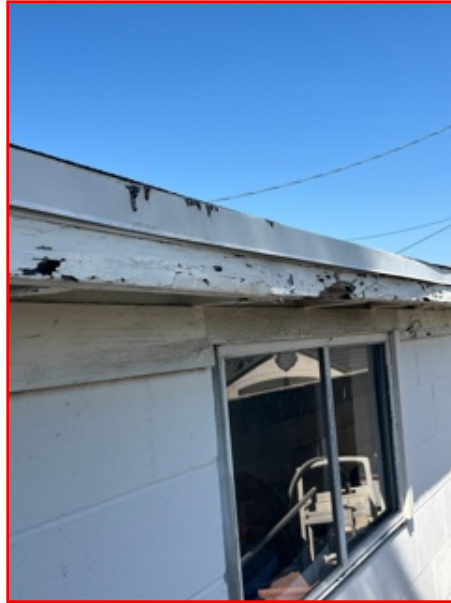
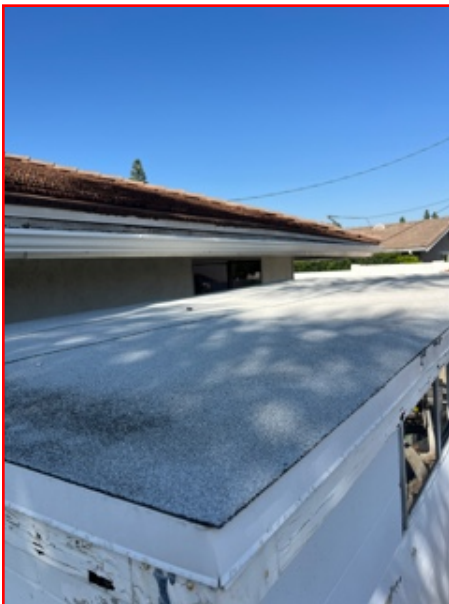
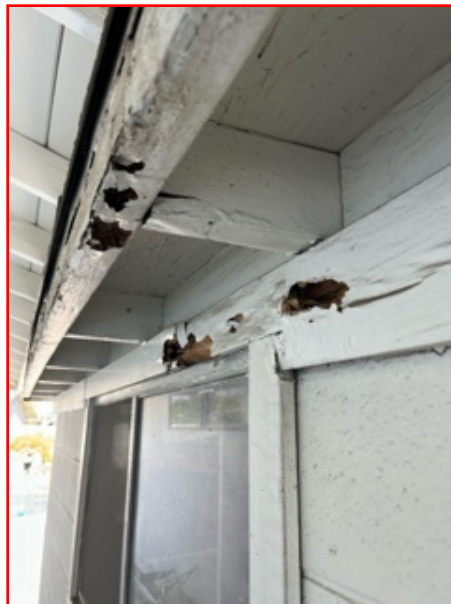
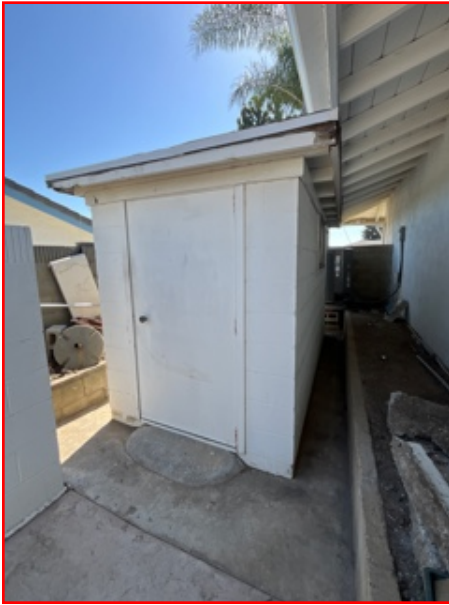
4) The right side storage shed shows termite damage and wood rot.

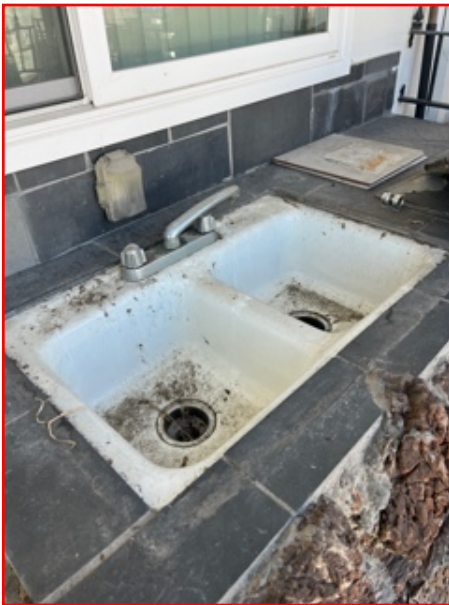
Figure 9-1

5) The backyard wet bar sink is not in use.

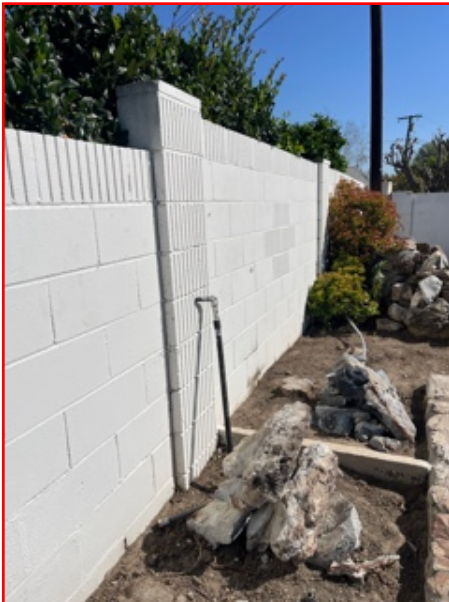
6) The rear block wall shows settling cracks.

The right side block wall shows outlines of settling between the blocks.

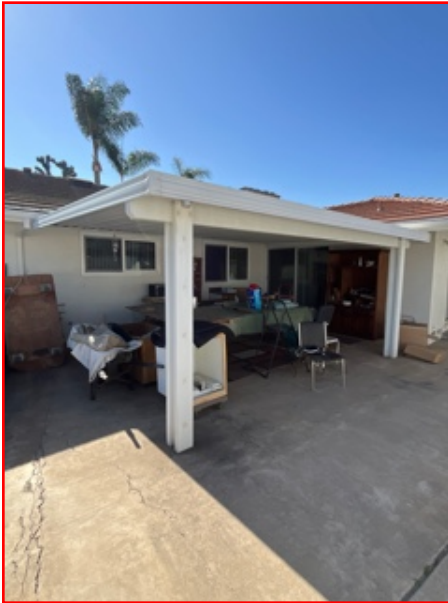
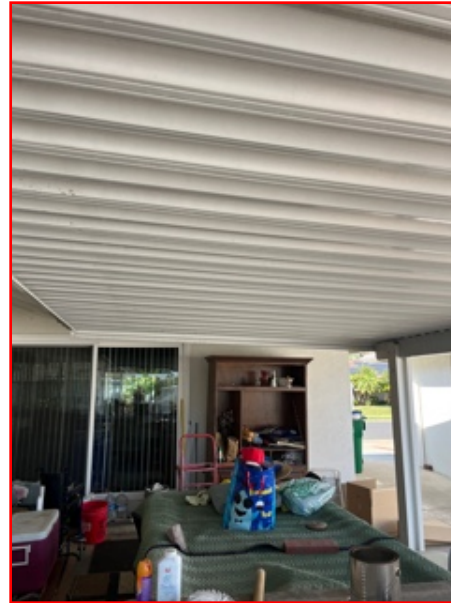
7) The aluminum patio cover appears to be tight and sound.

The patio cover roof attaches to the house, and there is damage in the eaves because of leaks.

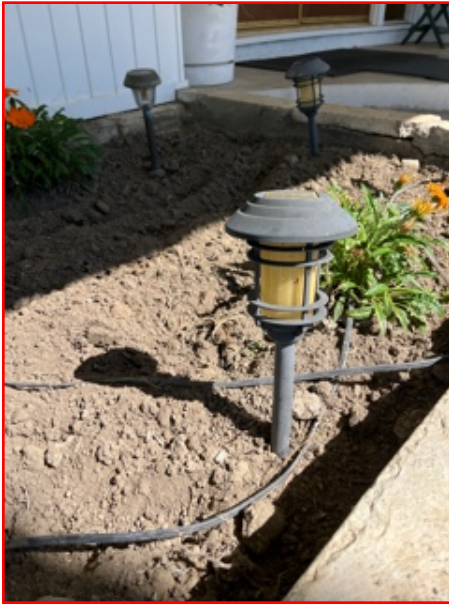
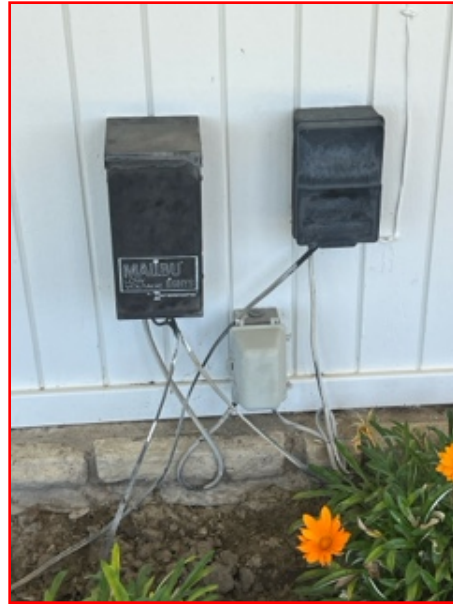
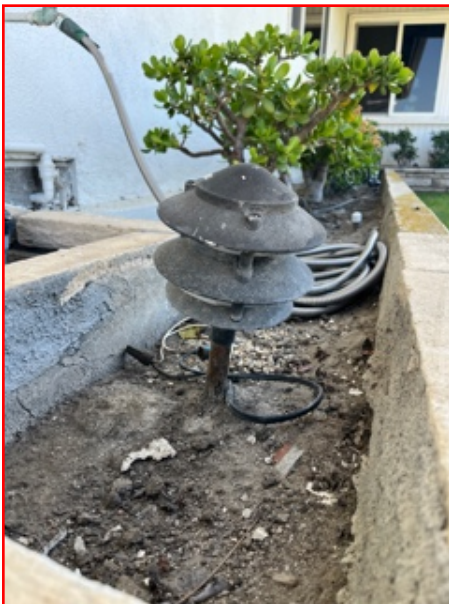
8) The Malibu style of lights can be very temperamental and will need ongoing maintenance. There are timer boxes for the lights in the front yard. Many of the lights are solar, and they also can be very temperamental.

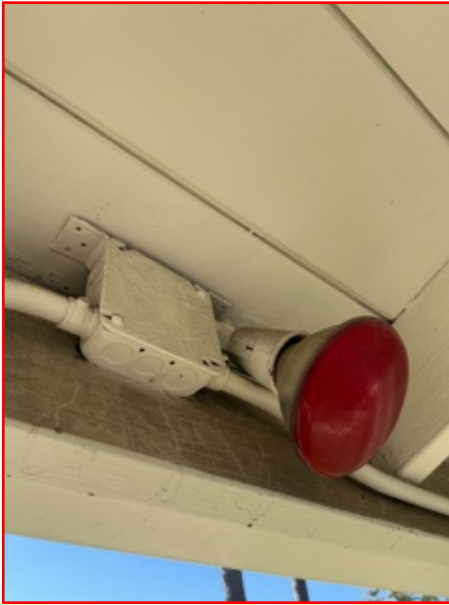
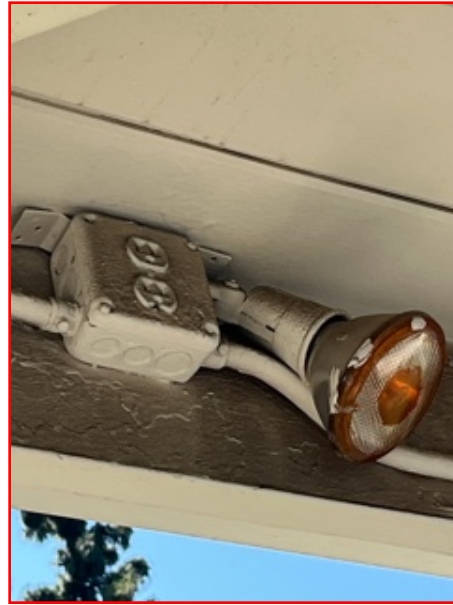
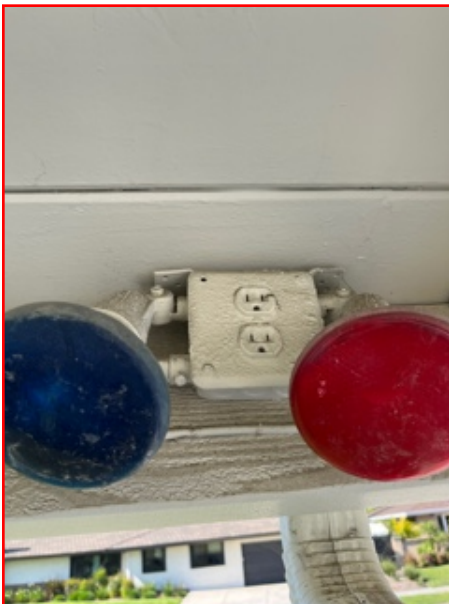
9) The outlet does not have a weather resistant cover plate. This is located in the eaves at the front right corner. At the left side of the house, there is also outlets that do not have weather resistant cover plates.

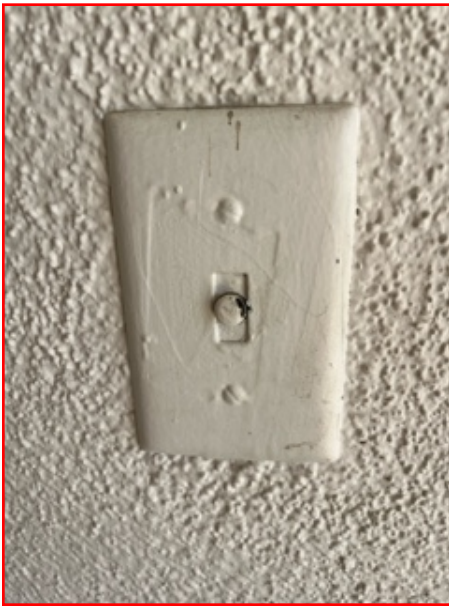
Figure 23-1

10) The doorbell chime only dings.

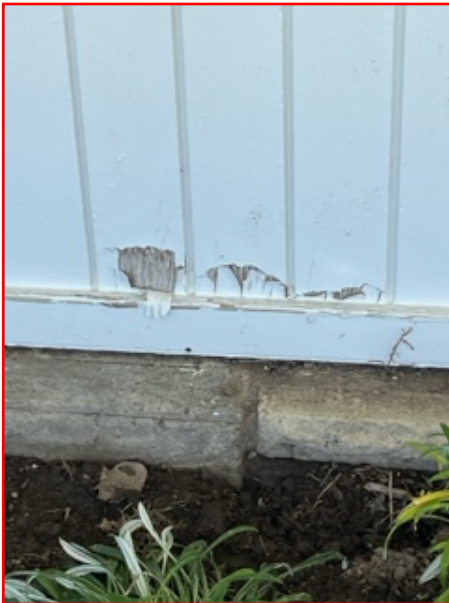
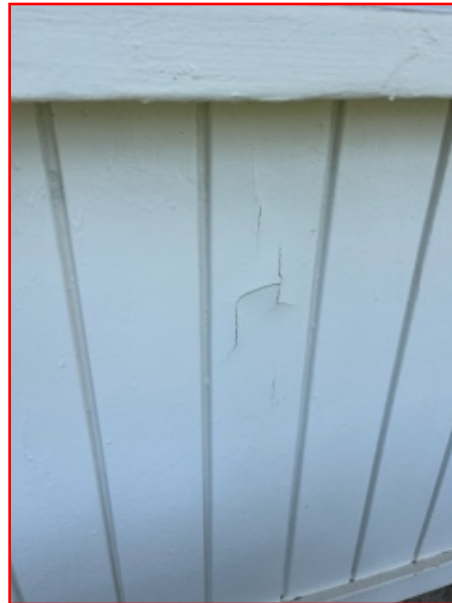
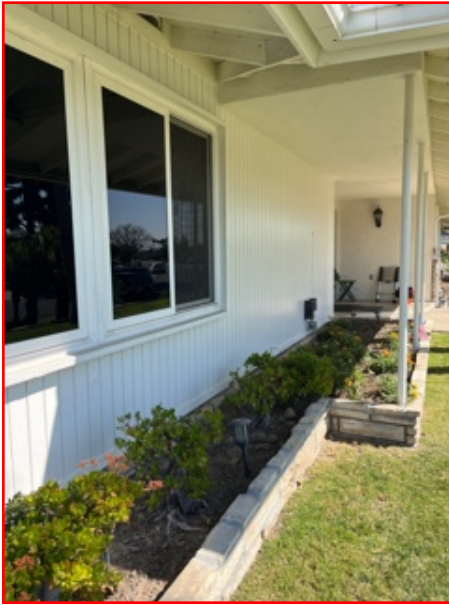
12) The front wood siding shows paint peeling exposing bare wood.

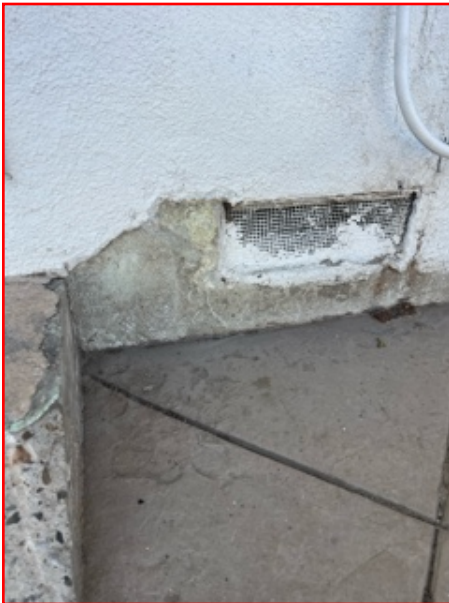
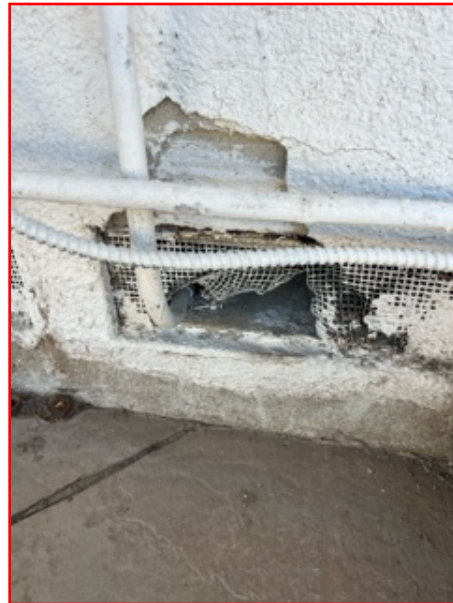
13) The stucco on the house at the rear shows flaking and crumbling. Repairs are needed at this time.

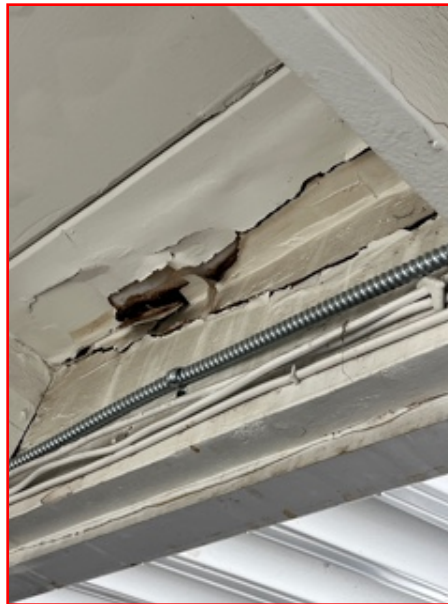
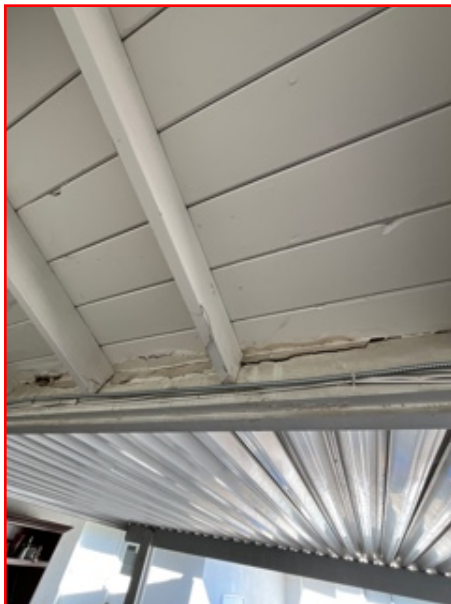
14) The ease at the rear of the house show wood damage and rocked because of the installation of the patio cover.

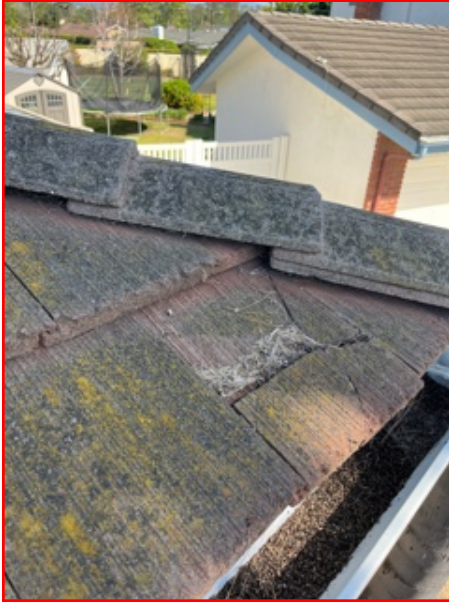
Figure 33-1

15) The front right corner tile is broken.

There is a second broken tile at the right side front corner.

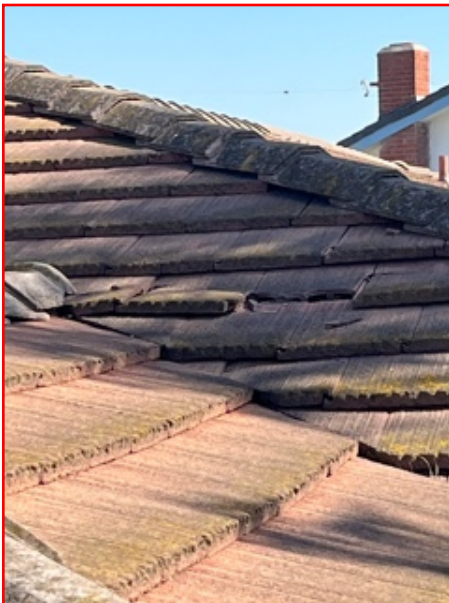
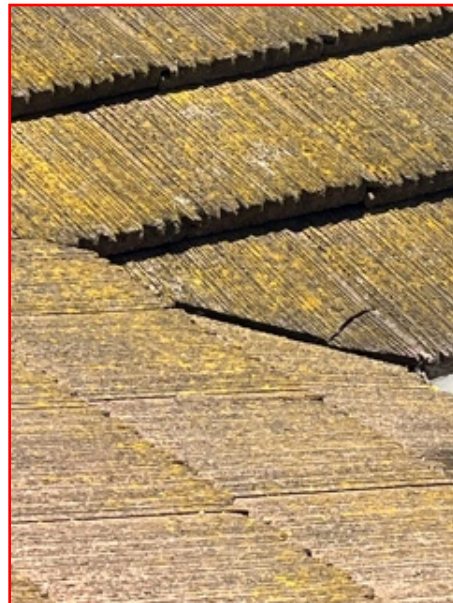
16) There are several broken tiles at the left side of the house near the valley area.

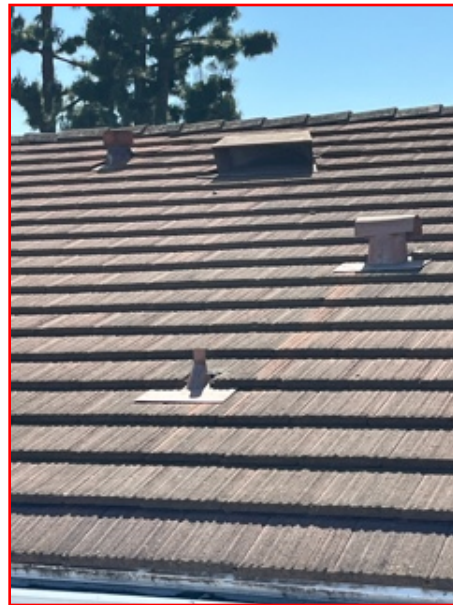
Figure 35-2

17) The rear roof shows broken roof tiles.

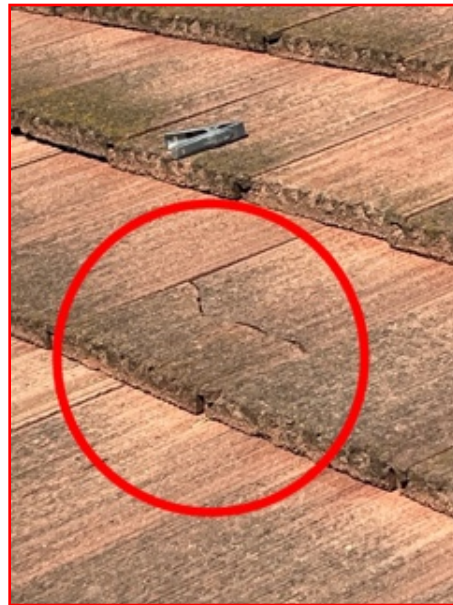
Figure 36-2

18) The garage roof also shows broken roof tiles.

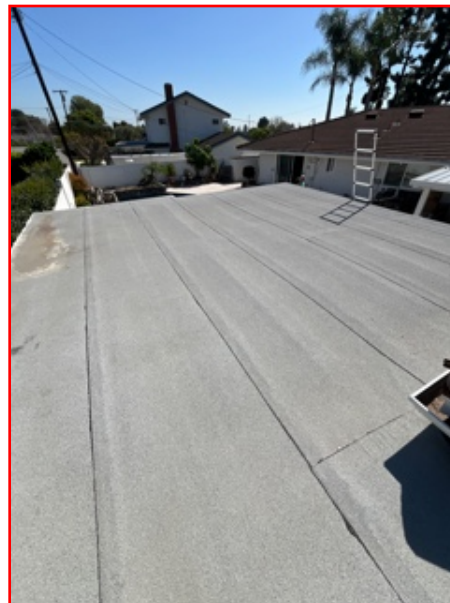
19) The flat roof over the garage/rear storage and room appears to be in overall good condition. There are water marks, indicating rainwater is pooling on this roof. Repairs are needed at this time.

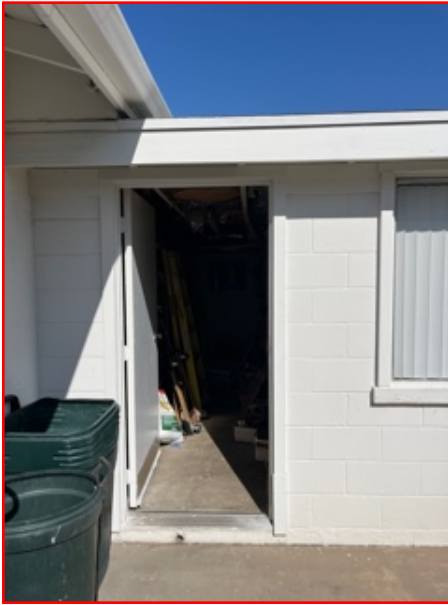
20) In the storage room behind the garage, the ceiling/plywood shows water stains from the flat roof.

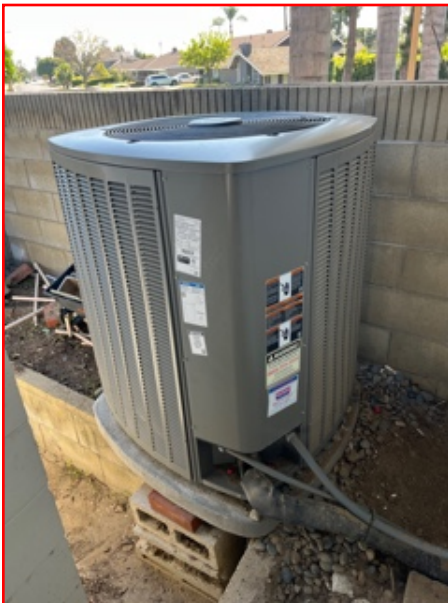
21) The outside condenser was installed in 2022. The unit uses the R410 A Freon. The condenser does not fit in the planter and has to have blocks stacked to support it from hanging over the edge.

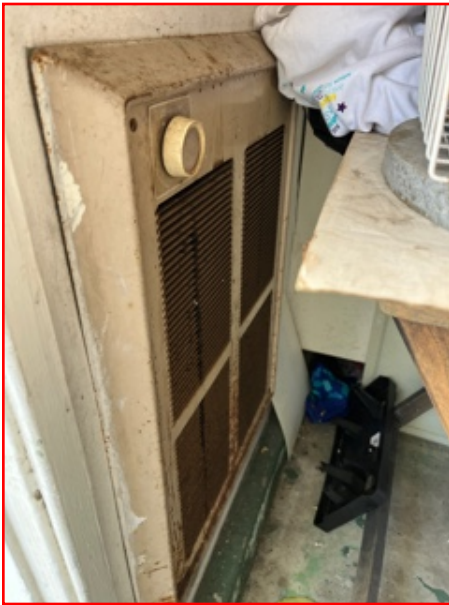
Figure 42-1

22) The electric heater in the garage does not operate.

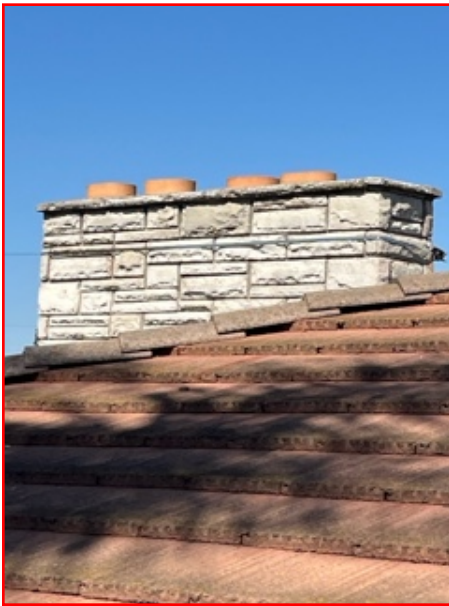
Figure 47-1

23) The chimney does not have spark arrestors installed.

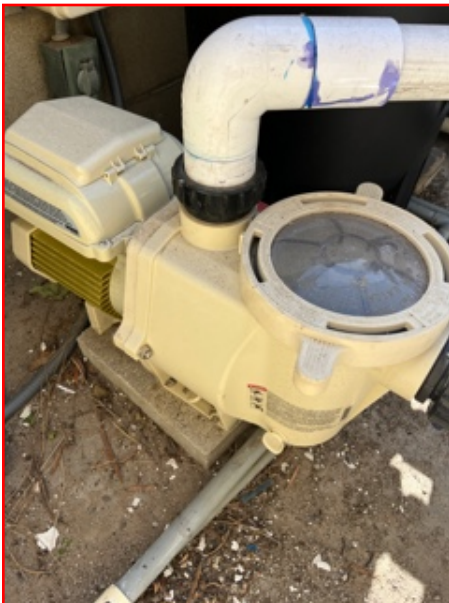
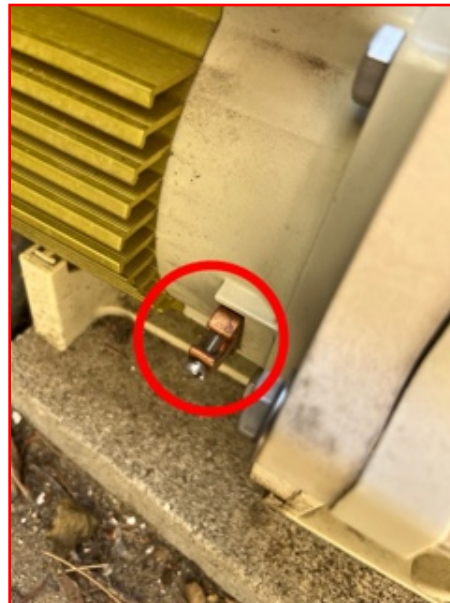
24) The pump motor is quiet and free of leaks.

There is not a ground wire attached to the pump motor or the heater.

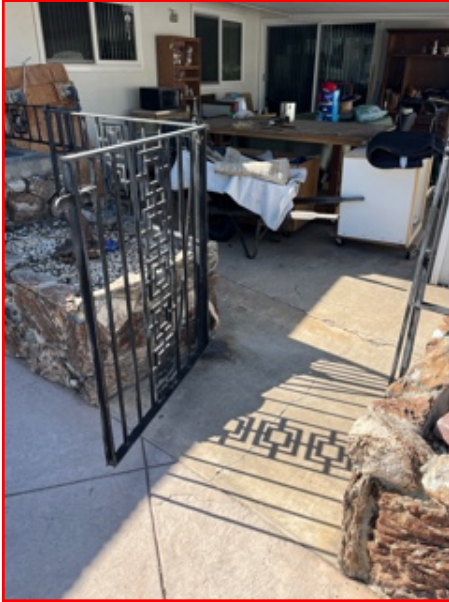
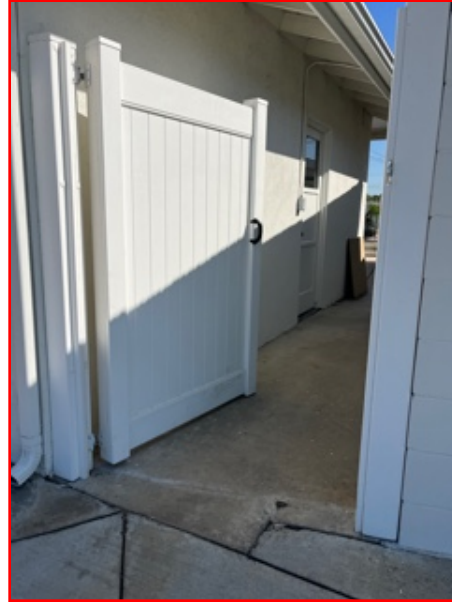
25) The gates going into the backyard are not self closing and latching. This does not meet the child safety codes.

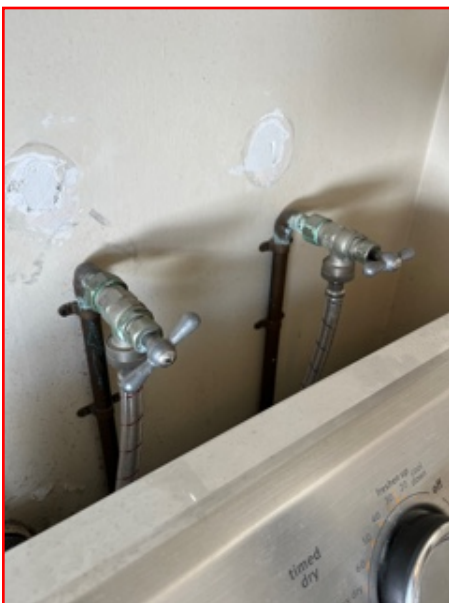
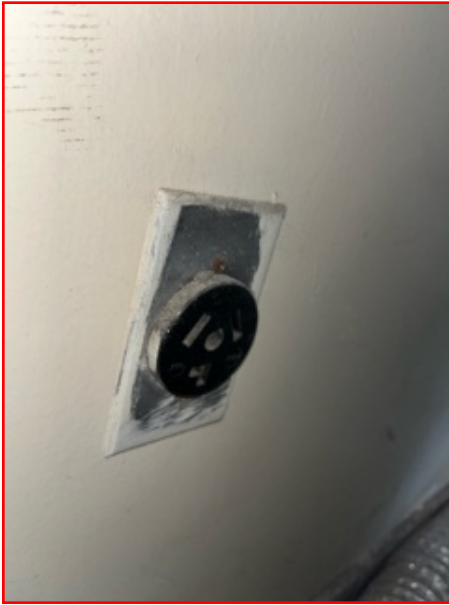
26) The laundry electrical 220 does not have power. The washer hook up valves are free of leaks. I recommend vacuuming, the dryer vent of lint and debris.

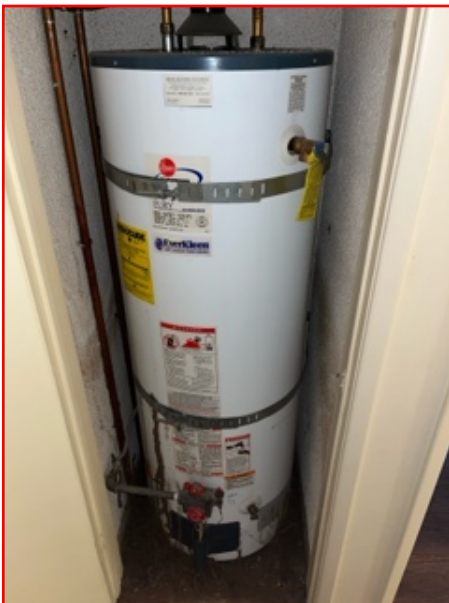
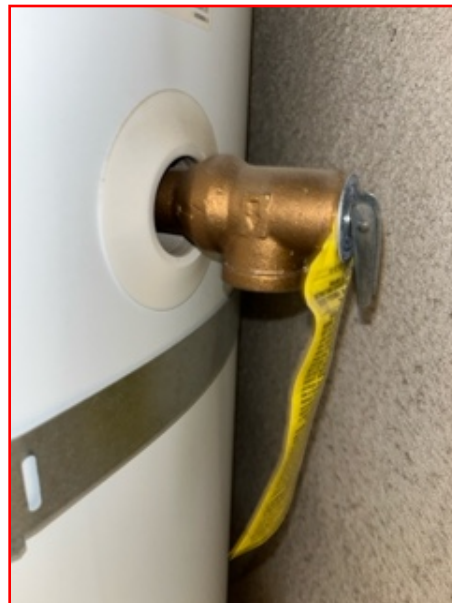
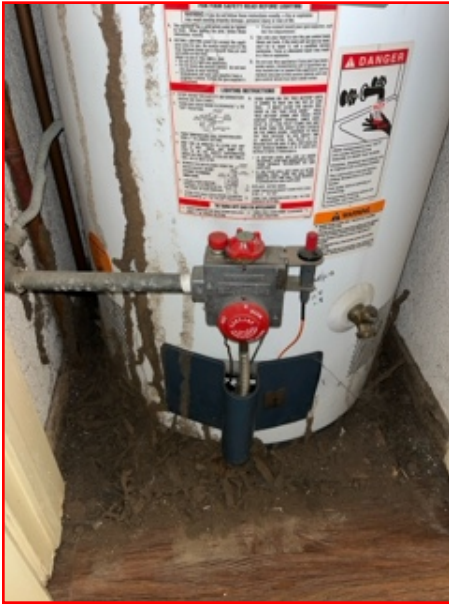
27) The bedroom hall water heater has two earthquake straps securely mounted. The pressure relief valve does not have a downspout pipe. The base of the closet shows subterranean termite mud tunnels. The gas line does not have a sediment trap. The water heater is not sitting in an overflow pan with a drain to the exterior. The water heater is old and nearing the end of its life.

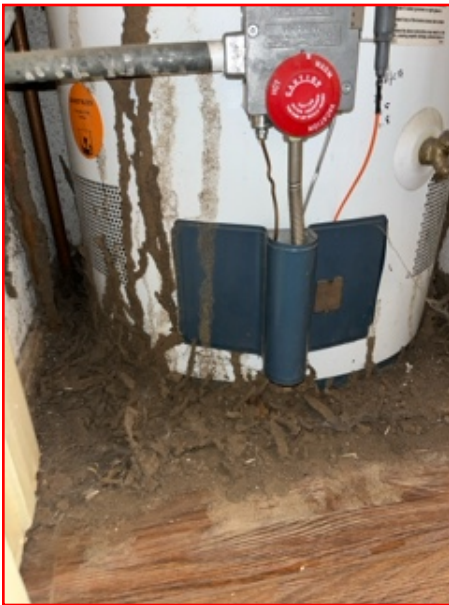
Figure 59-1

28) The water heater closet shows subterranean termites.

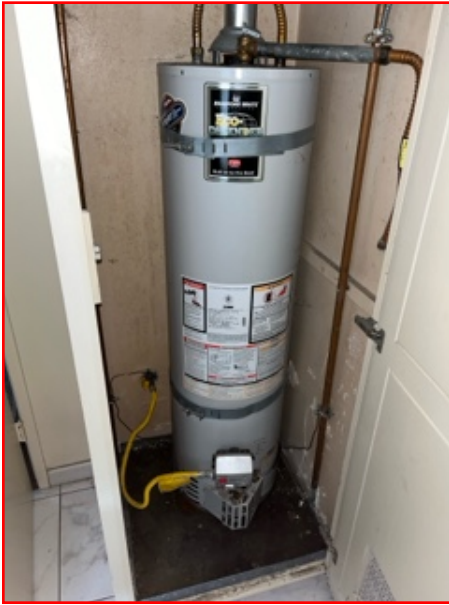
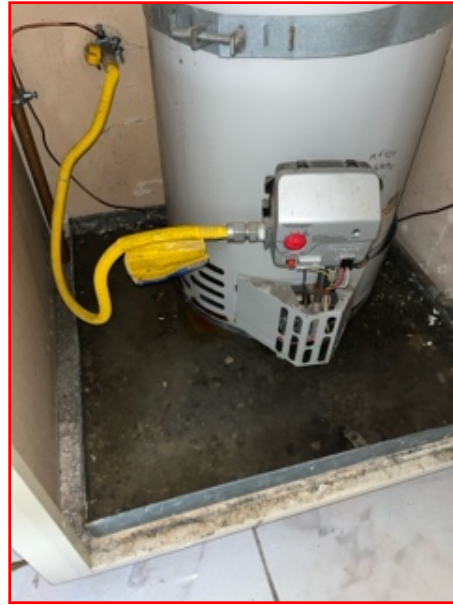
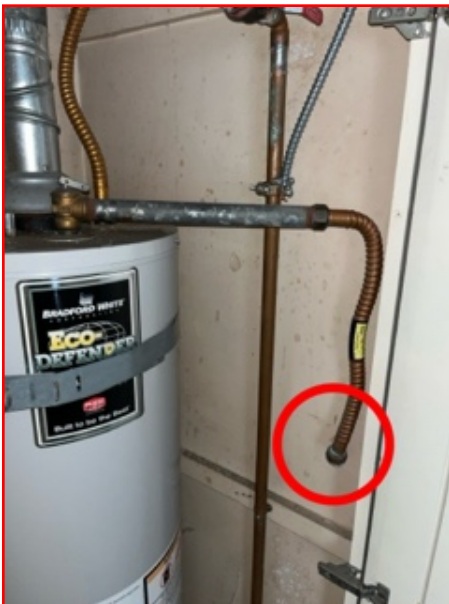
29) The water heater off the laundry room has two earthquake straps securely mounted. The gas line does not have a sediment trap installed. The pressure relief valve does not have a downspout to the floor.

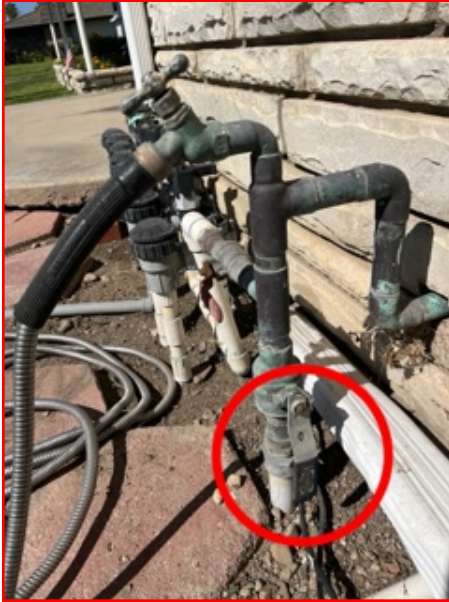
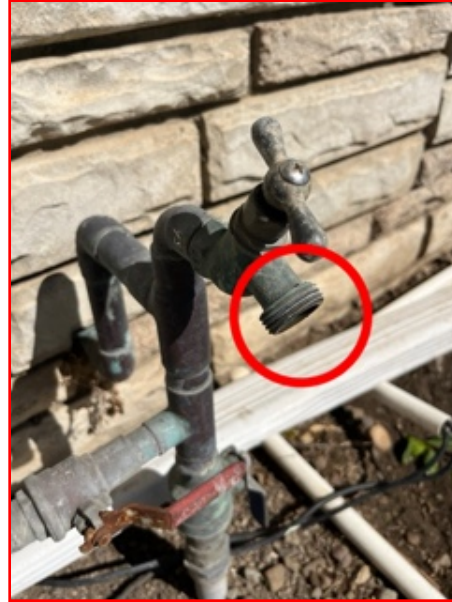
30) The main water shut off is located at the front of the house. The exterior hose bib does not have an antisiphon device installed.

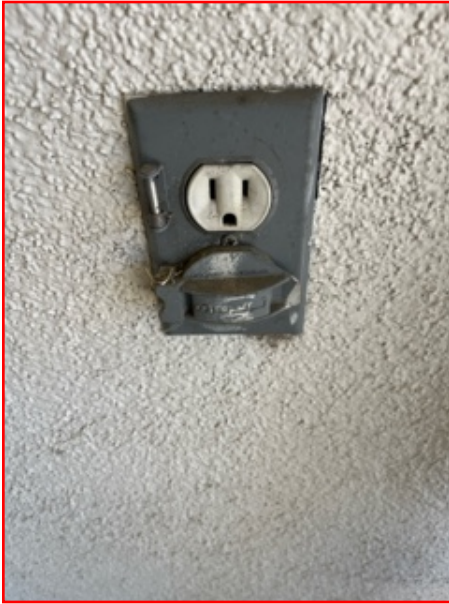
Figure 69-1

33) The front porch electrical outlet is missing its weather resistant cover plate. The outlet is not GFCI protected.

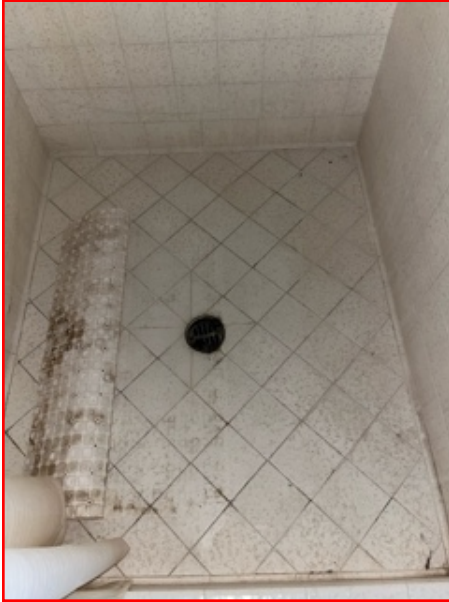
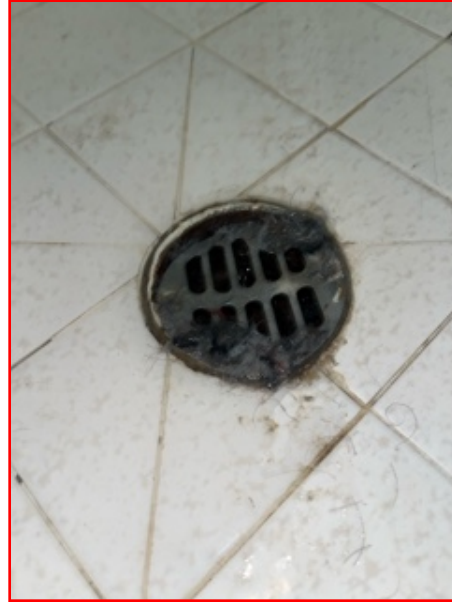
Figure 78-1

41) The master bathroom, shower tiles show cracks that have been sealed with caulking.

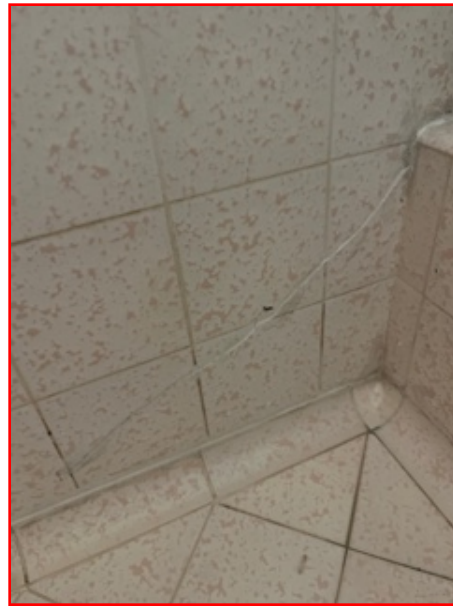
Figure 83-2

42) The master bathroom shower enclosure only has one door that operates.

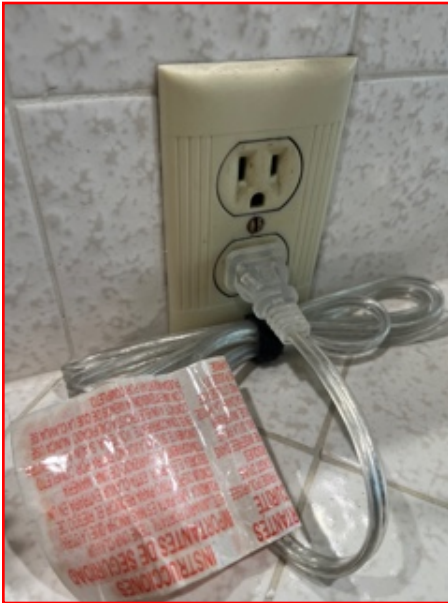
Figure 86-1

45) The master bathroom electrical outlet has reverse polarity.

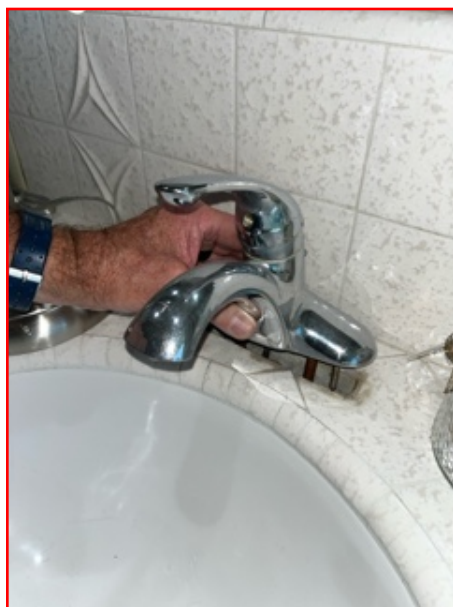
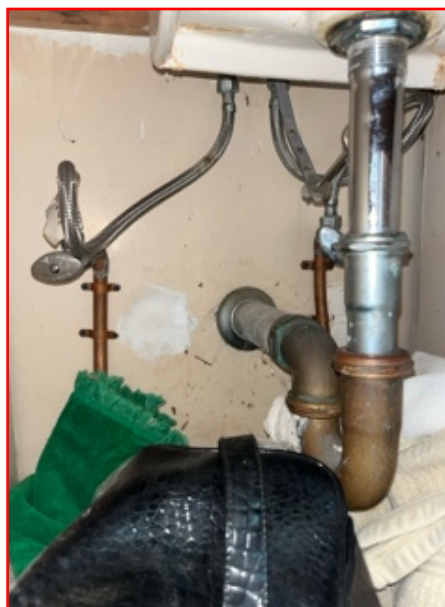
Figure 89-1

The master bathroom sink is draining slowly. The wasteline pipe appears free of leaks.

48) The master bathroom sink is draining slowly. The wasteline pipe appears free of leaks.

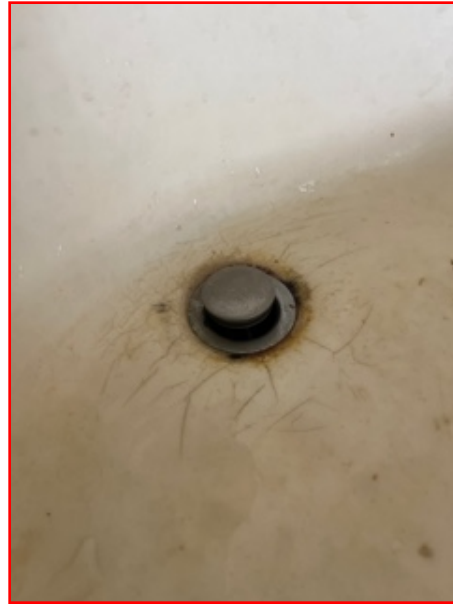
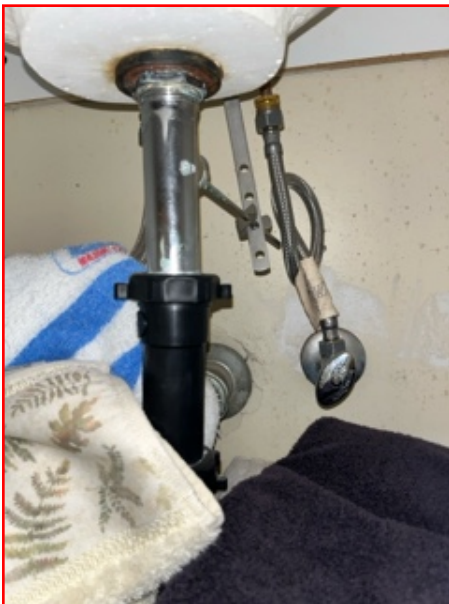
Figure 91-2

If it is confirmed that the ceiling has asbestos, it should not be disturbed.

The removal of the acoustic ceiling should be performed by a licensed trained professional.

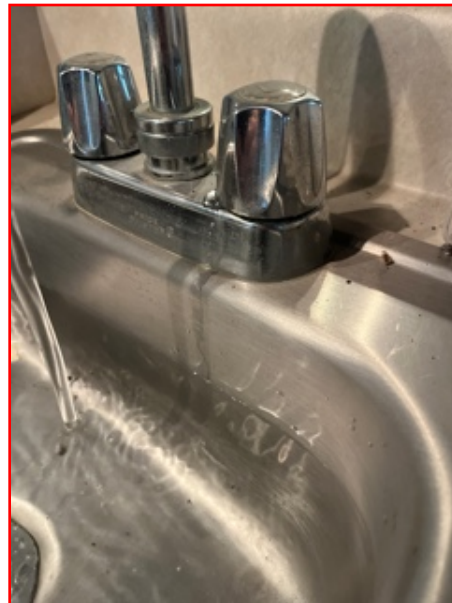
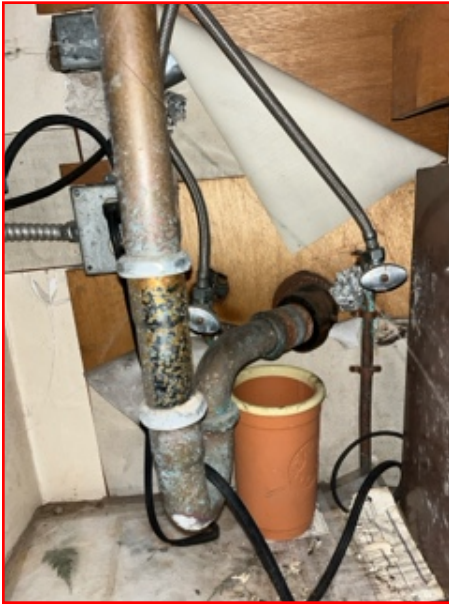
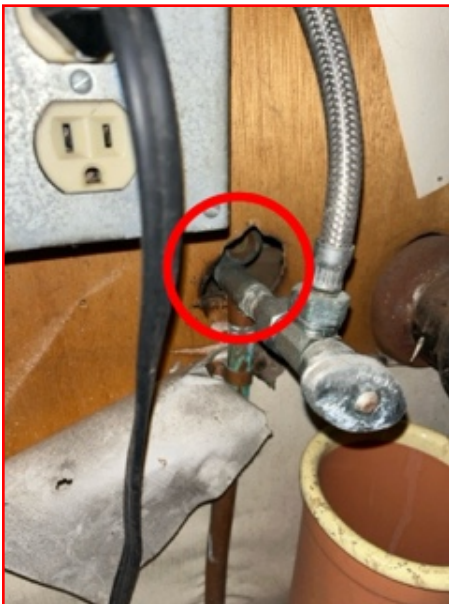
Figure 100-2

55) The cooktop is locked, and I was unable to operate it.

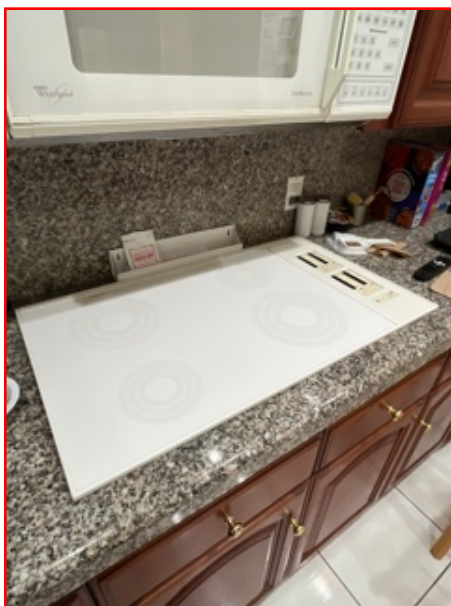
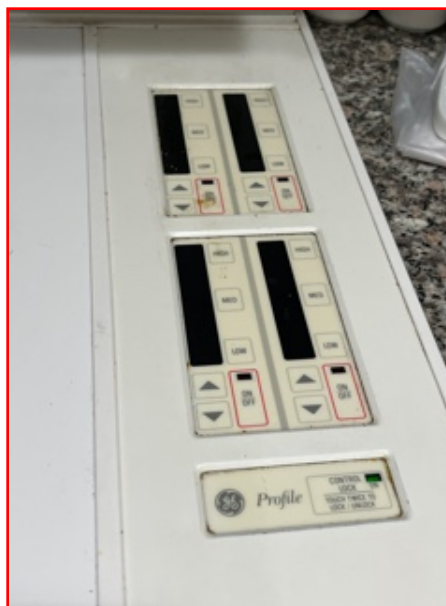
Figure 101-1

56) The microwave built-in above the oven does not have power and does not work.

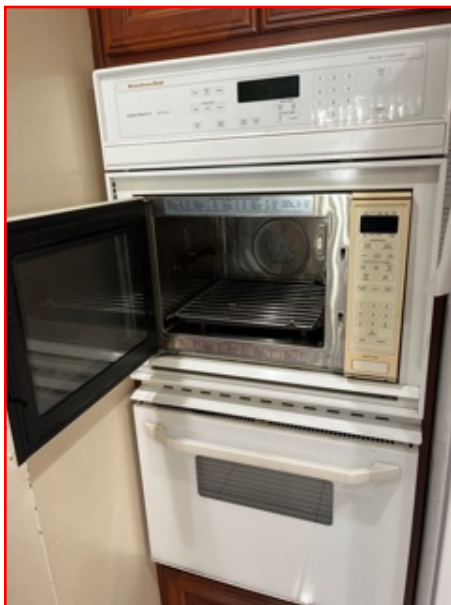
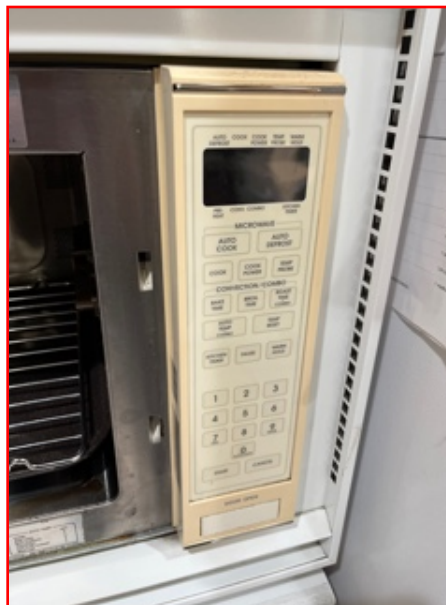
Figure 103-1

Cabinet pole knobs are missing. Adjustments are needed to the hinges.

57) Cabinet pole knobs are missing. Adjustments are needed to the hinges.

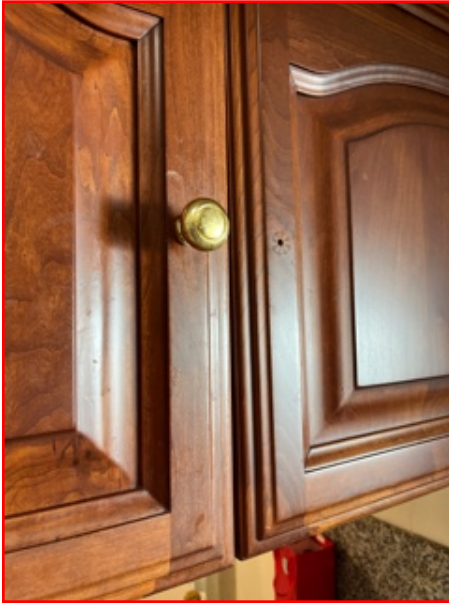
Figure 105-1

Comment 106:
Pull knobs are missing.

58) Pull knobs are missing.

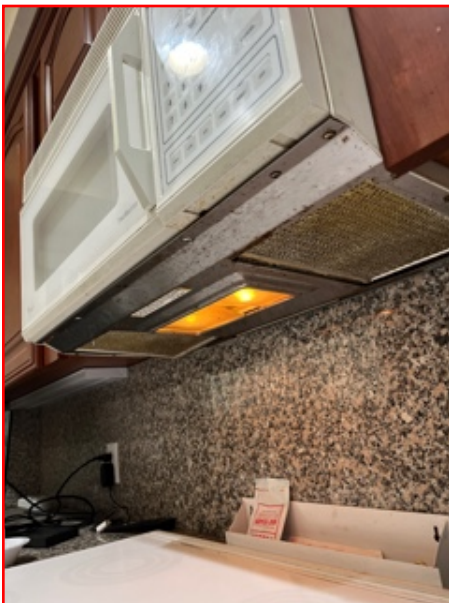
Figure 107-1

59) The exhaust fan and light are operating.
The exhaust vents back into the room.

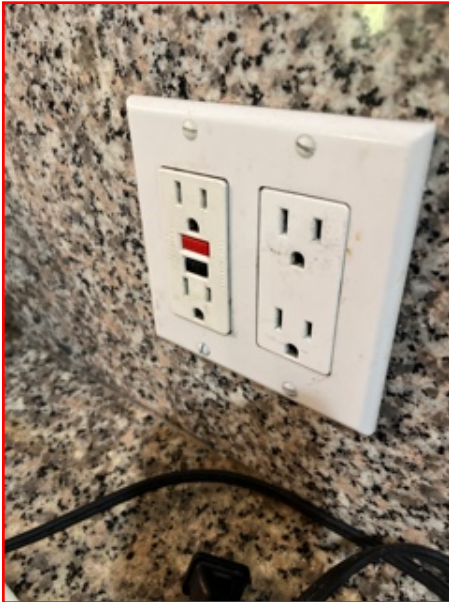
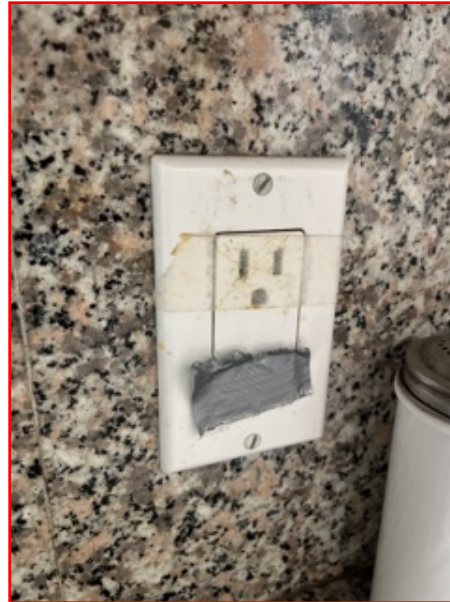
There is one outlet that has been taped over. I don't know if the outlet is safe to plug into.

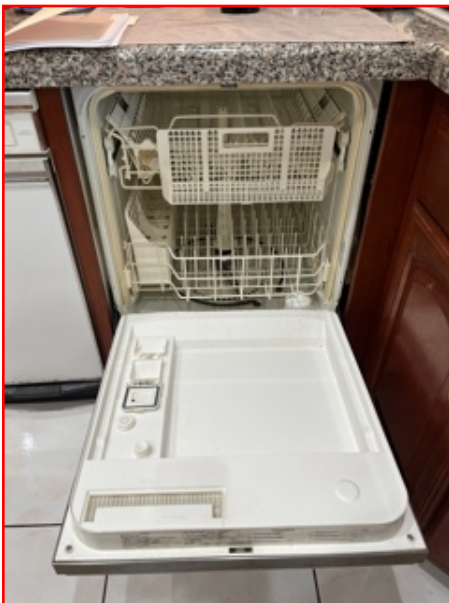
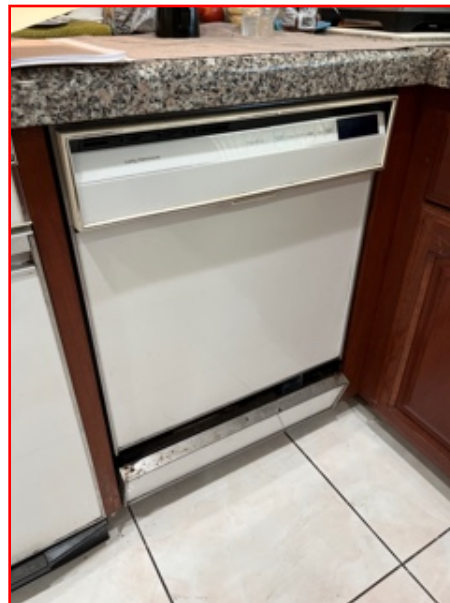
61) The dishwasher does not operate.

I recommend replacing the dishwasher.
