Mitch Fredericks Home Inspections

13614 Dall Lane

Inspected on Wed, Mar 11 2026 at 2:19PM

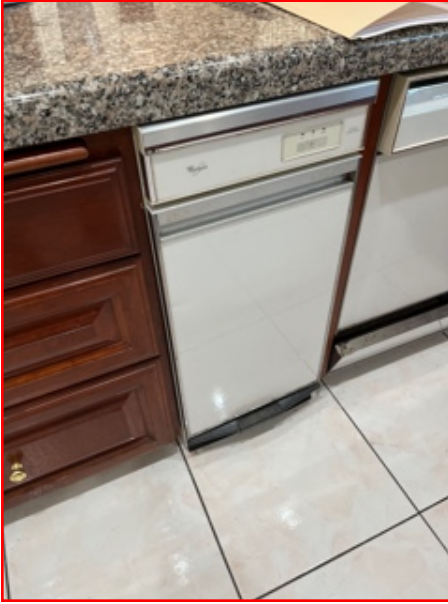
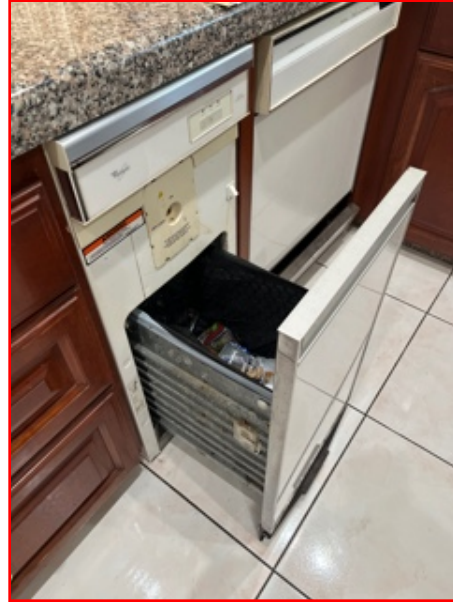
62) The trash compactor does not operate.

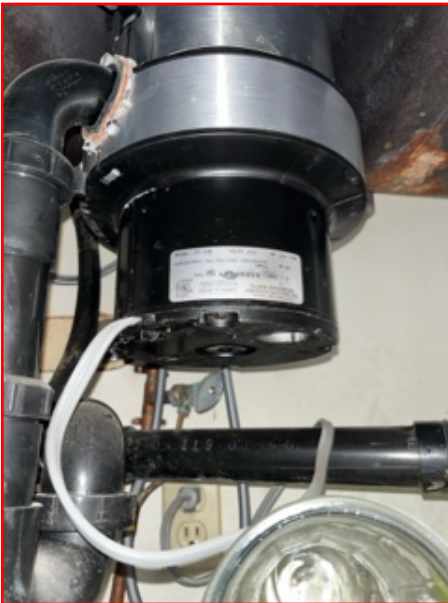
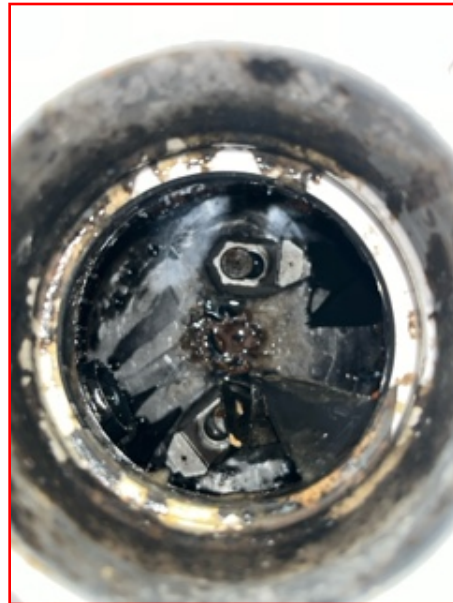
63) The garbage disposal is noisy and should be replaced.

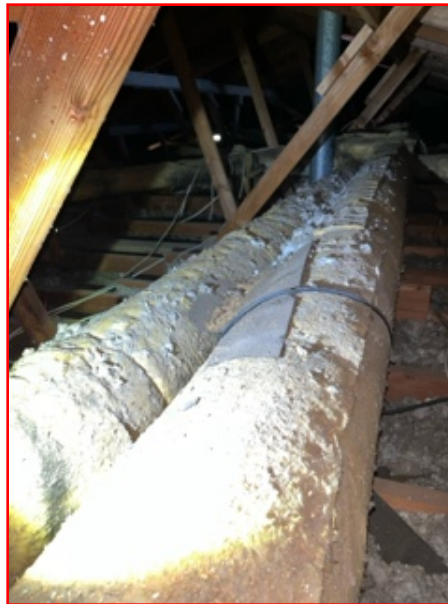
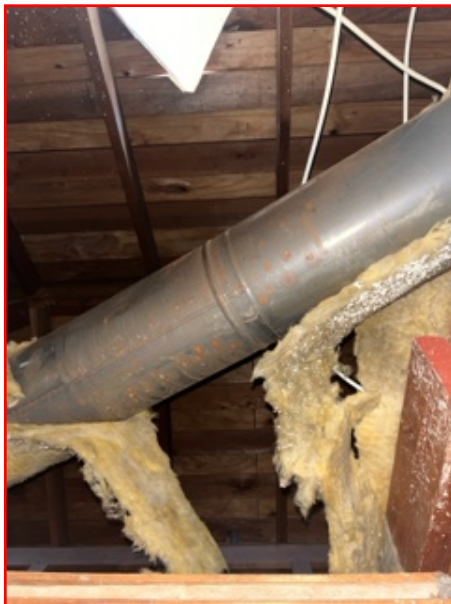
64) The heating ducts in the attic are sheet metal with insulation wrapped around them. One or two of the heating ducts are missing its insulation.

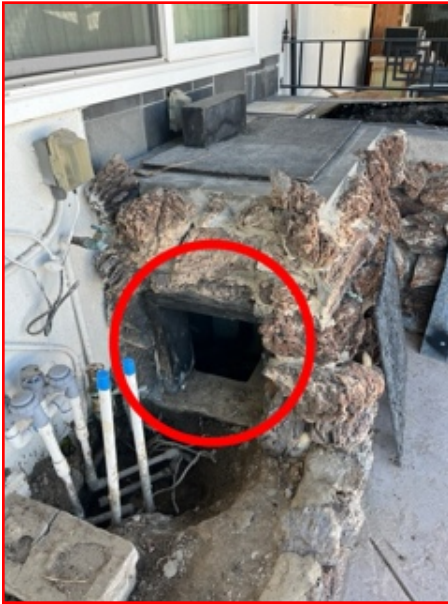
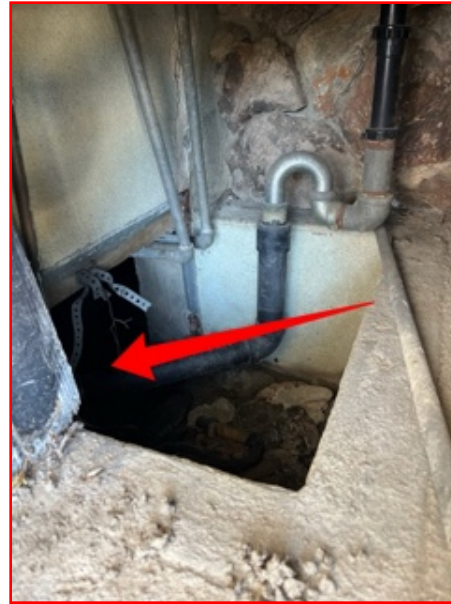
It is located under the wet bar in the backyard. The plumbing pipes are in the way of getting into the sub area.

The sub area was not inspected. It would be good to have someone check the foundation, the plumbing, the shower pans, and any wood damage.
