OC Home Inspect

General Home Inspection

715 East McFadden Avenue

Inspected On Wed, Feb 4, 2026 at 12:15 PM

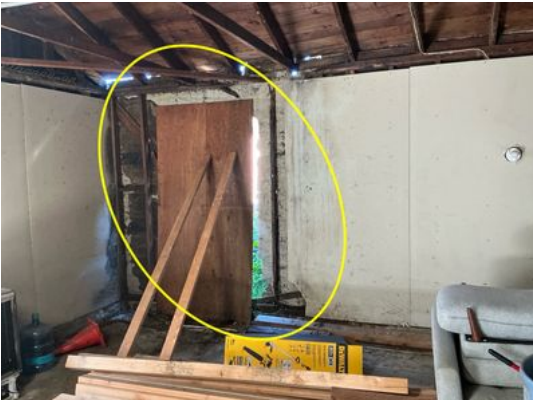
Water damage and visible apparent mold at roof and wall. Wall and roof are open to the elements.

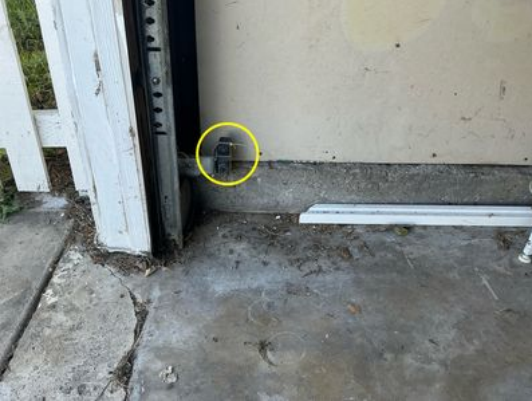
Garage door safety sensors are installed too high off ground.

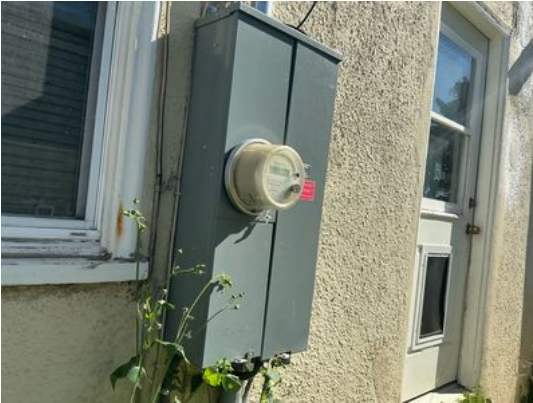
**Comment 28
Information**

Electrical Service Panel.

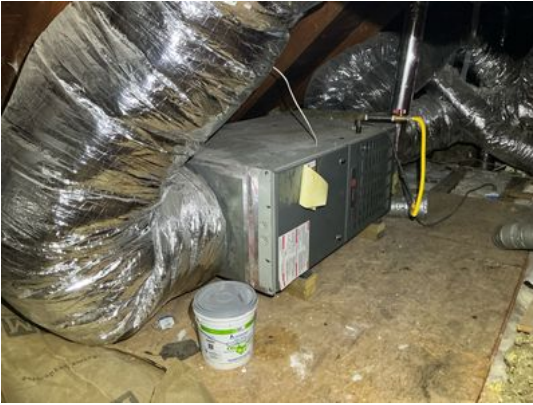
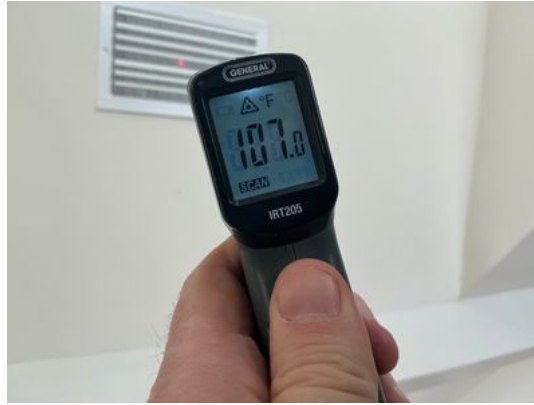
Comment 30
Information

Furnace.

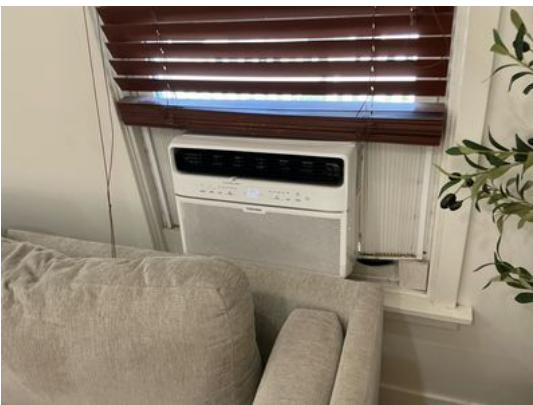
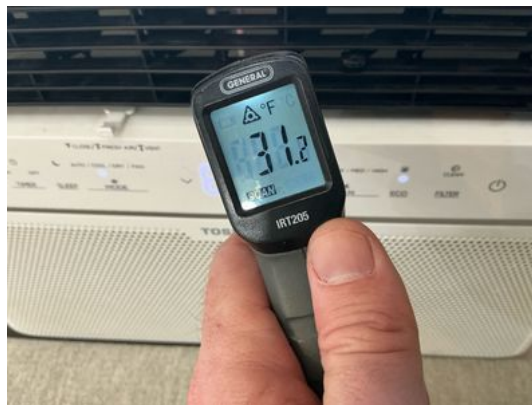
A/C unit.

Air conditioners over 10 years old and heat pumps over 5 years old should be checked, cleaned and serviced yearly by a licensed contractor.

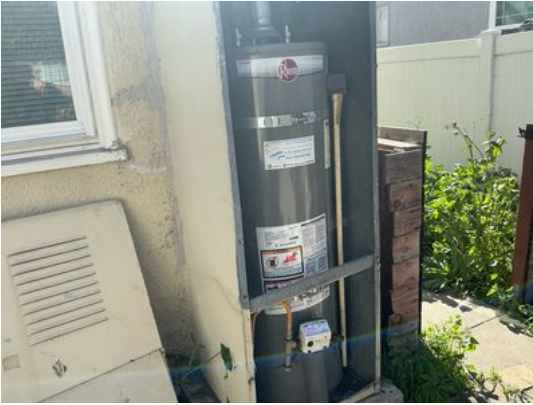
Comment 34
Information

Water Heater.

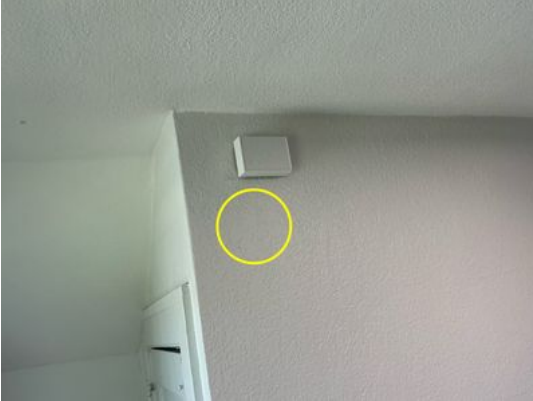
Smoke/carbon alarm is not installed outside sleeping area second floor.

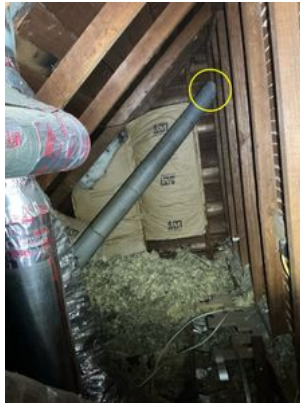
Range hood is not installed. Duct is abandoned in attic and does not extend outside.
