# Home Inspection Report

3229 Westridge Drive, Kelseyville , CA 95451

Monday February 2, 2026

2133

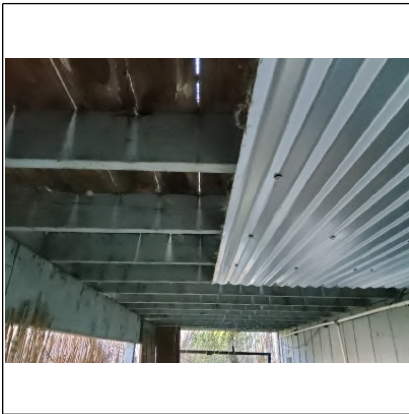
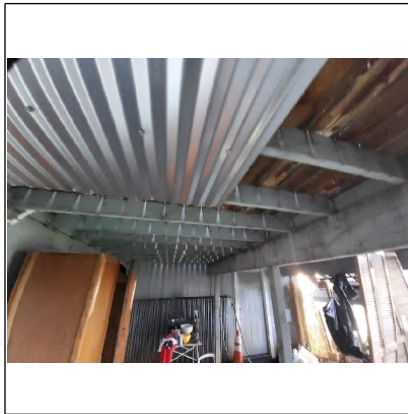
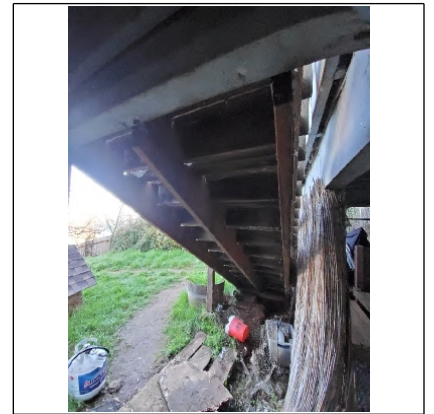
**Nails are popping up, recommend having all nails replaced with 3 1/2" exterior screws to properly fasten tread members.**

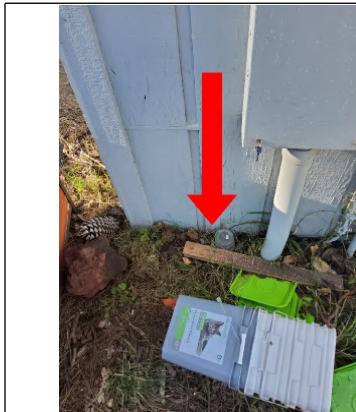
Wood in contact with dirt, recommend pulling dirt away from direct contact.

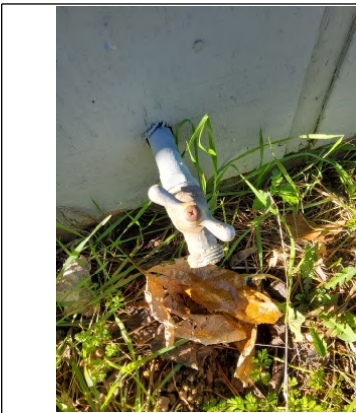
**Hose bib(s) leaking/dripping, recommend licensed plumber repair**

Hose bib is leaking, recommend repair

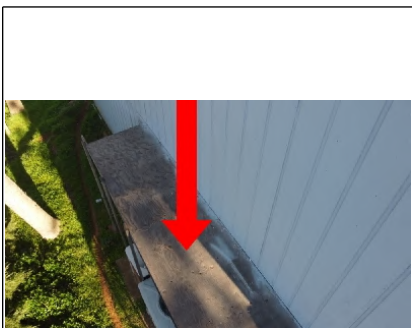
Recommend installing new roll asphalt roofing at location.

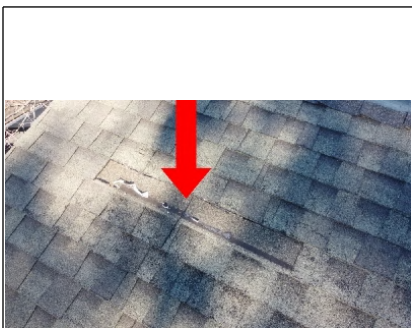
Missing shingles, recommend repair

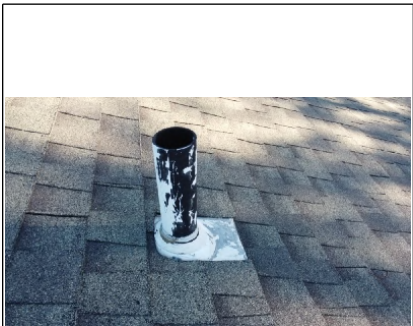
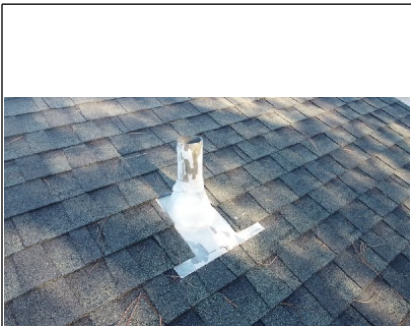
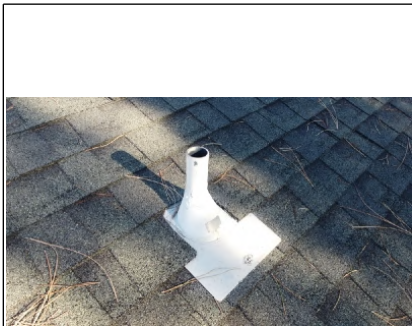
- ☐ Satisfactory ☒ Marginal ☐ Poor ☐ Curling ☐ Cracking ☐ Ponding ☐ Burn Spots  
☒ Broken/Loose Tiles/Shingles ☐ Nail popping ☒ Granules missing ☐ Alligating ☐ Blistering  
☐ Missing Tabs/Shingles/Tiles ☐ Moss buildup ☐ Exposed felt ☐ Cupping  
☐ Incomplete/Improper Nailing ☐ Recommend roofer evaluate ☐ Evidence of Leakage

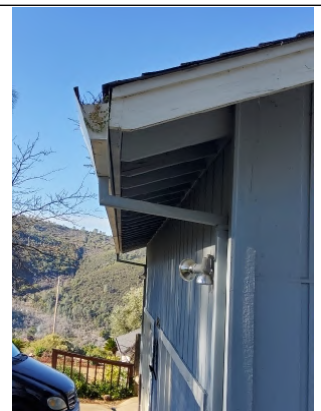
Active leak is evident on gutter, recommend replacing

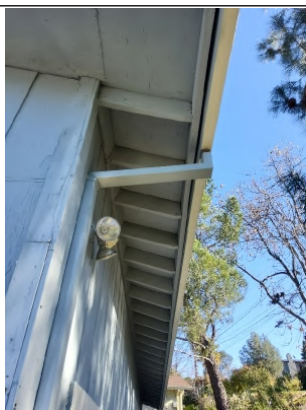
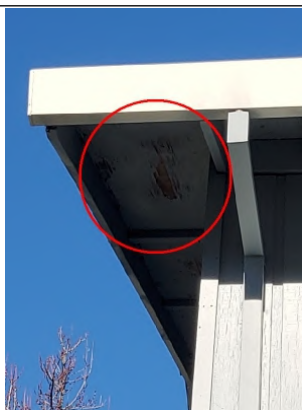
Overhang has exposed wood, recommend sanding and repainting

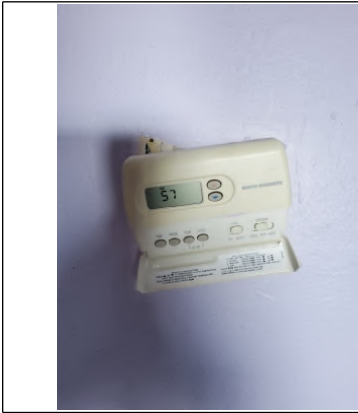
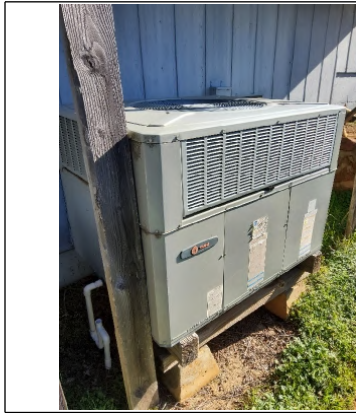
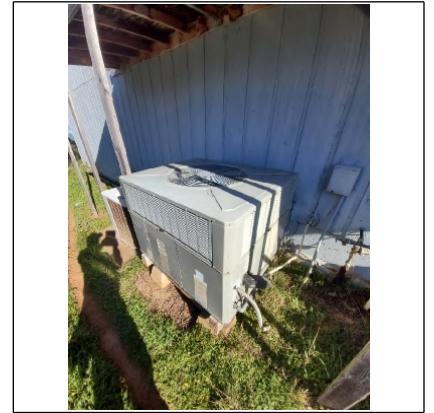
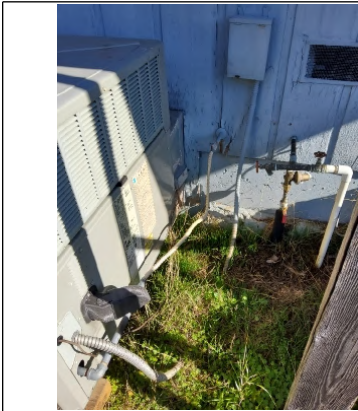
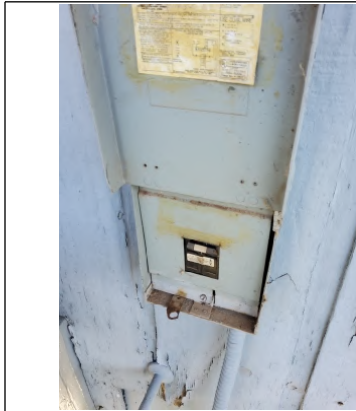
Comments **Recommend having unit serviced by a licensed HVAC contractor, unit operated but doesn't pull heat as lined is capped off.**

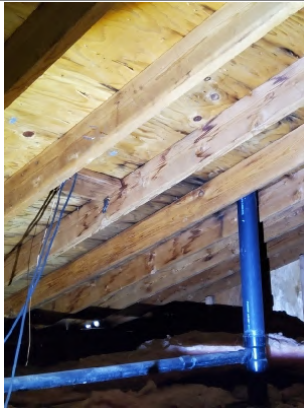
Moisture stains are evident on rafters and sheathing this could be from an active leak, recommend repair

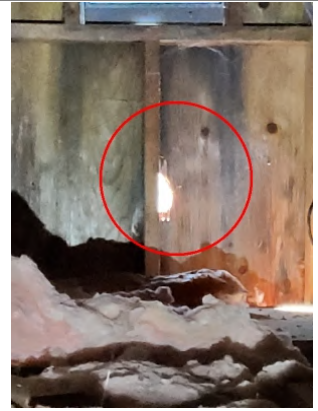
Damaged siding, recommend repair

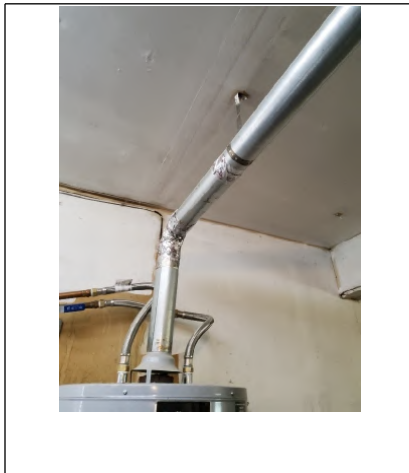
Vent cap loose, recommend repair

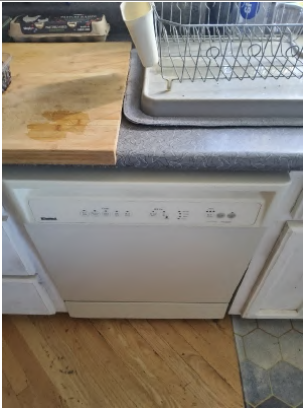
Dishwasher is not properly fastened, recommend repair

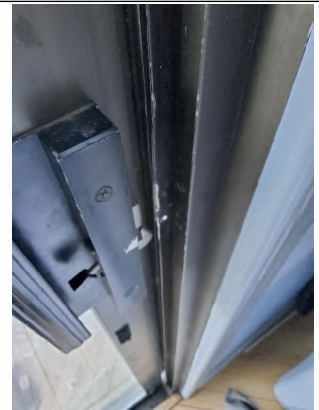
Missing latch hardware, recommend repair

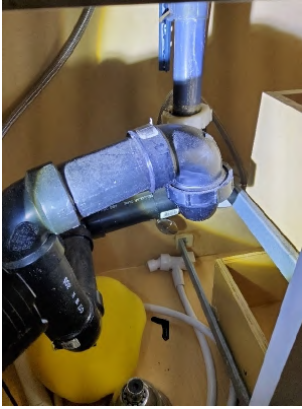
Drain pipe doesn't have proper pitch, recommend repair by a licensed plumber.

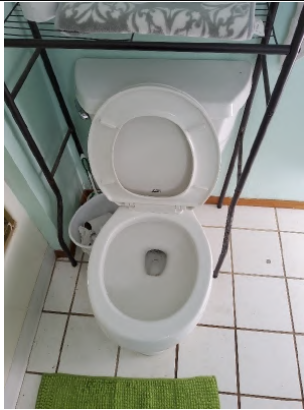
Active leak, recommend repair

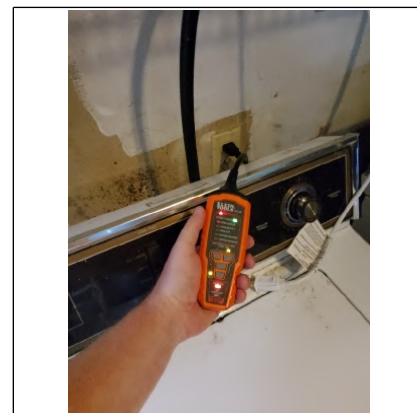
Dryer vent disconnected,  
recommend repair

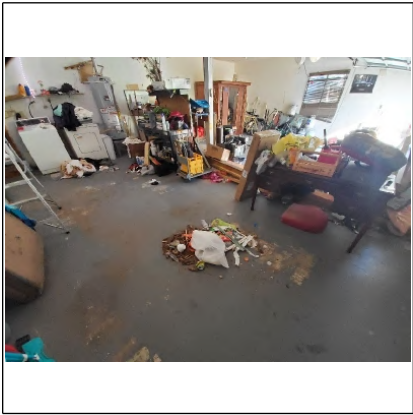
**Condition**    ☐ Satisfactory    ☒ Typical cracks    ☐ Large settling cracks    ☐ Recommend evaluation/repair

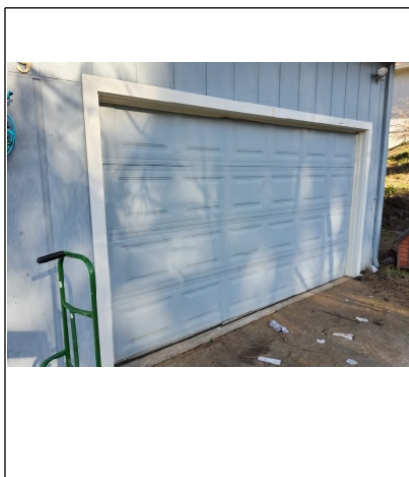
☐ Satisfactory ☐ Marginal ☒ Poor ☐ Hardware loose ☐ Safety Cable Recommended  
☐ Weatherstripping missing/damaged ☐ Loose/missing

Damaged flashing, recommend replacing

Loose garage door sweep, recommend repair

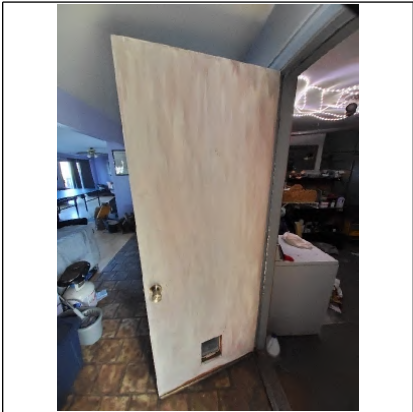
**Condition** ☐ Satisfactory ☐ Recommend repair ☐ Holes walls/ceiling ☒ Safety hazard(s)

**Fire door** ☐ Not verifiable ☒ Not a fire door ☐ Needs repair ☐ Satisfactory

Self closure ☐ N/A ☐ Satisfactory ☒ Inoperative ☐ Missing
