## PROPERTY INSPECTION REPORT

27703 Ortega Hwy Spc. 30  
San Juan Capistrano, CA 92675

Shari Kelley  
MAY 21, 2026

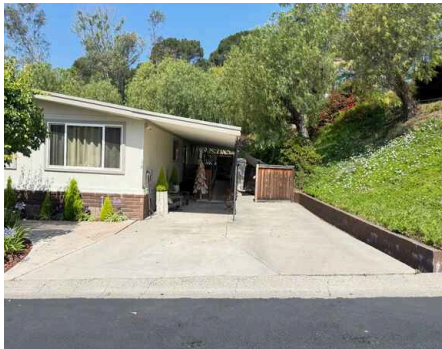
#### Driveway/Carport: Serviceable with cracking

The driveway/carport appears to be in serviceable condition. There is cracking in the concrete.

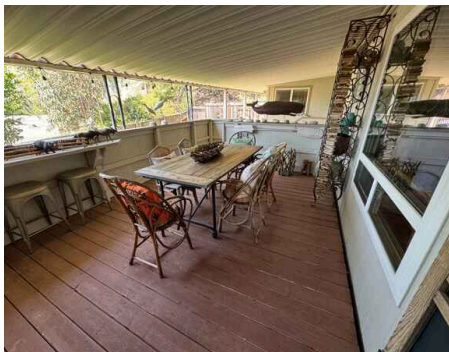
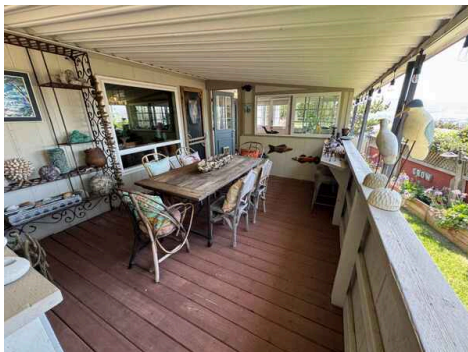
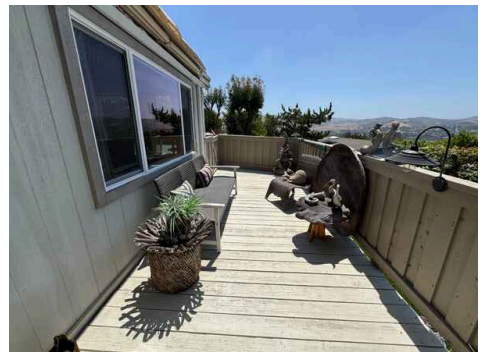
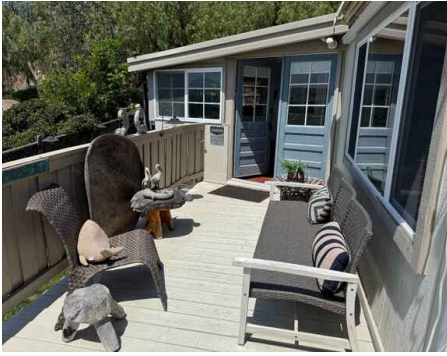
**Deck/Porch: Serviceable**

The deck/porch appears to be in serviceable condition.

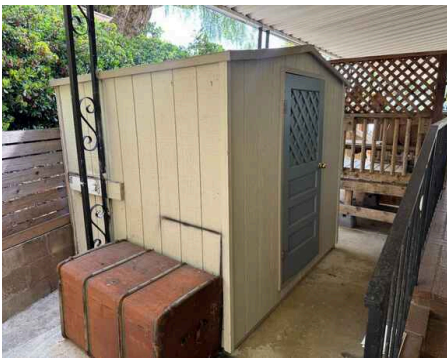
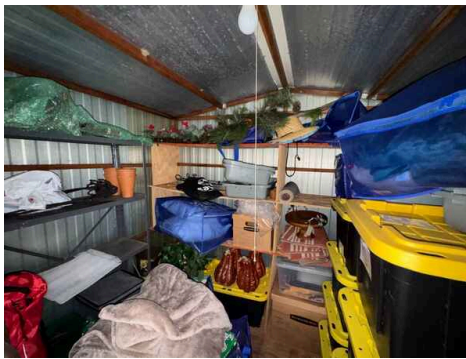
**Storage Shed: Serviceable**

The storage shed appears to be in serviceable condition.

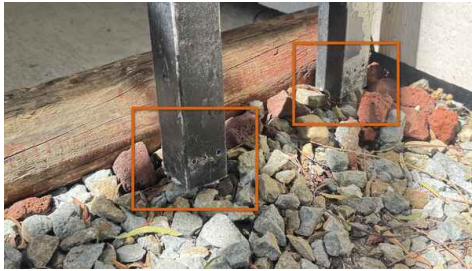
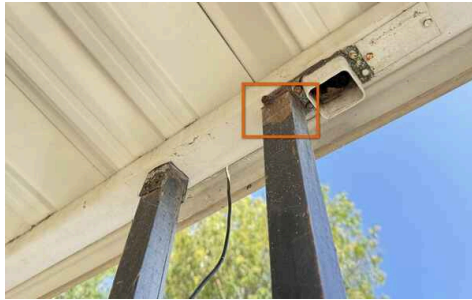
##### CARPORT COVER

The carport cover support posts are not properly connected to the ground. I recommend evaluation by a licensed contractor.

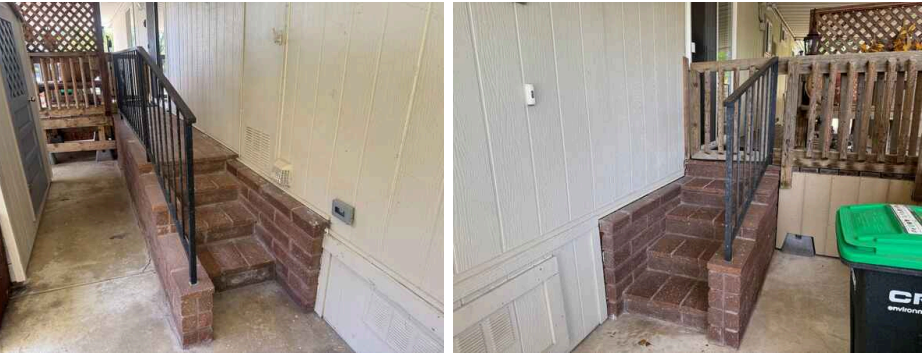
### Exterior Stairs: Carport stairs

The exterior stairs appear to be in serviceable condition.

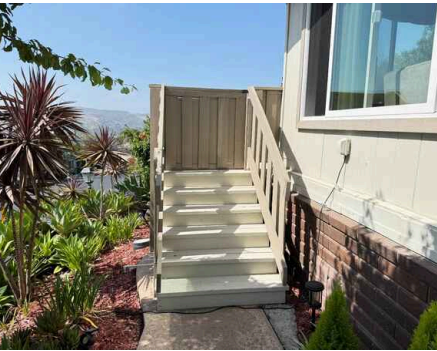
### Exterior Stairs: Front stairs

The exterior stairs appear to be in serviceable condition.

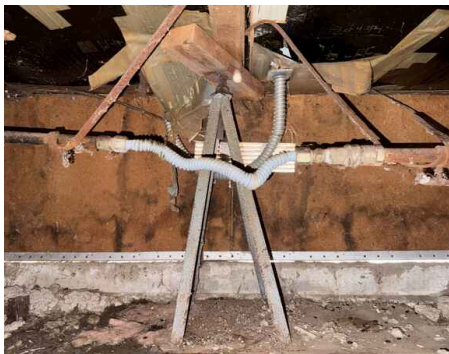
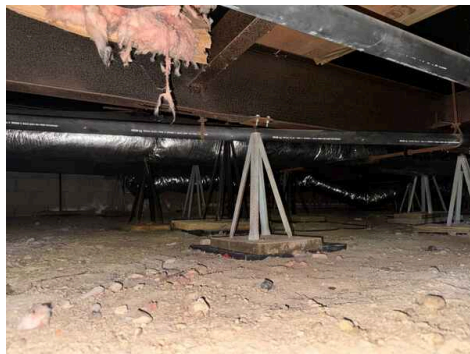
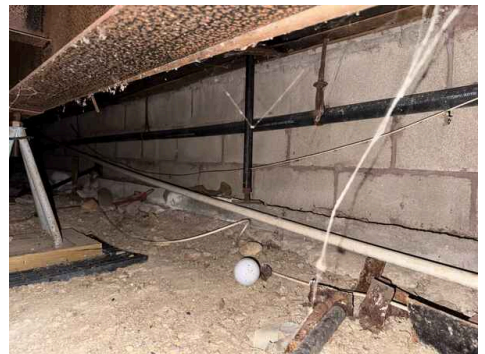
#### Crawl Space: Entered/Inspected

The crawl space was entered and inspected

**Crawl Space: Crawlspace - Dry**  
The crawlspace was dry.

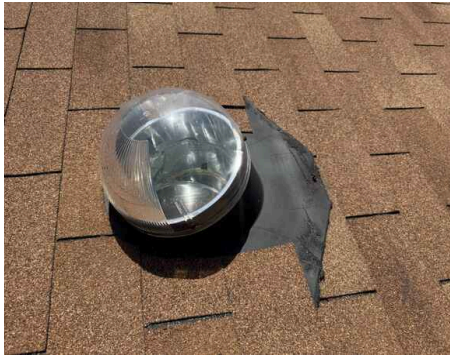
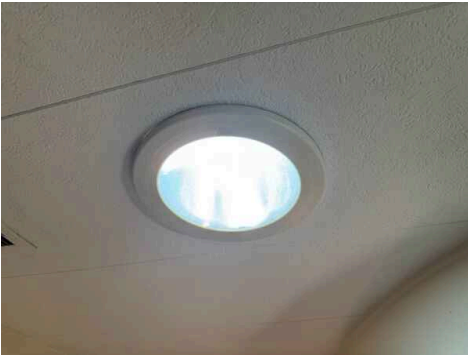
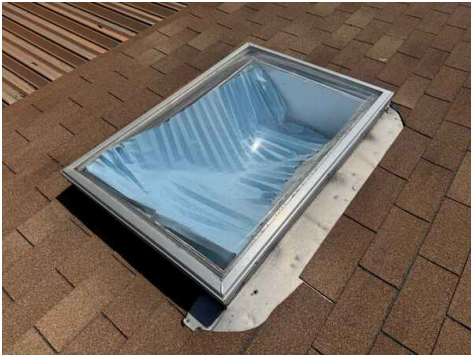
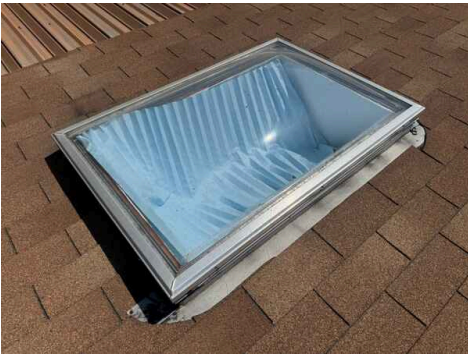
**Skylights: Serviceable**

The skylights appear to be in serviceable condition.

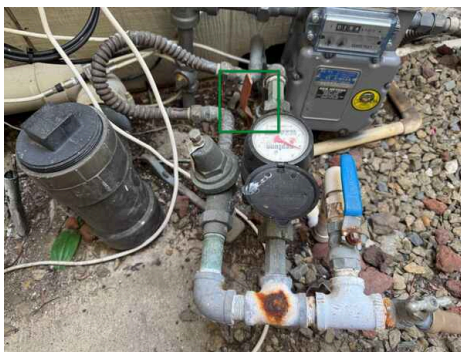
**Main Water Supply: Shut off valve Location**  
Carport side of home

**Main Water Supply: Valve Serviceable**

The main water shut off valve appear to be in serviceable condition.

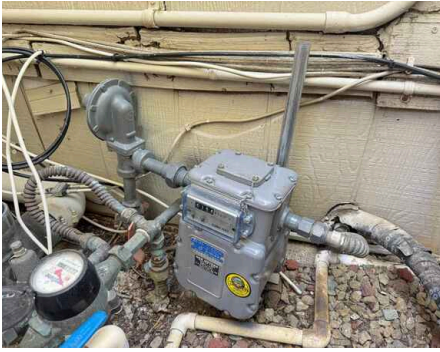
**Fuel System : Natural gas meter serviceable**

The natural gas meter and shut off valve appear to be in serviceable condition.

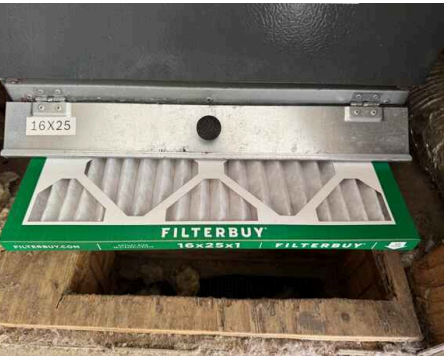
**Furnace Air Filters: Serviceable**

The air filter appears to be in serviceable condition.

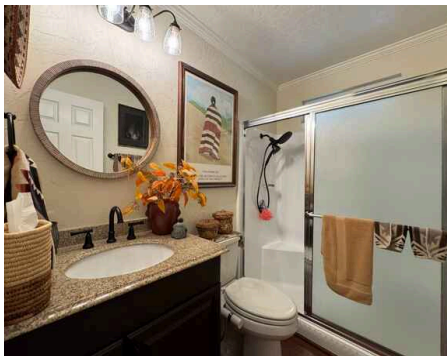
### Sink(s): Serviceable

The sink appears to be in serviceable condition.

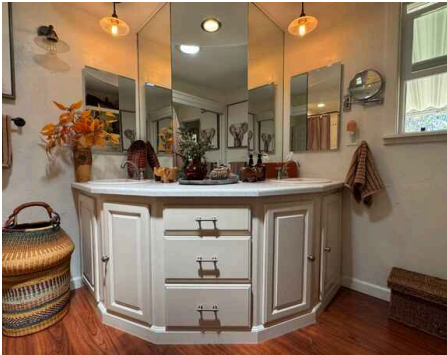
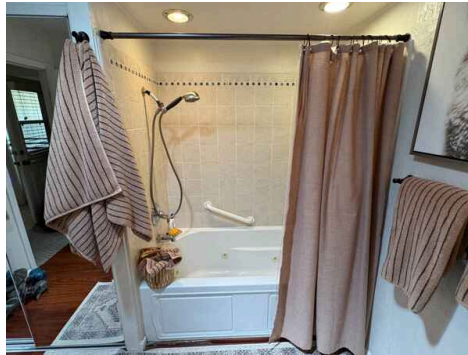
### Sink(s): Multiple Sinks

The sinks appear to be in serviceable condition.
