# PROPERTY INSPECTION REPORT

**FOUR POINT**  
HOME INSPECTION INC.

**4960 Glenhill Ln**

**Date of Inspection: 4/29/2026**

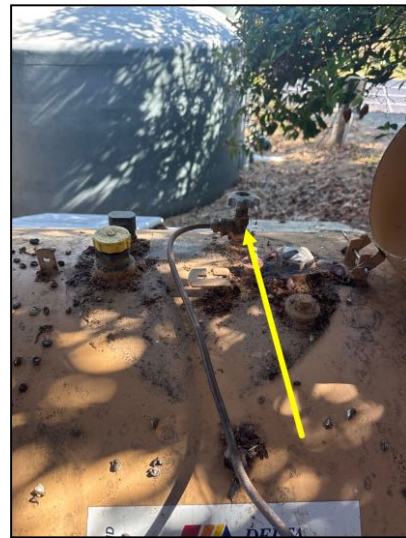
Main shut off to the liquid propane tank

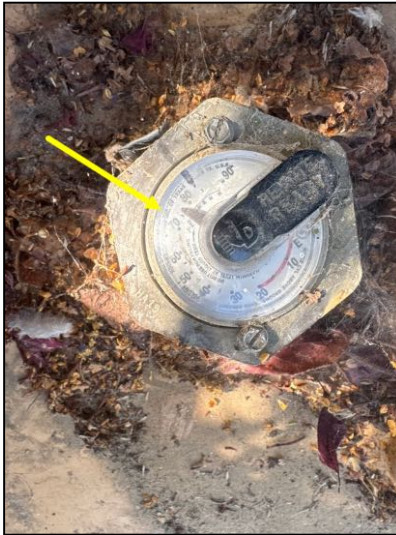
The gas gauge at the propane tank indicated that the tank had 75 % remaining.

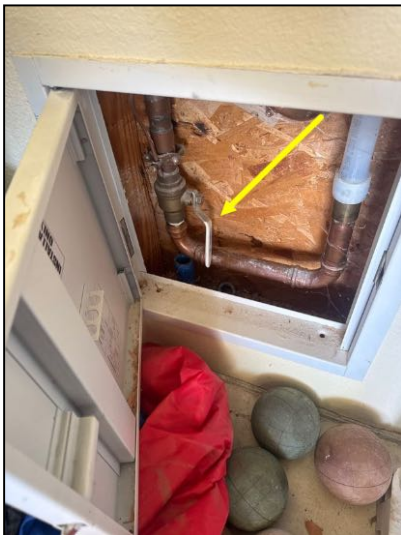
Main water shut off to the home where the main water line enters the home.

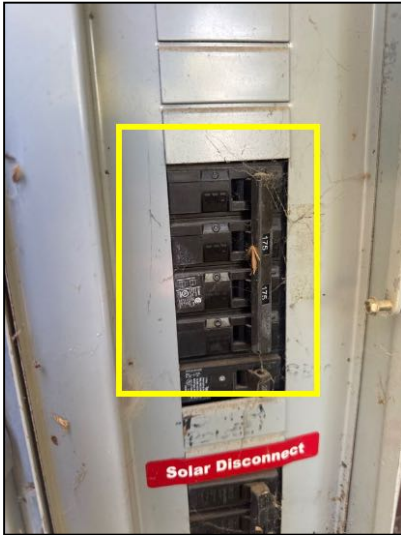
Main electrical shut off at the electrical pedestal.

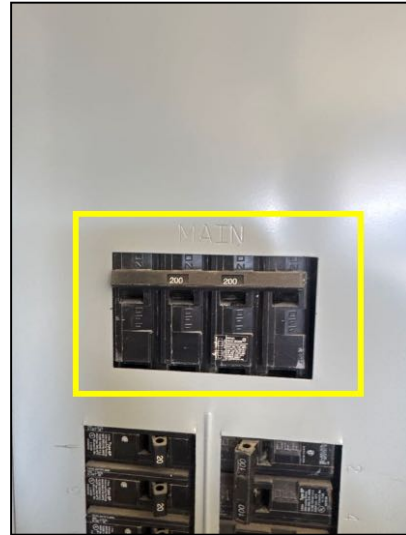
Main electrical shut off inside the sub panel.

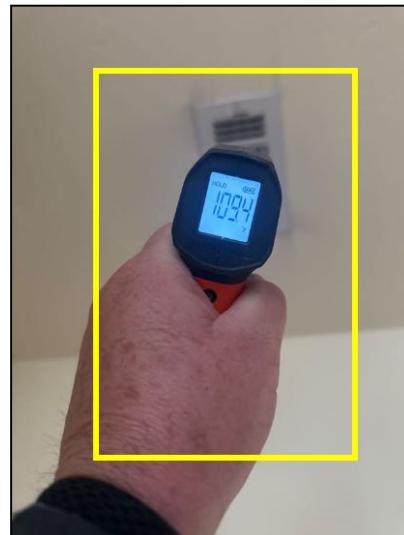
The supply air temperature at the registers should be 100 °F - 125 °F + to be considered running efficiently.

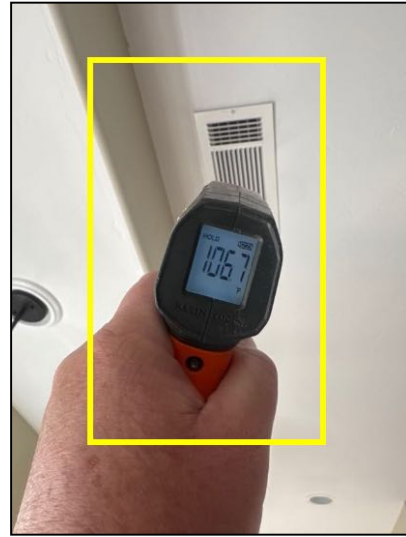
The supply air temperature at the registers should be 100 °F - 125 °F + to be considered running efficiently.

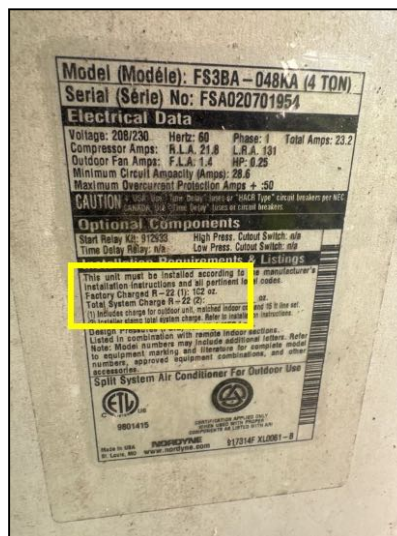
*Monitor R22 Refrigerant:* The AC unit uses R-22 refrigerant

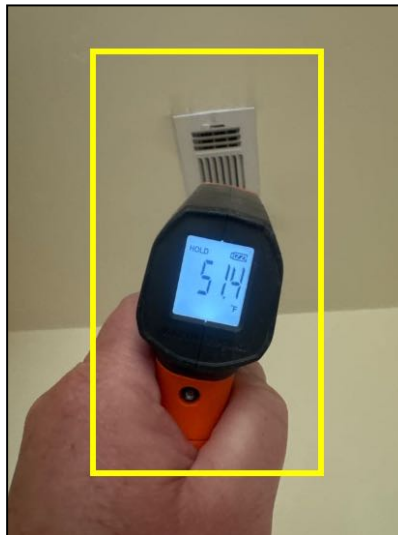
Supply Temperature

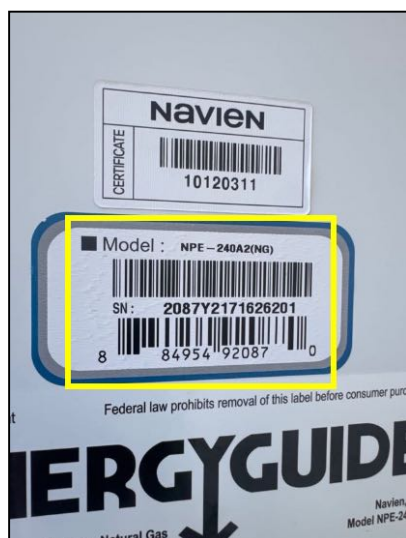
Water heater model and serial number

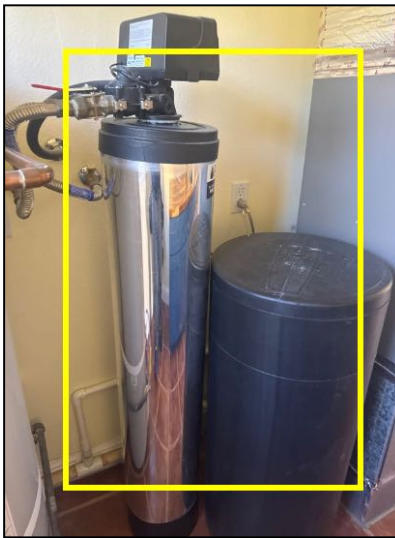
Water Softener is connected to water supply

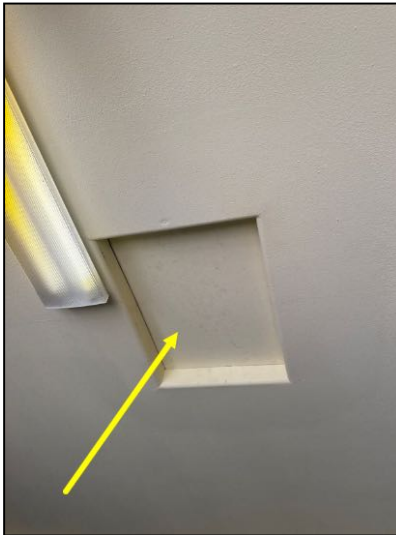
Attic access in garage is considered a breach in the fire wall. Fire walls are fundamental to the integrity of fire barriers which provide resistance to the spread of fire, smoke, and toxic gasses. This means that should a fire occur in the garage, this door does not afford protection until fire-rescue people arrive. A fire rated access panel should be installed to complete the fire wall.

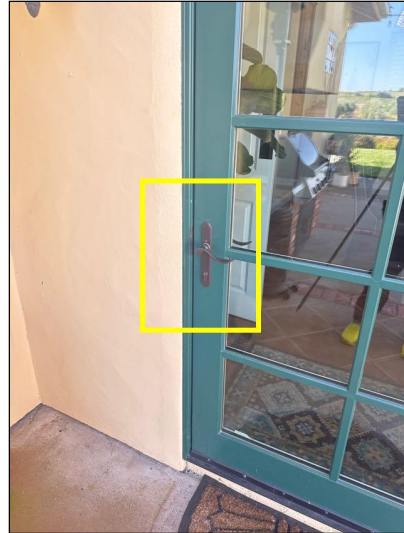
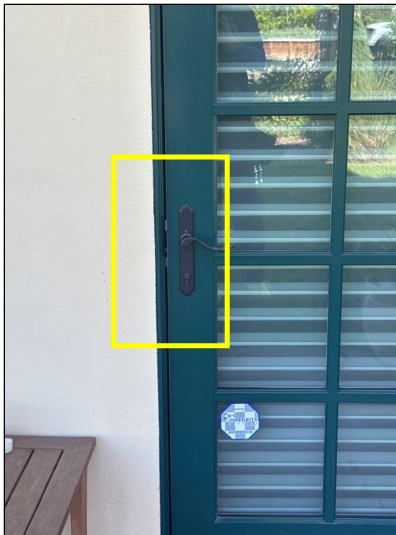
**Safety Improvement:** The exterior door opens outward and leaves the locking hardware exposed to force entry. For safety installing latch guards is one of the most effective methods of securing an outward swinging door. These are basically plate covers extending from the door's outer side to prevent forced entry.
