## Home Inspection Report

**Address: 16670 Moorpark St, Los Angeles, CA  
91436**

**Inspector: Tyler Molloy**  
**Agent: Michael Mehdizadeh**  
**Report Number: TM02081826**  
**Date of Inspection: 8/18/2026**

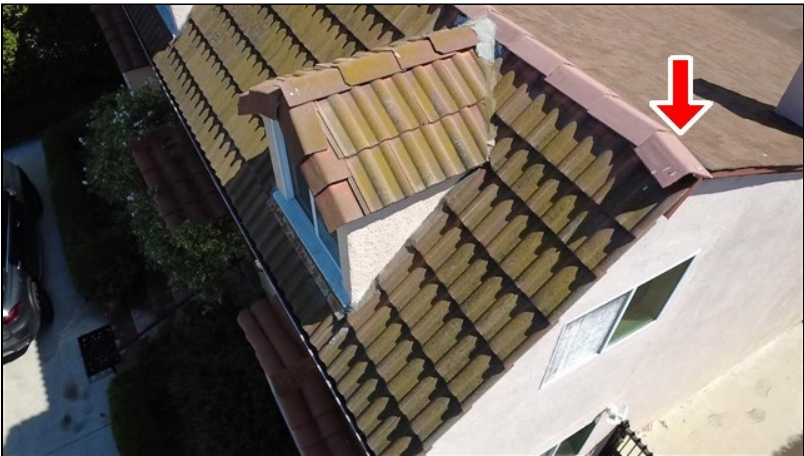
1.0.A Item 4(Picture)

(4) Green material observed on coverings. Recommend correcting.

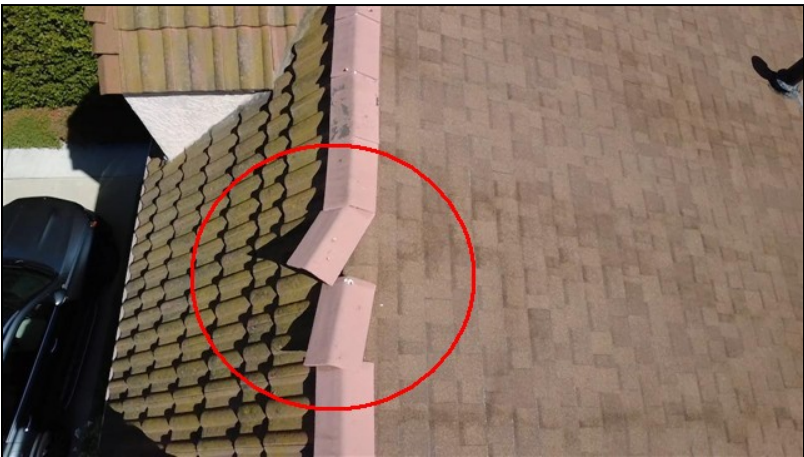
1.0.A Item 5(Picture)

(5) Loose roofing material observed. We recommend further review of the entire roofing system by a qualified roofer, prior to the release of contingencies.

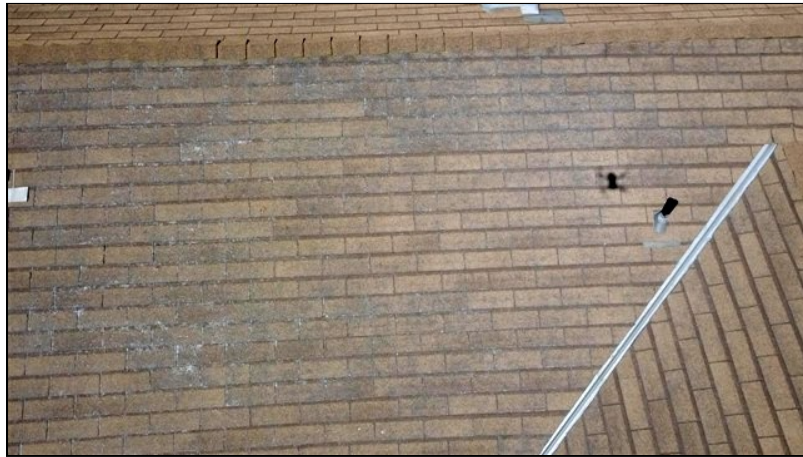
1.0.B Item 2(Picture)

(1) Roofing material it beyond its estimated service life. We recommend further review of the entire roofing system by a qualified roofer, prior to the release of contingencies.

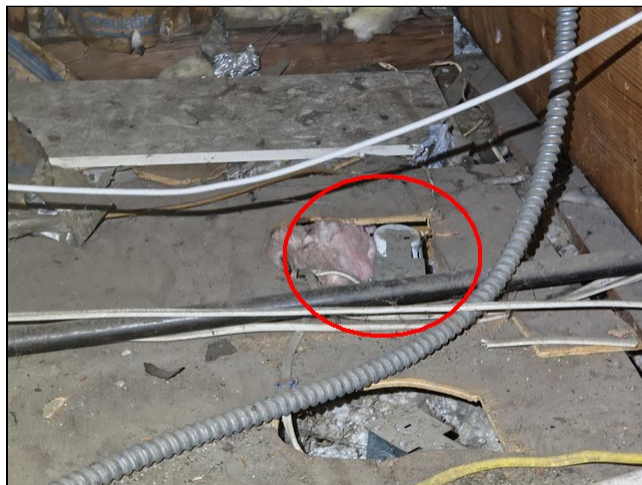
2.3.A Item 2(Picture)

(2) Insulation is in contact with the light fixtures. Recommend correcting.

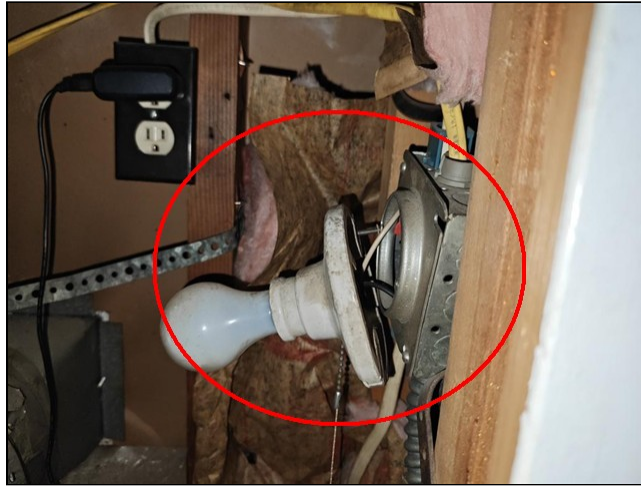
2.5.A Item 1(Picture)

(1) Loose light at attic. Recommend repair.

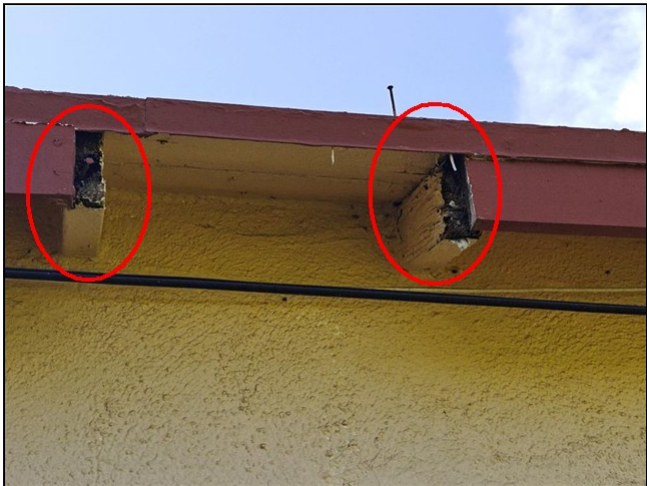
3.3 Item 2(Picture)

Deterioration observed in areas. We recommend further evaluation by a qualified termite specialist, prior to the release of contingencies.

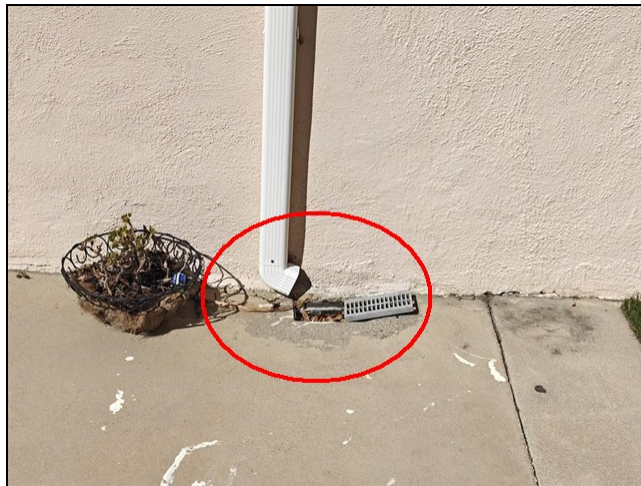
3.4 Item 2(Picture)

(2) Grading and drainage is inadequate at the front, rear, and sides of the buildings. We recommend regrading, filling in any low lying areas, or adding alternative means of drainage as needed.

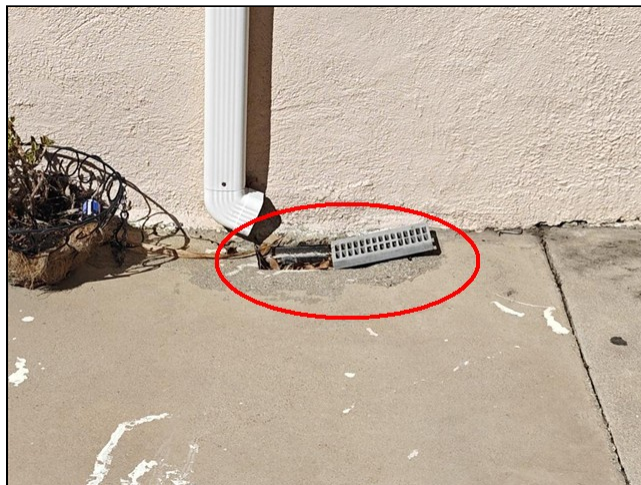
3.4 Item 3(Picture)

(3) Sub surface drainage observed on property. We advise the client to verify the overall condition with a qualified drainage contractor, prior to the release of contingencies.

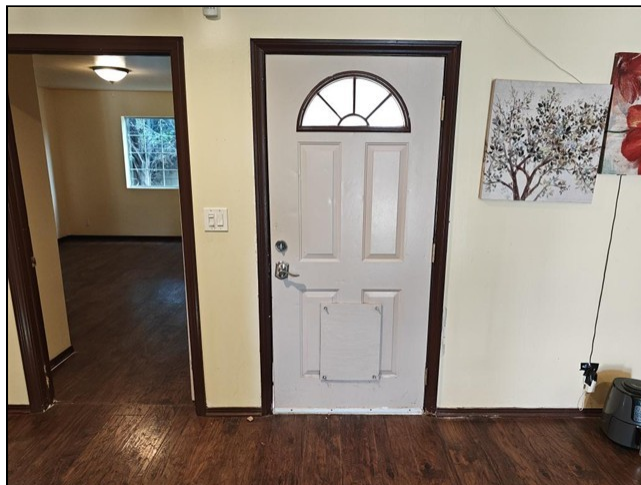
3.6 Item 1(Picture)

Missing/deteriorated weather stripping observed at back house door. Recommend repair.

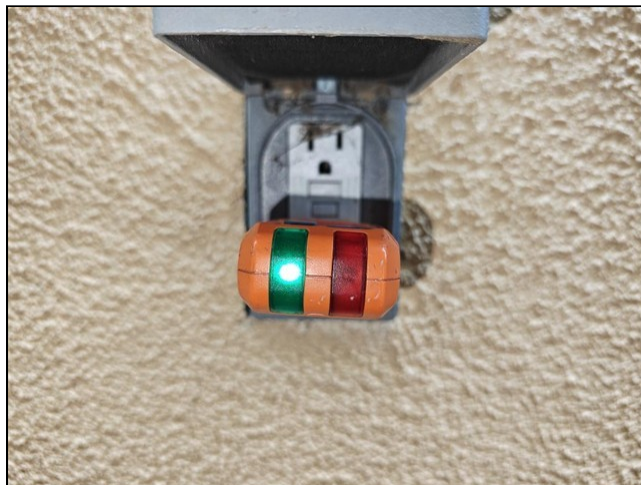
3.9 Item 1(Picture)

Ground fault circuit interrupter function did not respond to test at exterior outlets. Recommend repair.

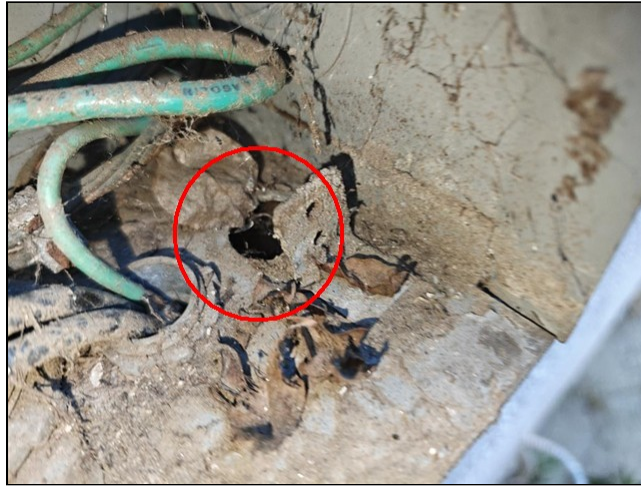
4.1 Item 1(Picture)

(1) Wire bushing is missing at the interior of the panel. Recommend correcting.

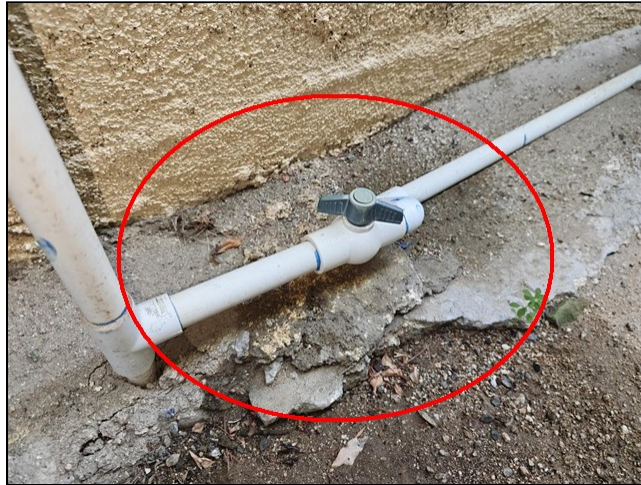
5.1 Item 1(Picture)

(1) Leaking observed at supply piping to sprinkler line at back house. Recommend repair.
-

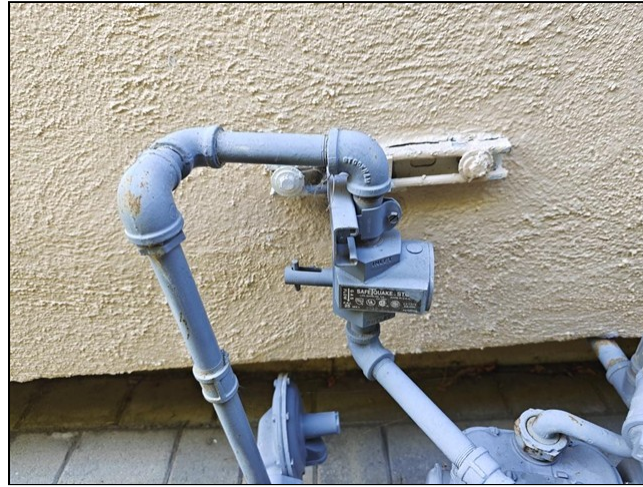
5.3 Item 1(Picture)

(1) Gas leak detection is beyond the scope of this inspection, and seismic shut-off valve is installed. We advise the client to annually test for leaks and verify the condition of the gas system and appliances.

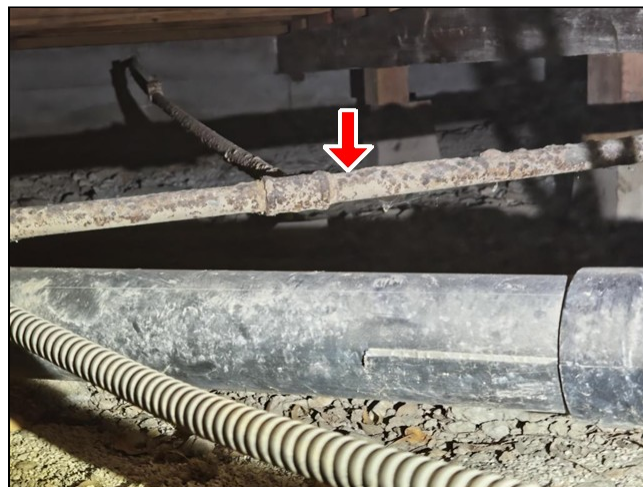
5.3 Item 2(Picture)

(2) Rust/corrosion observed at the gas supply piping. Recommend further review by a qualified plumber, prior to the end of the contingency period.

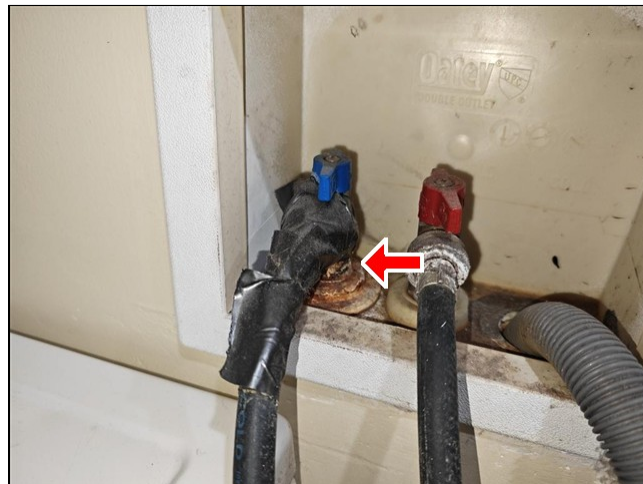
5.4 Item 3(Picture)

(2) Evidence of leaking observed at rear house washing machine faucets. Recommend repair.

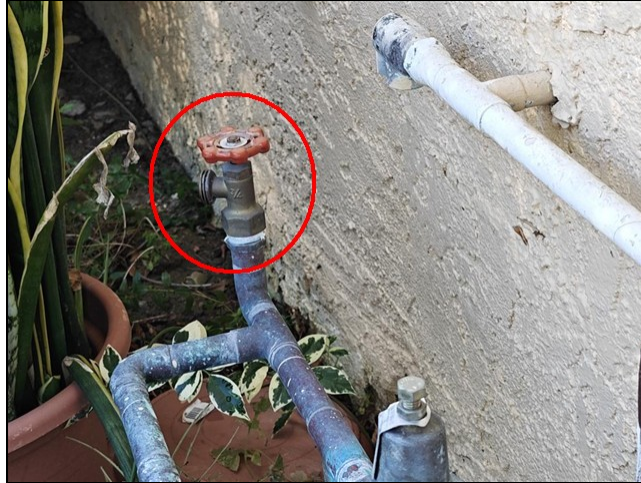
5.6 Item 1(Picture)

(1) Hose spigot is installed upstream of the reducing valve. Recommend correcting.

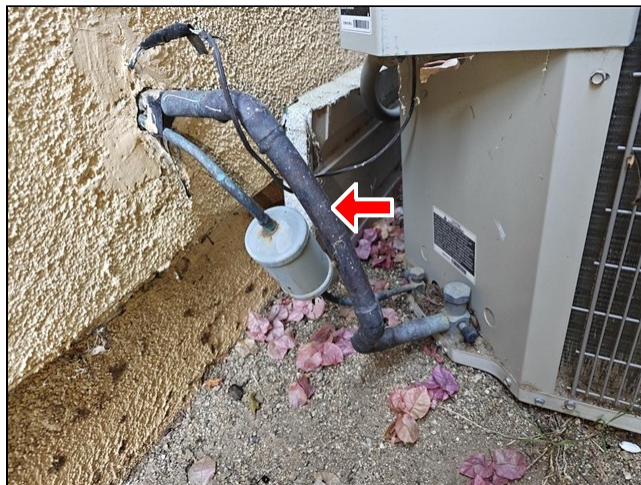
6.2.B Item 1(Picture)

(1) Deterioration or missing insulation at refrigeration line. Recommend replacement.

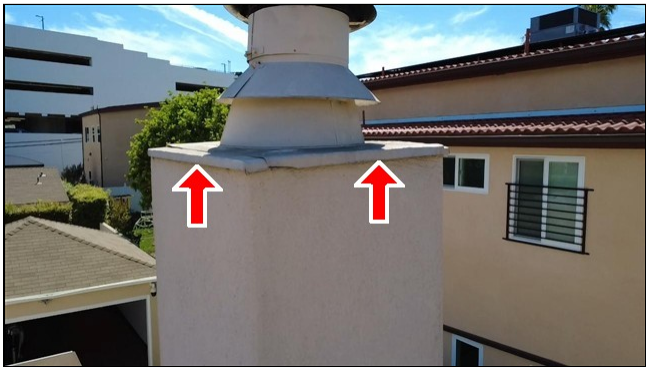
7.0 Item 1(Picture)

Chase cover is sealed to chase. We recommend further review by a qualified fireplace specialist, prior to the release of contingencies.

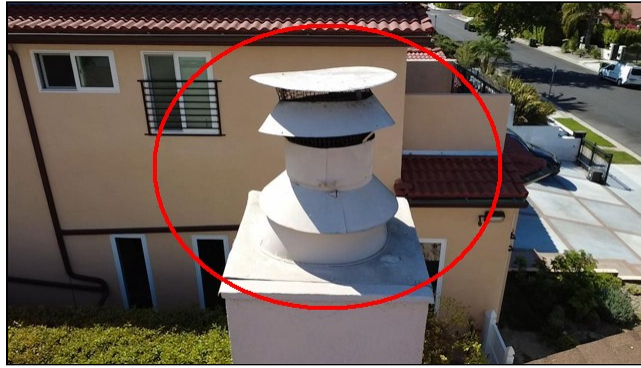
7.1 Item 1(Picture)

Physical damage and missing sealant observed at termination cap. We recommend further review by a qualified fireplace specialist, prior to the release of contingencies.

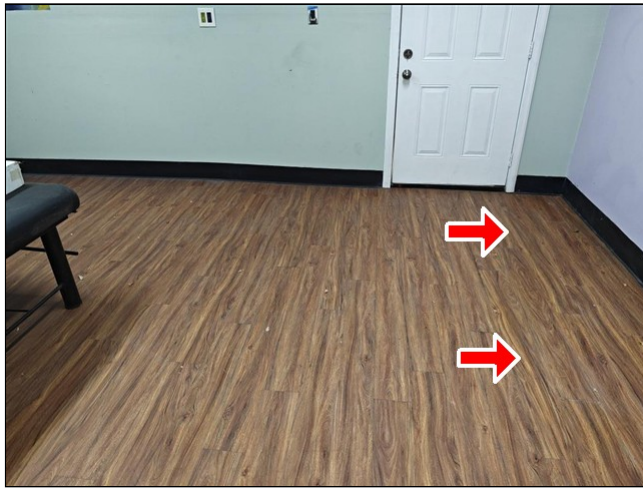
Sloping uneven floor observed and racked door frame. We recommend further review by a qualified contractor, prior to the release of contingencies.

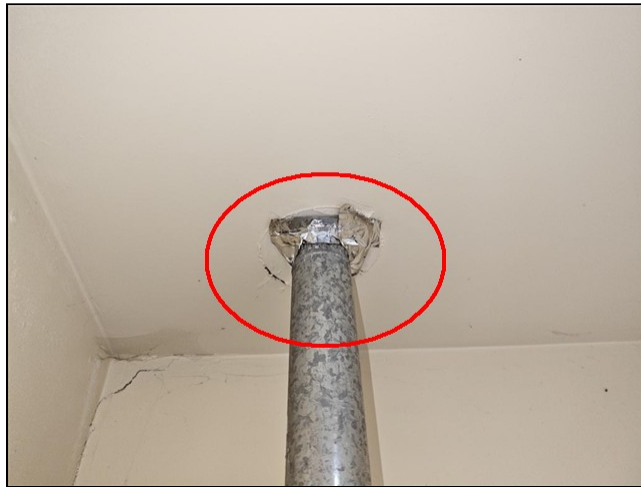
9.0.B Item 1(Picture)

Poorly fitted vent pipes observed. Recommend correcting.

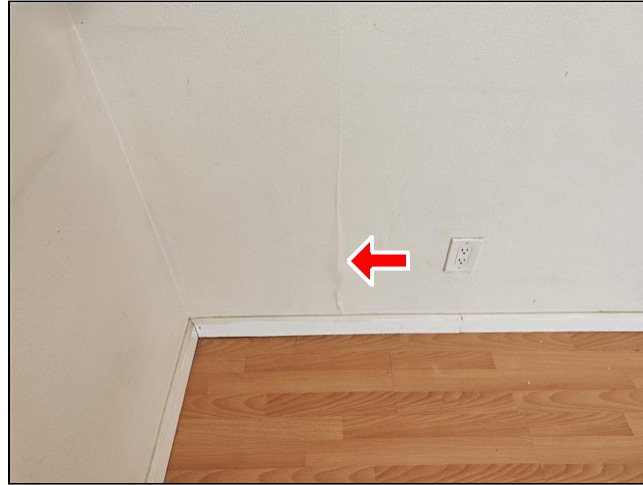
11.1.A Item 1(Picture)

(2) Cracks observed in a number of areas throughout the home. Suggest repairs.

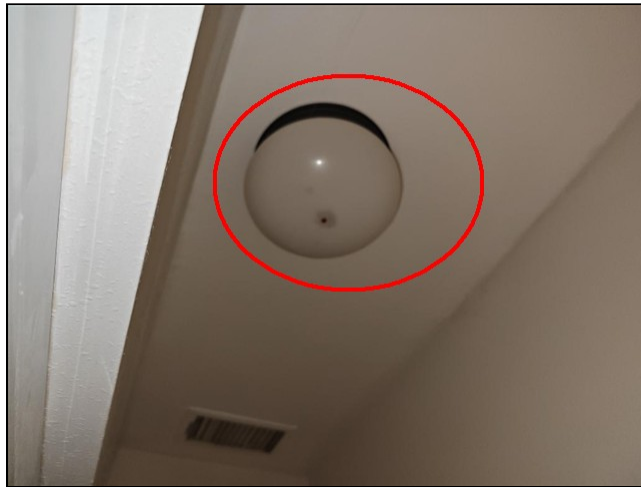
11.6.A Item 1(Picture)

Water observed at light fixture in bedroom closet. We recommend further review by a qualified contractor, prior to the release of contingencies.

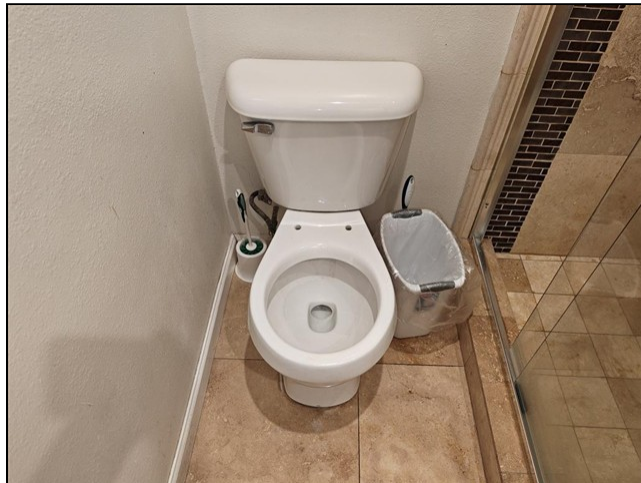
11.7.A Item 1(Picture)

(1) Toilet base is loose at hall bathroom. The wax ring at the toilet base must have a water-tight seal to prevent leakage from occurring. Therefore, we recommend replacing the wax ring and securing the base of the toilet to the floor.

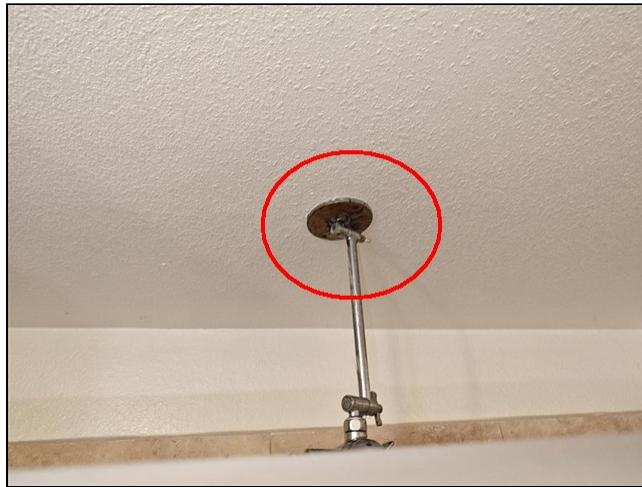
11.8.A Item 1(Picture)

(1) Leaking observed at shower head stem in master bathroom. Recommend repair.

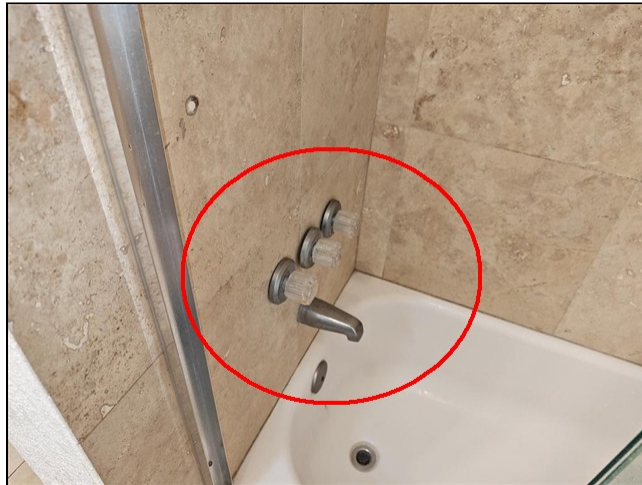
11.8.A Item 2(Picture)

(2) Shower diverter is inoperable at master bathroom. Recommend repair.

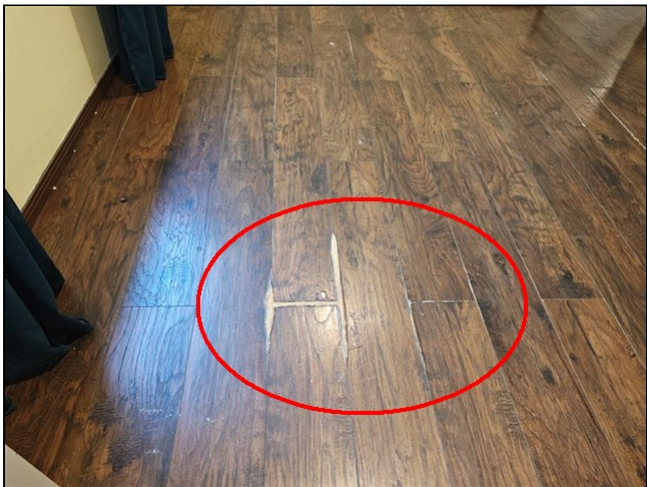
11.0.B Item 3(Picture)

(2) Excessive wear and tear observed at flooring material throughout unit. Recommend replacement.

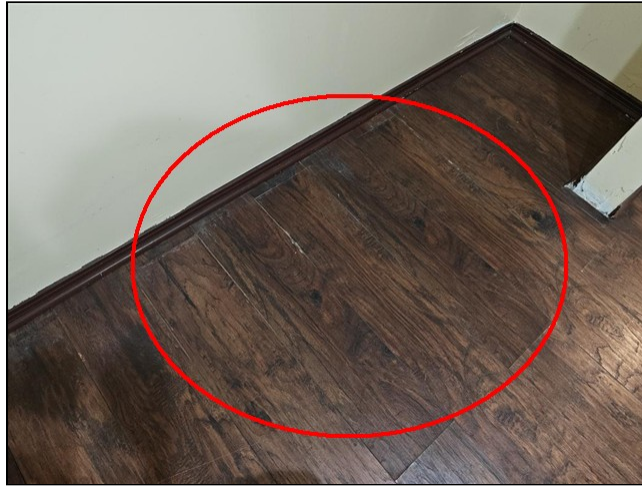
11.0.B Item 4(Picture)

(3) Cupping observed at master bedroom and laundry room vinyl. Hidden damage may not be observable. Recommend further review by a qualified contractor, prior to the end of the contingency period.

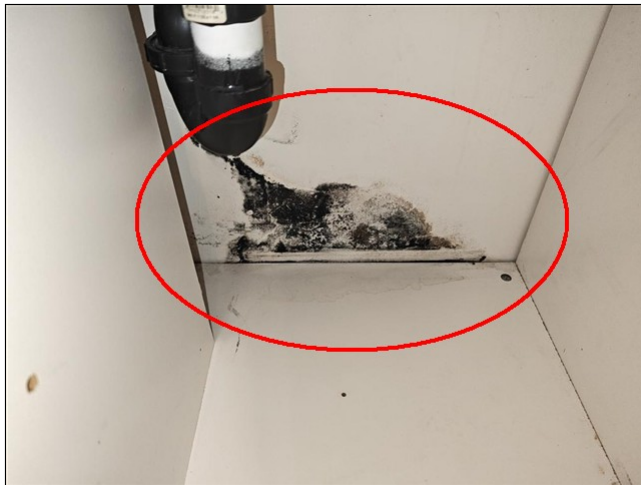
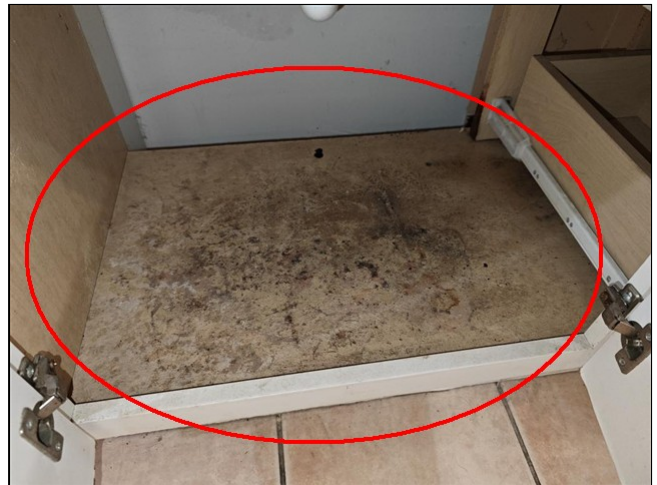
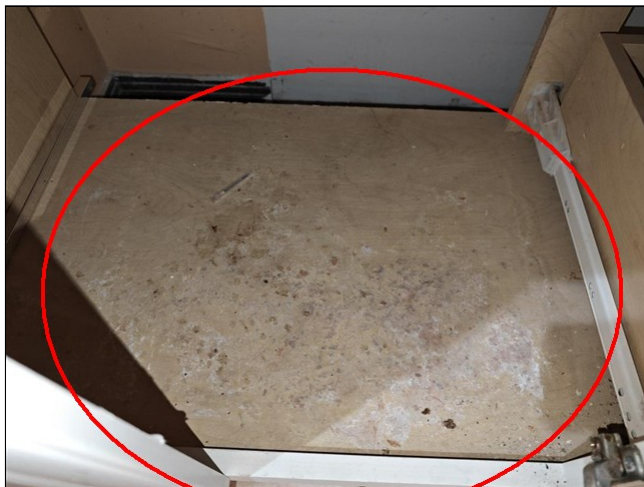
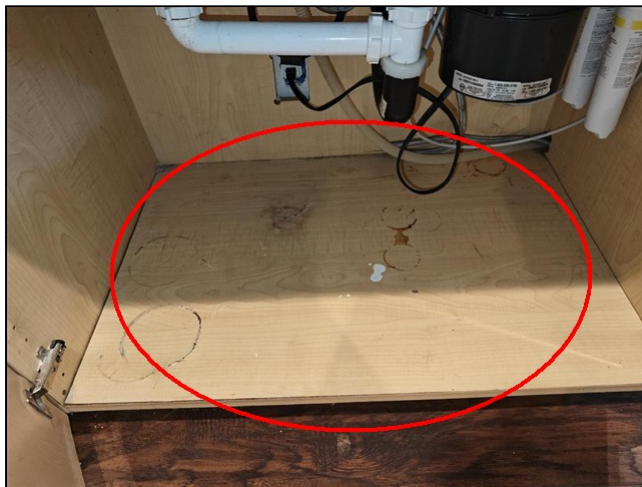
Black staining and moisture damage observed at ensuite bathroom cabinetry, jack/jill bathroom cabinet, and kitchen cabinets. Hidden damage may not be observable. We recommend further review by a qualified mold specialist, prior to the release of contingencies.

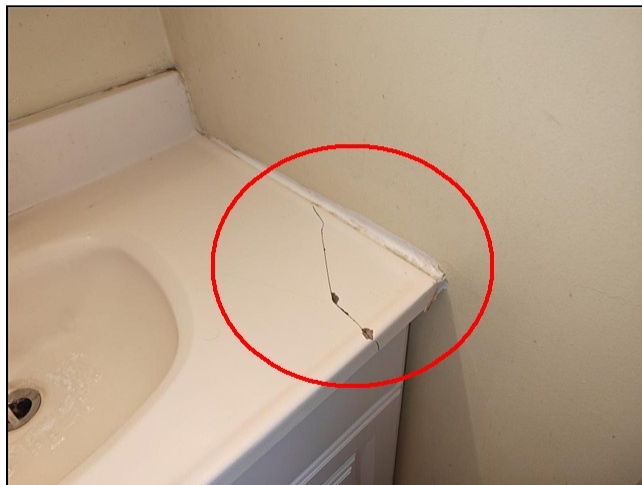
11.7.B Item 1(Picture)

(1) Sink at ensuite bathroom is cracked. Recommend repair.

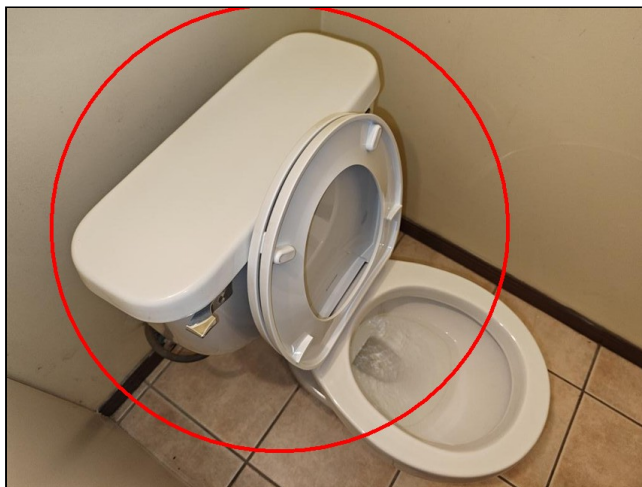
11.7.B Item 3(Picture)

(2) Toilet tank is loose at the toilet in the rear ensuite bathrooms. Recommend correcting.

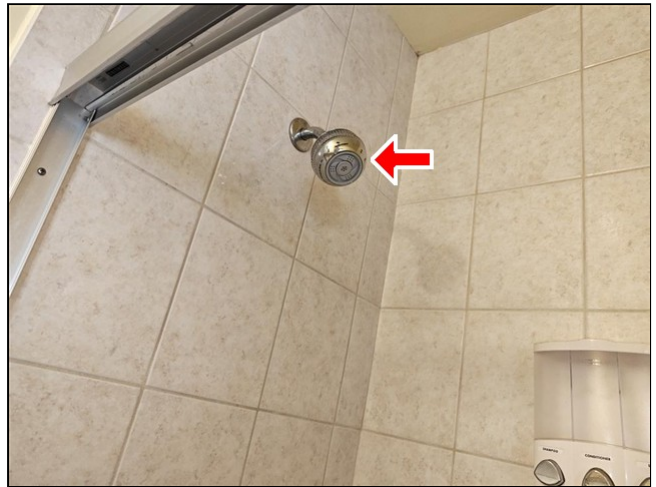
11.8.B Item 3(Picture)

(3) Tub/shower faucet did not respond to test at rear ensuite bathroom and Jack and Jill bathroom. Recommend correcting.

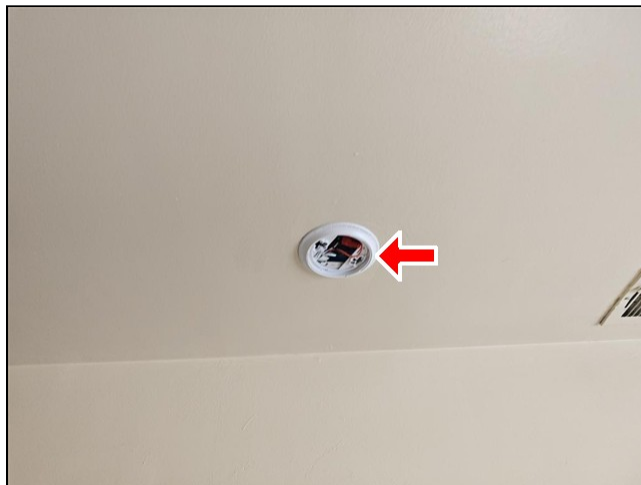
11.9.B Item 1(Picture)

(1) Smoke detector is not installed at the bedroom - safety concern. Recommend installing.

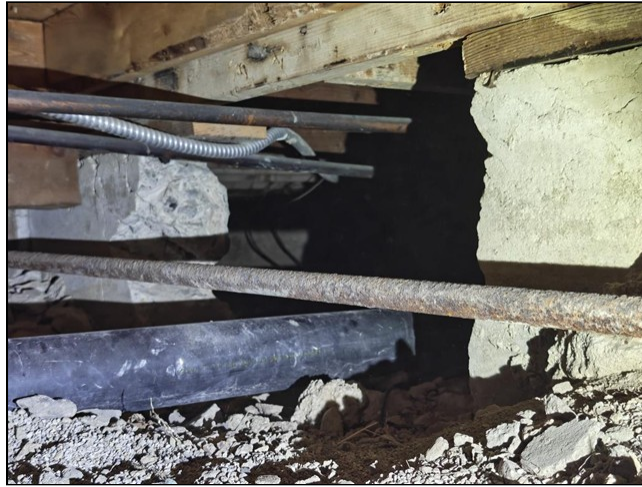
12.0 Item 1(Picture)

Limited evaluation of the crawlspace due to restrictive clearances.

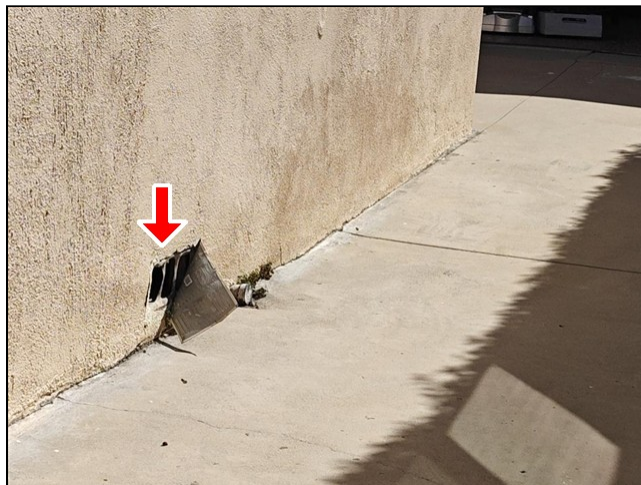
12.5 Item 1(Picture)

Open, loose, and missing screens observed at vents. Recommend correcting.
