## **HOME INSPECTION REPORT**

**3732 Mayfield Ave., La Crescenta, CA 91214**

**Prepared for: Steve Aranda**

Inspection Date: 7/11/2026  
Report Number: 2026071101ATja  
Real Estate Agent: Steve Aranda  
Home Inspector: Ali Tfaily

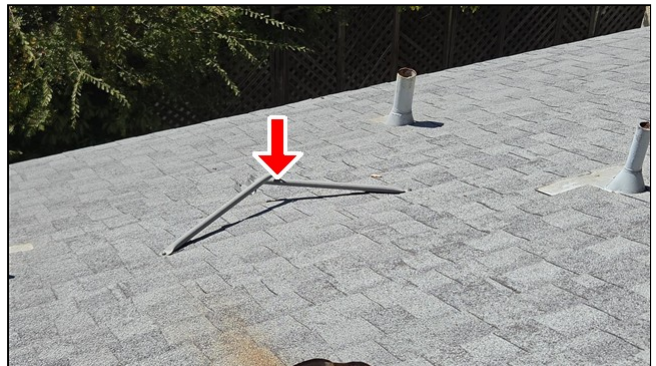
1.0 Item 3 (Picture)

(4) Vegetation on or overhanging the roof. Suggest cutting back the trees/vegetation.

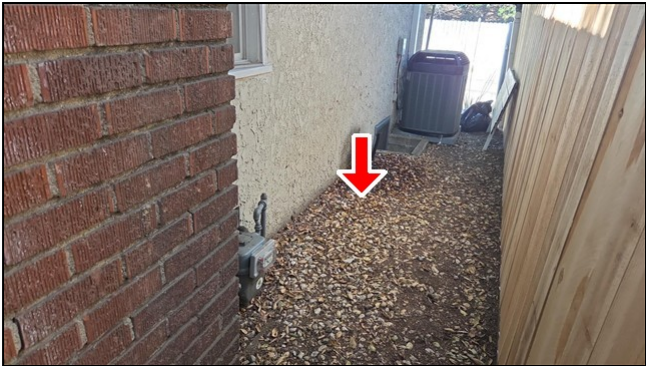
3.5 Item 2 (Picture)

Inadequate grade drainage observed at right side of the house and rear and left side of the garage. Regarding, filling low lying areas or adding alternative means of drainage is recommended to assure all water drains away from the foundation and exterior walls.

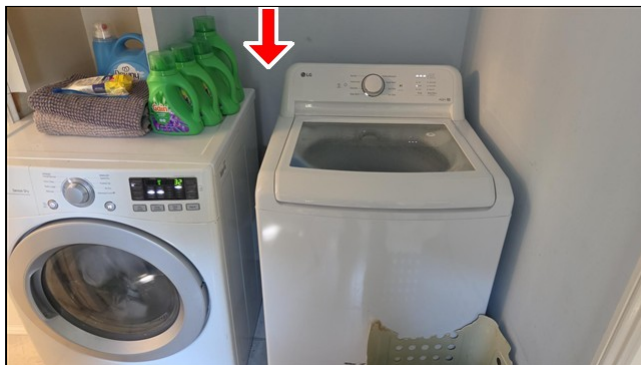
5.4 Item 2 (Picture)

(2) Ground fault circuit interrupters are not installed at all required locations. Recommend installing.

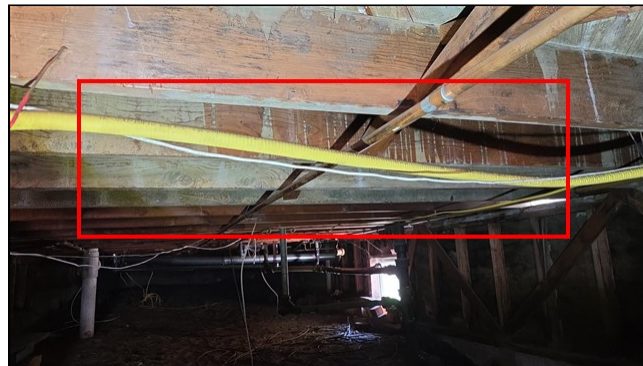
6.3 Item 2 (Picture)

(3) Yellow CSST: Manufacturers believe the product is safer if properly bonded and grounded as required by the manufacturer's installation instructions. Proper bonding and grounding of the product can only be determined by a licensed electrical contractor.

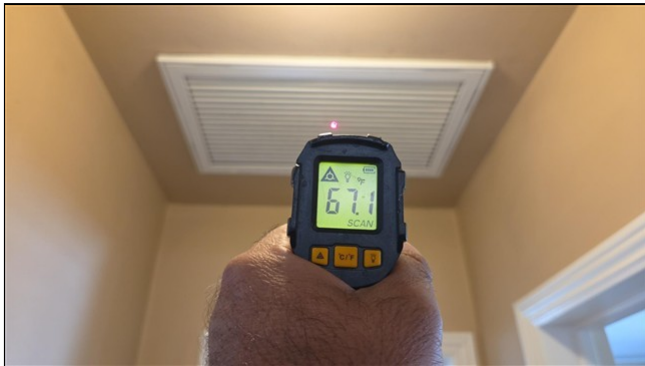
8.2 Item 1 (Picture)

The air conditioning system was operated using normal operation controls (thermostat). The difference between the return air vent and the service registers was between the recommended range of 15 to 20 degrees Fahrenheit. Changing the air filters, servicing and regular maintenance of the components is necessary to prolong the service life of the system.

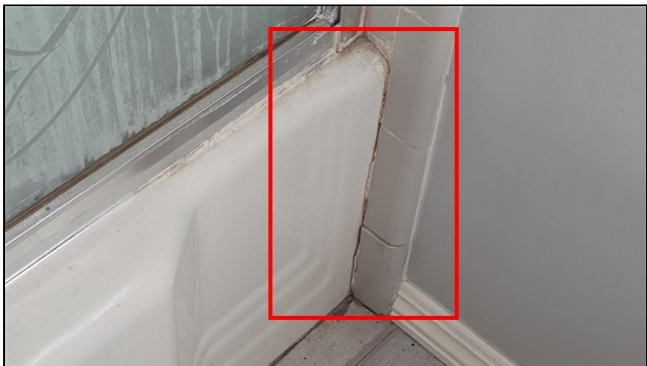
11.1 Item 2 (Picture)

(2) Moisture damage observed at the bathroom shower surround at at the laundry area service door trim. Hidden damage may not be observable. Recommend further review by a qualified professional.

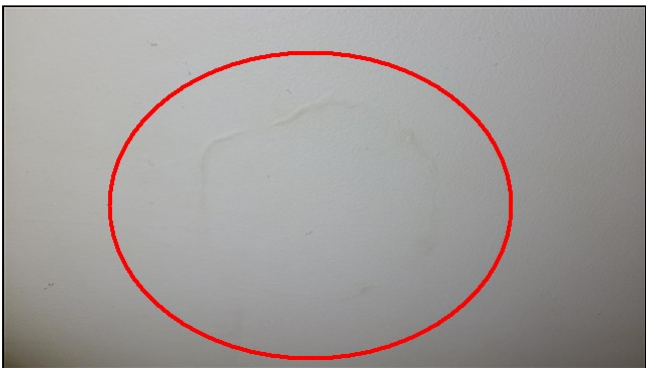
11.1 Item 5 (Picture)

📍 (3) Blistering finish and discoloration observed at the family room ceiling and blistering observed on the wall above the fireplace mantel. Recommend further review by a qualified professional.

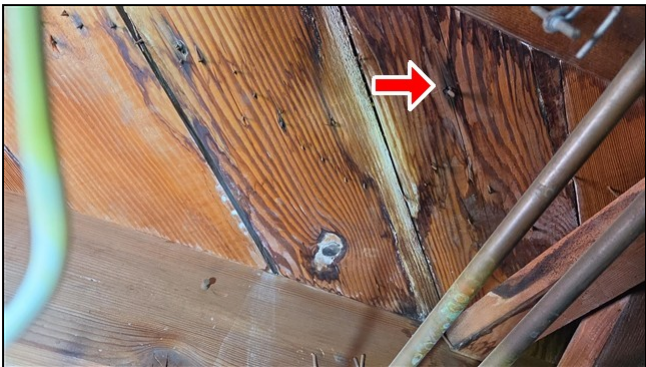
12.3 Item 2 (Picture)

Water staining observed at the subflooring under the kitchen, laundry area and bathroom in the crawlspace. Recommend further review by a qualified professional.

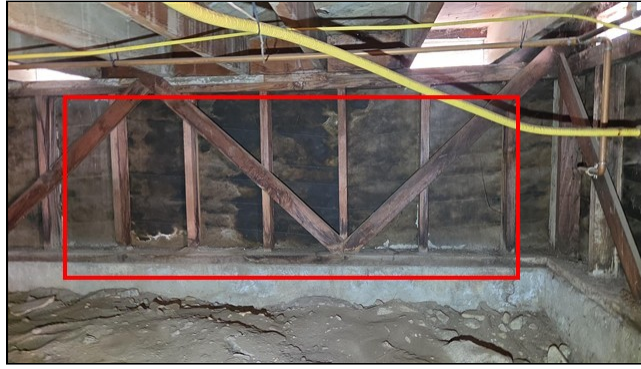
12.6 Item 1 (Picture)

Cripple walls are not braced. Bracing cripple walls enhances earthquake safety.

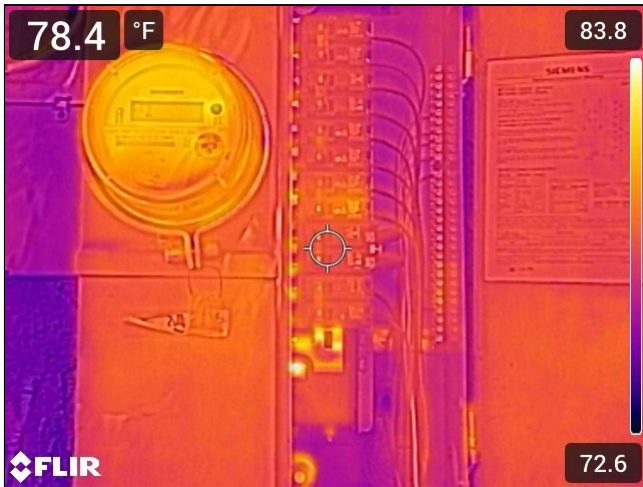
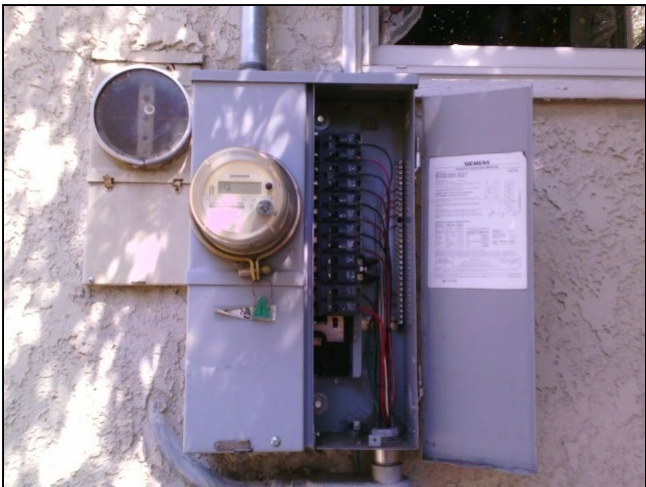
Main/sub panel(s) scanned. No thermal anomalies detected.

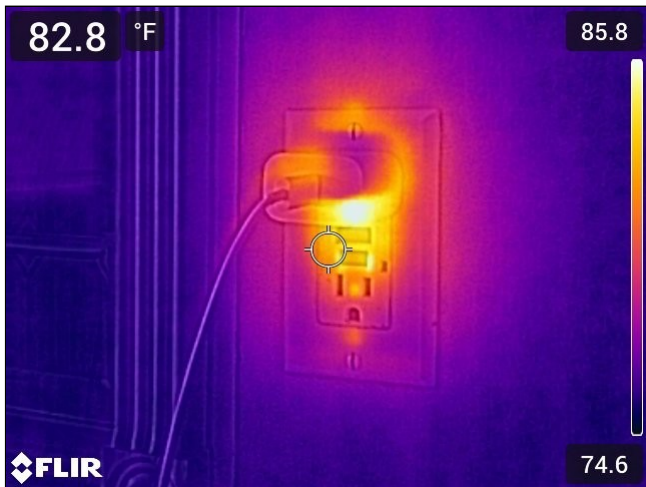
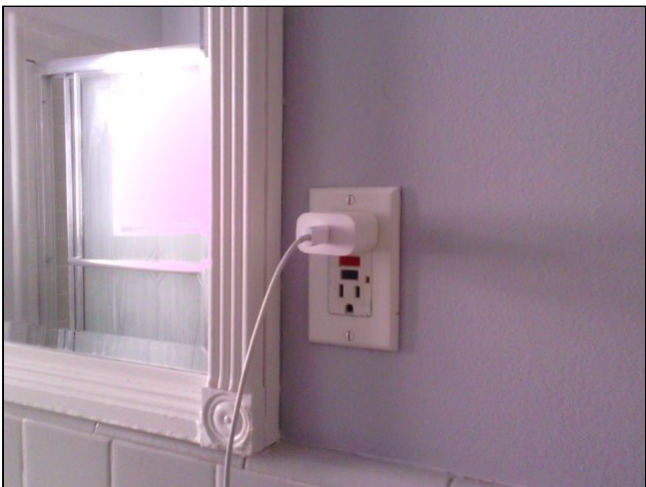
Accessible outlets, switches, and light fixtures scanned. No thermal anomalies detected.

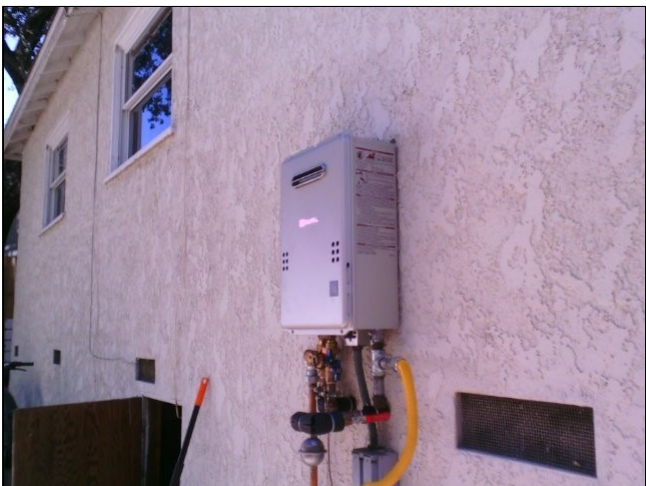
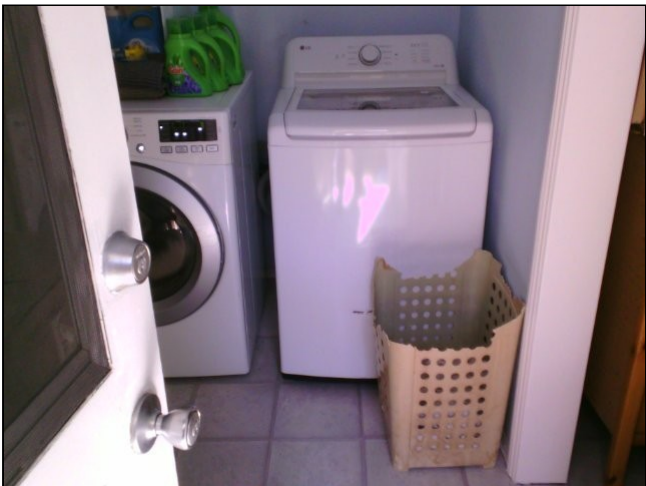
Water heater and laundry areas scanned. No thermal anomalies detected.

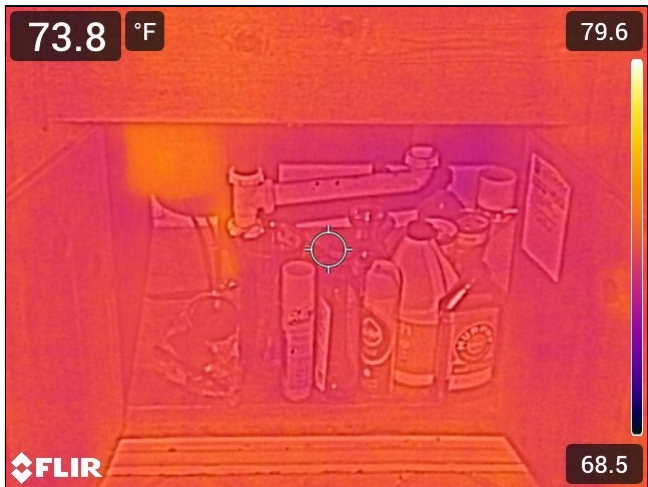
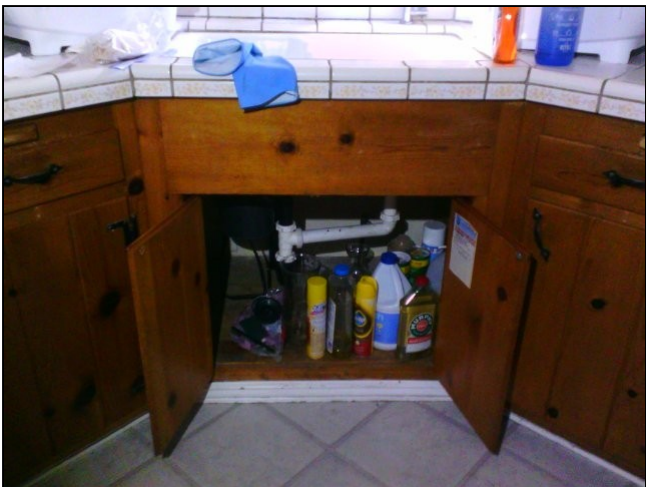
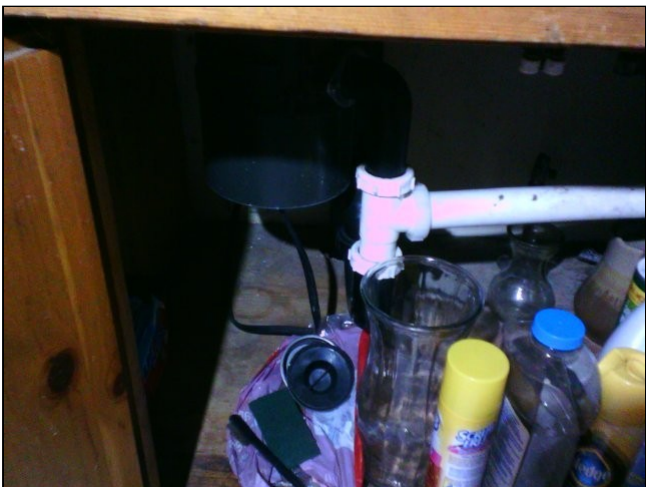
Kitchen area and sink cabinetry scanned. No thermal anomalies detected.

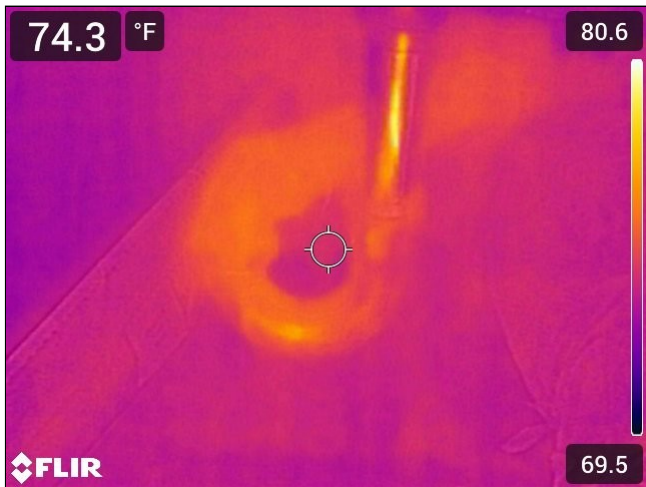
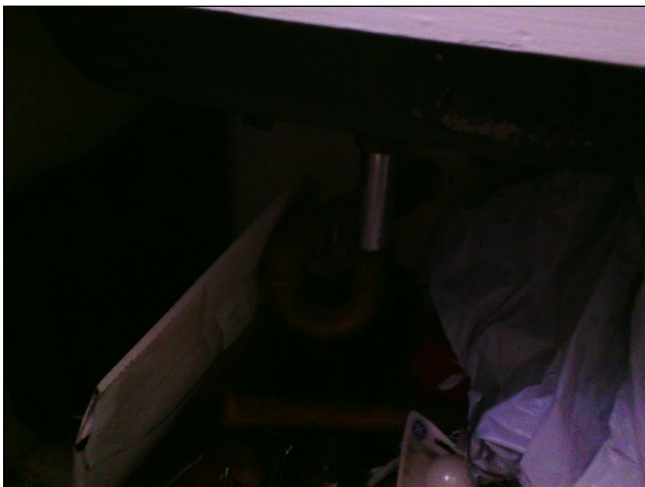
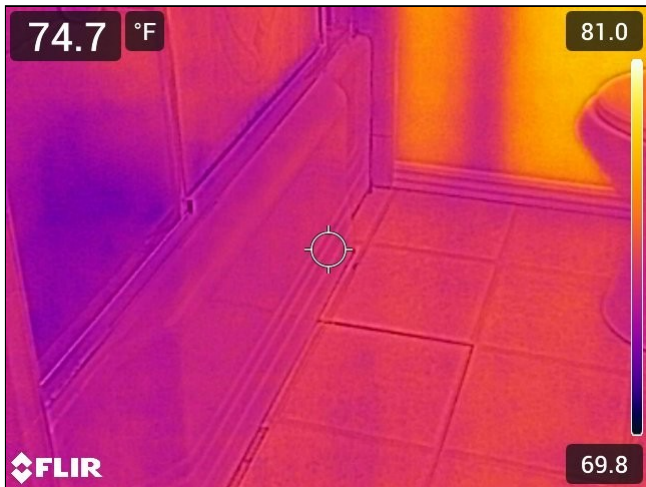
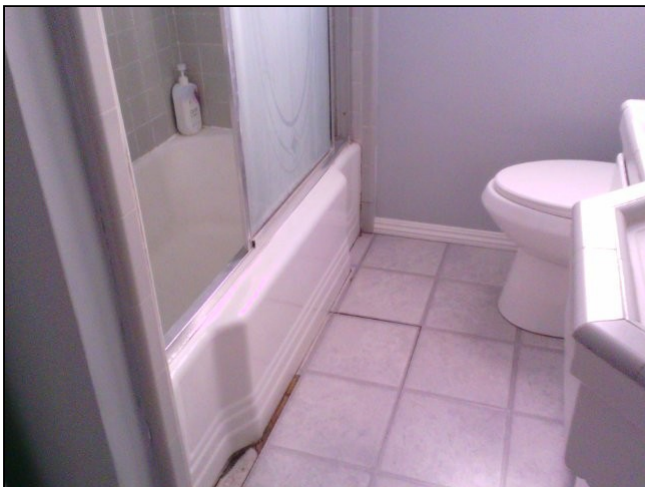
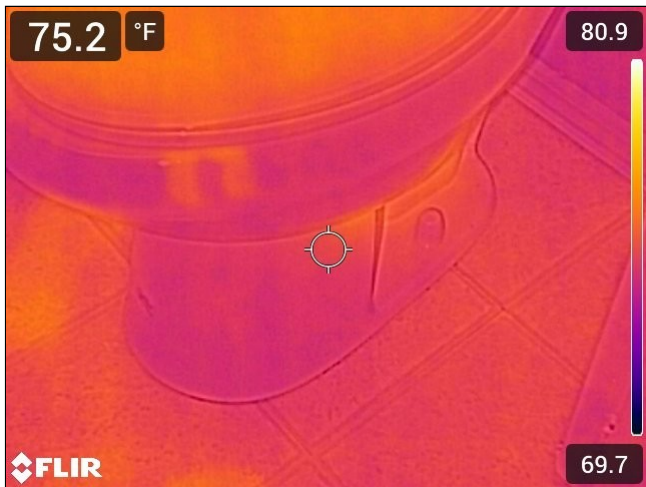
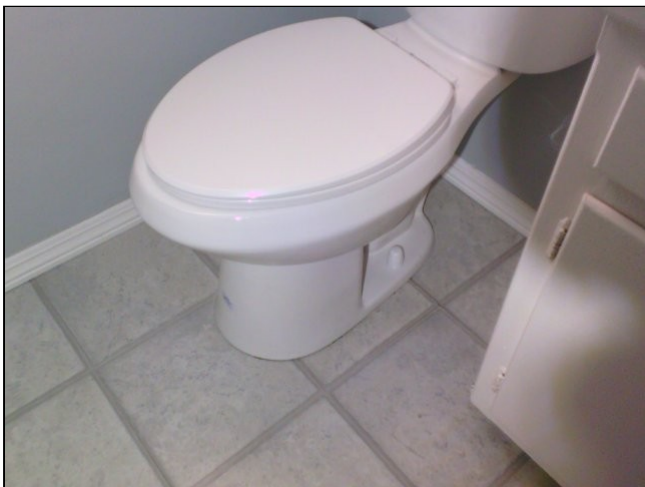
Bathroom areas and sink cabinetry scanned. No thermal anomalies detected.

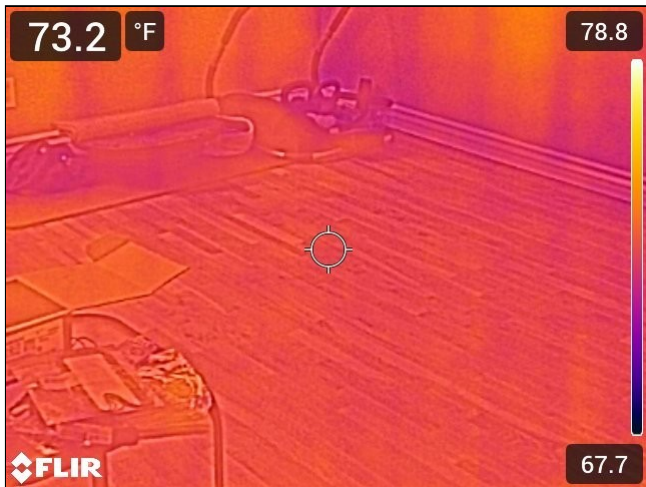
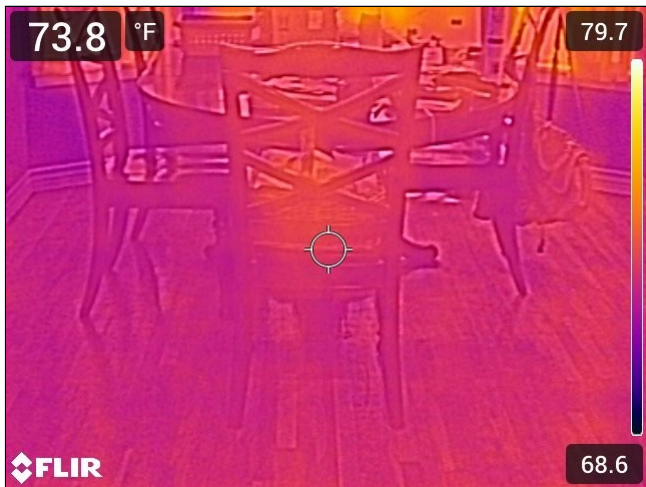
Accessible flooring areas scanned. No thermal anomalies detected.
