# PROPERTY INSPECTION REPORT

**519 W Taylor St Spc 185**

**Santa Maria CA 93458**

**Date of Inspection: 7/20/2026**

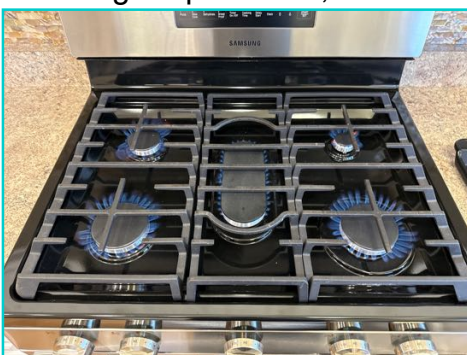
*All burners lit*

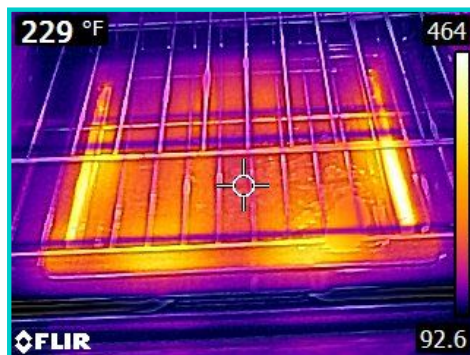
*bake heated up*

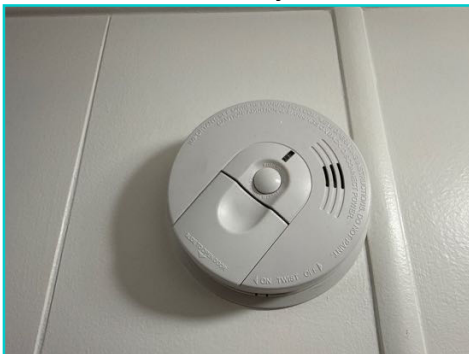
- Smoke detector placement appeared to be adequate and responded to the "having power" test button. Smoke detector operation is not tested as part of a general home inspection. Pushing the "Test" button only verifies that there is power at the detector--either a battery or hard wired to the house power--and not the operational workings of the detector. The operational check is done by filling the sensor with smoke and is beyond the scope of this inspection. Battery operated smoke alarms should be checked routinely.

*Smoke detector here*

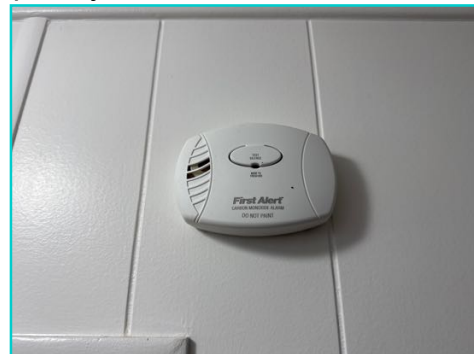
- CO detector placement appeared to be adequate and responded to the "having power" test button. CO detector operation is not tested as part of a general home inspection. Pushing the "Test" button only verifies that there is power at the detector--either a battery or hard wired to the house power--and not the operational workings of the detector. The operational check is done by filling the sensor with CO and is beyond the scope of this inspection. Battery operated CO alarms should be checked routinely and the batteries changed frequently.

*CO detector here*

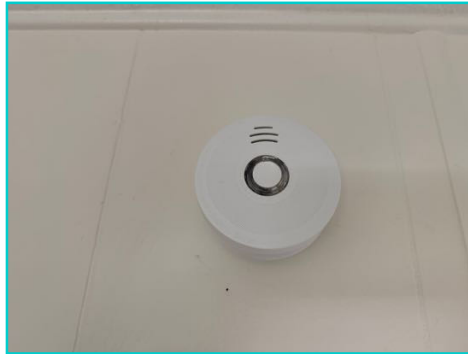
- Smoke detector placement appeared to be adequate and responded to the "having power" test button. Smoke detector operation is not tested as part of a general home inspection. Pushing the "Test" button only verifies that there is power at the detector--either a battery or hard wired to the house power--and not the operational workings of the detector. The operational check is done by filling the sensor with smoke and is beyond the scope of this inspection. Battery operated smoke alarms should be checked routinely.

*smoke detector here*

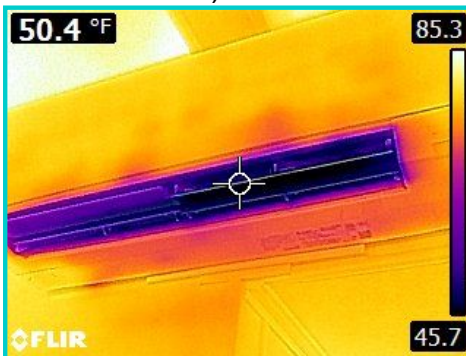
*working properly*

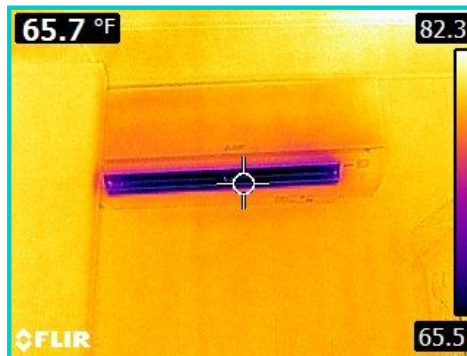
*working properly*

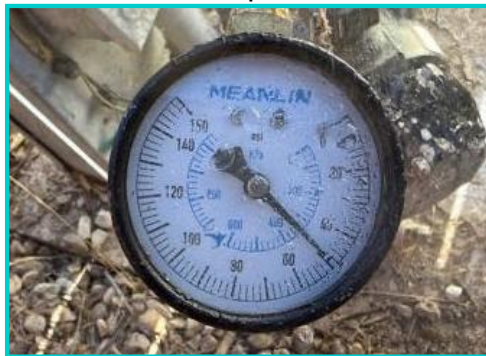
- Water pressure measured **50 pounds per square inch (psi)** at the time of the inspection. Acceptable water pressure is between 40 and 80 psi.

*50 PSI*

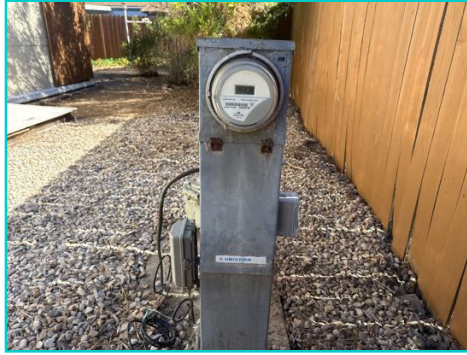
*located at the rear of the home.*

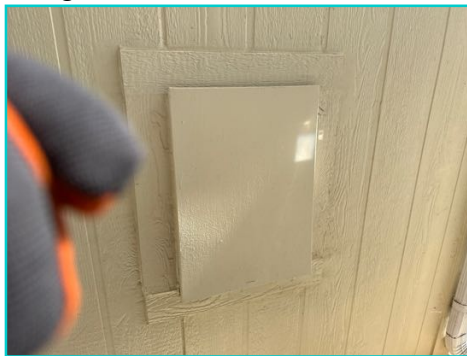
*on right side of the house*

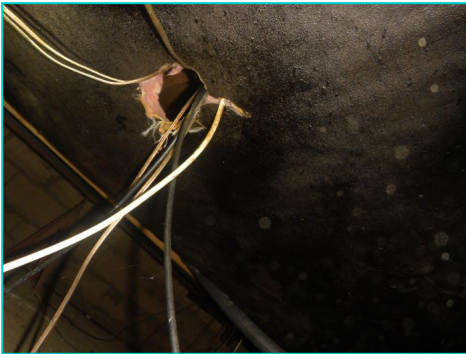
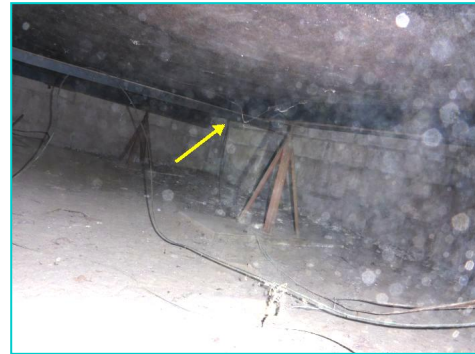
- These wires go from dining room and living room to front of living room.
