**Service:** Full Home Inspection

**Prepared for:** Austin & Jenie Vang

Site Address: **4200 Canyon Crest Road West, San Ramon, CA, 94582**

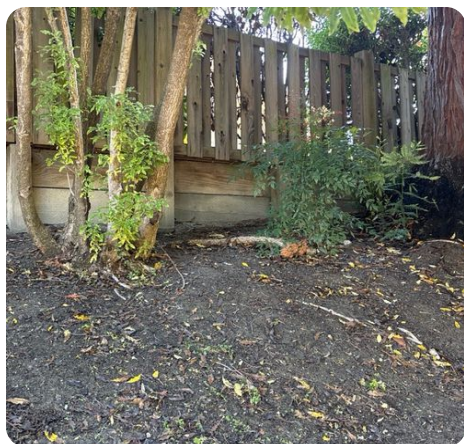
Functional wooden retaining wall at rear property edge.

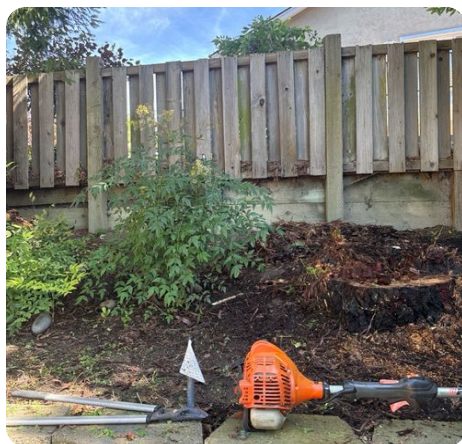
Functional wooden retaining wall at rear property edge.

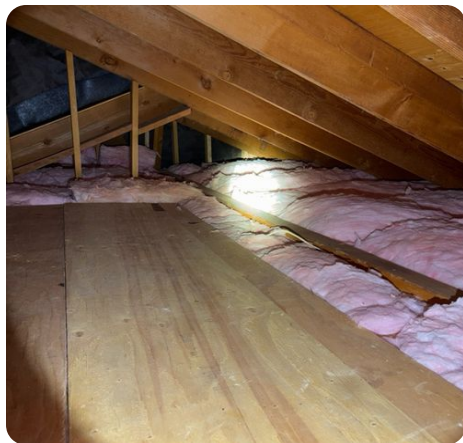
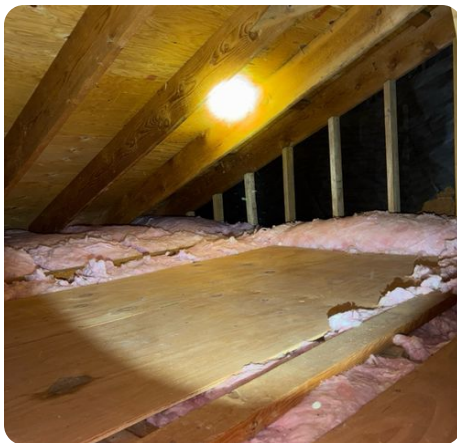
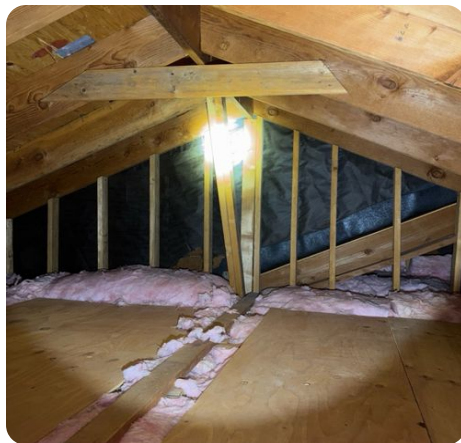
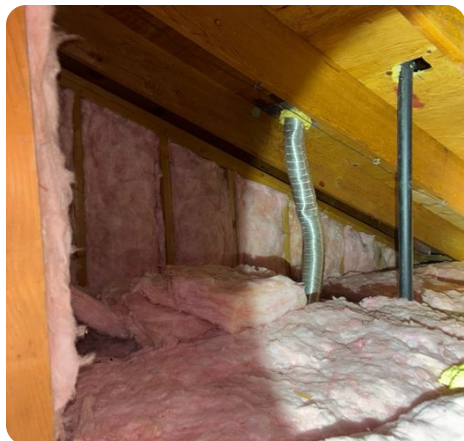
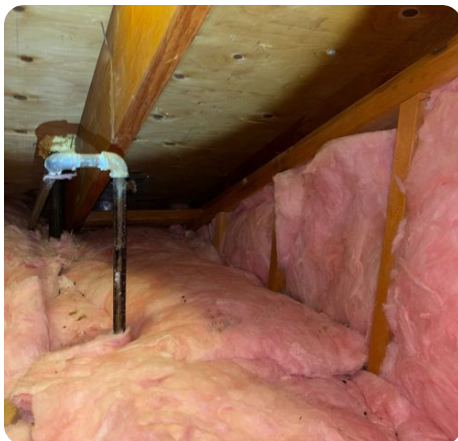
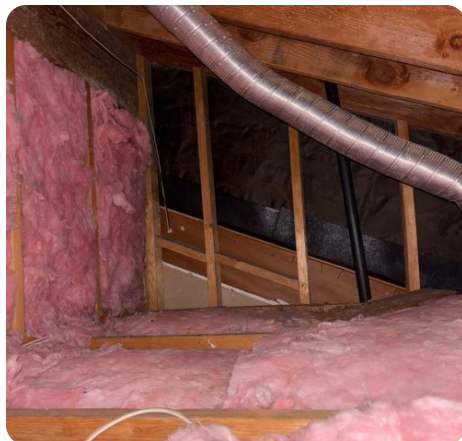
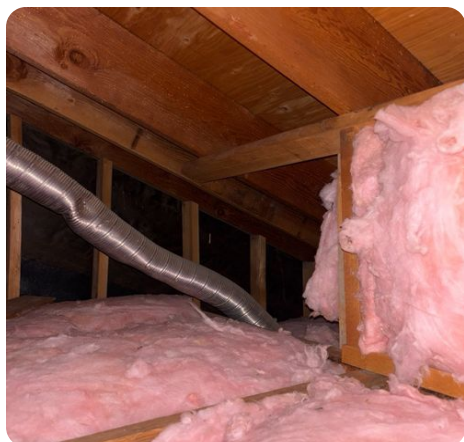
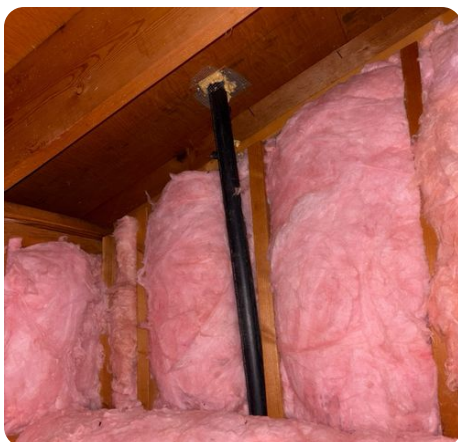
The underside of the visible and accessible areas of the roof system were inspected and found in functional condition.
