# INSPECTION REPORT

For the Property at:  
**714 SUZANNE DR**  
MERCED, CA 95348

RE: Report No. 8956  
714 Suzanne Dr  
Merced, CA  
95348

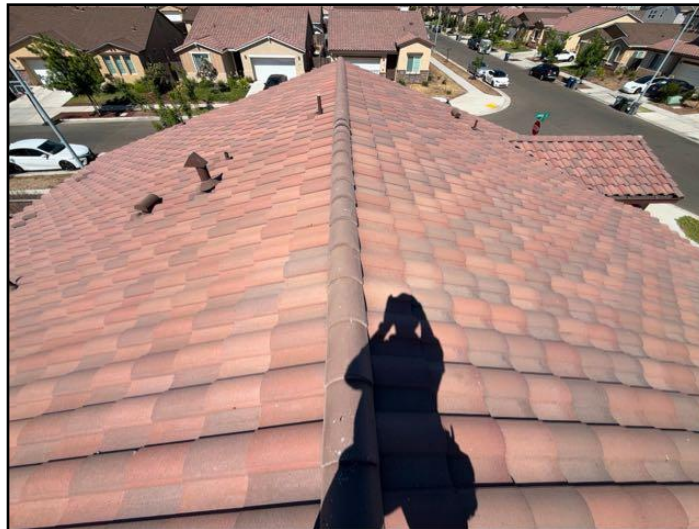
1. Concrete tile

Appears serviceable

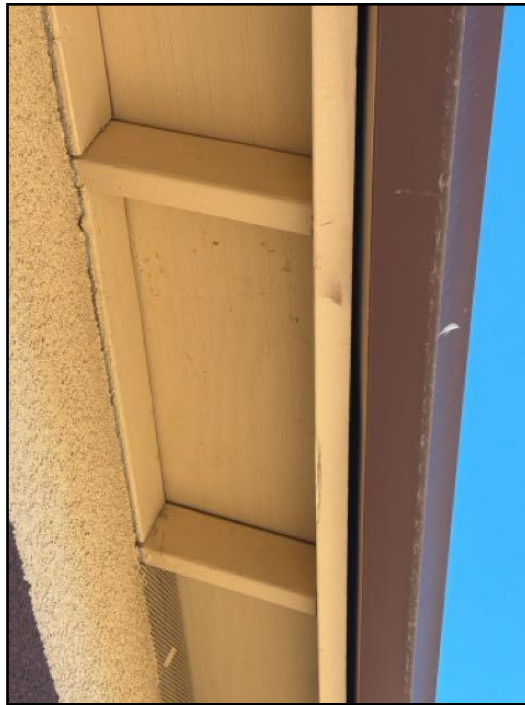
6. Hardboard/Plywood

Appears serviceable

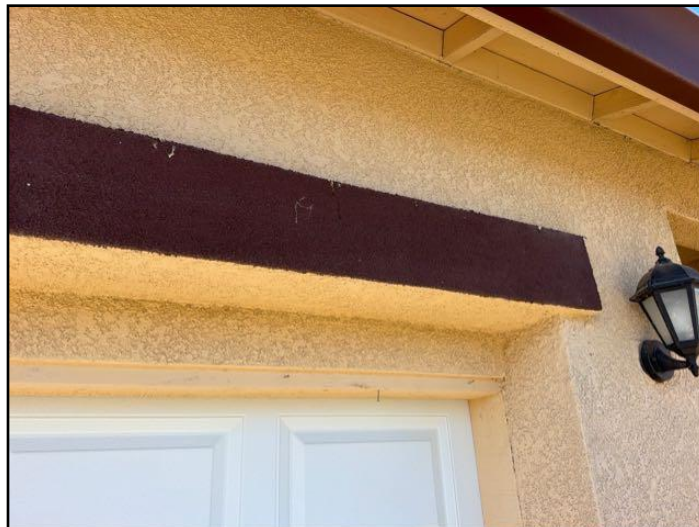
7. Stucco

Appears serviceable

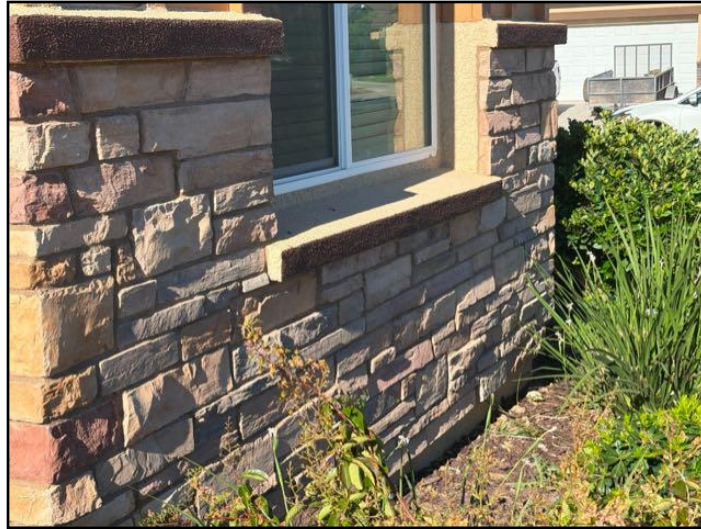
8. Artificial stone

Loose and missing artificial stones. Recommend repairs by a qualified handyman or a licensed contractor.

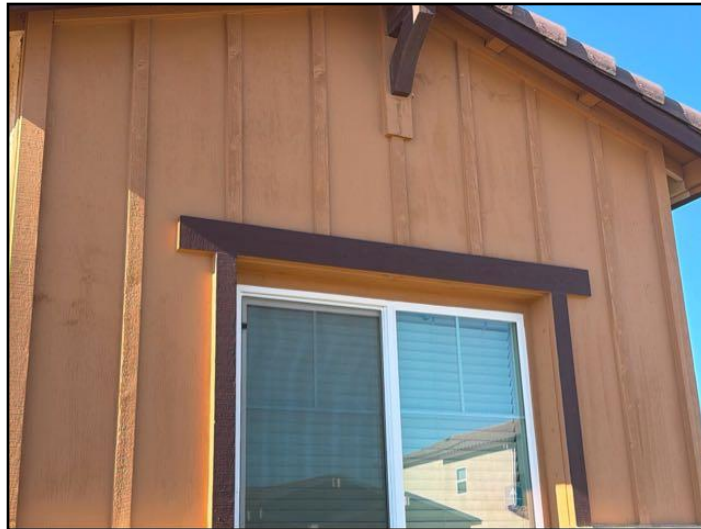
9. Hardboard, plywood or OSB (Oriented Strand...

Appears serviceable

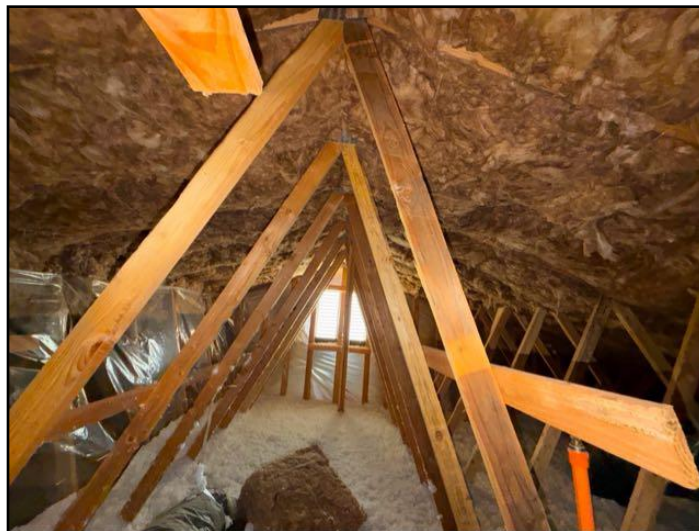
24. Trusses

Appears serviceable

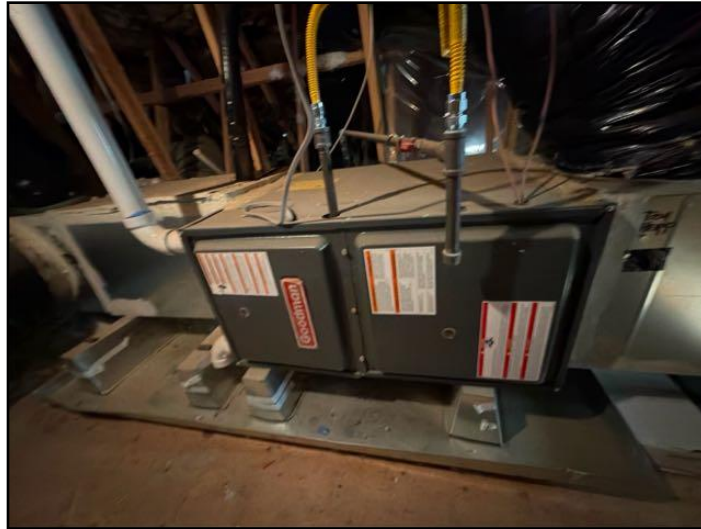
27. Furnace

Appears serviceable

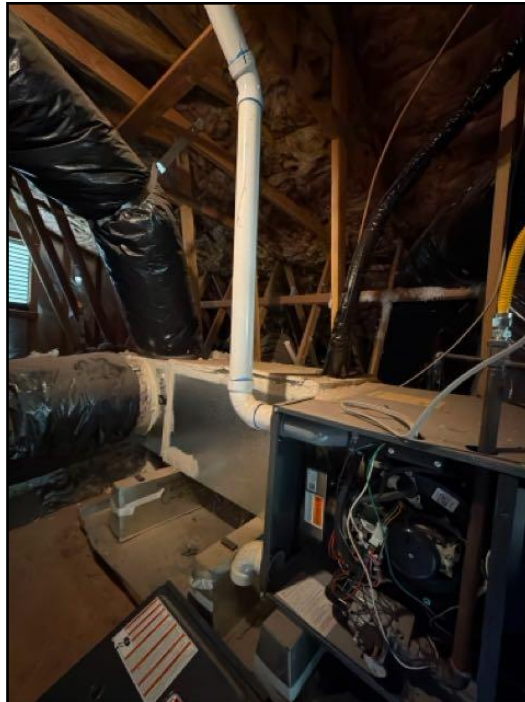
29. Direct vent

Appears serviceable

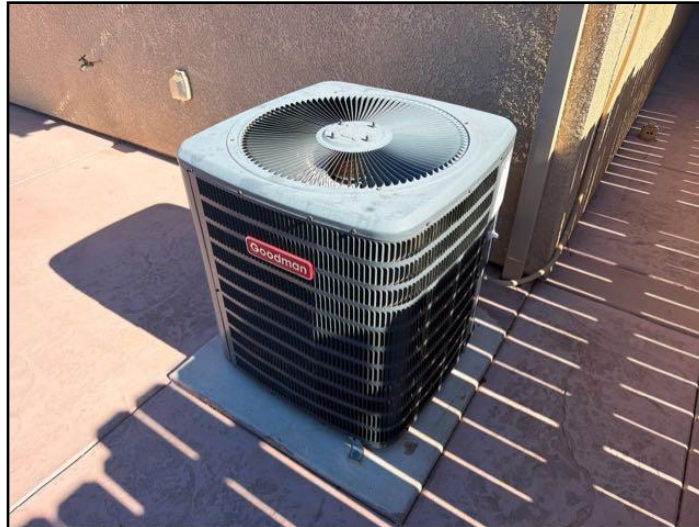
32. Air cooled

Appears serviceable

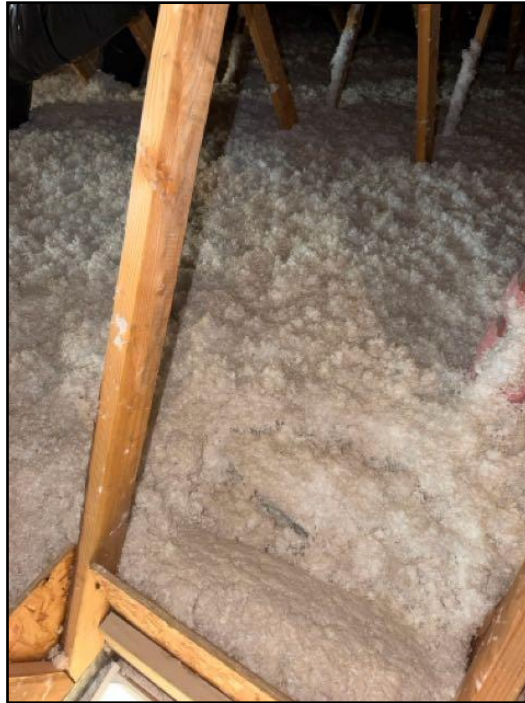
36. Blown-in Fiberglass

- Blown-in Fiberglass  
Appears serviceable

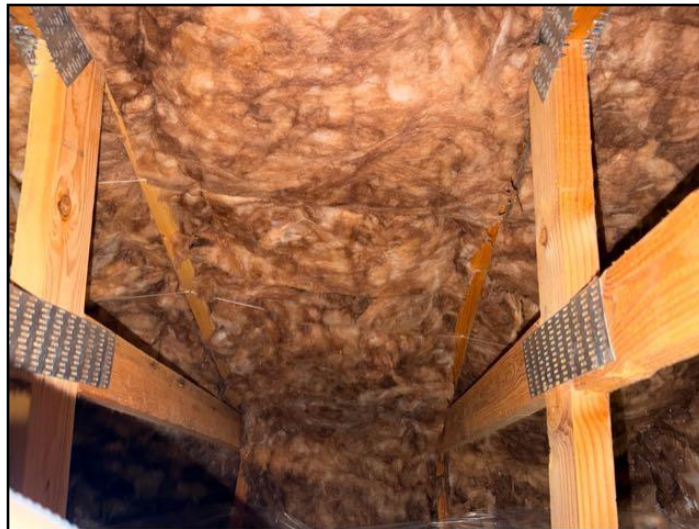
37. Glass fiber

- [Glass fiber](#)  
Appears serviceable

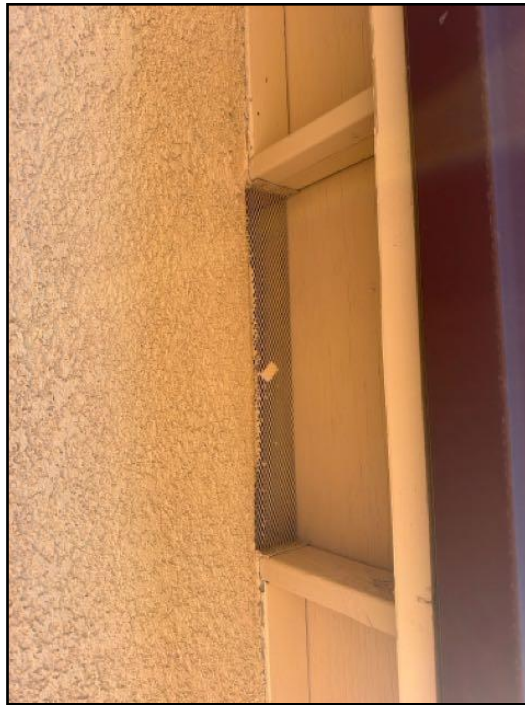
**38.** Soffit vent

Appears serviceable

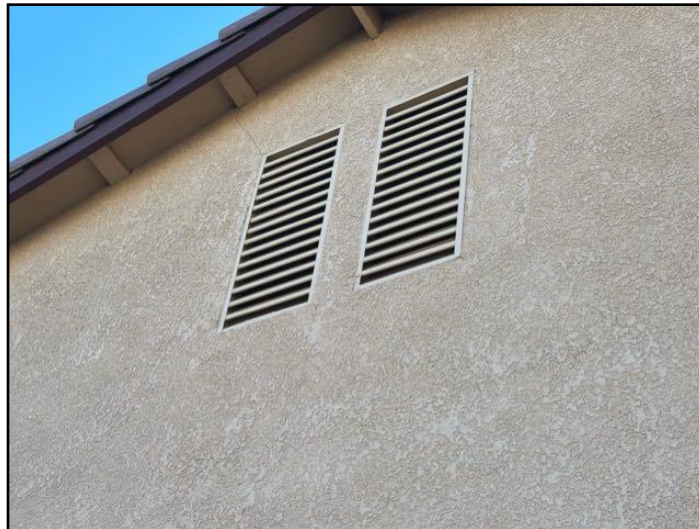
**39.** Gable vent

Appears serviceable

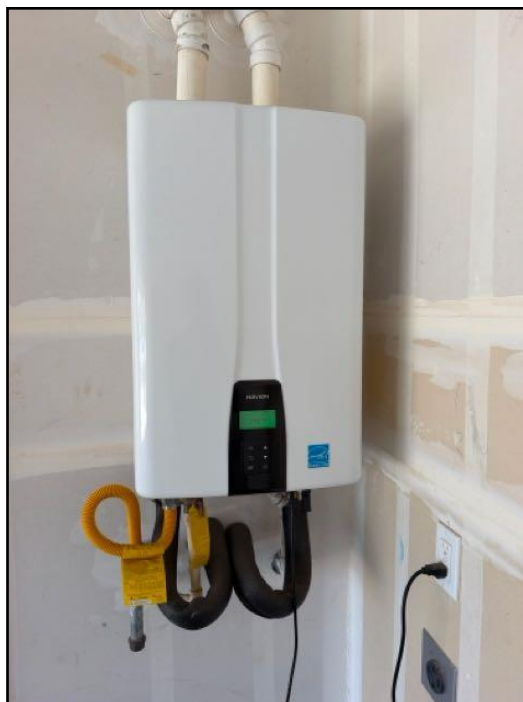
42. Tankless/On demand

- Tankless/On demand
- Appears serviceable

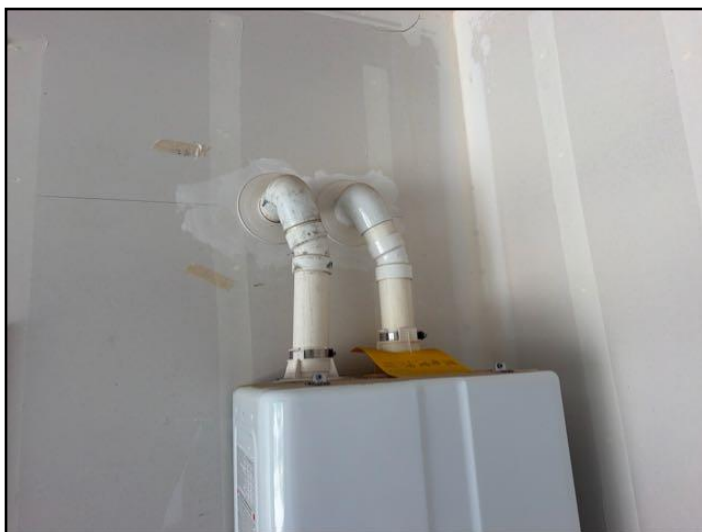
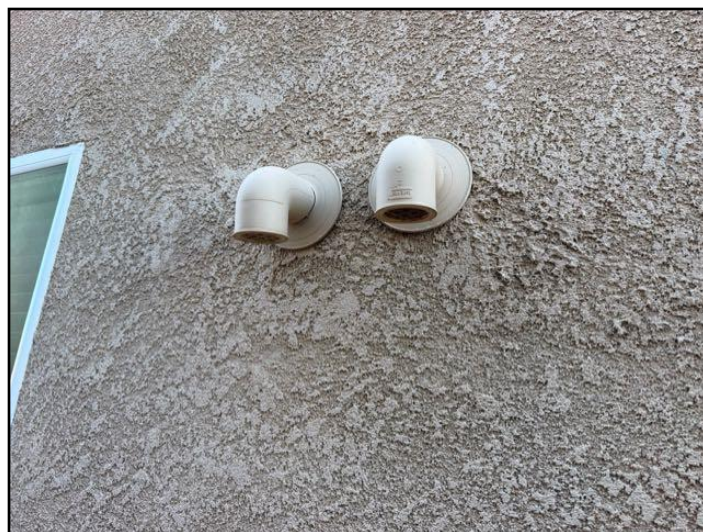
Appears serviceable

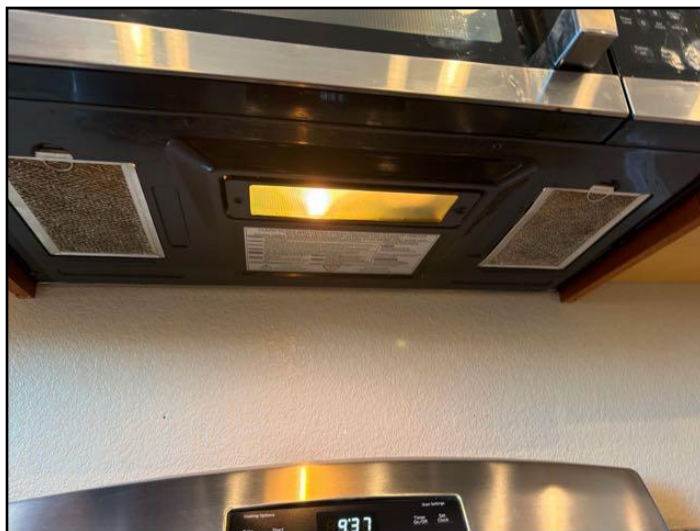
52. Microwave Vent

Appears serviceable

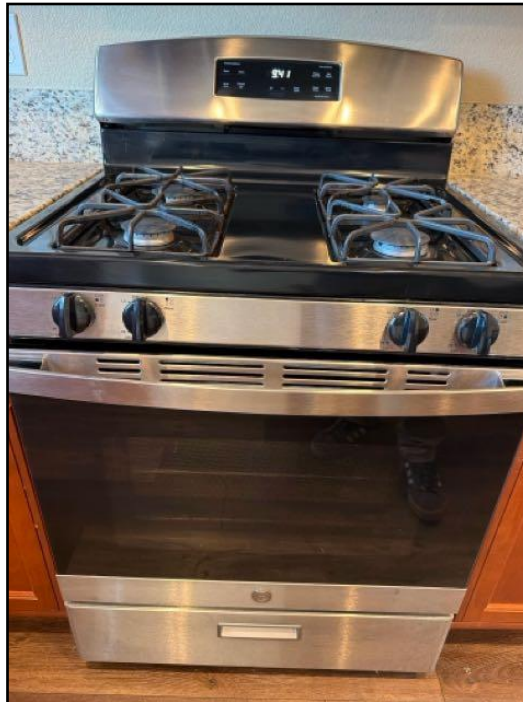
53. GE

- GE
- Appears serviceable
