**ELITE GROUP**  
INSPECTION PROFESSIONALS

PROPERTY LOCATION: 207 W Buffalo Ave Santa Ana, CA 92706

# INSPECTIONREPORT

Date of Inspection: 7/31/2026 at 10:00 AM

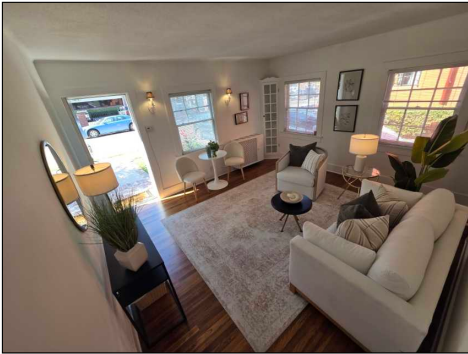
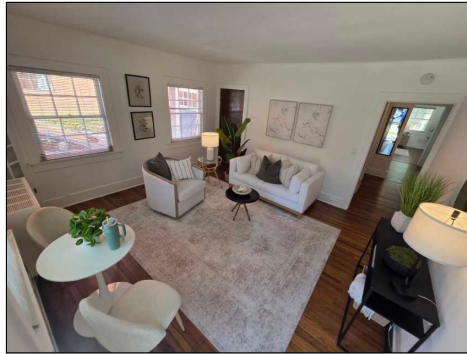
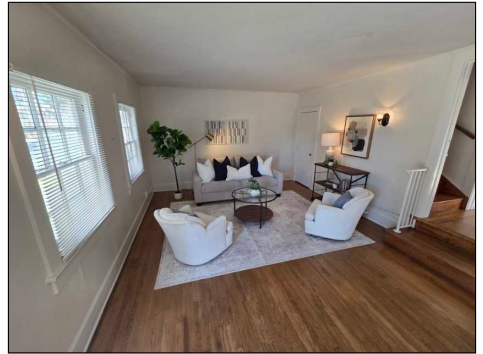
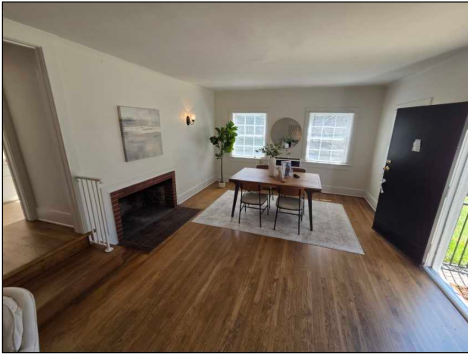
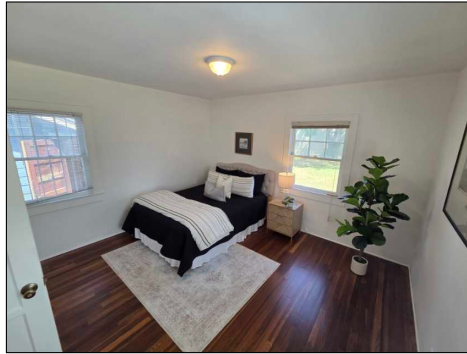
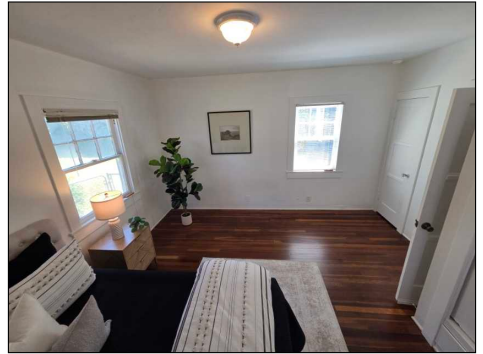
- Some areas not accessible/visible due to access limitations/personal items
- No major visible defects at the time of the inspection
- Walls are worn with cosmetic blemishes - typical for the age

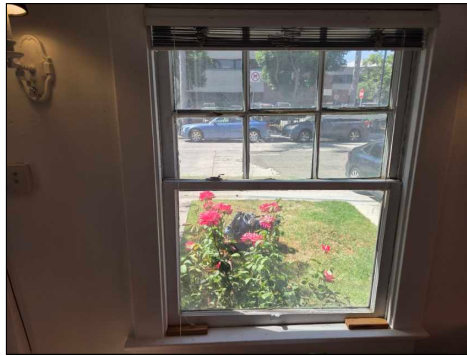
**Older single pane windows present in areas**

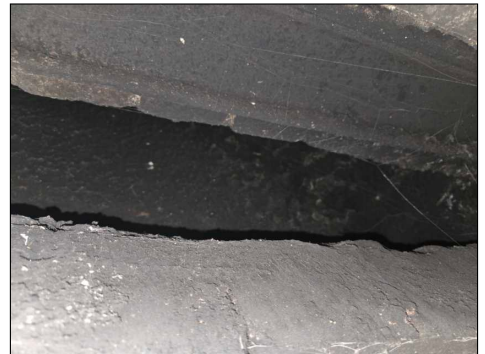
**No damper door - typical for age or type of system**

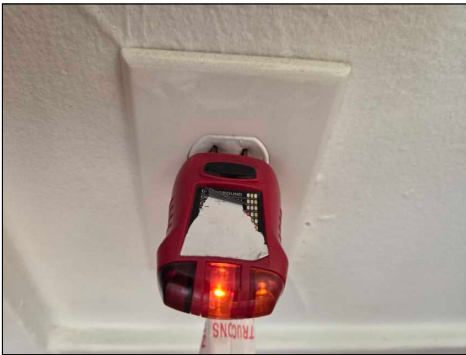
- A representative number of receptacles were tested
- Outlets/switches/fixtures had normal wear for age of the materials
- Ungrounded outlets present - needs to be serviced

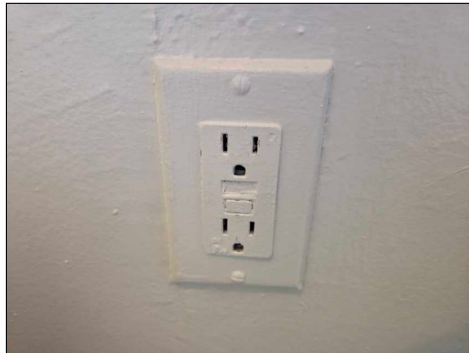
**GFCI tripped but would not reset - needs to be serviced @ 207**

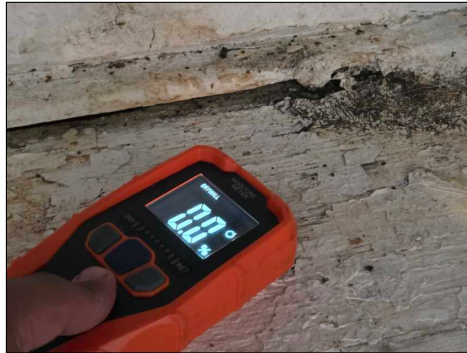
**Stained areas below sink - dry at time of inspection**

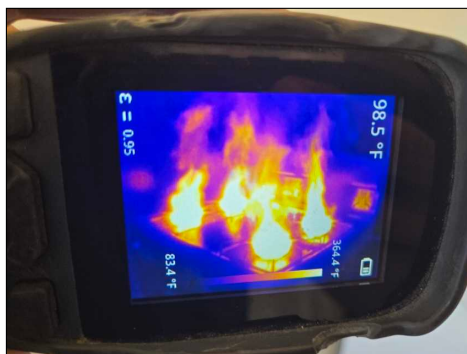
Range/stove tested and operated

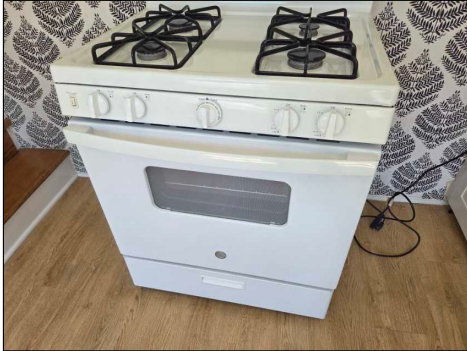
Oven tested and operated

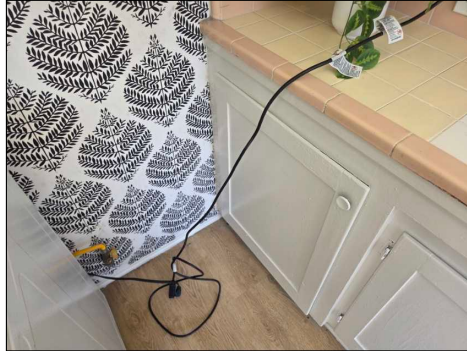
Unit runs on extension cord - may be problematic

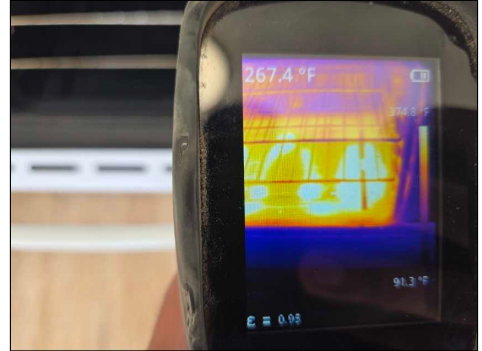
Oven temperature = 350°+

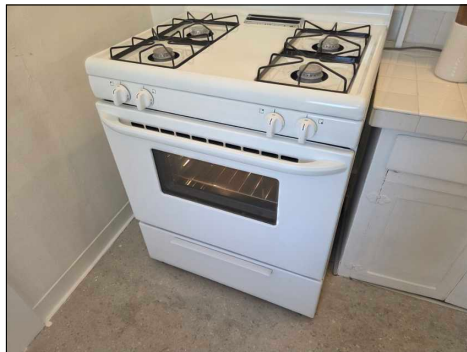
**Not operating - not reaching desired temperatures - gas smell detected when running fixture - needs to be serviced @ 207½**

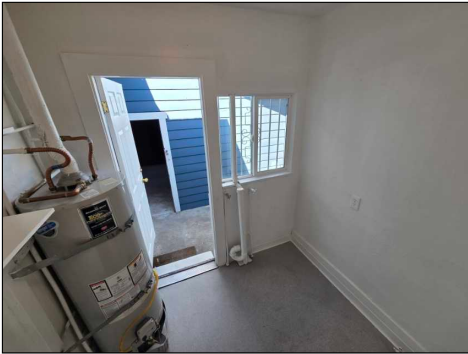
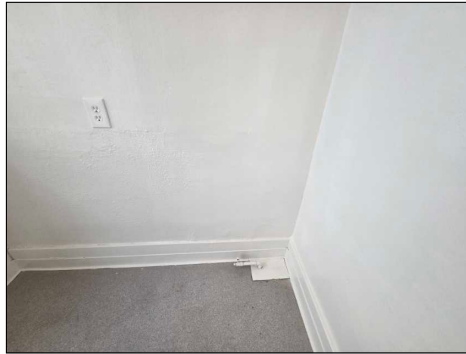
- No major visible defects observed at the time of the inspection
- Visible areas of the vent have normal wear
- No dryer vent installed- needs to be serviced @ 207½

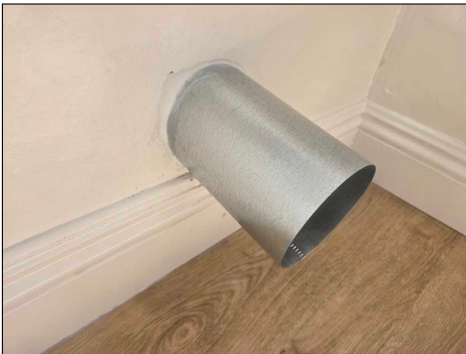
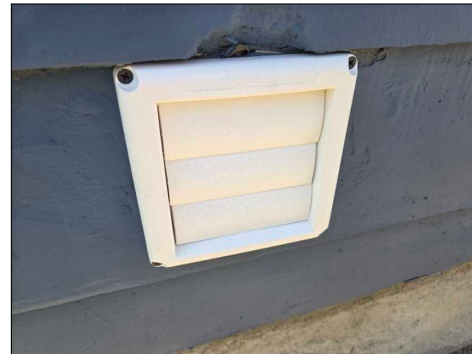
**No dryer vent installed- needs to be serviced @ 207½**

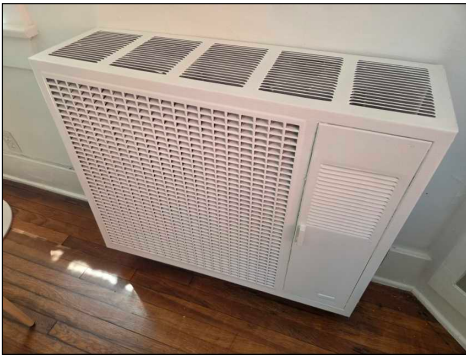
- Worn/older furnace present - unit appears to be nearing the end of its expected useful life
- **Thermostat not operating - unit not tested - needs to be serviced**

**Thermostat not operating - unit not tested - needs to be serviced @ 207½**      **Thermostat not operating - unit not tested - needs to be serviced @ 207**

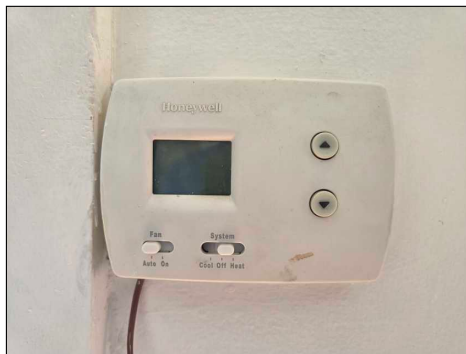
- **Not operating - needs to be serviced**

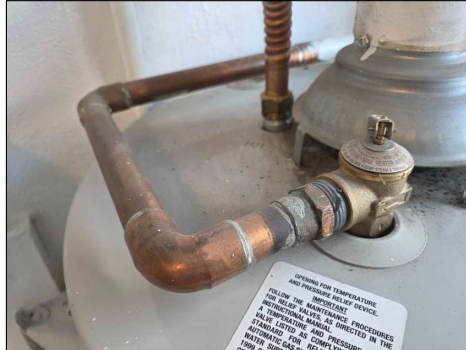
- Temperature was above 120° F at the unit, this a potential scald hazard - needs to be serviced/adjusted

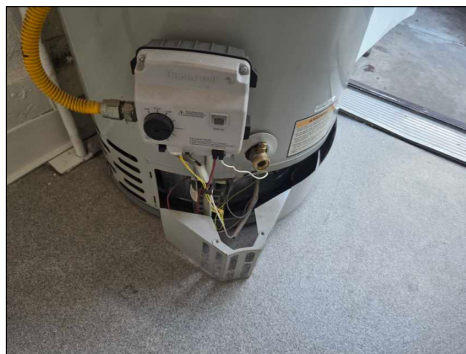
- No catch pan and drain: unit is installed over finished living space - recommend installing pan and drain accordingly

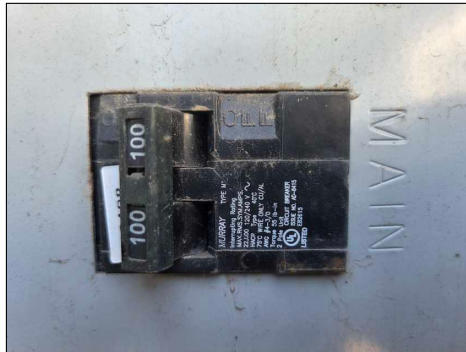
100amp

- 100 amp - while common for many structures, this may be considered low capacity for today's electrical uses - consider upgrading services

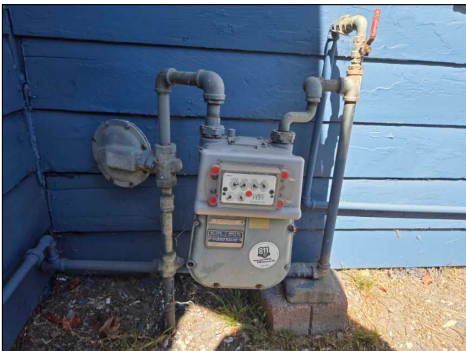
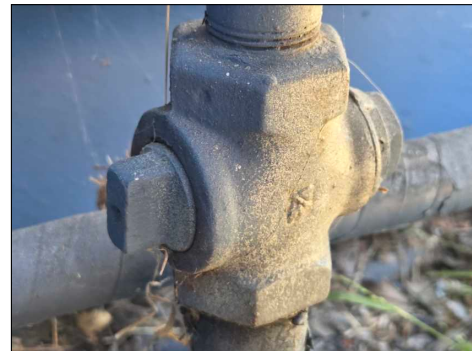
- Natural gas present
- Valve has normal wear for the age of the materials
- Recommend gas valve wrench be placed near valve for optimal preparedness
- No seismic safety valve present - recommend installation for increased safety

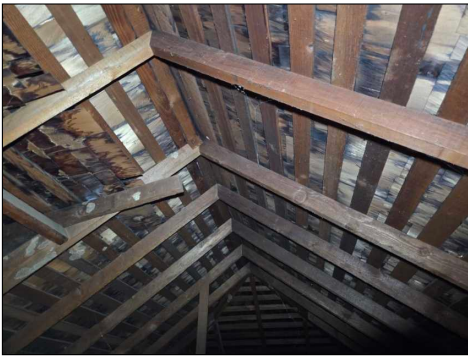
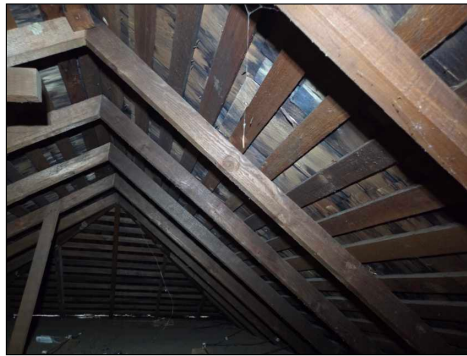
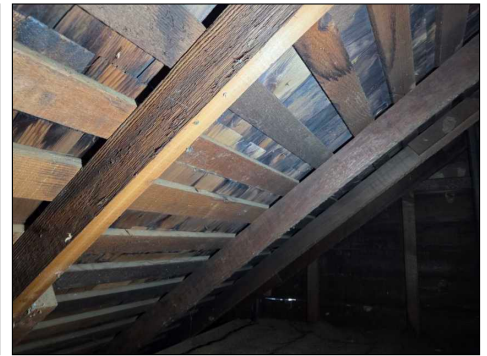
- **Consult termite report** for all wood areas in the attic
- Conventional framing present with worn/weathered materials - consult the termite report regarding the condition of wood members
- Cracking small at wood members - typical for age
- Visible daylight can be seen in areas - recommend sealing all holes/gaps
- Limited attic inspection - many areas are not accessible to to limited space, lack of proper walk boards, electrical, plumbing, ductwork, etc.
- **No visible roof sheathing at rafters - this is an irregular roofing installation**

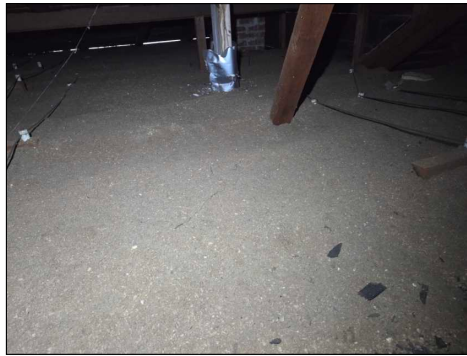
- Visible insulation is worn/older/dirty - this structure would benefit from new insulation
- Inadequate insulation observed - this structure would benefit from new insulation - recommend servicing
- The inspector does not determine R-value of the insulation
- Insulation generally blocks visible inspection access to framing below level of insulation

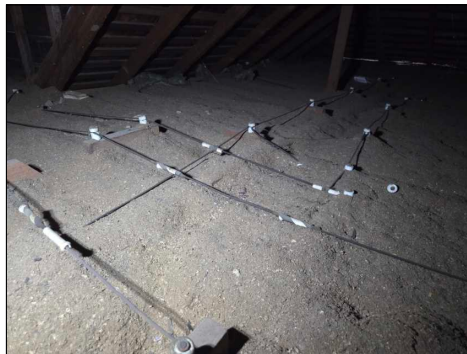
- Live knob and tube wiring present - this type of wiring is considered old technology and should be upgraded as soon as possible

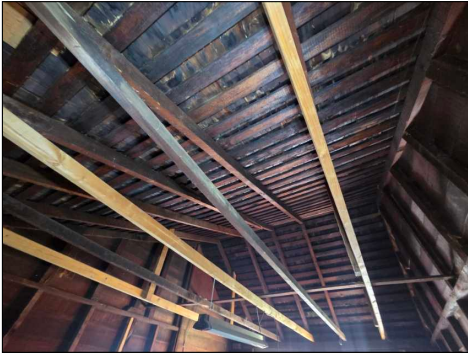
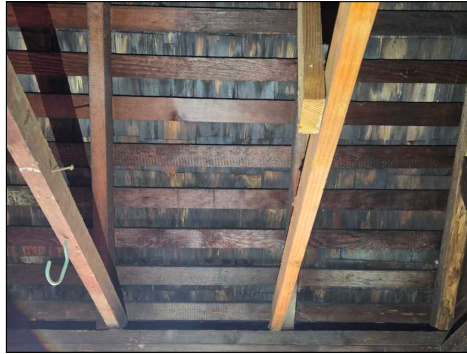
- Exposed wood rafters/joists - consult termite report for all wood
- Worn/stained/deteriorated wood members - needs to be serviced/further evaluated - consult the termite report
- New lumber/patched areas - consult seller for past repairs
- **Deteriorated wood members - needs to be serviced**

**Deteriorated wood members - needs to be serviced**

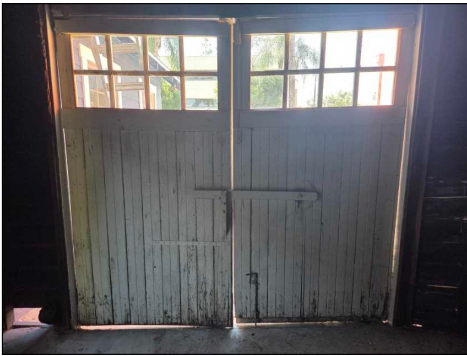
- **Deteriorated wood present - needs to be serviced - consult termite report**

Deteriorated wood present - needs to be serviced

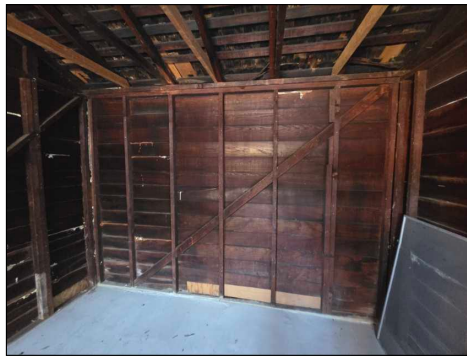
- **Consult termite report for any wood areas in garage**
- Walls are in a worn/older condition - we recommend maintenance/patching as needed
- Consult termite report for all exposed wood members in the garage
- **Worn/stained/distressed wood members - older materials**

Worn/stained/distressed wood members - older materials

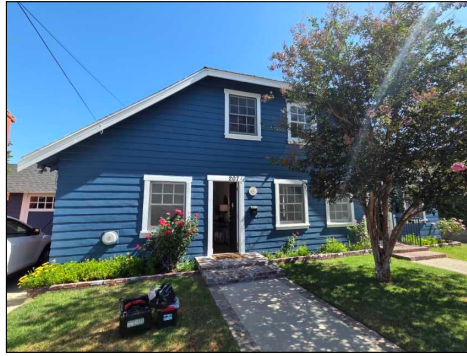
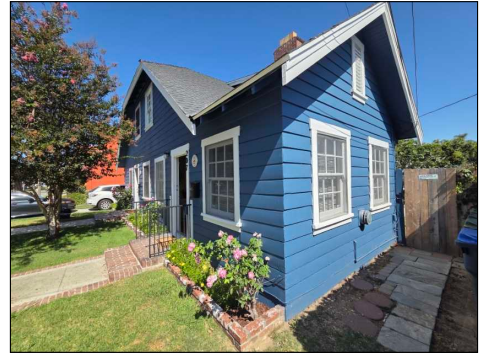
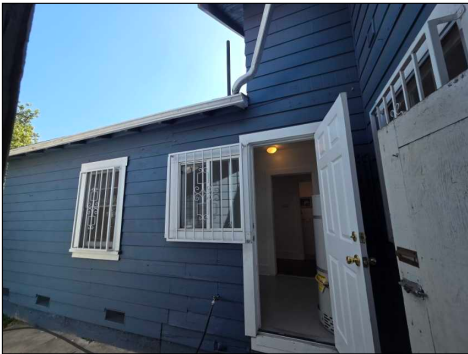
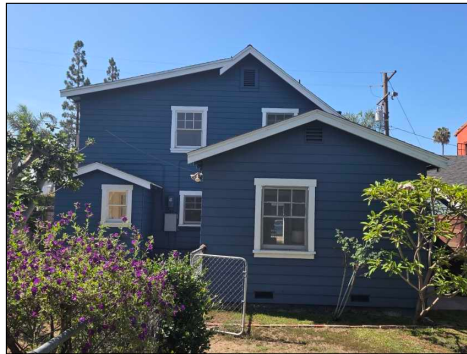
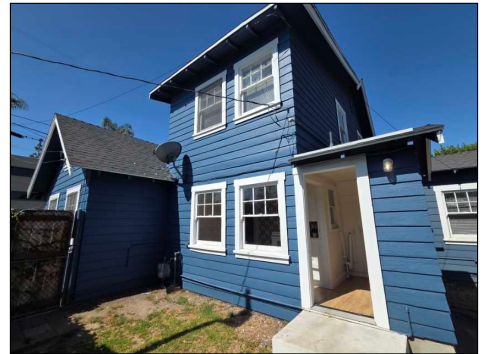
- Consult termite report for all exterior wood
- Older siding present - materials appear to be near the end of their useful
- **Worn/older materials - we recommend siding maintenance**

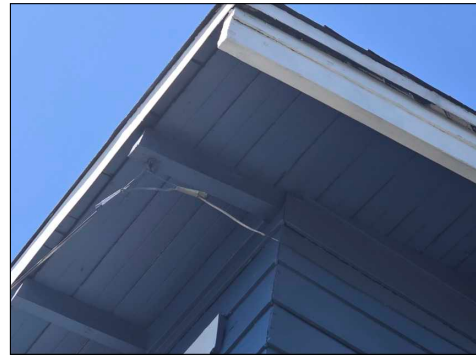
- Consult termite report for all wood areas at the structure
- Note: exposed exterior wood will require seasonal maintenance and paint
- Wood members are weathered/peeling/cracking - indicative of age/weather exposure
- **Deteriorated wood - recommend evaluation by termite inspector**

**Deteriorated wood - recommend evaluation by termite inspector**

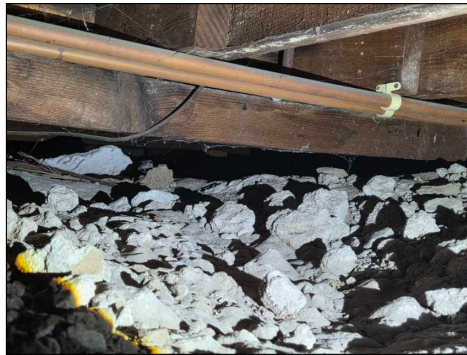
Debris/soil obstructing access in areas - confined areas in crawl space - very limited access

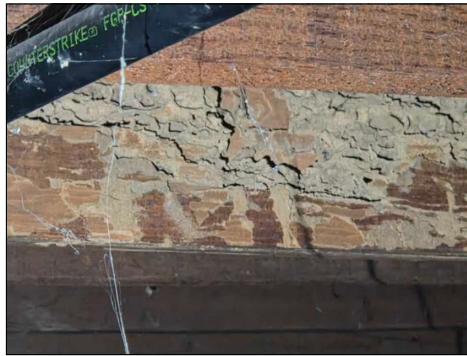
- Consult the termite report for all wood areas in the crawl space
- Wood is worn and stained in areas where visible
- Deteriorated wood observed - consult the termite report for all wood deterioration/moisture damage under structure
- Structure inspection limited due to access hindrances such as insulation/ductwork/pipes/wires - some areas of the sub floor are not visible or inspected
- Some areas of the sub floor are not visible or inspected
- **Heavily deteriorated joist in areas - needs to be serviced/further evaluated by a specialist**

**Heavily deteriorated joist in areas - needs to be serviced/further evaluated by a specialist**

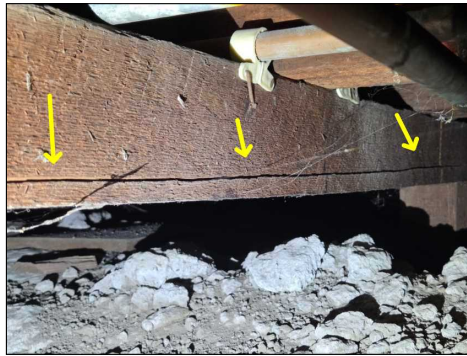
**Cracked/sagging girder - needs to be serviced**

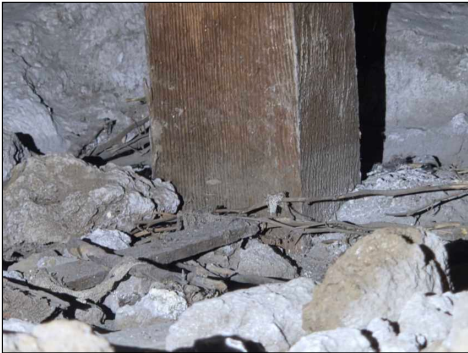
**Posts in contact with soil - needs to be serviced - consult the termite report**

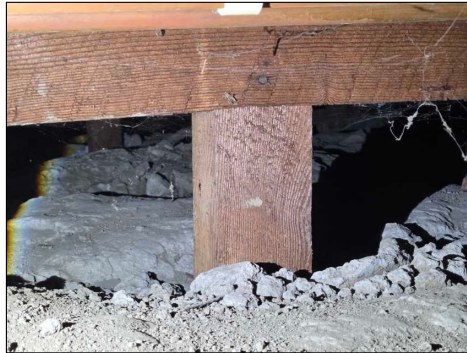
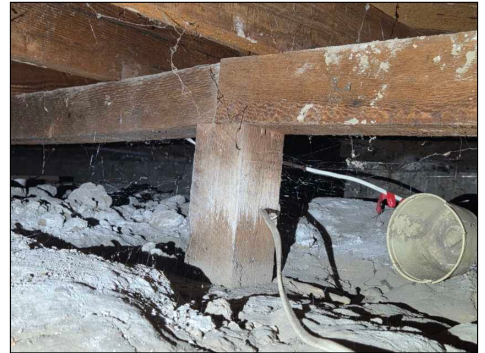
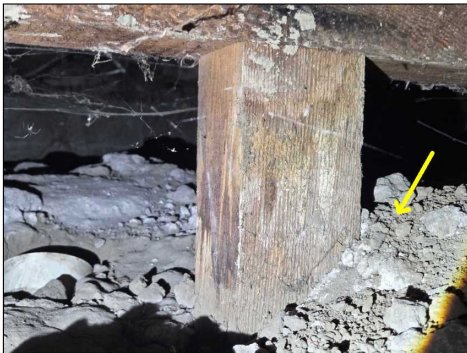
**Posts in contact with soil - needs to be serviced - consult the termite report**

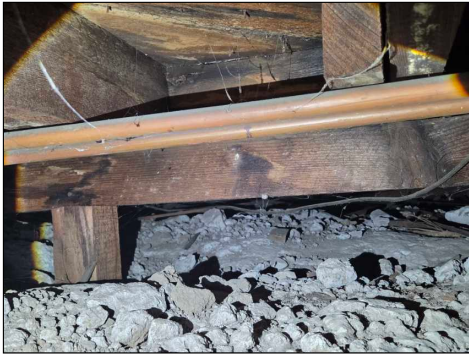
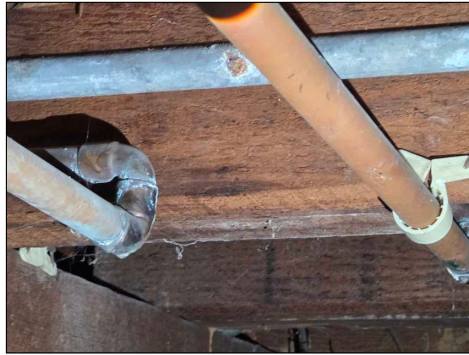
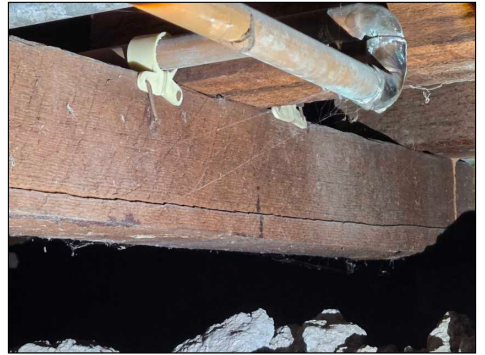
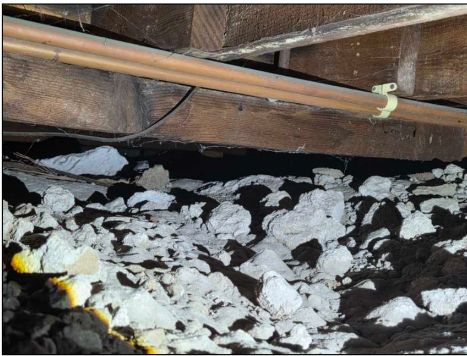
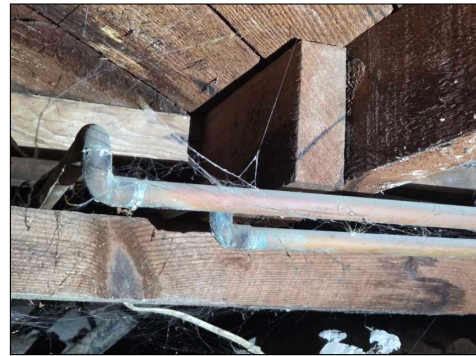
- Distribution line appears to have been upgraded - **check permits** to ensure that proper workmanship was done in accordance with local building codes
- Copper piping present with normal wear - no major visible defects at the time of the inspection
- Drain line not visible/accessible

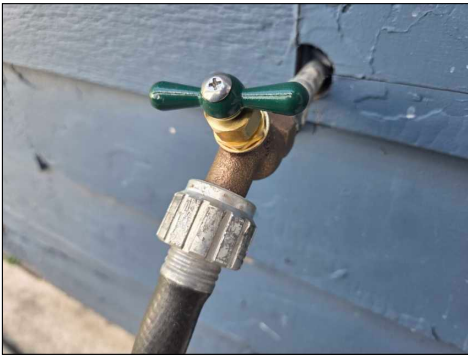
Hose bibb(s) tested and operated

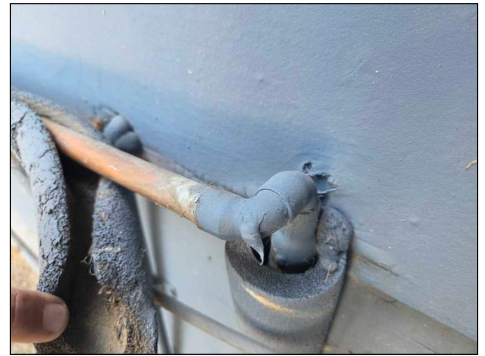
Exterior plumbing is present and not original to the structure - check all installation permits to ensure installation to building code

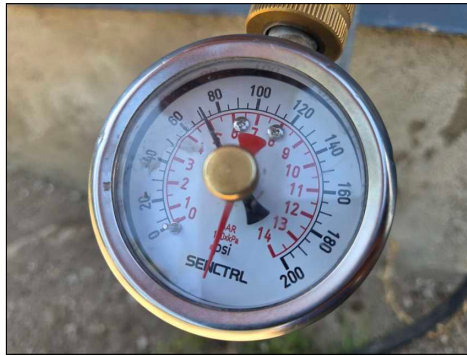
- Recommended water pressure is between 55 to 80 pounds per square inch (psi)
- Water Pressure can fluctuate depending upon time of day and municipal service adjustments
- Approximate pounds per square inch: 60

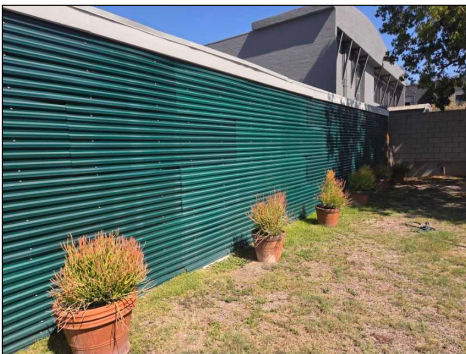
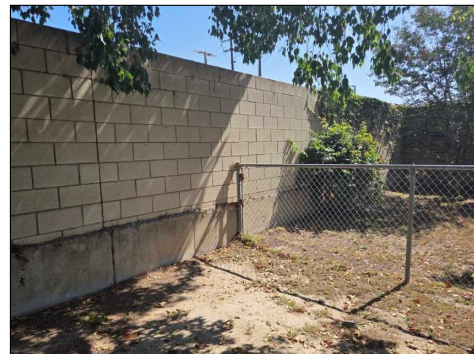
- No major visible defects observed at the time of the inspection
- Fencing/walls have normal wear for the age of the materials

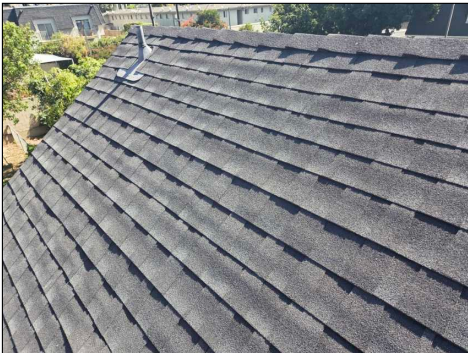
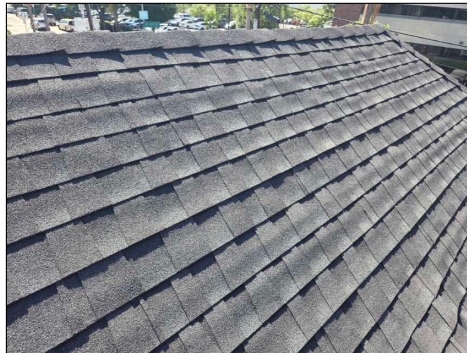
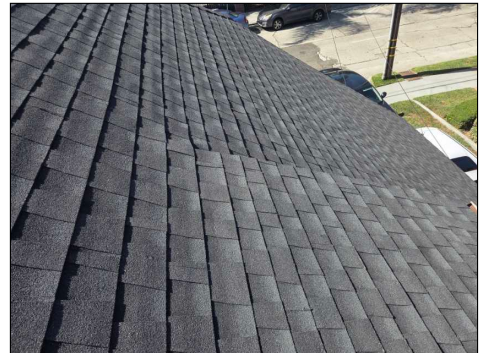
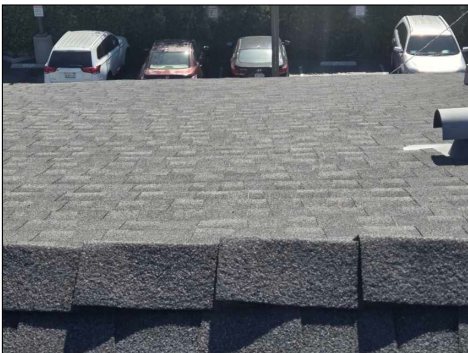
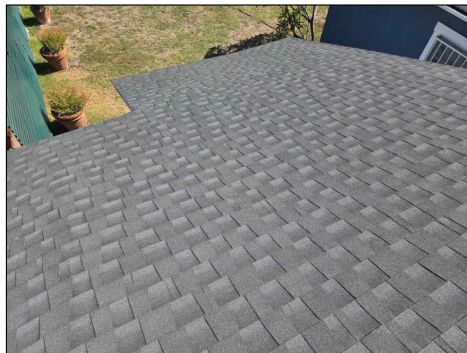
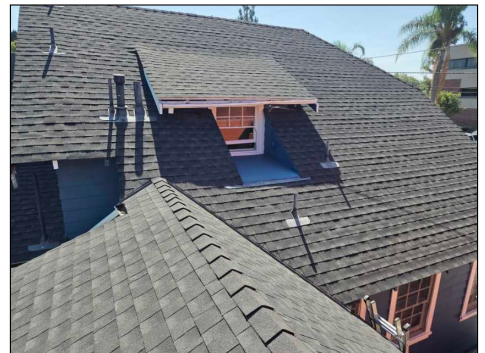
- No major visible defects found at the time of the inspection
- Visible materials show signs of normal wear for the age of the materials - we recommend continued seasonal maintenance to extend the life of the roof

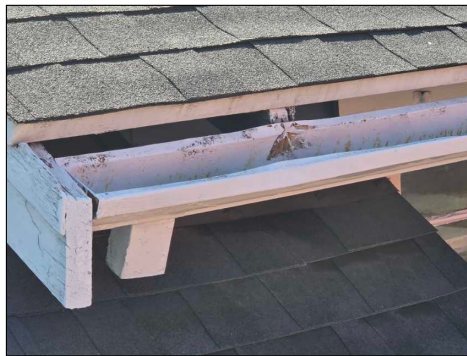
- Partial gutter systems in areas – recommend gutters on all feasible sides of structure to help divert water away from the structure
- Bent/dented gutter areas - recommend maintenance and repair as needed

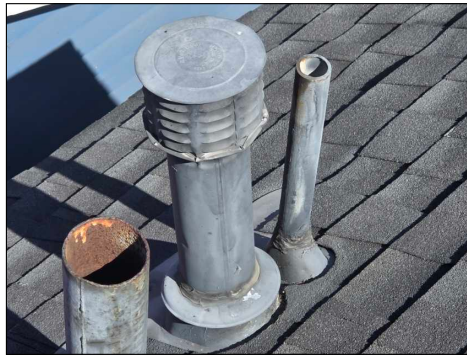
- No major visible defects found at the time of the inspection
- Normal wear at the time of the inspection

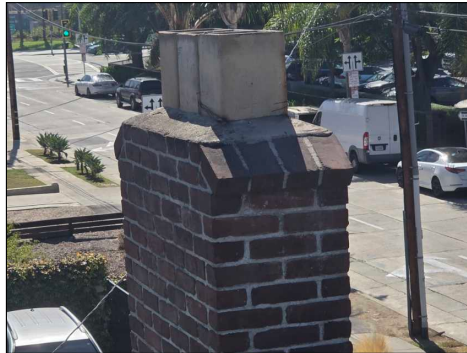
- Couldn't fully access - limited visual inspection
- No major visible defects found at the time of the inspection
- Chimney is worn/weathered – typical for the age

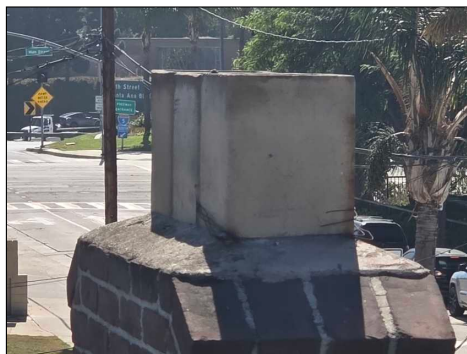
- No spark arrestor/rain cap present - recommend installation
