# ***Cornerstone Inspection***

## **Property Inspection Report**

***9040 Caleta Ln, 93422, Atascadero, CA 93422***  
***Inspection prepared for: Chris Cucchiara***  
***Real Estate Agent: Chris Cucchiara - Keller Williams***

***Date of Inspection: 8/26/2026 Time: 9:00 AM***

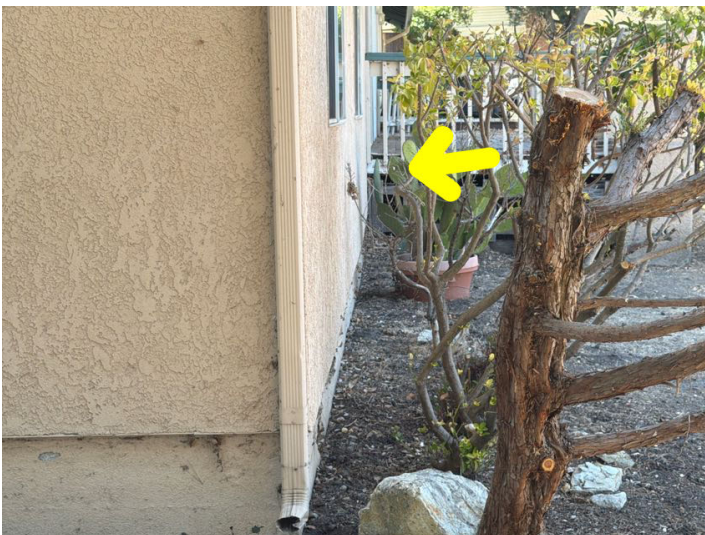
Vines, shrubs or bushes are growing on the house walls and although they are attractive they can introduce pests and rodents and accelerate deterioration. Therefore, you may wish to consider having them removed or cut back to 12 inches (30 cm) away from the home.

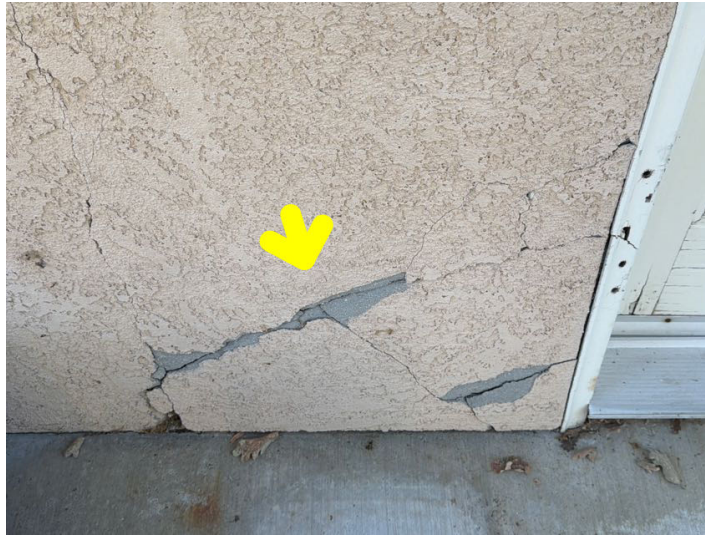
The siding needs typical maintenance, such as sealing and painting. This should include caulking and filling gaps or openings such as small cracks or openings at hose bibs, and sealing with a proper primer-sealer, then one or two finish coats.

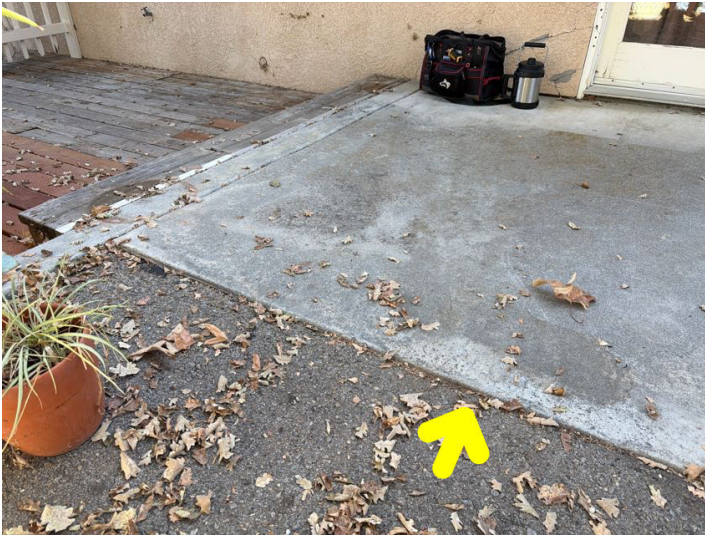
There are one or more offsets in the driveway that could prove to be trip-hazards.

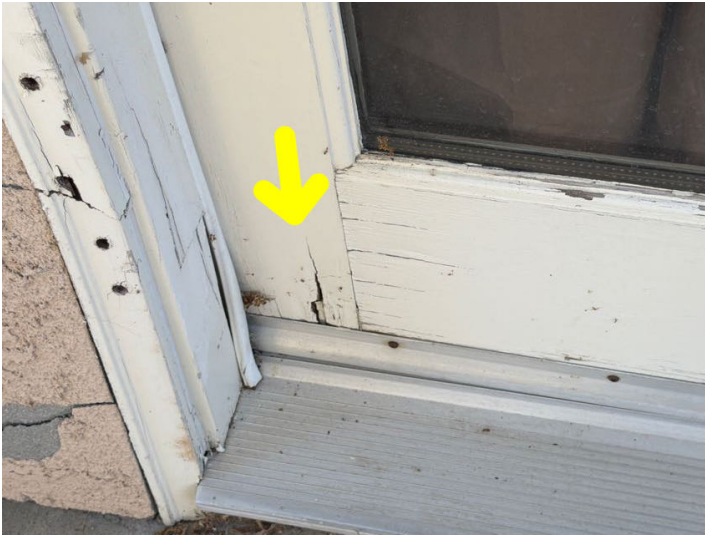
Damage was noted to the exterior door. There are many sizes and styles of exterior doors, many are no longer available and an exact match may not be possible. Refer to the pest report for further clarification.

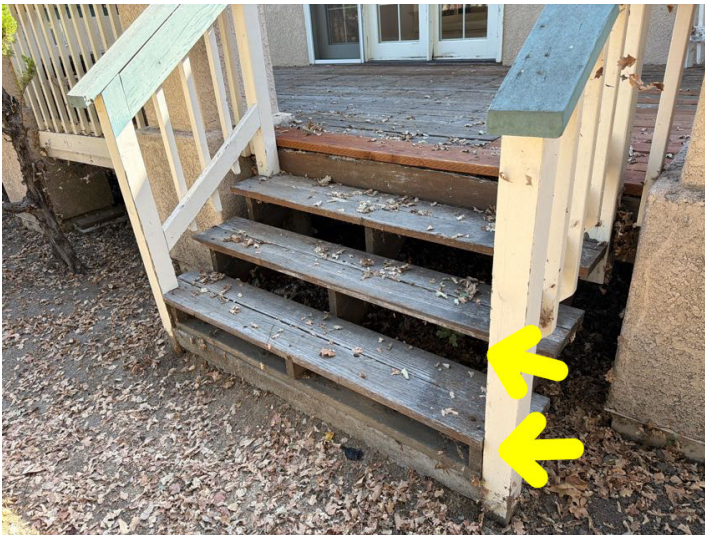
One or more steps have unequal treads or risers. Steps are required to be uniform to prevent trip-hazards. The rise of any step should be no less than four inches and no greater than seven and three-quarter inches, and the run should be no less than eleven inches. Also, the dimensions of the largest step should not exceed that of the smallest by more than three-eighths of an inch.

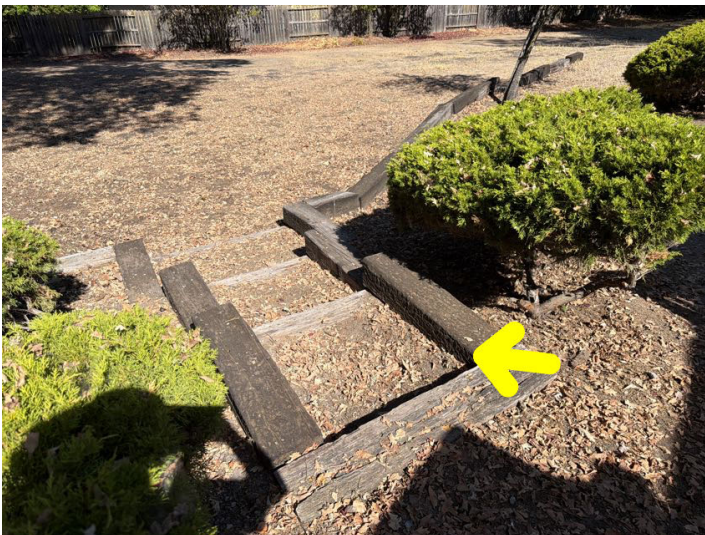
The railroad tie, wooden post, or natural stone steps are landscape components and would not conform to common standards requiring certain dimensions, handrails, guardrails, etcetera.

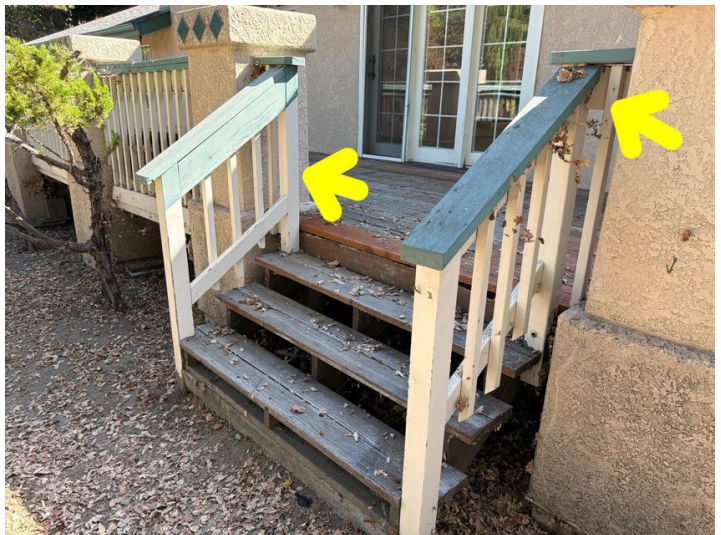
One or more handrails are not secure and should be serviced for optimal safety.

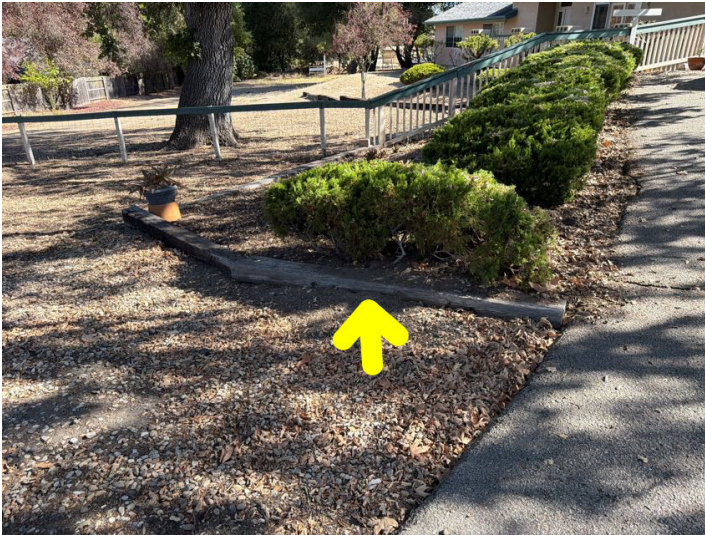
The railroad-tie or wooden yard walls, though functional, have no structural value as retaining walls and will need to be periodically monitored for movement.

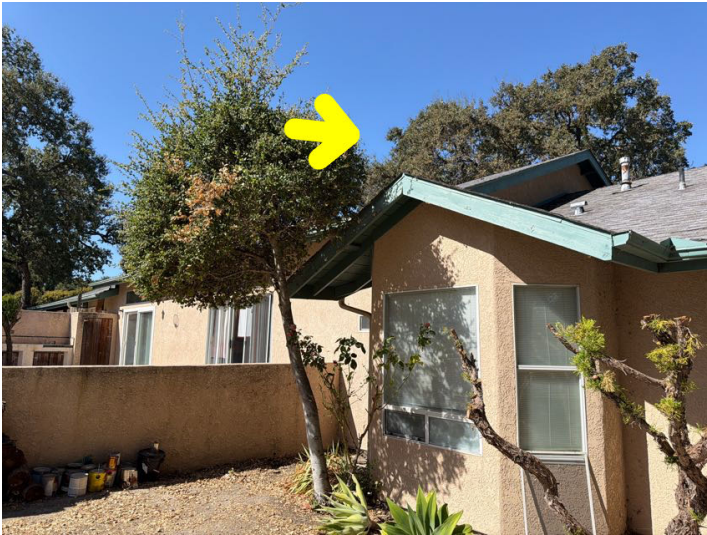
There are tree limbs over growing the residence that should be trimmed or monitored to ensure that they do not impact or damage the roof or its components.

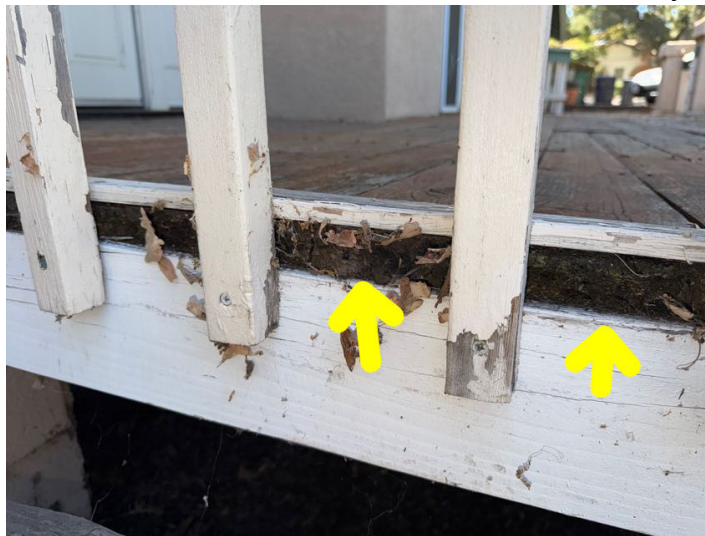
There is damage to one or more decks that should be evaluated by the pest inspector.

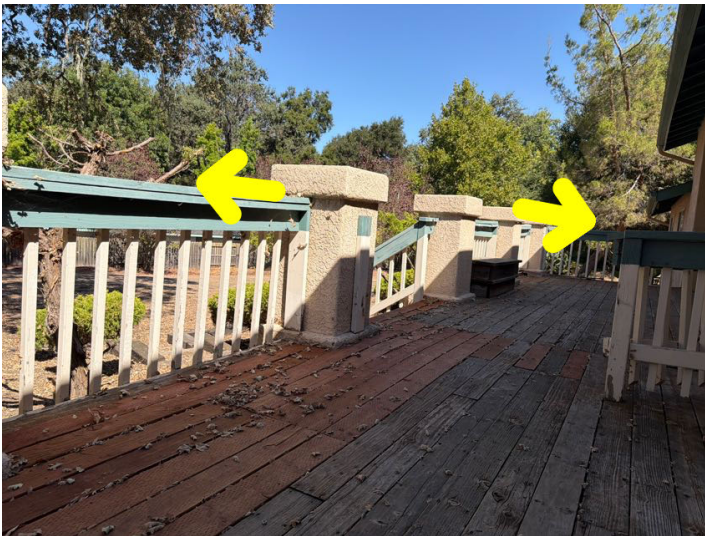
One or more guardrails do not conform to common safety standards. Common safety standards require them to be a minimum of 42 inches high when the standing surface is 30 inches or more above grade. Also, guardrail pickets should be no more than 4 inches apart for child safety.

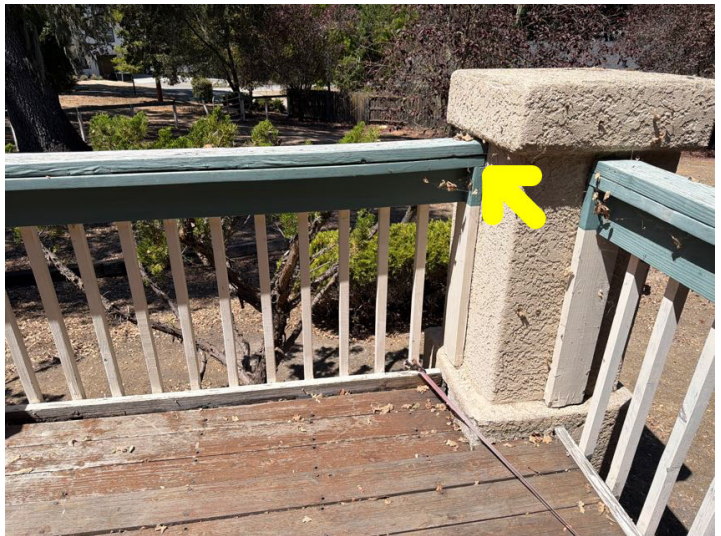
One or more guardrails are not secure, and should be serviced by a qualified specialist.

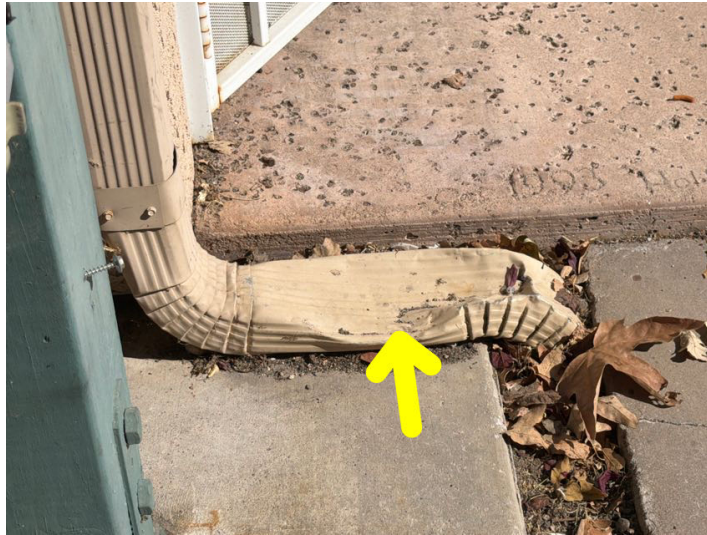
A downspout is physically restricted where the water exits and should be fully opened to prevent debris from backing up the gutter system.

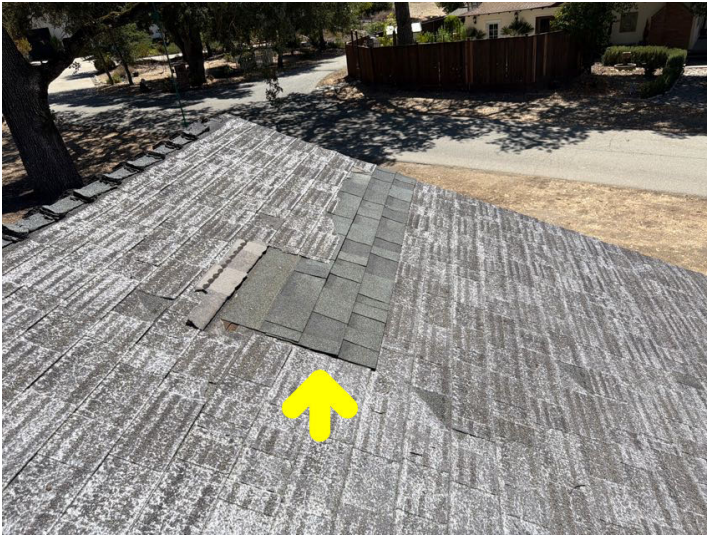
We observed repairs done to the roof. You should have the sellers disclose the reason that the repairs were completed, as well as any documentation of any warranty or guarantee from the roofer.

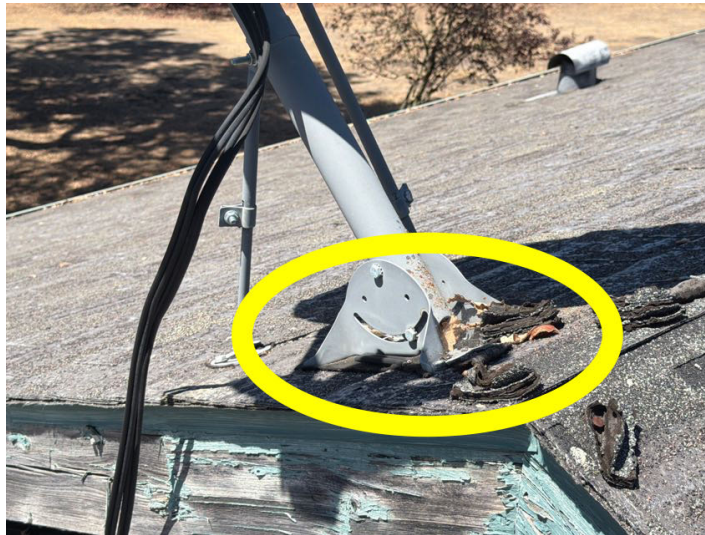
There is/was a satellite dish that was installed on the roof without flashing, and the area will need to be sealed regularly to prevent moisture from entering during rains.

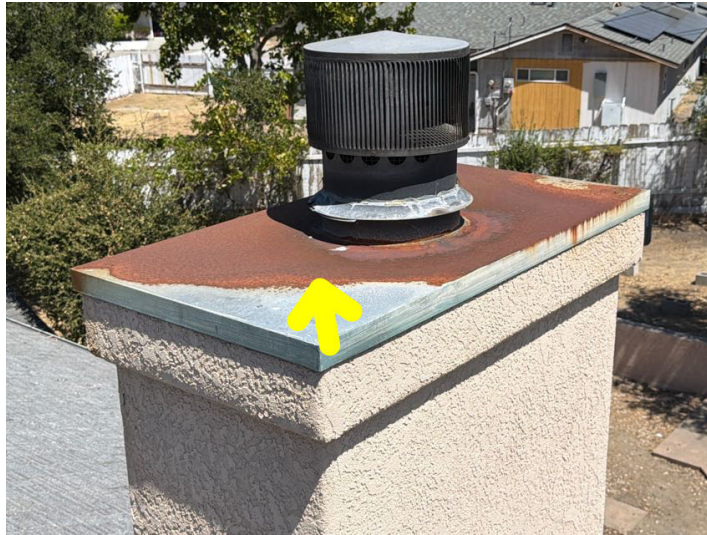
The sheet metal chase cover, which is designed to seal the chimney wall and shed rainwater, is damaged, deteriorated, or rusted and should be serviced by a certified fireplace specialist.

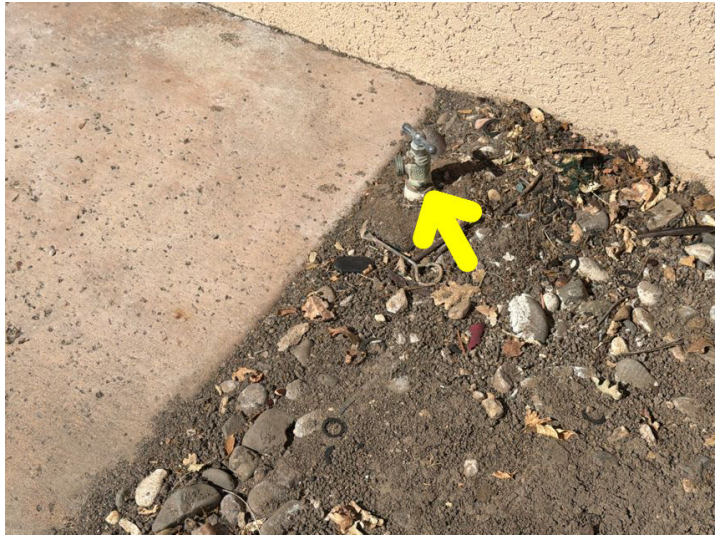
A hose bib on the rear is not functional or has been abandoned.

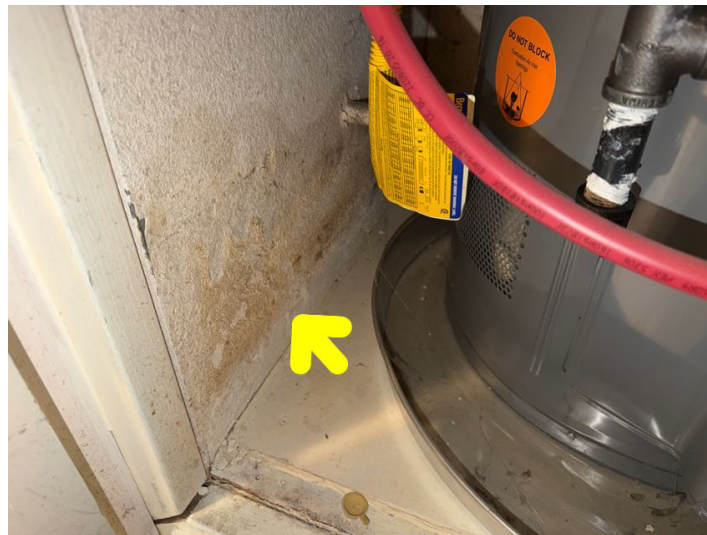
There is a moisture stain on the wall or ceiling that should be explained or explored further.

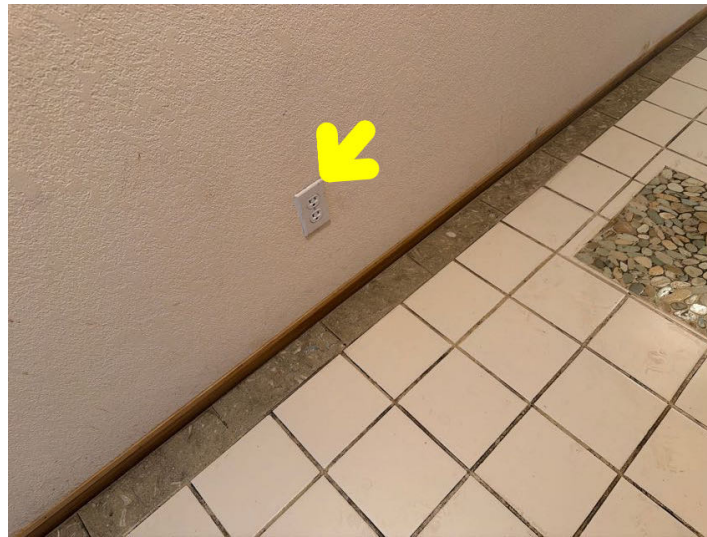
One or more outlets have an open-neutral, and should be evaluated and serviced by a licensed electrical contractor.

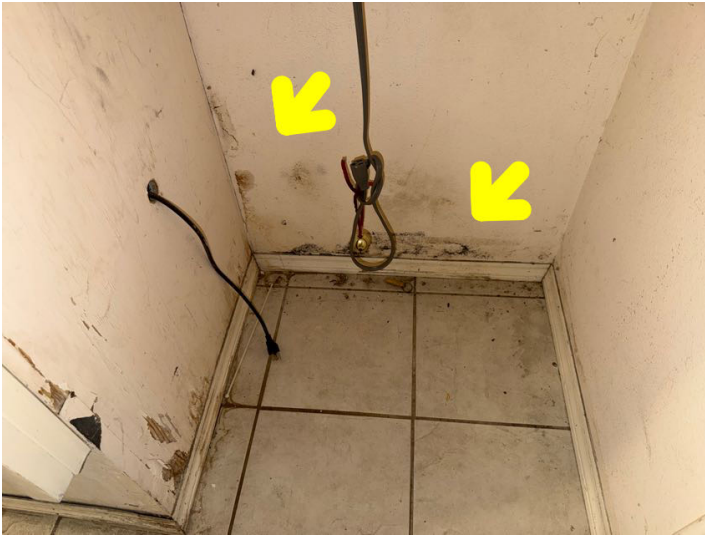
There is a mold-like substance present, which should be evaluated by a specialist and serviced as necessary. All molds flourish in a damp environment and many are commonplace, but some are toxic and may represent a health threat.

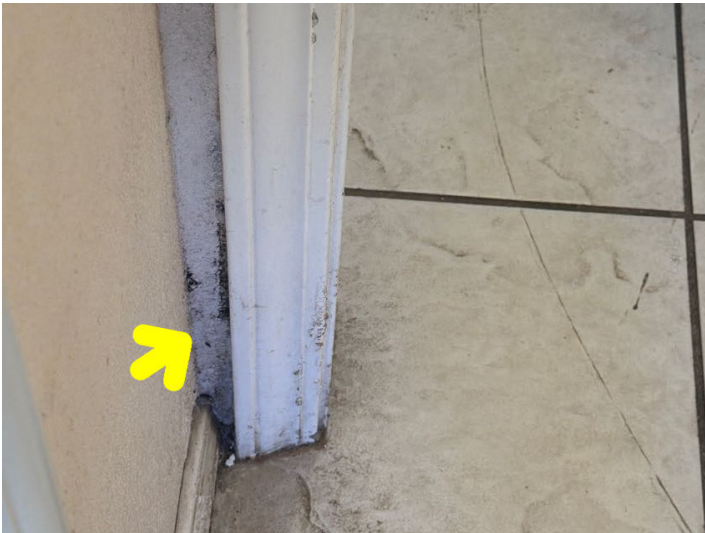
There is a mold-like substance present, which should be evaluated by a specialist and serviced as necessary. All molds flourish in a damp environment and many are commonplace, but some are toxic and may represent a health threat.

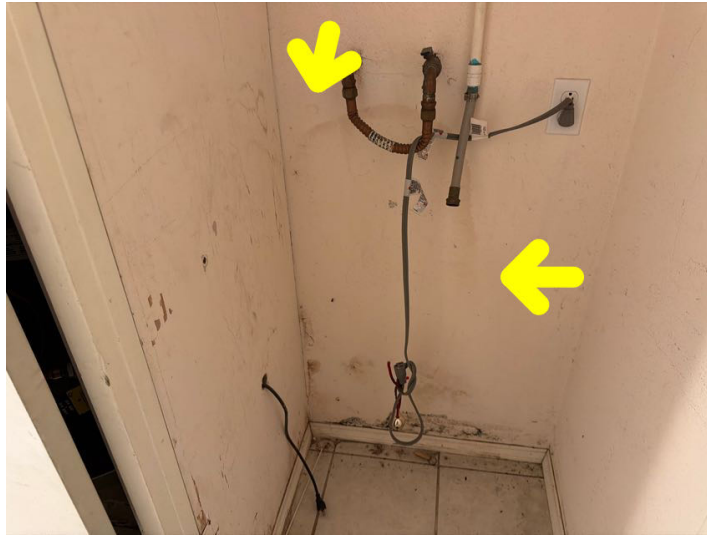
There is a moisture stain on the wall or ceiling that should be explained or explored further.

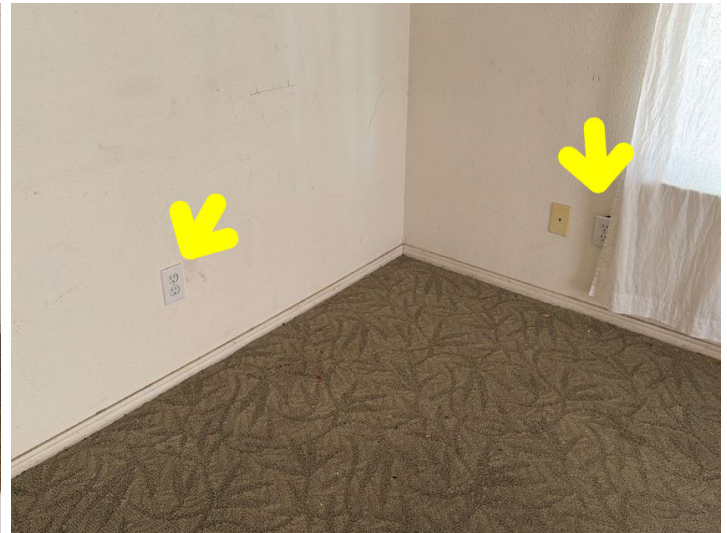
One or more outlets have an open-neutral, and should be evaluated and serviced by a licensed electrical contractor.

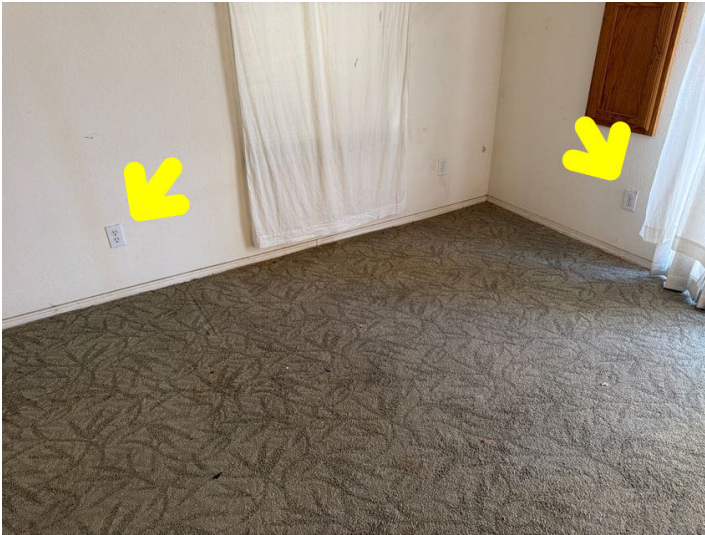
One or more outlets have an open-neutral, and should be evaluated and serviced by a licensed electrical contractor.

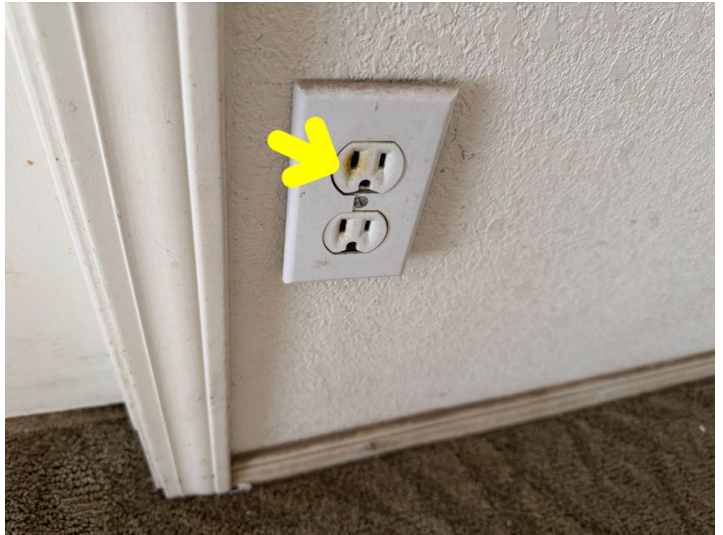
One or more outlets have a scorch mark, and should be evaluated and serviced by a licensed electrical contractor.

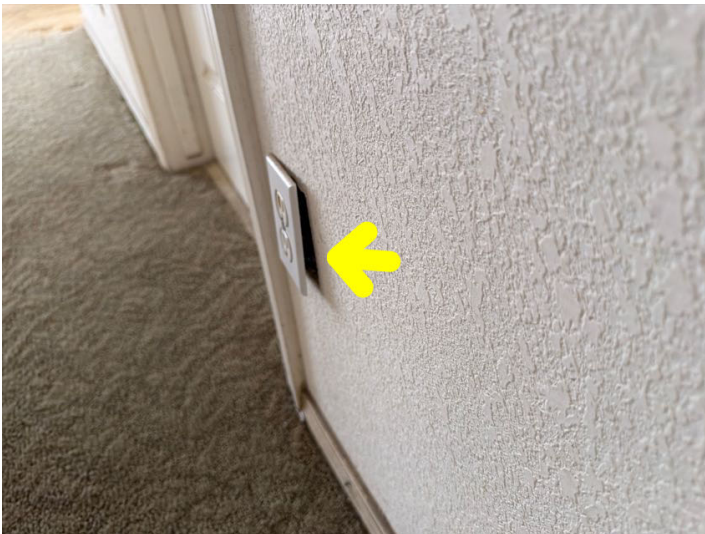
One or more outlets are not secure, and should be evaluated and serviced by a licensed electrical contractor.

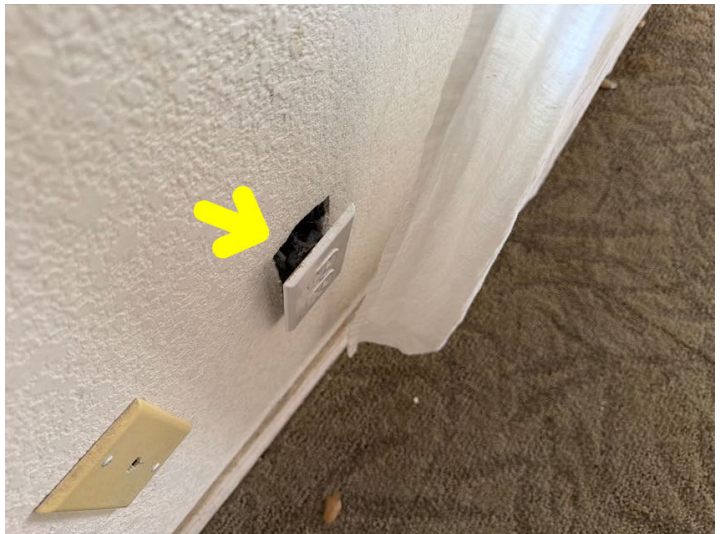
One or more outlets are not secure, and should be evaluated and serviced by a licensed electrical contractor.

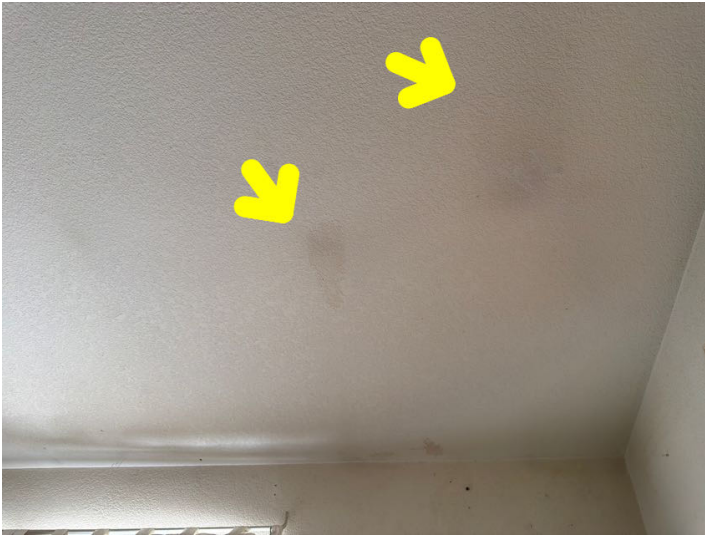
There is a moisture stain on the wall or ceiling that should be explained or explored further.

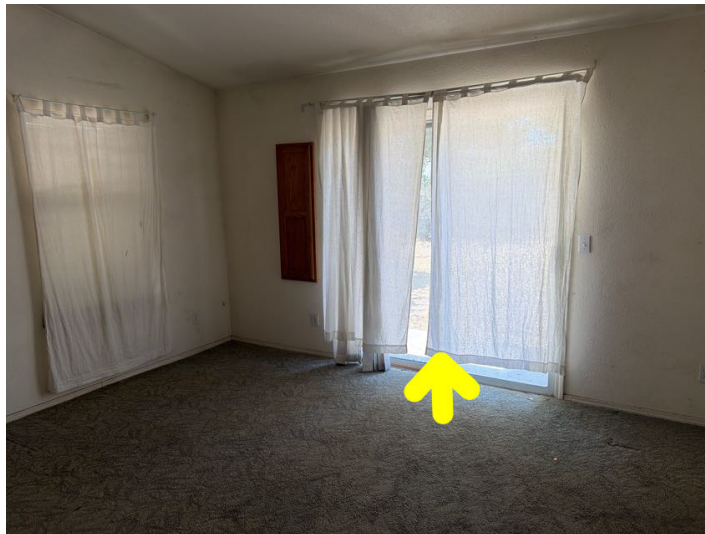
One or more windows may have a broken hermetic seal, which you may wish to have replaced. This is evident from fogging or condensation forming between the panes of glass, which implies that the seal has failed.

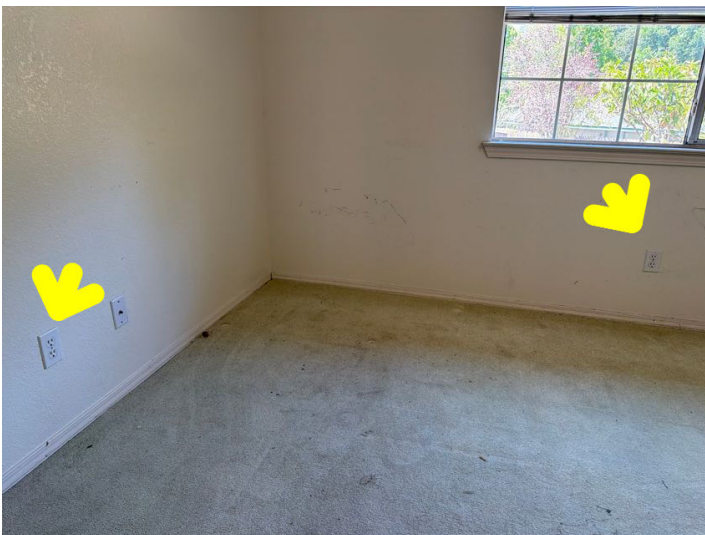
One or more outlets have an open-neutral, and should be evaluated and serviced by a licensed electrical contractor.

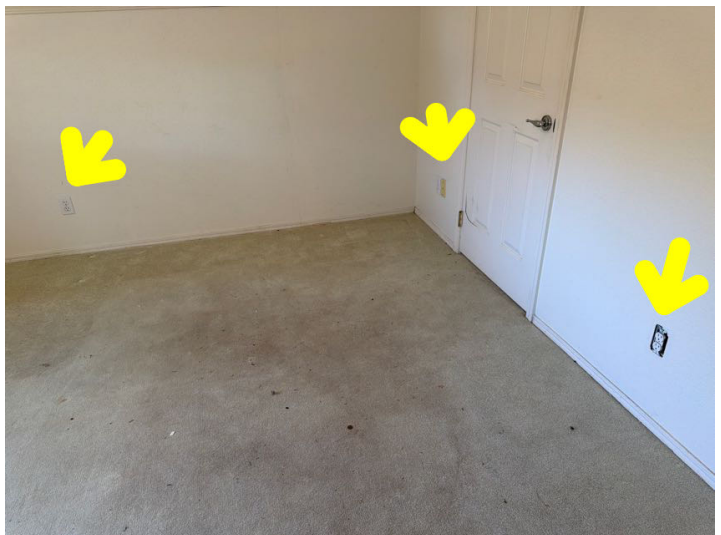
One or more outlets have an open-neutral, and should be evaluated and serviced by a licensed electrical contractor.

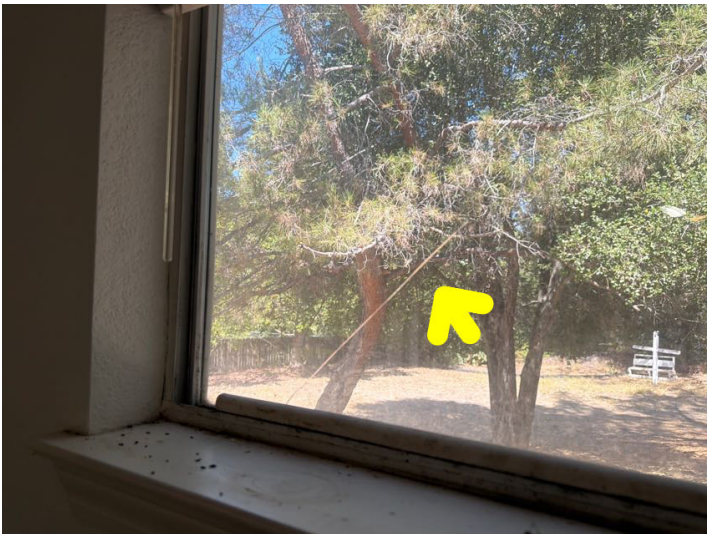
A window pane is cracked or broken and should be replaced.

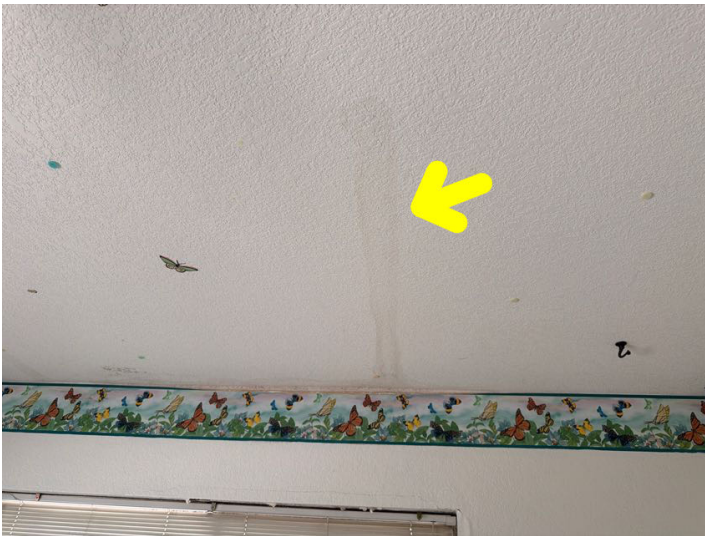
There is a moisture stain on the wall or ceiling that should be explained or explored further.

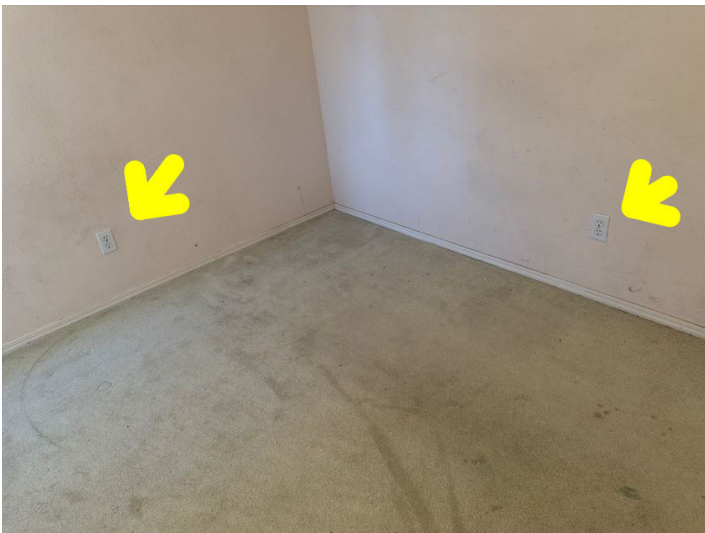
One or more outlets have an open-neutral, and should be evaluated and serviced by a licensed electrical contractor.

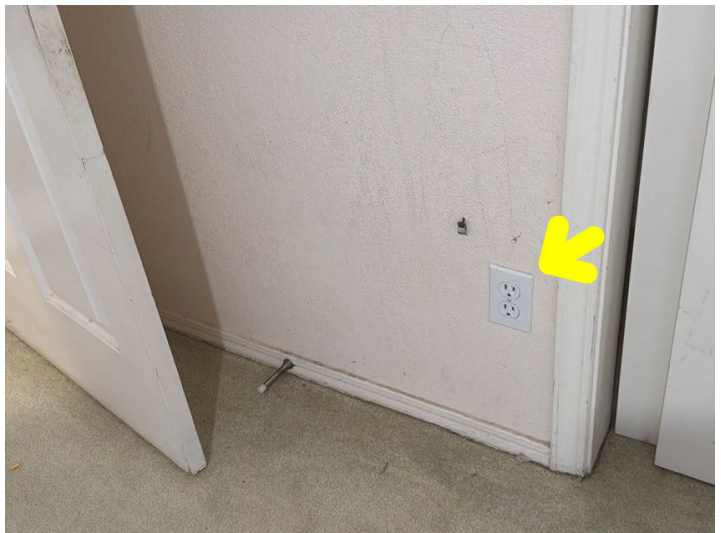
One or more outlets have an open-neutral, and should be evaluated and serviced by a licensed electrical contractor.

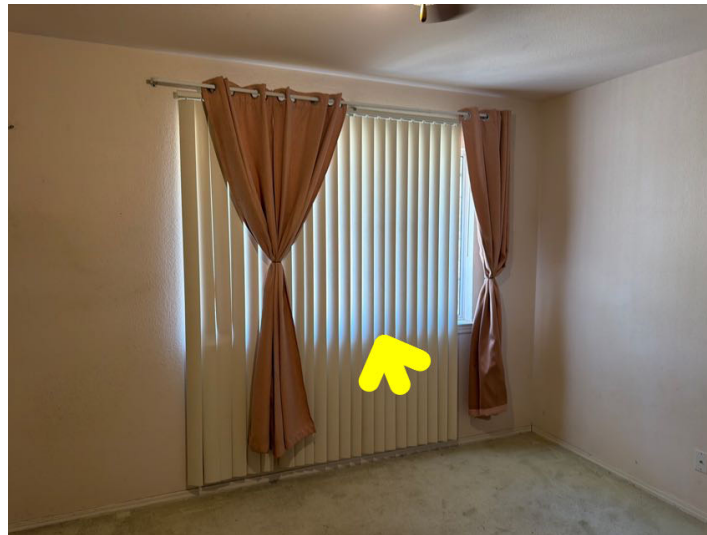
One or more windows may have a broken hermetic seal, which you may wish to have replaced. This is evident from fogging or condensation forming between the panes of glass, which implies that the seal has failed.

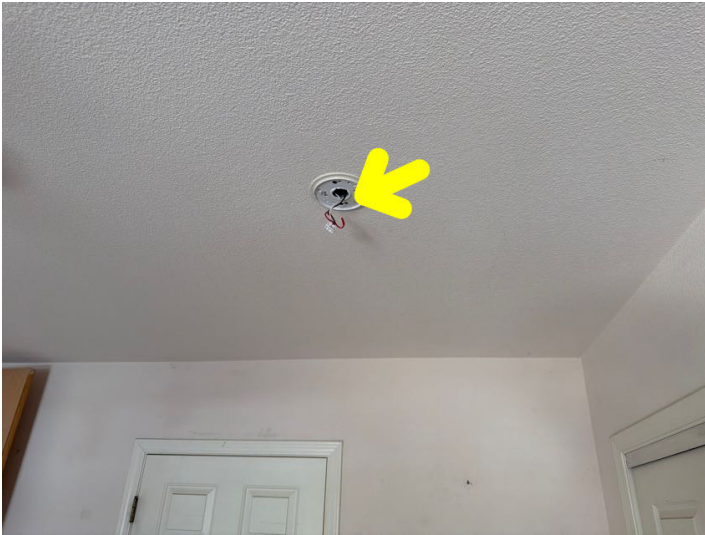
A pre-wired smoke detector is missing and should be replaced.

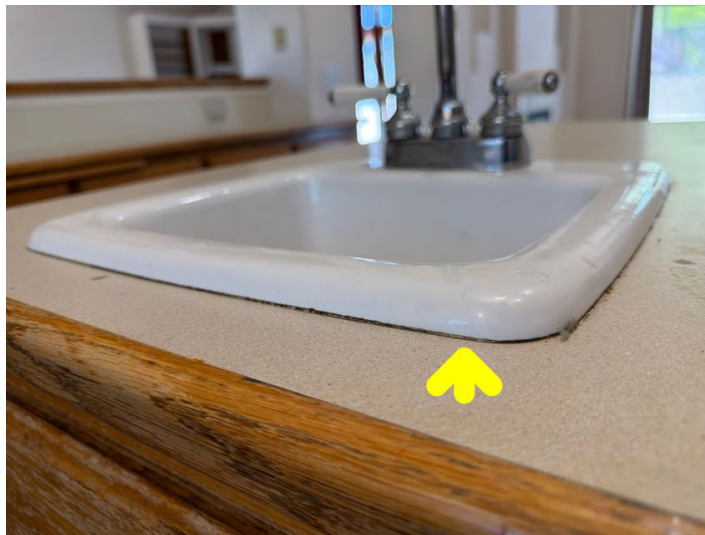
An open seam between the sink and the counter top needs to be caulked or re-grouted to forestall moisture intrusion.

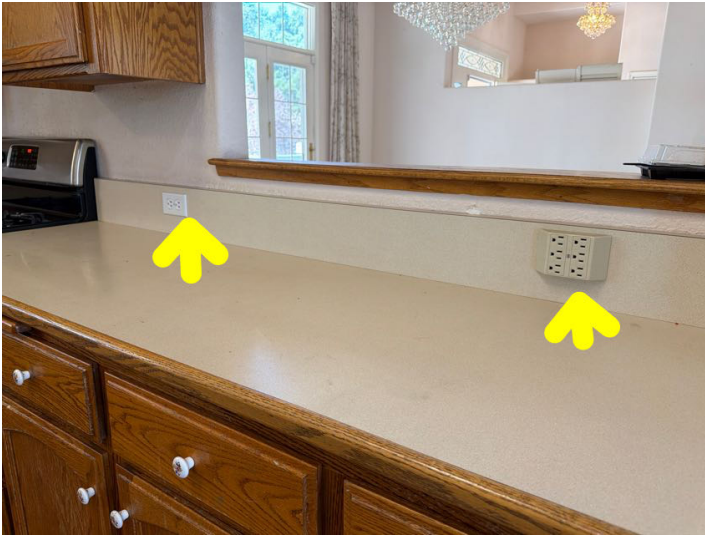
One or more of the outlets in the kitchen are not GFCI protected, which is mandated by current standards and is an important safety feature.

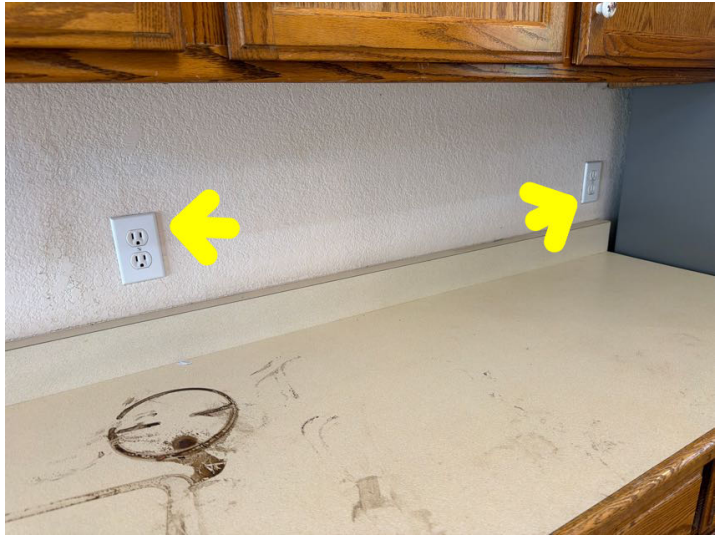
One or more of the outlets in the kitchen are not GFCI protected, which is mandated by current standards and is an important safety feature.

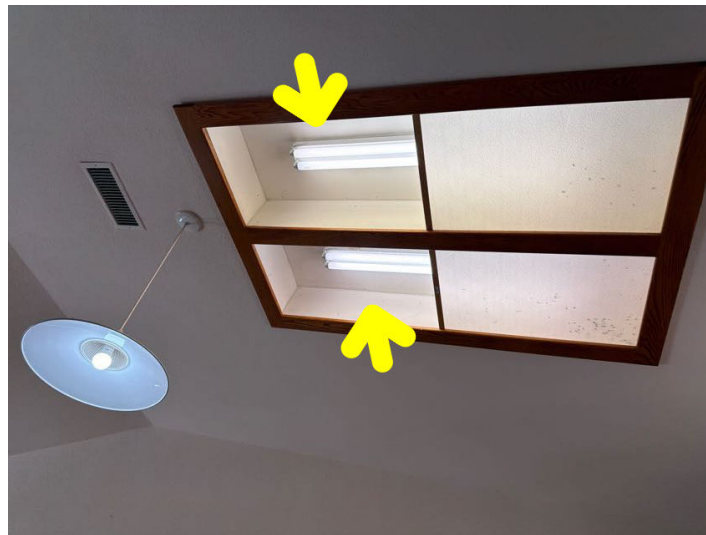
A ceiling light panel is missing or broken and you may wish to have it replaced.

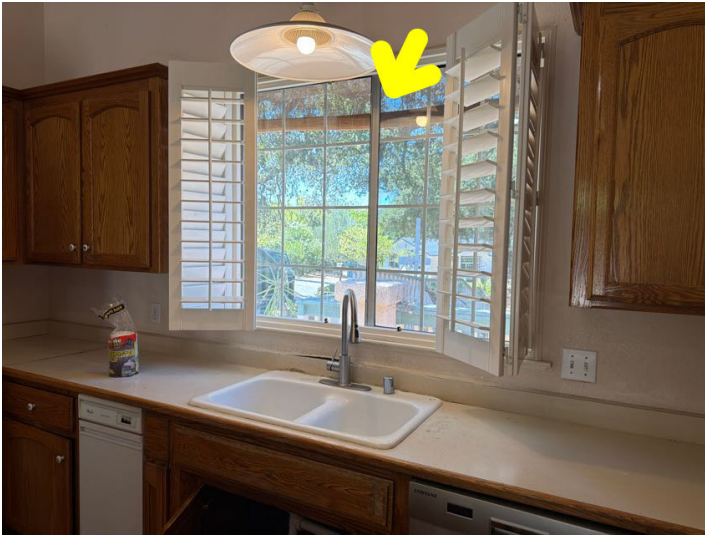
One or more windows may have a broken hermetic seal, which you may wish to have replaced. This is evident from fogging or condensation forming between the panes of glass, which implies that the seal has failed.

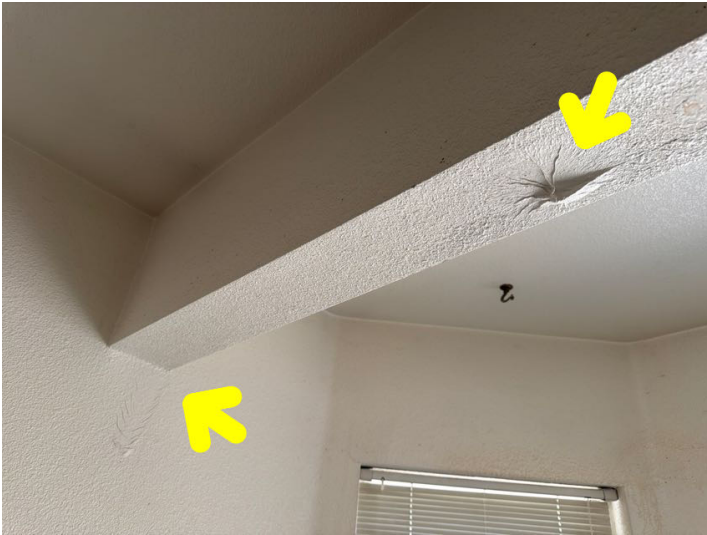
There is a moisture stain on the ceiling that should be explained by the sellers or further evaluated as to its cause.

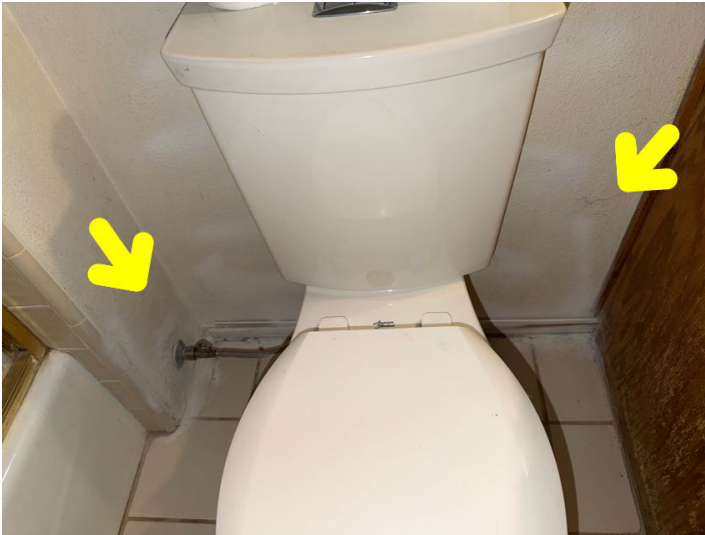
There has been a drywall repair that should be explained by the seller.

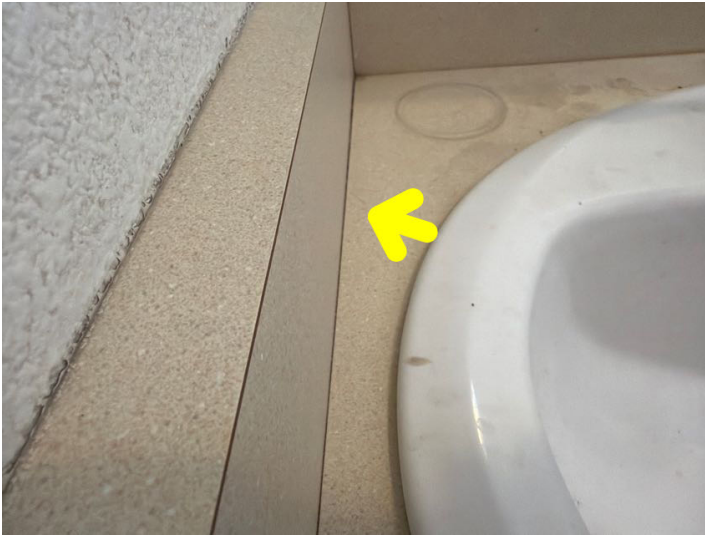
There is a separation between the sink countertop and the back-splash, which should be sealed to forestall moisture intrusion between the cabinet and the wall.

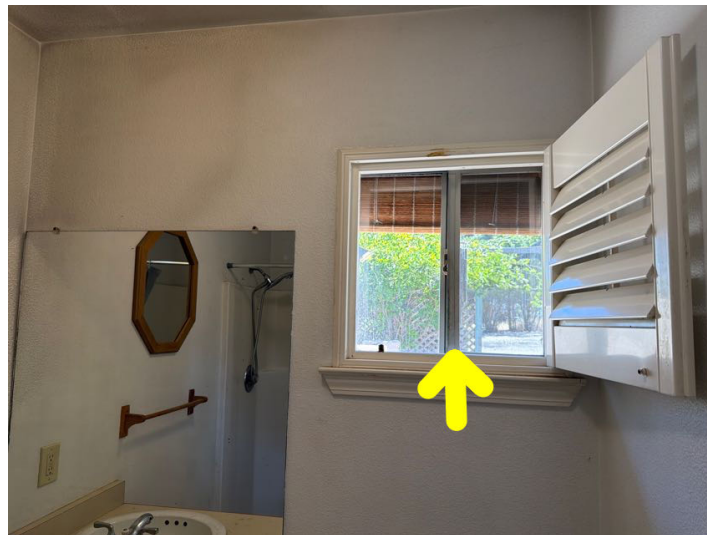
One or more windows may have a broken hermetic seal, which you may wish to have replaced. This is evident from fogging or condensation forming between the panes of glass, which implies that the seal has failed.

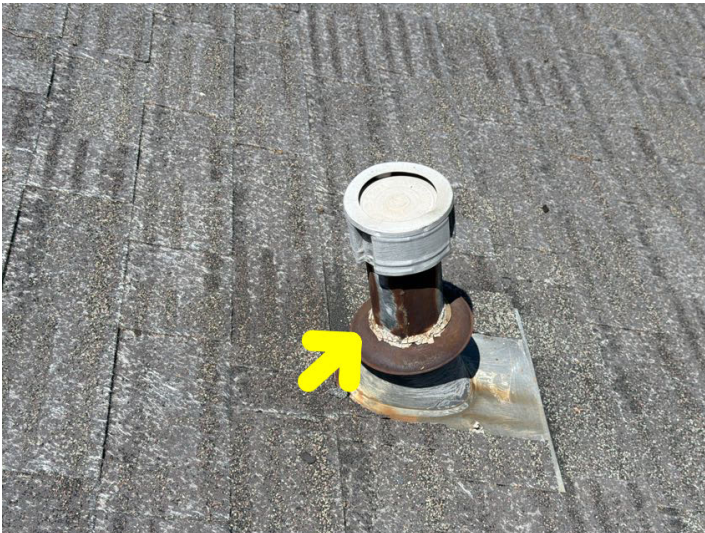
The vent pipe on the roof is rusted or deteriorated, and should be serviced by a qualified tradesperson.

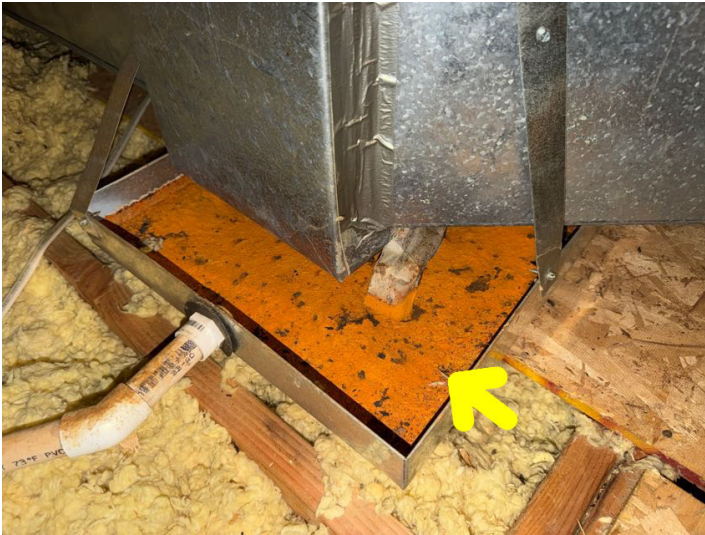
- 1.12. The thermostat is missing and should be replaced.
- 1.13. The drain pan is rusted or deteriorated, which indicates previous standing water in the pan, and we recommend an evaluation and service by a qualified tradesperson.

The drain pan is rusted or deteriorated, which indicates previous standing water in the pan, and we recommend an evaluation and service by a qualified tradesperson.

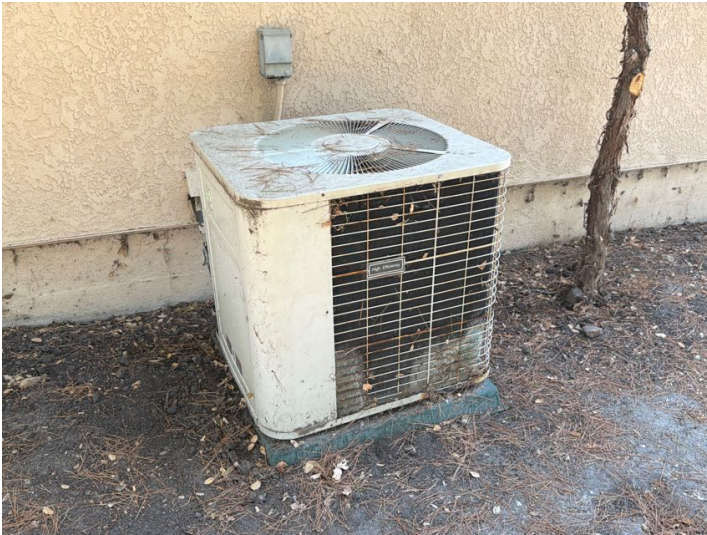
Central heat and air-conditioning are provided by a single split-system, consisting of a furnace with an evaporator coil that is located in the attic and a condensing coil that is located on the exterior.

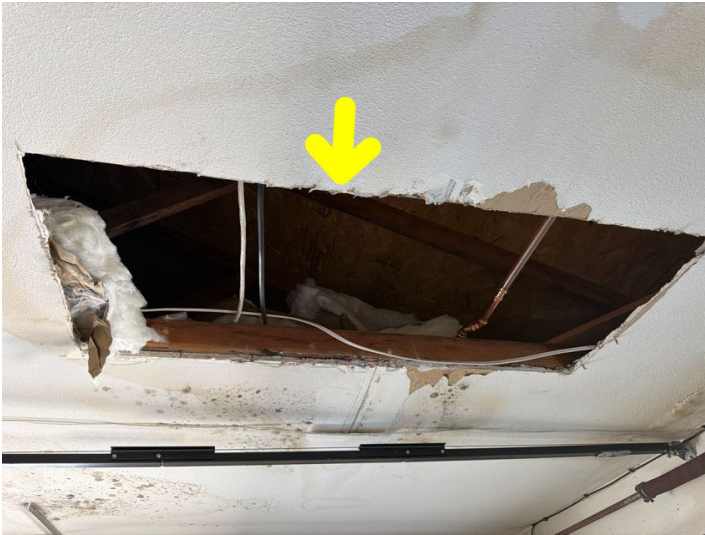
1.10. The voids in the garage firewall must be repaired, in order to maintain the necessary firewall separation between the garage and the residence.

The voids in the garage firewall must be repaired, in order to maintain the necessary firewall separation between the garage and the residence.

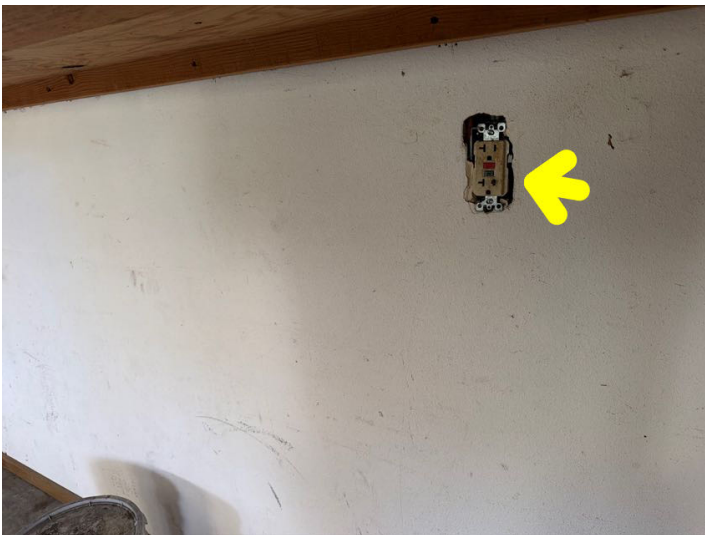
1.14. One or more outlet covers are missing and should be installed.

One or more outlet covers are missing and should be installed.

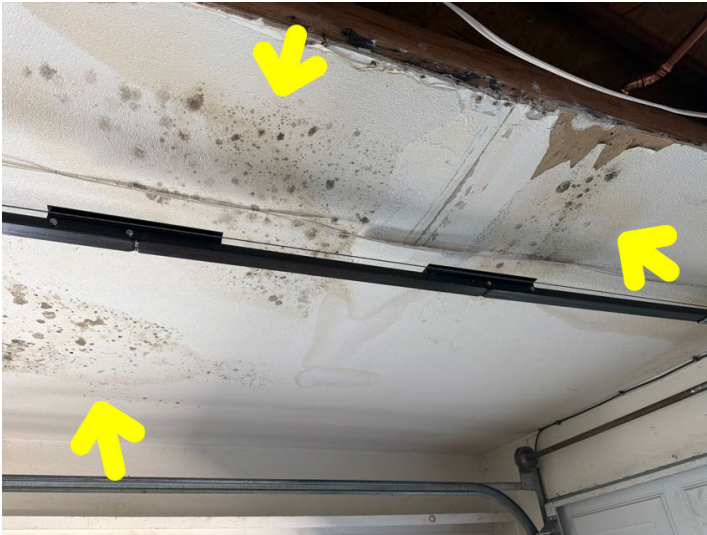
There is a mold-like substance present, which should be evaluated by a specialist and serviced as necessary. All molds flourish in a damp environment and many are commonplace, but some are toxic and may represent a health threat.

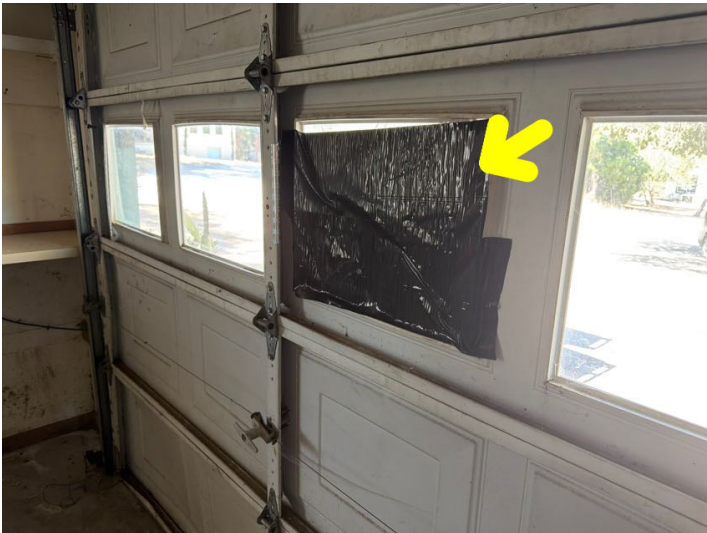
1.15. A window pane is cracked or broken and should be replaced.

A window pane is cracked or broken and should be replaced.
