# ***Cornerstone Inspection***

## **Property Inspection Report**

***1301 Los Osos Valley Rd, Los Osos, CA 93402***

***Date of Inspection: 1/30/2026 Time: 9:00 AM***

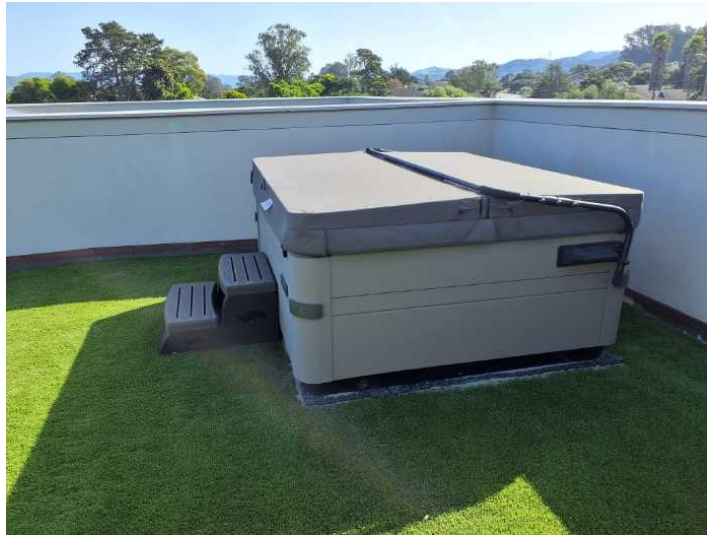
The requirements of 'two of the seven drowning safety features' as required by the Swimming Pool Safety Act as updated by SB 552, do not apply to Spas or hot tubs with locking type covers complying with ASTM International F1346 standard. We cannot confirm the hot tub cover meets this standard. We recommend further evaluation by a qualified licensed swimming pool specialist and service or correct and required to meet current safety standards.

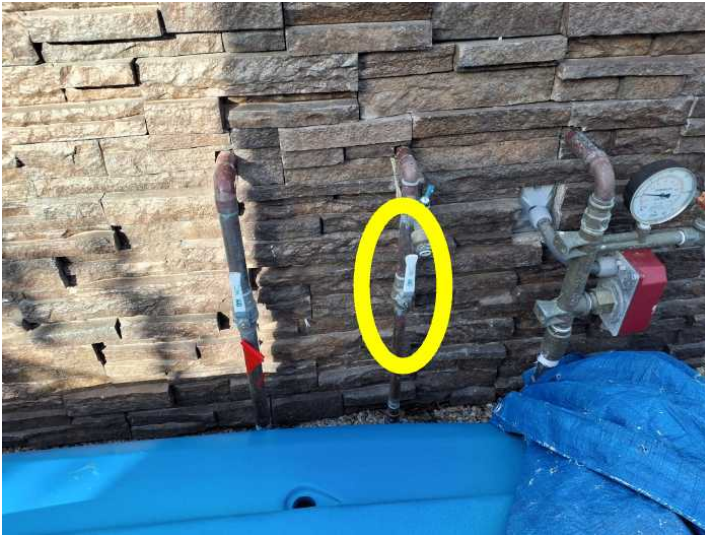
The main water shut-off valve is located at the left side of the home, unit, or building.

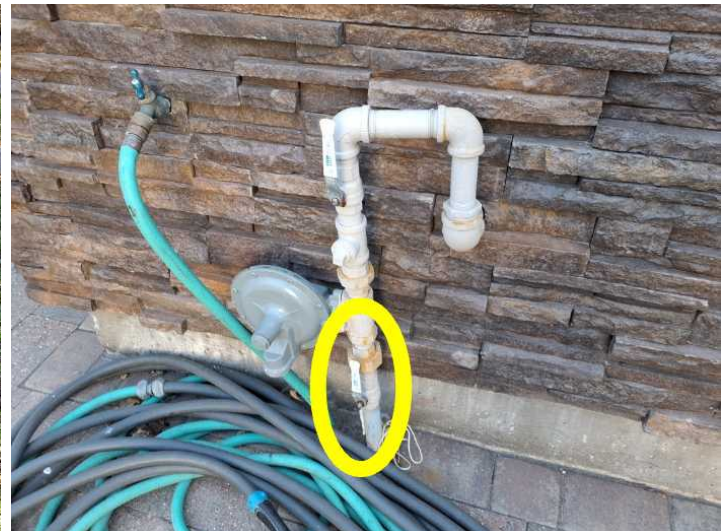
The local gas shut-off is located on the right side of the home, unit or building.

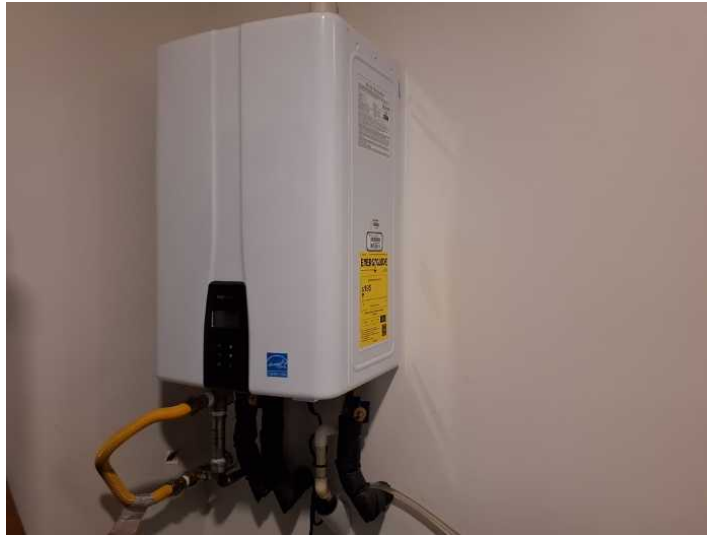
The residence is served by a tankless water heater located in the utility room.

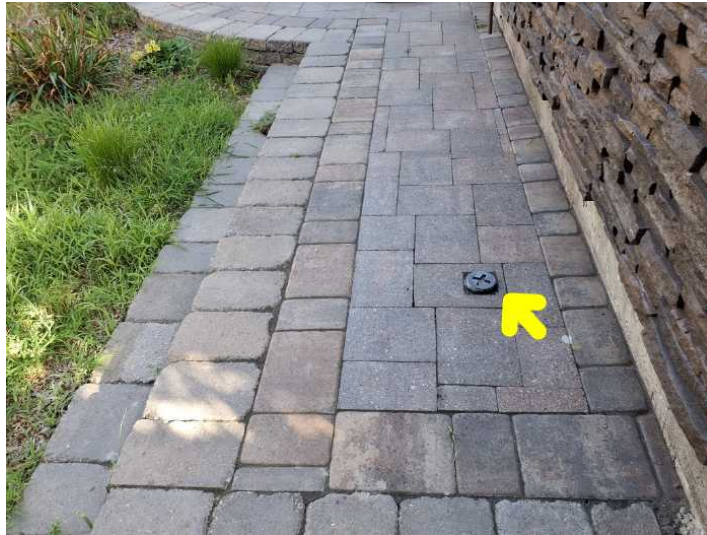
A clean-out is located at the right side.

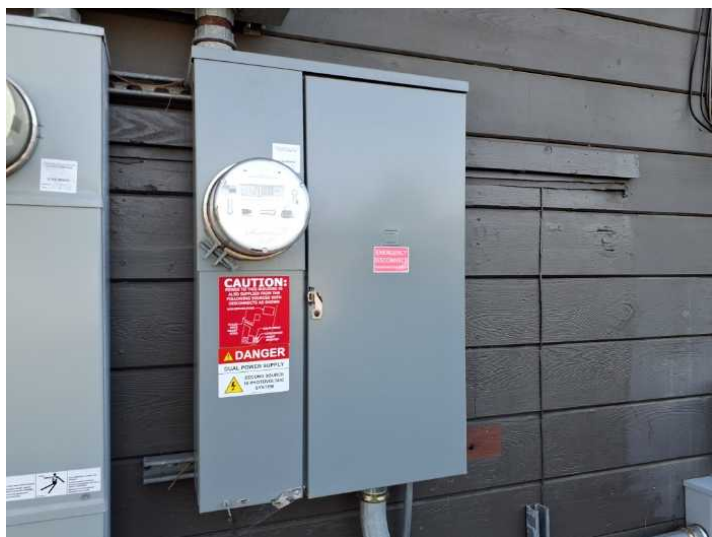
The residence is served by a 200 amp main electrical panel, located at the exterior of the office unit.

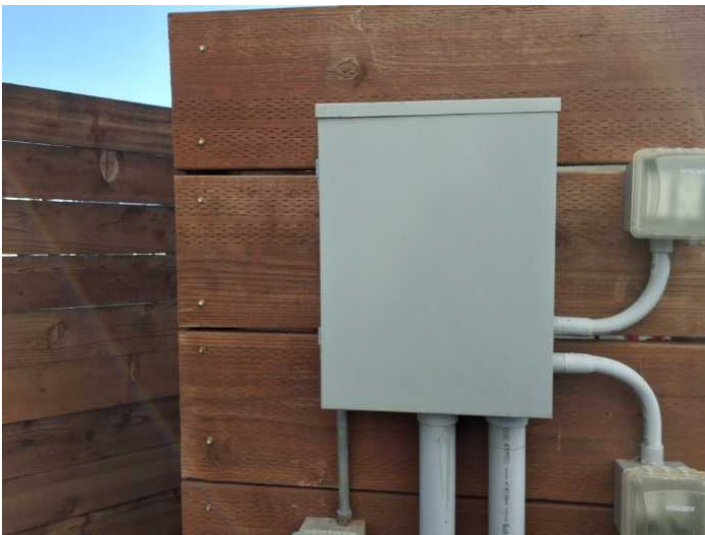
3.7. There are voids or open knockouts in the cover of the electrical sub panel that should be covered.

The sub panel is located at the left exterior side of the home.

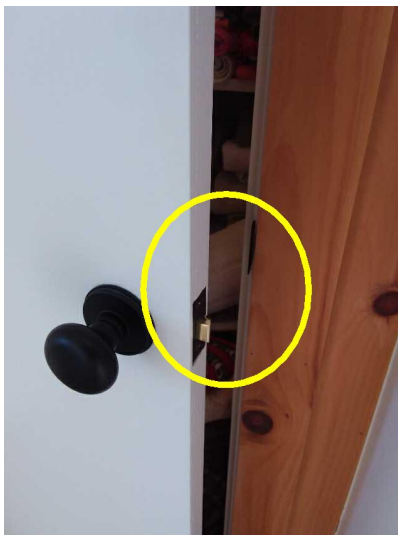
The door striker plate needs to be adjusted for the striker pin to engage.

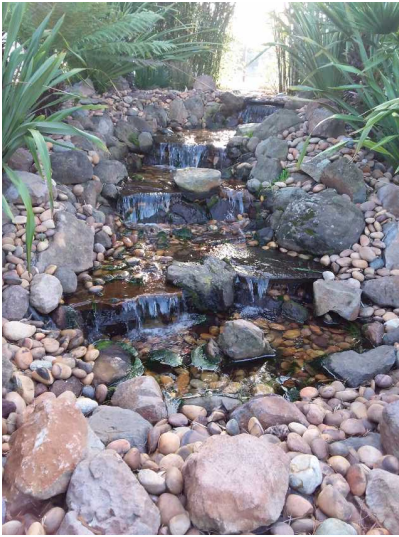
We do not evaluate ponds or water features as a part of our inspection.

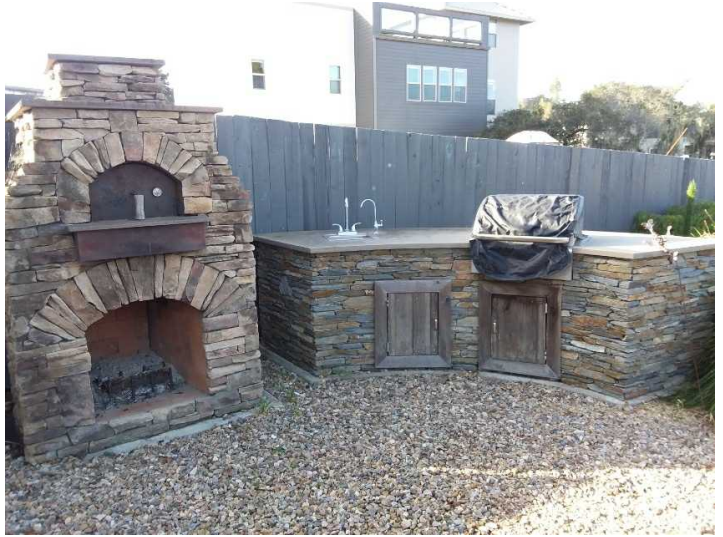
There is a BBQ on the property that we do not evaluate, unit should be demonstrated as functional by the sellers.

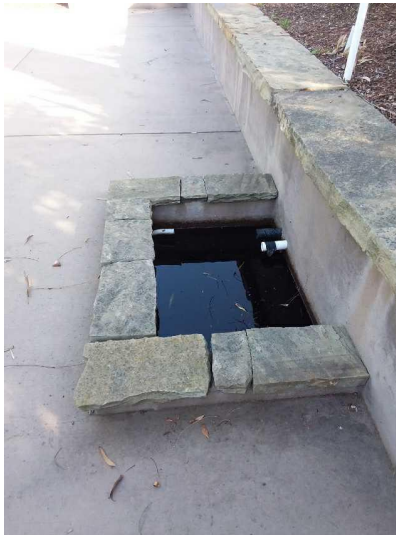
There is a pond in the yard that could prove to be dangerous to small children however our service does not include evaluations of ponds or their equipment.

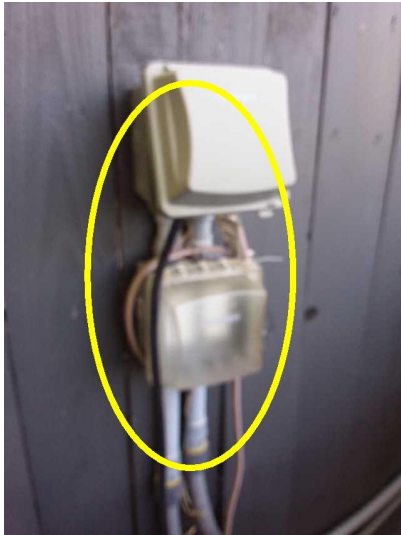
Some of the exterior outlets do not have ground-fault protection, and should be upgraded to include this modern safety feature.

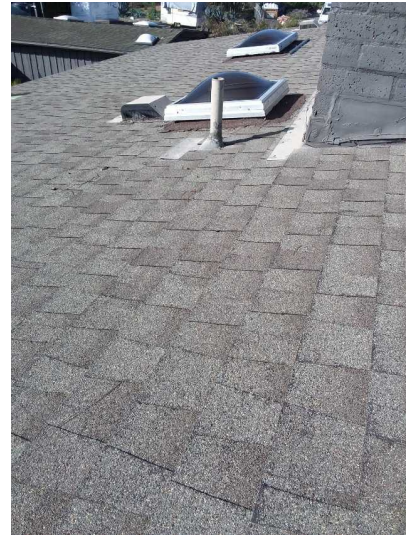
The composition shingle roof is in acceptable condition, but it will need to be kept clean and should be inspected annually. However, our service does not include any guarantee against leaks. For a guarantee, a roofing company would have to perform a water-test and issue a roof certification.

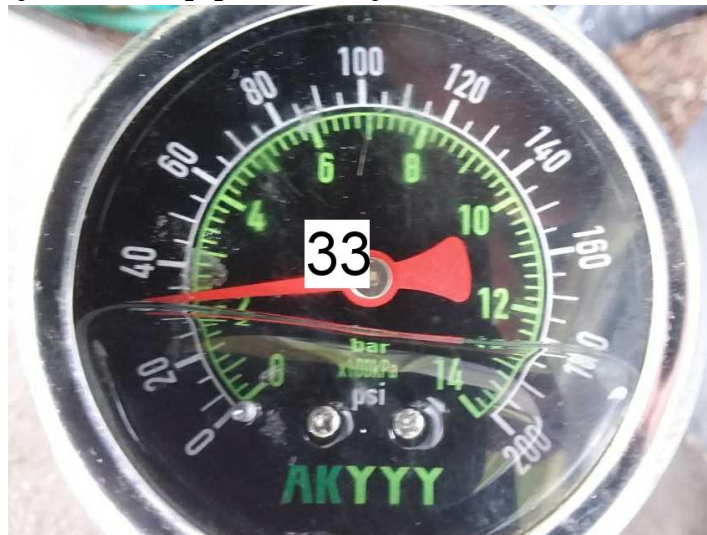
The water pressure entering the residence is under 80psi and a regulator is not required on the plumbing system.
