**SoCal Home Inspections**  
(909) 489-1211  
socalhomeinspections.net

## Home Inspection Report

813 Poe Court  
Lake Arrowhead, CA 92407

**Prepared For: Matt Mitchell**  
Inspected On Tue, Sep 22, 2026 at 11:00 AM

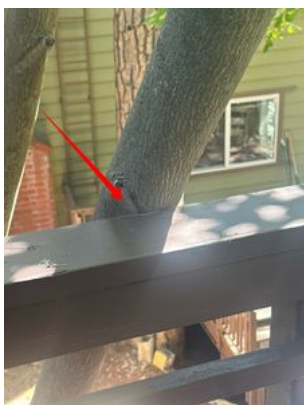
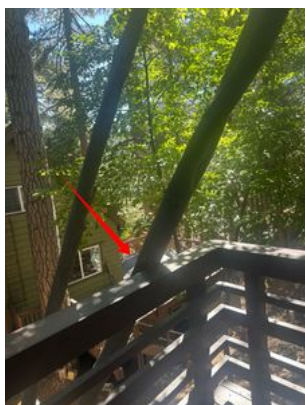
East side tree limb is growing against wood deck on south.

Needs trimming

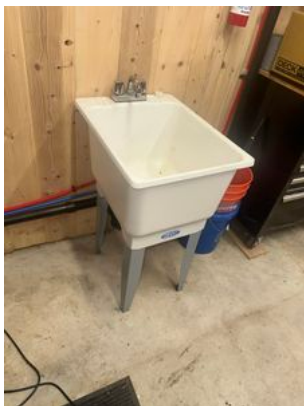
Laundry sink needs to be secured to floor or wall.

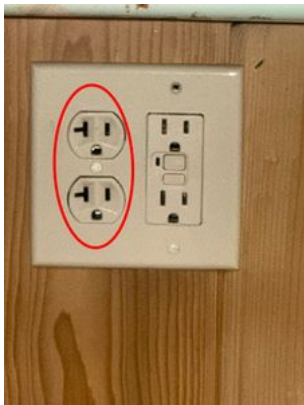
Ungrounded outlet next to GFCI in laundry area needs to be protected by GFCI.

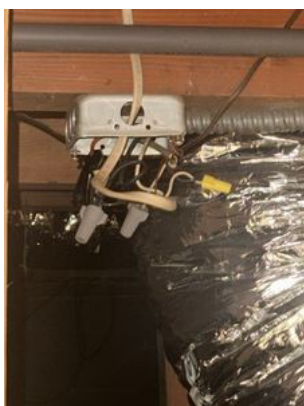
Exposed electrical present in build up just on other side of stem wall.

Needs j box cover installed.

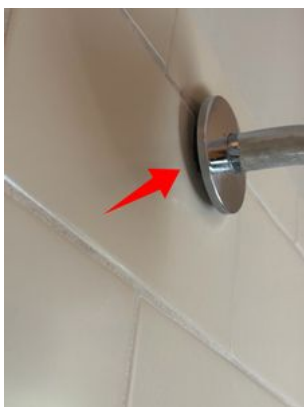
Re seal fixture cap to wall in shower and downstairs bathroom

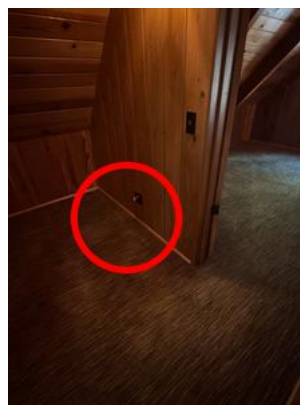
Ungrounded 3 prong outlets are a N.E.C violation on South Wall in loft and left side wall before entering West bedroom area

Needs repair

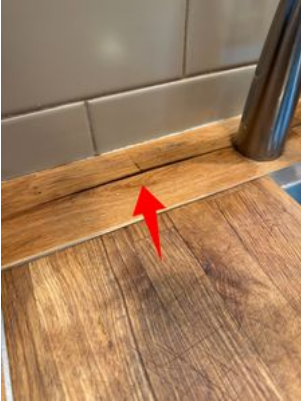
Counter wood is lifting

Needs repair

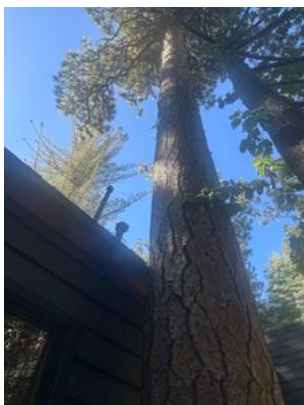
Tree growing on north side of home is almost touching home and very tall hanging over roof.

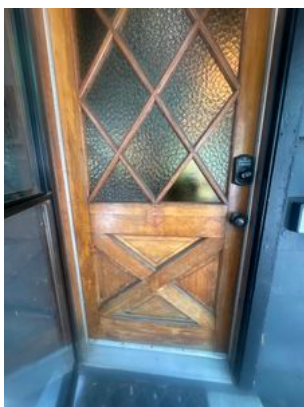
Suggest re sealing/ painted front exterior door.

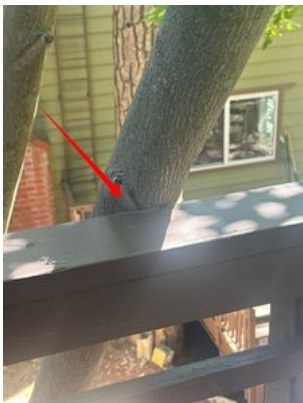
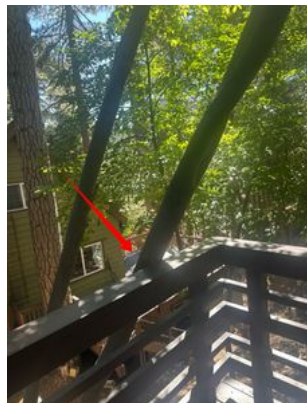
East side tree limb is growing against wood deck on south.

Needs trimming

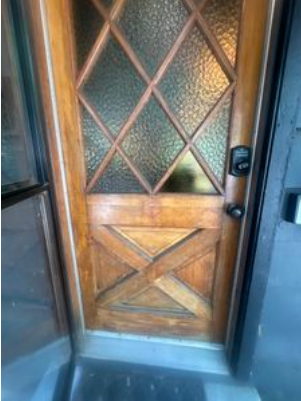
Suggest re sealing/ painted front exterior door.

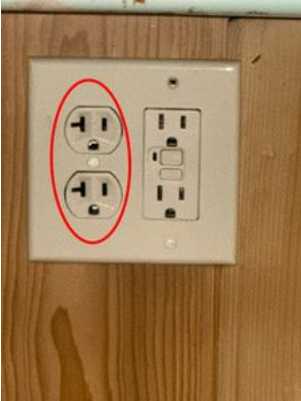
Ungrounded outlet next to GFCI in laundry area needs to be protected by GFCI.

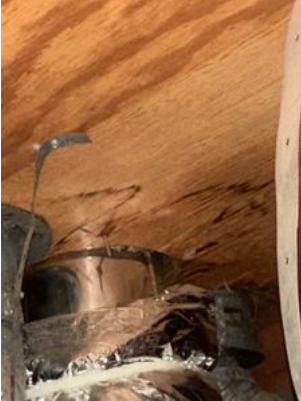
Moisture staining present on sub flooring surrounding furnace vent pipe in build up.

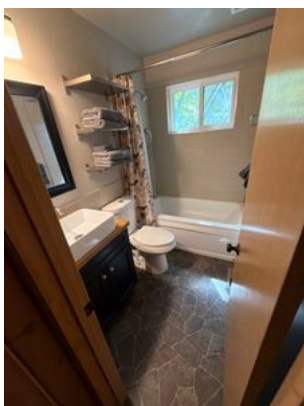
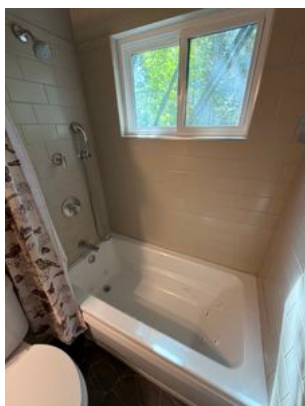
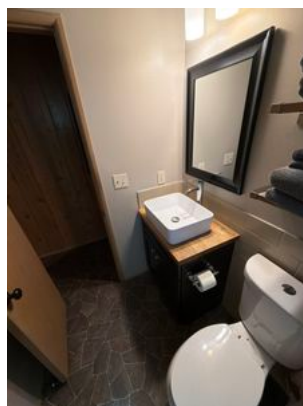
Downstairs bathroom

Flooring in downstairs bathroom is missing piece next to toilet.

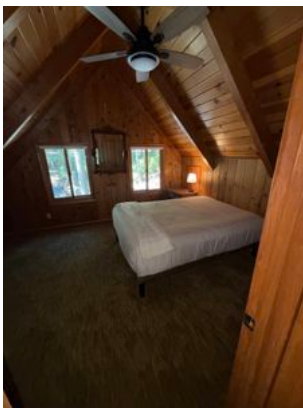
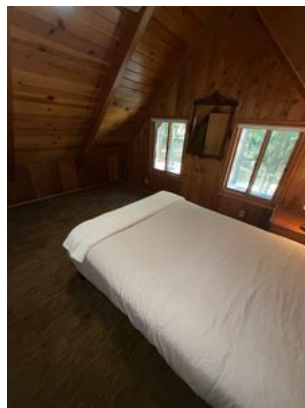
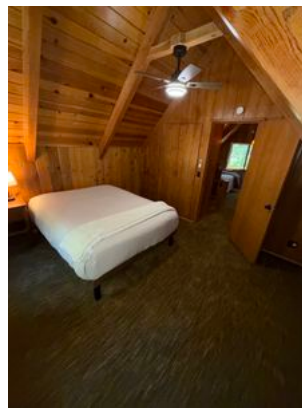
Upstairs West bedroom

3 prong, Ungrounded NEC violation, All plugs/outlets accessible, Lights working

Ungrounded 3 prong outlets are a N.E.C violation in upstairs West bedroom

Needs repair

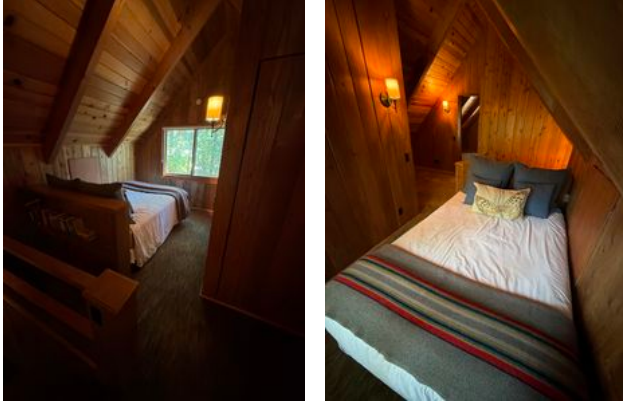
Upstairs loft/ bedroom

3 prong, Ungrounded NEC violation, All plugs/outlets accessible, Lights working

Ungrounded 3 prong outlets are a N.E.C violation on South Wall in loft and left side wall before entering West bedroom area

Needs repair
