# Home Inspection Report

70 Shaul St., Clearlake Oaks, CA 95423

Tuesday August 4, 2026

1323

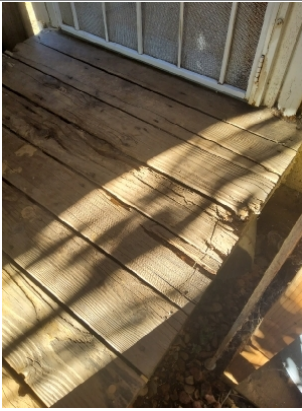
☐ Satisfactory ☐ Marginal ☐ Poor ☒ Safety Hazard ☐ Uneven risers ☐ Rotted/Damaged  
☐ Cracked ☐ Settled

**Recommend replacing damaged tread members that are noted, structurally the steps are of no concern.**

Recommend replacing damaged treads

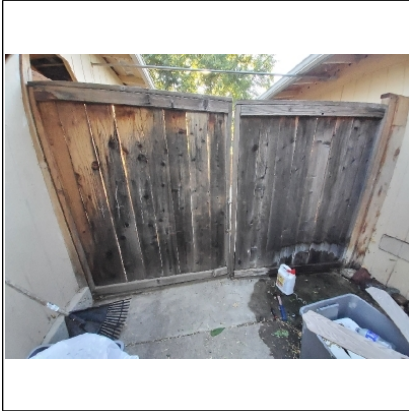
## Fence/Wall 2

**Type** ☐ Brick ☐ Block ☒ Wood ☐ Metal ☐ Chain Link ☐ Rusty ☐ Vinyl  
**Condition** ☐ Satisfactory ☒ Marginal ☐ Poor ☐ Typical cracks ☐ Loose Blocks/Caps  
**Gate** ☐ N/A ☐ Satisfactory ☒ Marginal ☐ Poor ☐ Planks missing/damaged Operable: ☐ Yes ☐ No  
**Comments** *Fencing was in need of maintenance repairs.*  
**Photos**

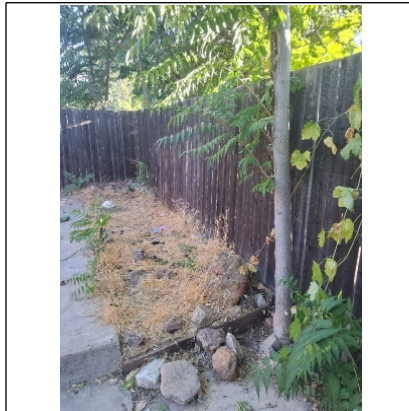
## Fence/Wall 3

☐ Not evaluated ☐ None  
**Type** ☐ Brick ☐ Block ☒ Wood ☐ Metal ☐ Chain Link ☐ Rusty ☐ Vinyl  
**Condition** ☐ Satisfactory ☒ Marginal ☐ Poor ☐ Typical cracks ☐ Loose Blocks/Caps  
**Gate** ☒ N/A ☐ Satisfactory ☐ Marginal ☐ Poor ☐ Planks missing/damaged Operable: ☐ Yes ☐ No  
**Comments** *Fencing was in need of maintenance repairs.*  
**Photos**

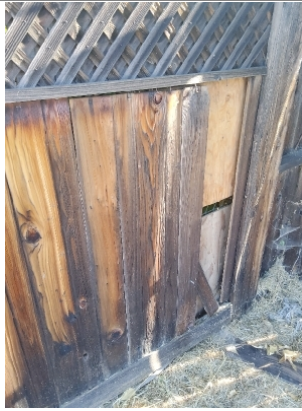
Missing and damaged planks,  
recommend repair

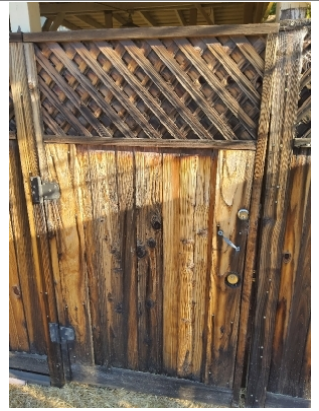
Gate needs to be readjusted to  
properly swing, recommend  
repair

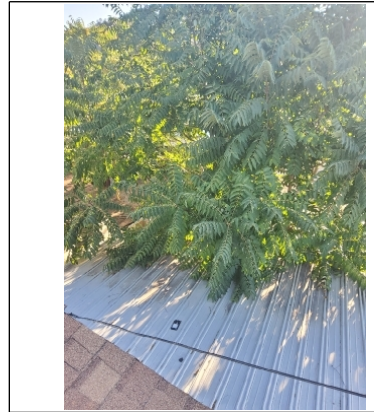
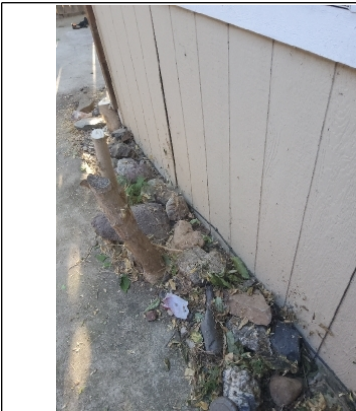
## Landscaping affecting foundation

**Negative Grade** ☐ East ☐ West ☐ North ☐ South ☐ Satisfactory ☐ Recommend additional backfill  
☐ Recommend window wells/covers ☒ Trim back trees/shrubberies  
☒ Wood in contact with/improper clearance to soil

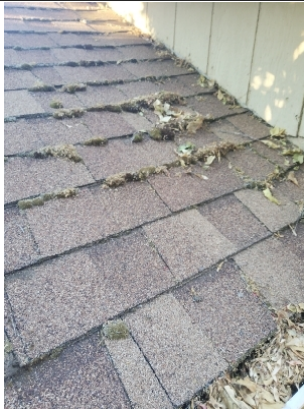
Moss is evident but shingles are not damaged during time of inspection, recommend having removed.

*With the moss build up I always recommend applying Wet & Forget this can be purchased at Home Depot, look at the forecast for about a week to make sure no rain is in site and then spray the chemical on the roof and do not use a pressure washer sprayer ever on asphalt shingles. This will kill the moss in about a month. Option 2 is on a damp morning get a dull chisel and pick the moss off then apply the Wet & Forget after.*

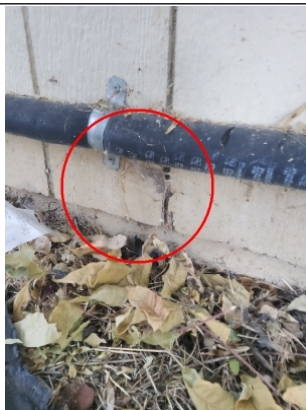
Slight damage on siding, however majority of siding is in satisfactory condition.

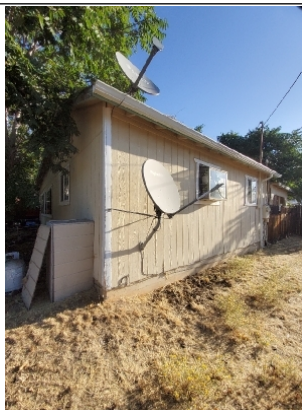
Siding is warped at section of house, recommend having replaced by a licensed contractor. A temporary option can be fastening the bottom portion of the siding with 2" exterior screws into the mudsill.

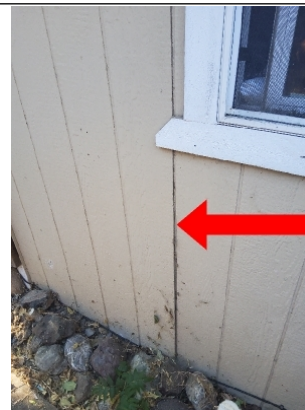
Recommend refastening section of siding to frame member

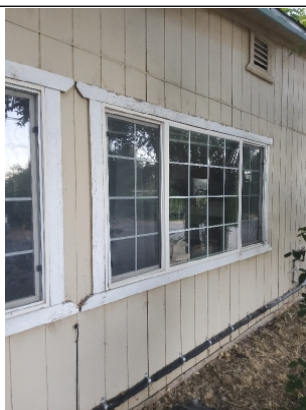
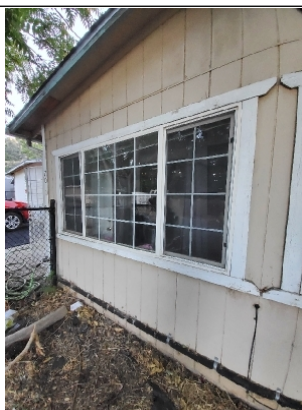
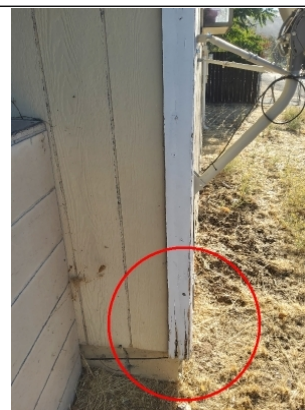
**Comments** *Trim was in need of normal painting maintenance.*

Damaged trim, recommend replacing

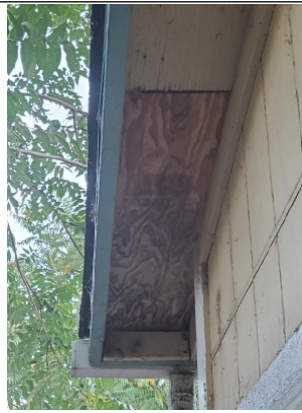
Recommend having soffit painted by a licensed painter

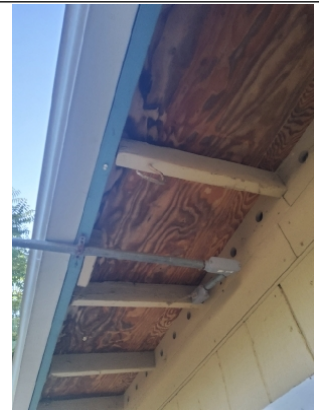
Moisture stains are evident, recommend having soffit painted by a licensed painter and monitor location.

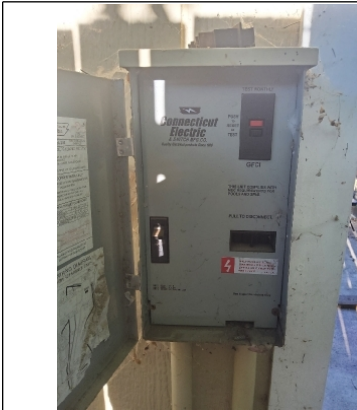
Outside disconnect on panel box was not tested during time of inspection as it was shut off during time of inspection this appears to be used for a hot tub.

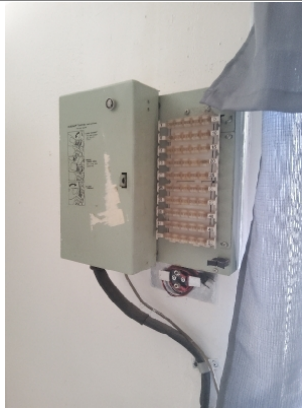
Appears to be disconnected, however will recommend further evaluation of panel box if being used.

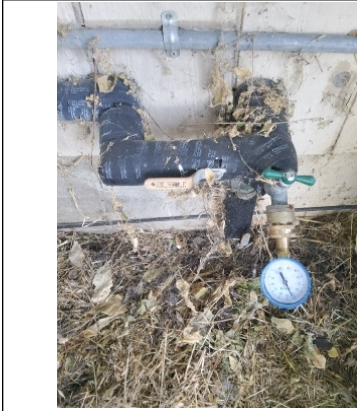
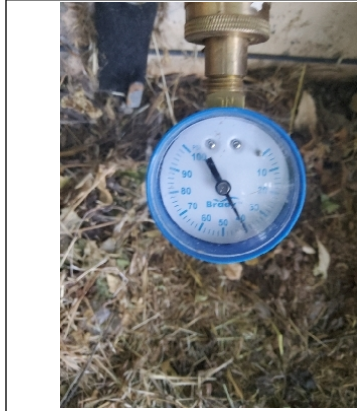
## Main fuel shut-off location

Rust is evident, however gas line is not leaking during the time of inspection.

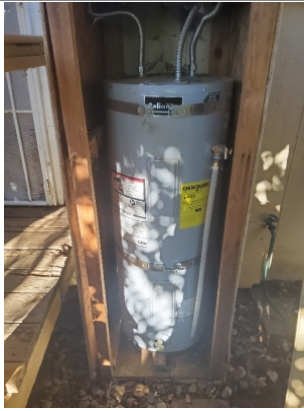
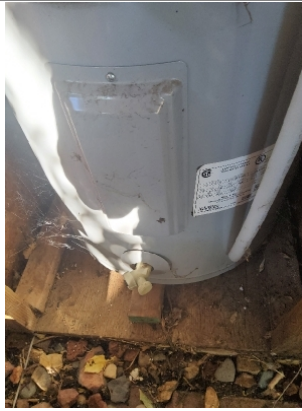
Drain pan is not required as the water heater is located at the exterior of the home.

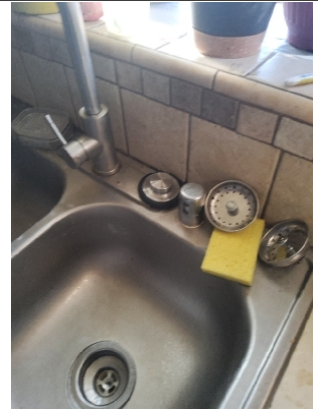
Recommend regrouting between tile and backsplash (Comes in a caulking silicone tube)

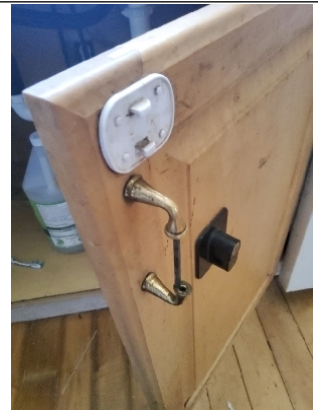
Broken door handle, recommend repair

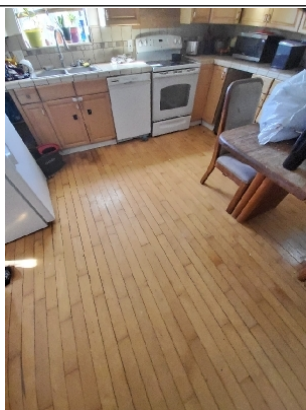
Moisture stains are evident, but no structural concerns during the time of inspection.

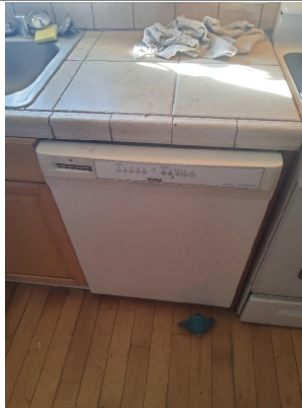
Dishwasher not operable during time of inspection, recommend repair

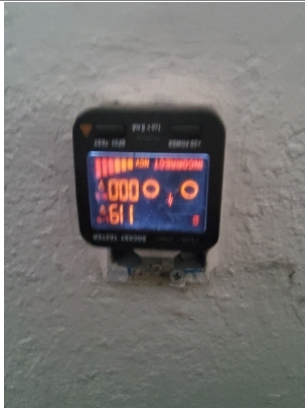
Open ground, recommend further evaluation and repair by a licensed electrician.

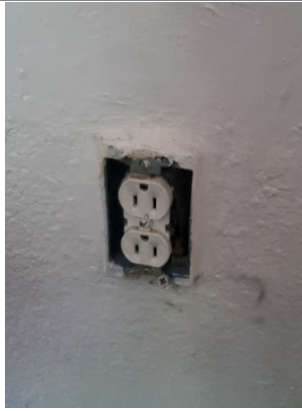
Missing cover plate, recommend repair

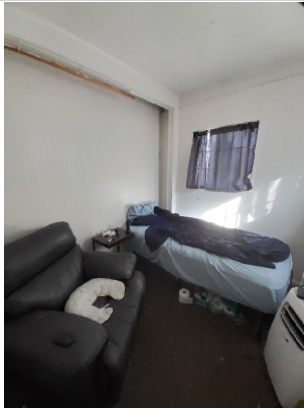
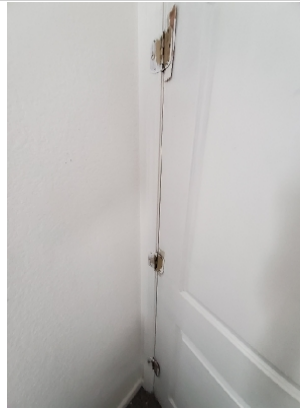
Recommend installing new hinges on interior door

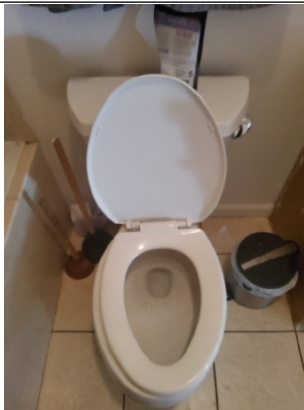
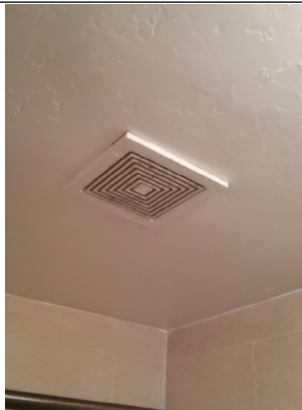
Exhaust fan is noisy, recommend replacing

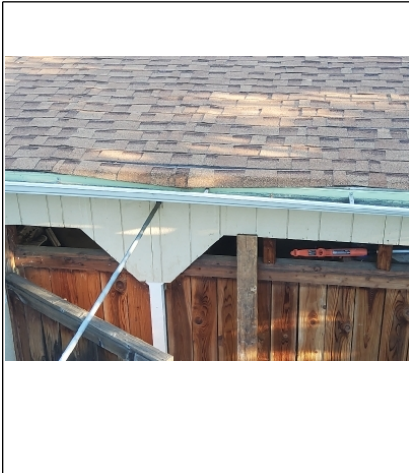
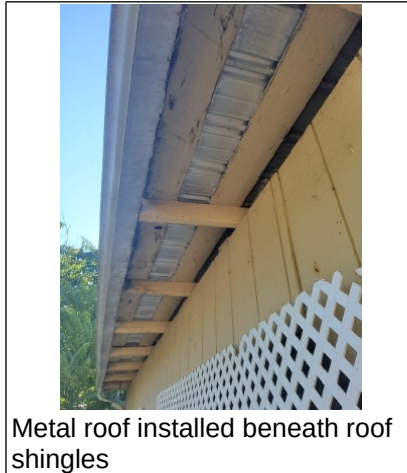
Metal roof installed beneath roof shingles

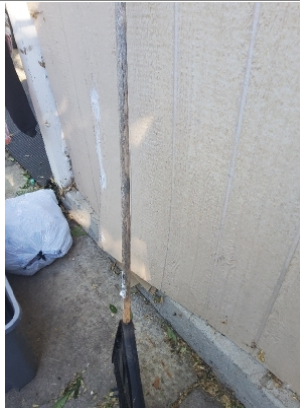
Damaged siding, recommend replacing

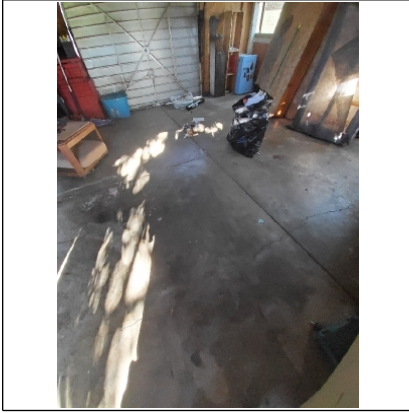
Moisture stains are evident, recommend further evaluation and repair by a licensed pest control operator.

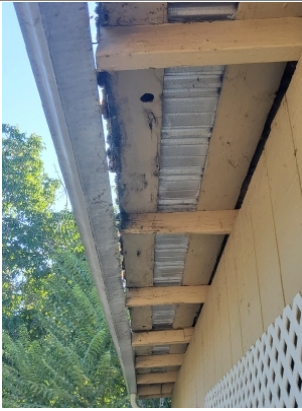
Moisture damage is evident on edge of rafters, recommend further evaluation and repair by a licensed pest control operator.

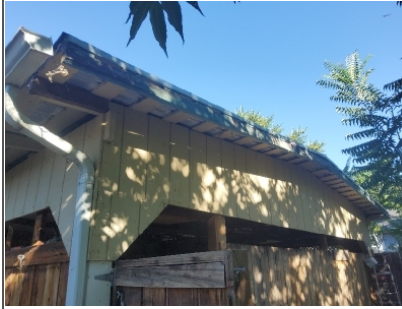
Moisture damage is evident on fascia, recommend repair

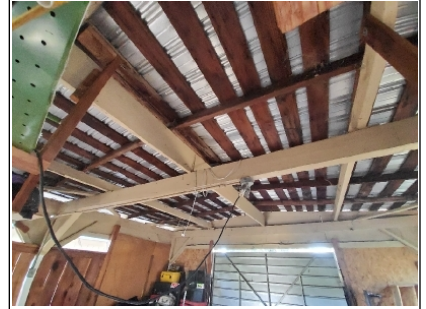
Active roof leaks are evident, but structurally of no concern.
