## Home Inspection Report

**4541 Patria Dr**

**San Diego, CA 92115**

Inspected On: Tue, Sep 29 2026 at 1:00PM

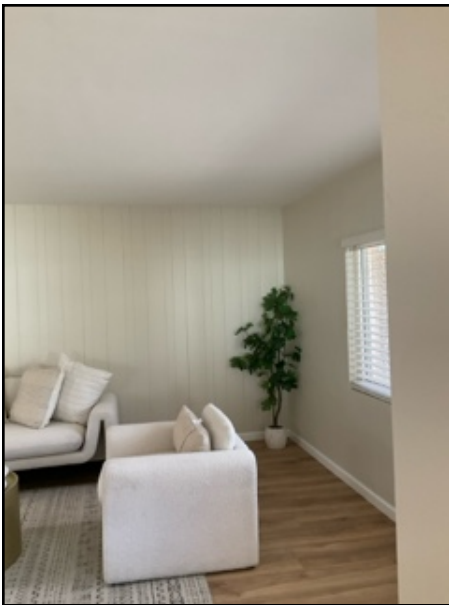
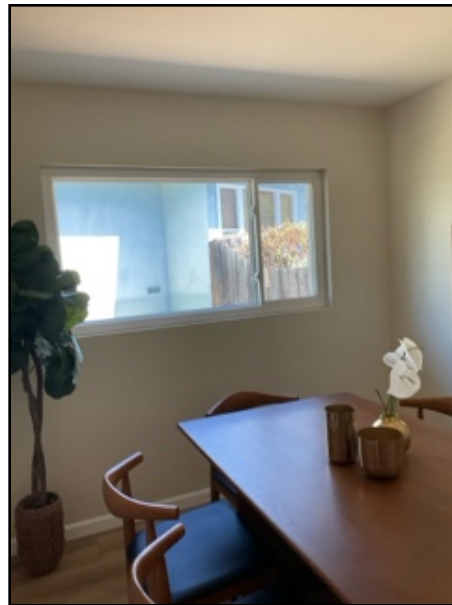
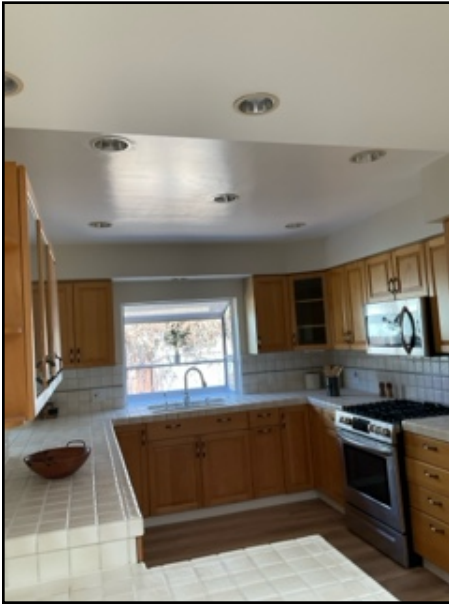
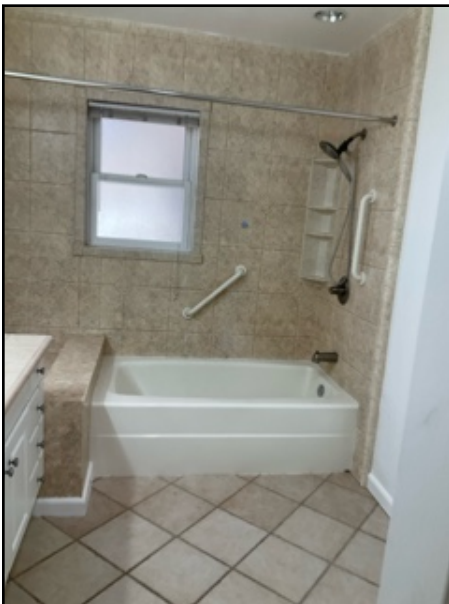
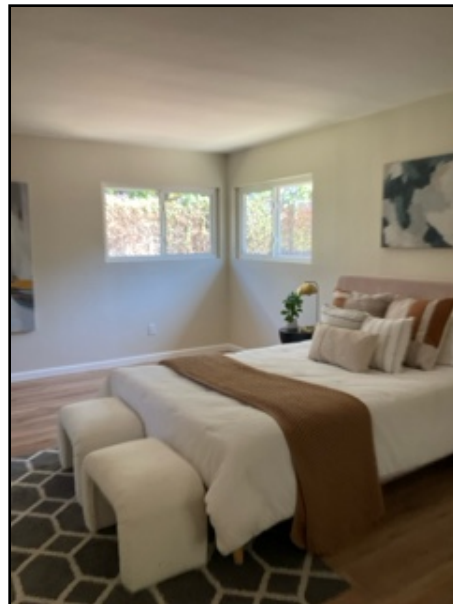
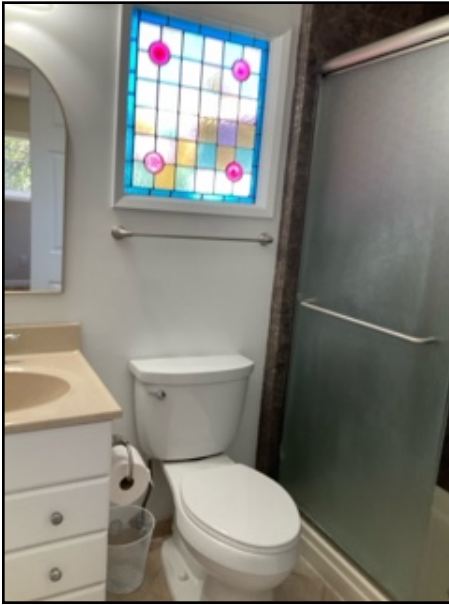
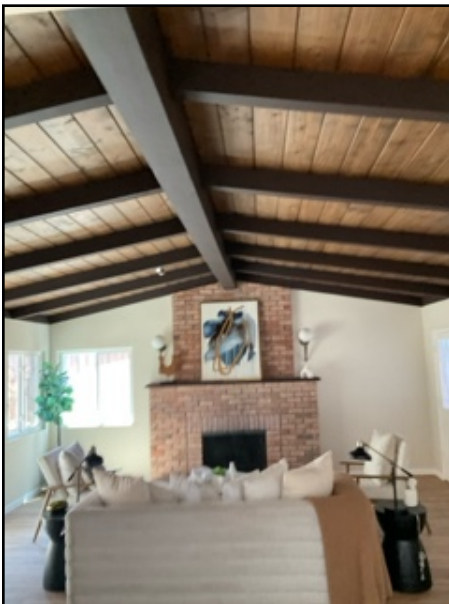
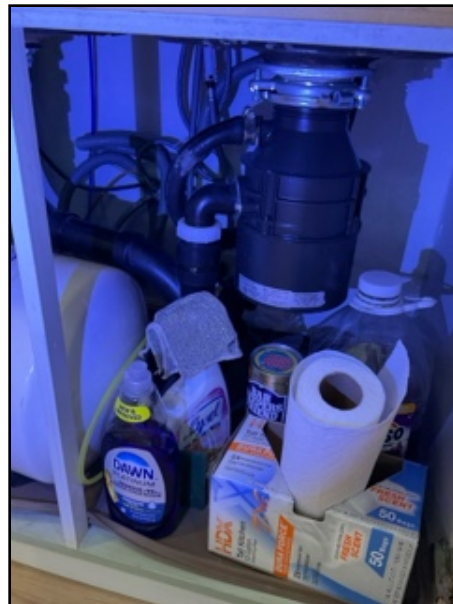
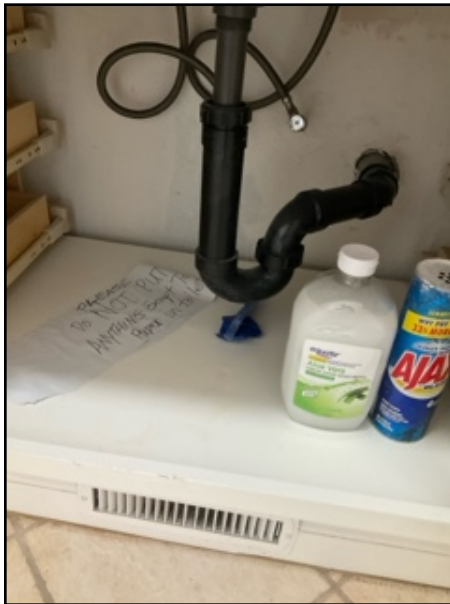
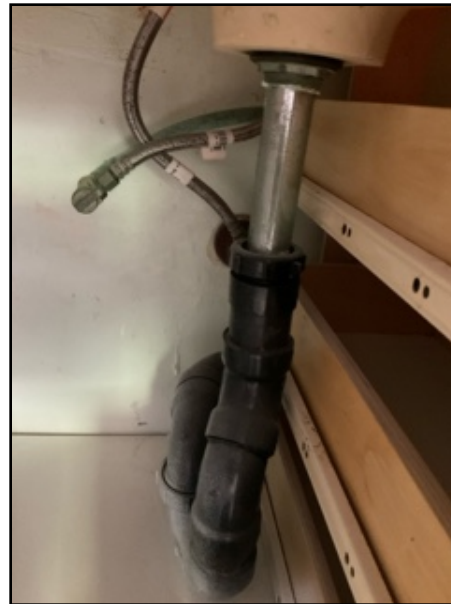
Personal property present at time of inspection, some areas and systems are not fully visible due to current occupants personal items.

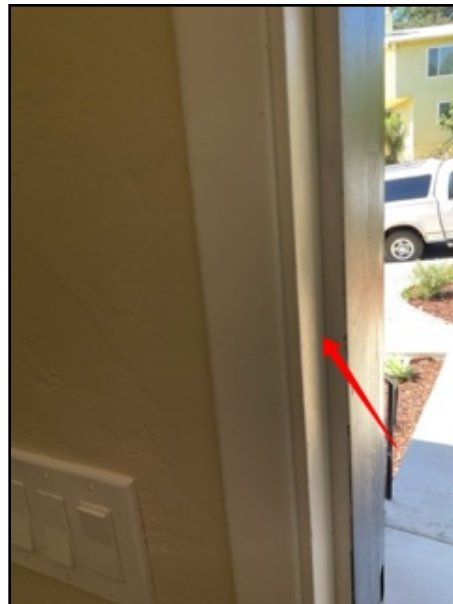
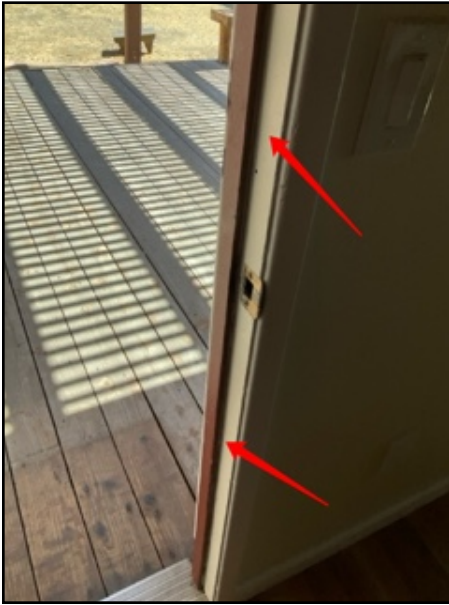
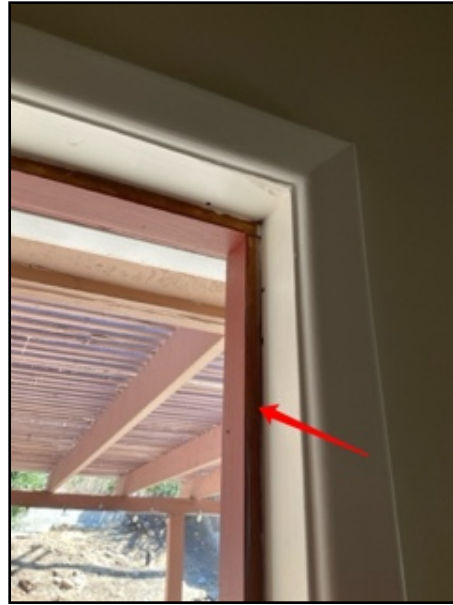
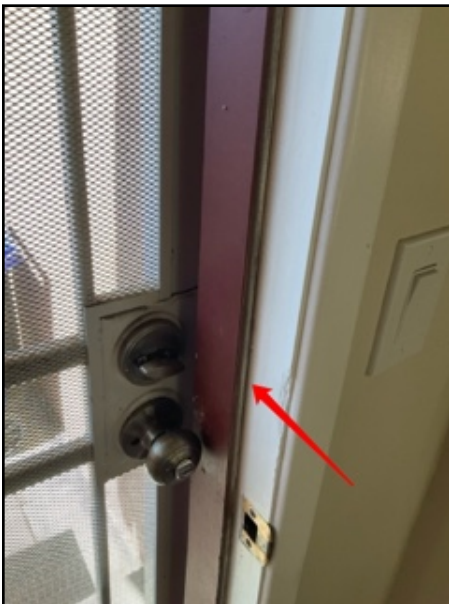
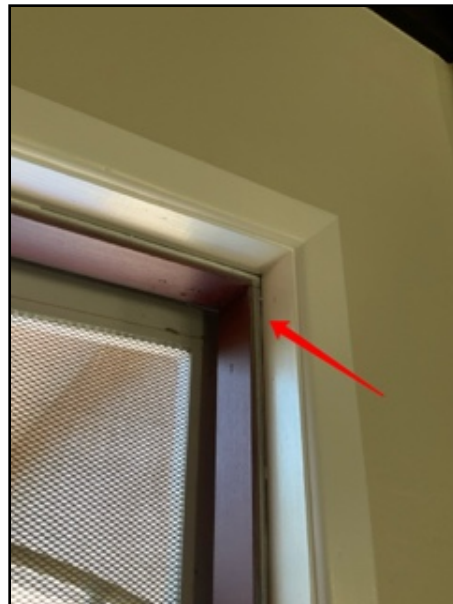
REPAIR OR REPLACE: Weatherstripping noted as not installed on exterior doors.

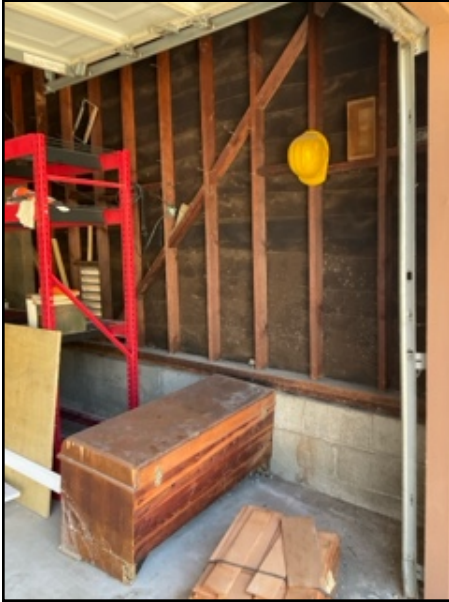
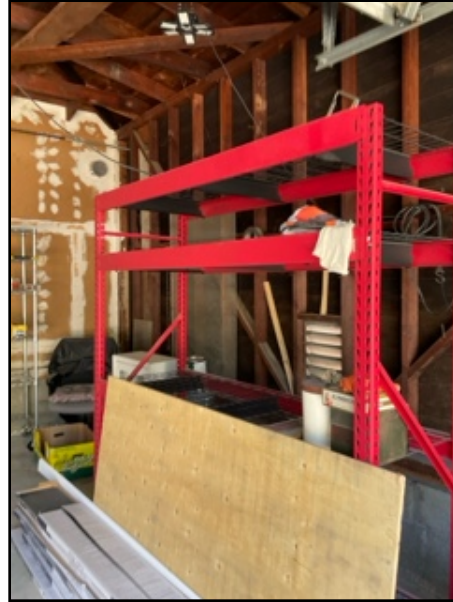
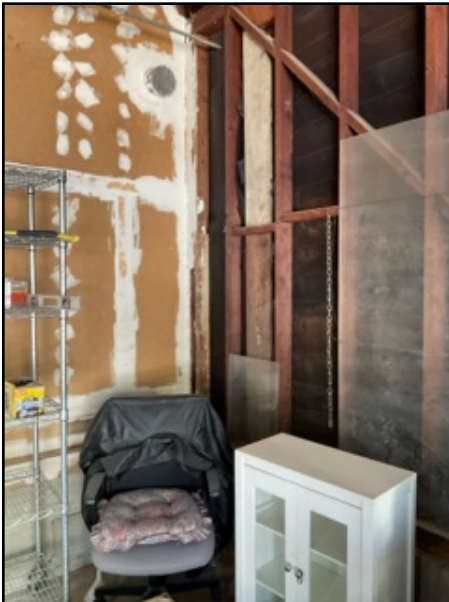
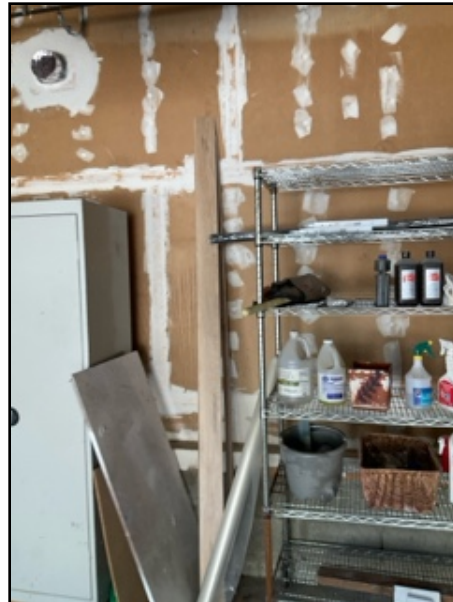
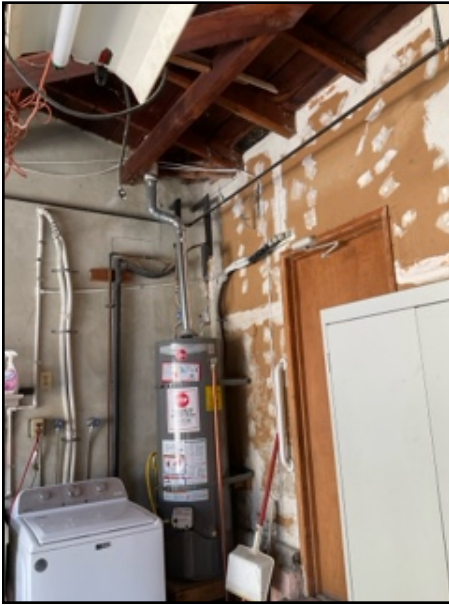
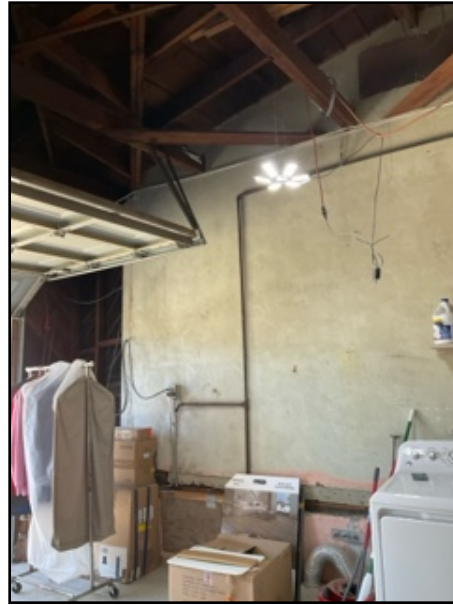
Personal belongings stored in garage prevented inspection of some aspects of the garage.

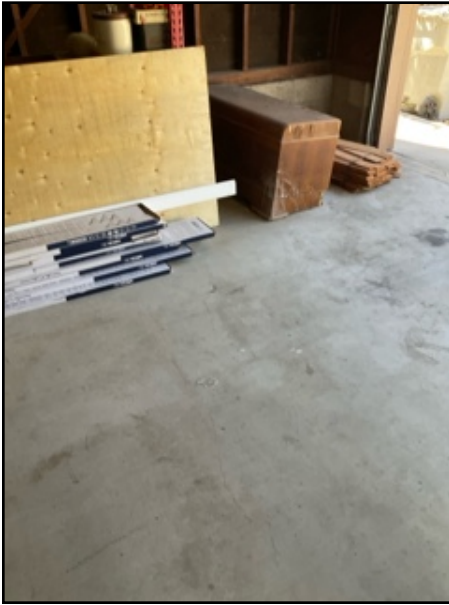
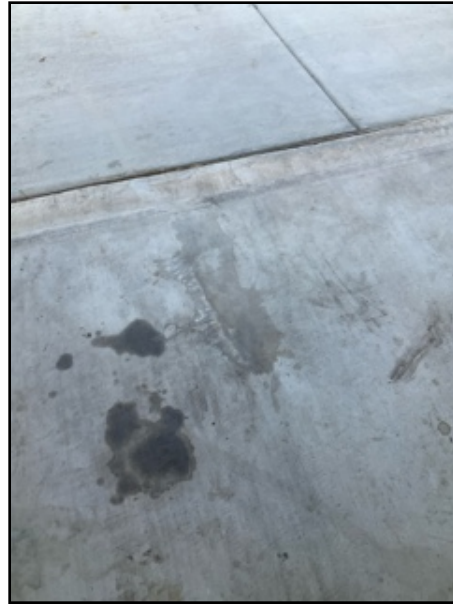
Comment 16:  
Cracks and stains noted at garage floor.

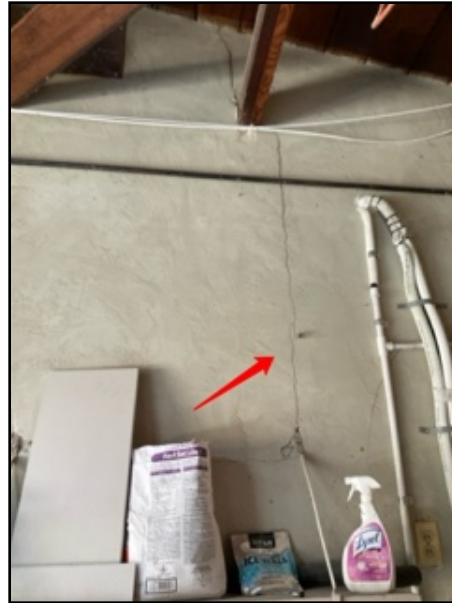
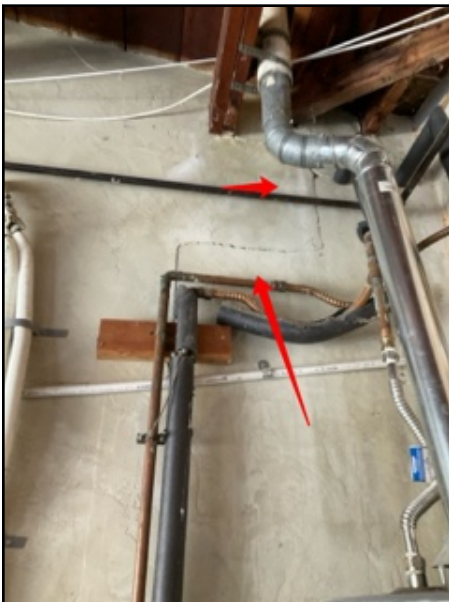
**FURTHER EVALUATION REQUIRED:** Evidence of possible wood destroying organisms noted on garage, wood framing. Cracks noted on concrete interior wall near water heater.

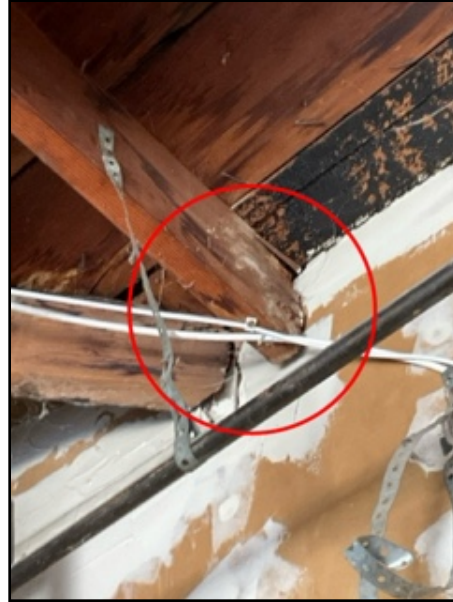
Figure 19-2

**Comment 19:**  
**FURTHER EVALUATION REQUIRED:** Evidence of possible wood, destroying organisms/dry rot noted on roof framing.

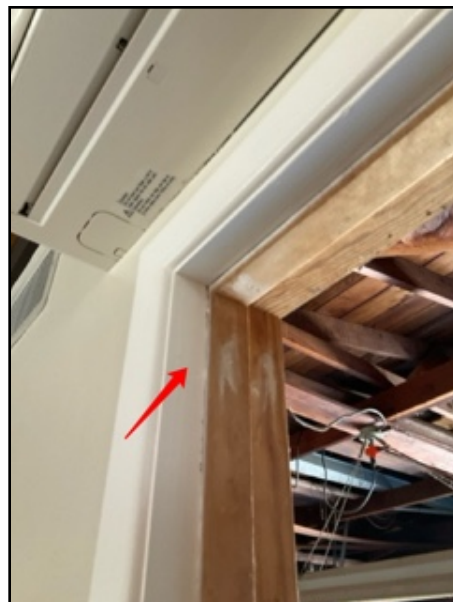
Figure 20-2

**Comment 20:**  
**REPAIR OR REPLACE:** Weatherstripping noted as not installed on garage entry door.

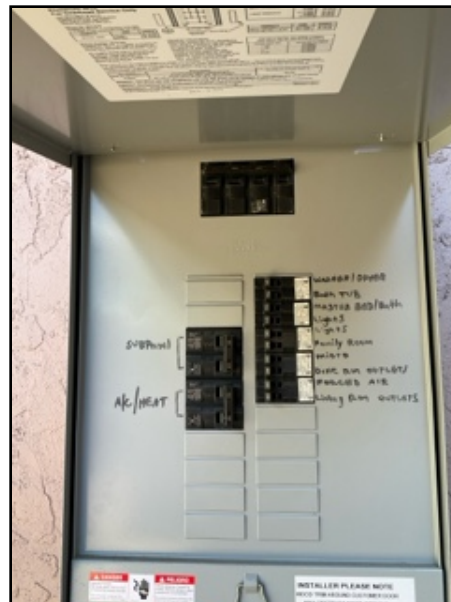
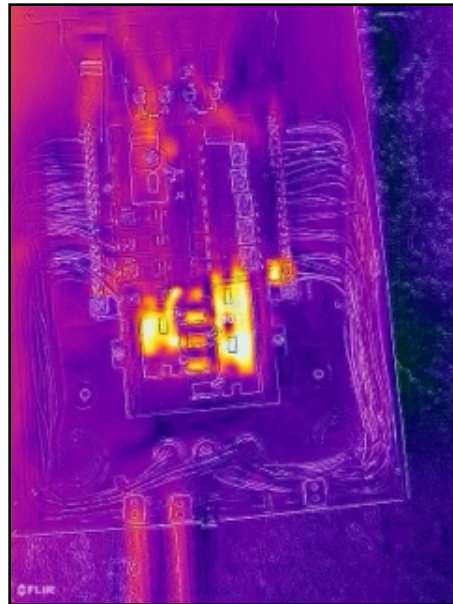
Service panel inspection pictures. A thermal scan was conducted and no significant hot spots were noted.

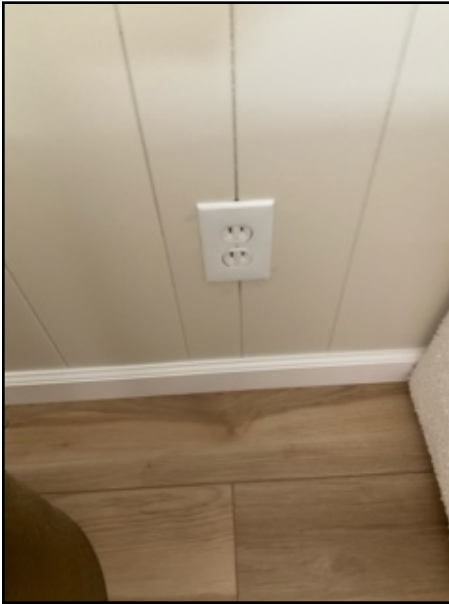
Parts of the electrical system are not grounded. While grounding may not have been required at the time of construction, ungrounded outlets must match the panel configuration in order to ensure that adequate safety precautions have been taken. Two-pronged outlets, individual grounding at three-pronged outlets, or the installation of GFCI protection is adequate in the appropriate circumstances.

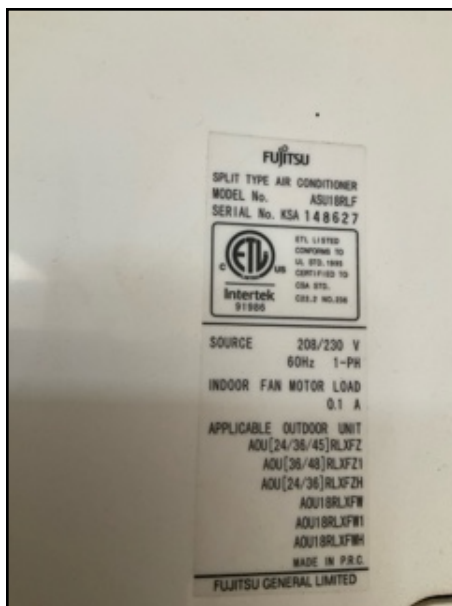
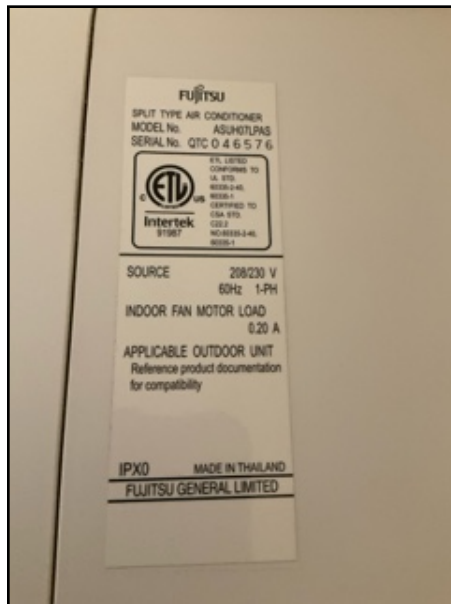
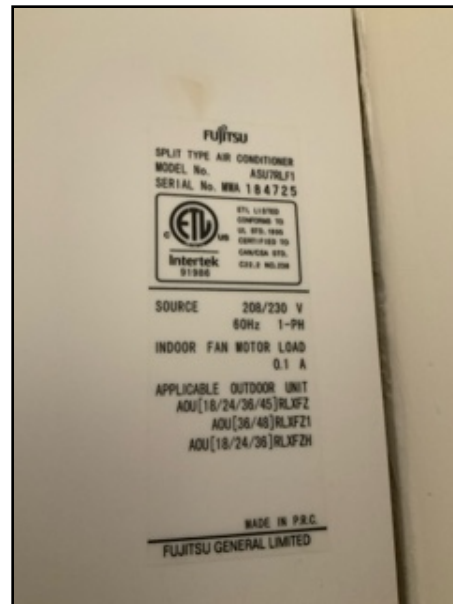
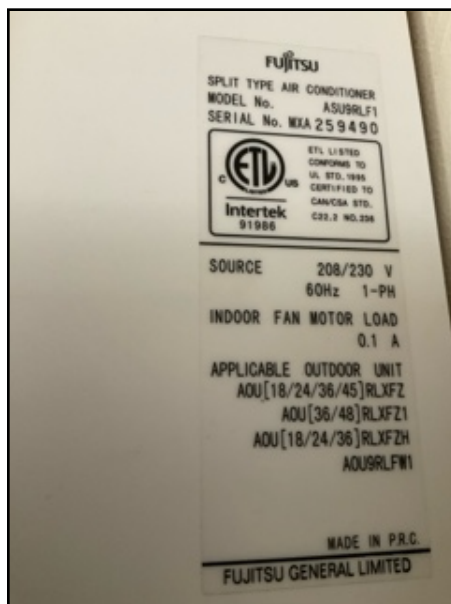
Heater data plate picture.

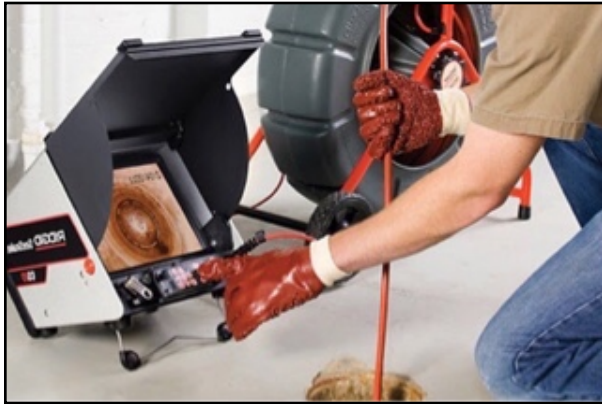
Figure 37-1

Visible and apparent leaks are noted under separate comments. In order to see the inside of drain lines the main sewer line may be inspected by a qualified technician with modern endoscopic video equipment.

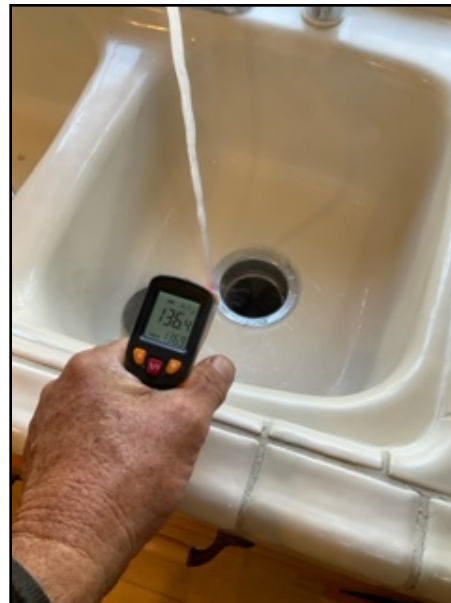
Figure 38-2

Water temperature was 136°F. Most appliance manufacturers recommend a temperature of around 120°F. Generally temperatures above 130°F are considered unsafe.

FURTHER EVALUATION REQUIRED: Thermostat on water heater noted as set to the A setting at time of inspection. Water temperature reach 136°F. Inspector recommends turning down thermostat to recommended manufactured setting.

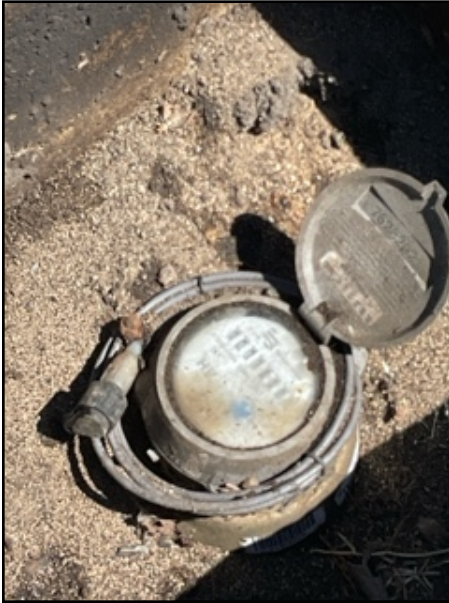
Figure 39-1

Main water meter with leak detector.

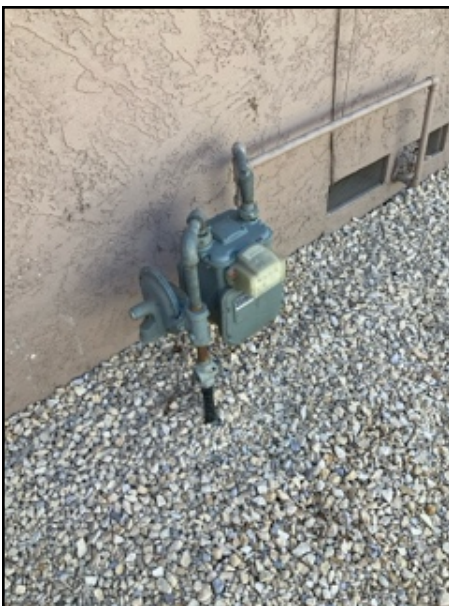
Figure 40-1

Main gas shut off.

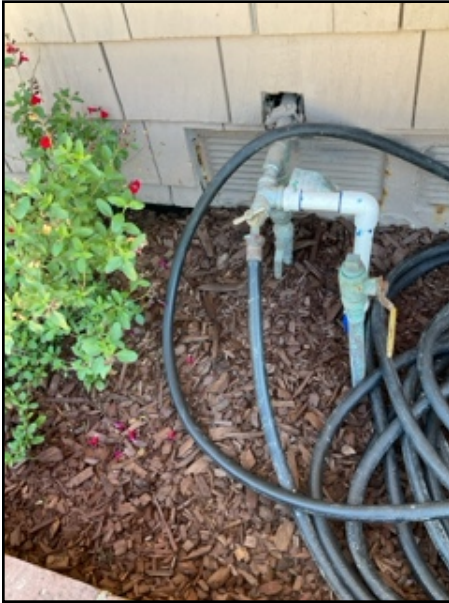
Figure 41-1

Comment 41:  
Main water shut off.

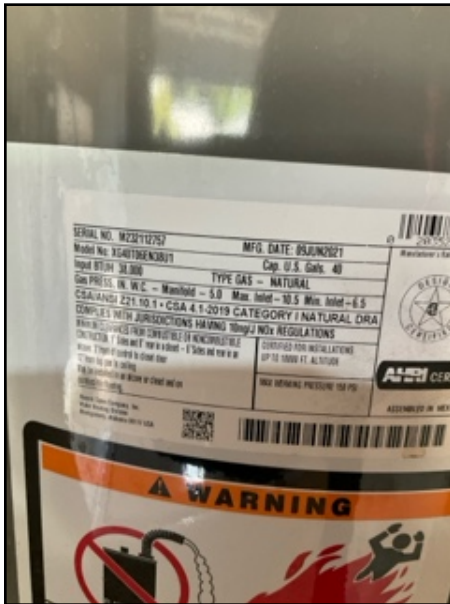
Figure 43-1

Water Heater Data Plate Pictures:

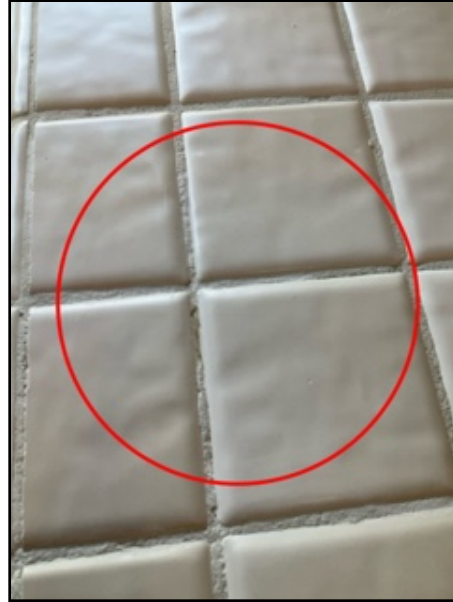
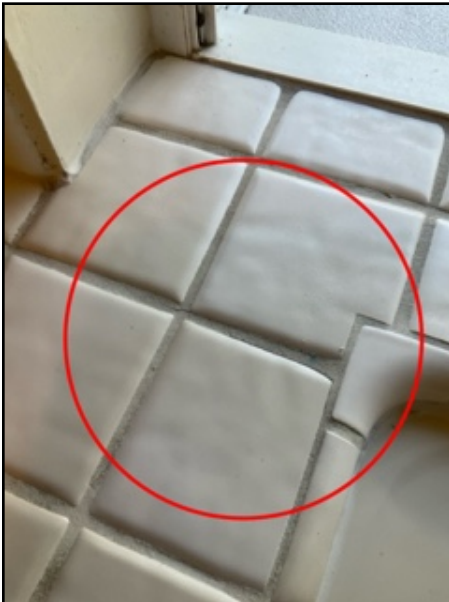
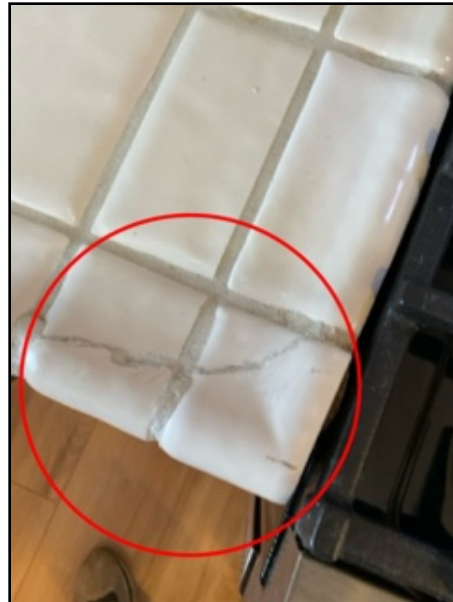
Figure 55-2

REPAIR OR REPLACE: Tile countertop noted as cracked. Grout between tile noted as deteriorated.

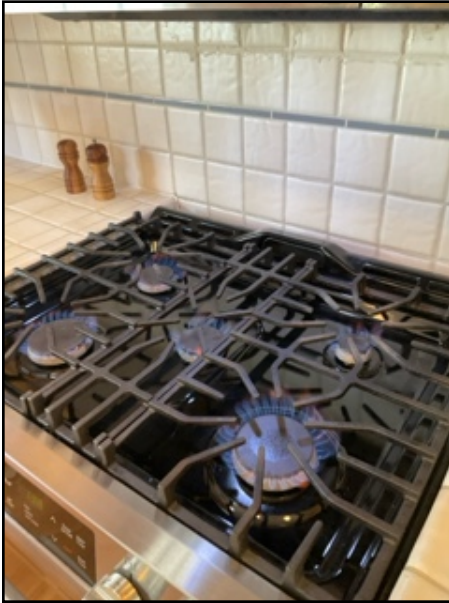
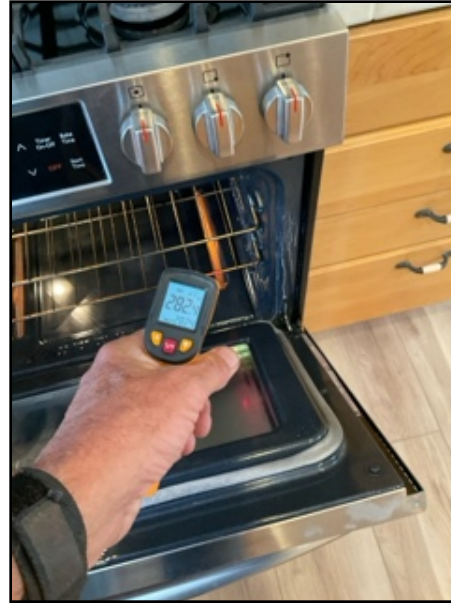
Figure 57-1

Comment 57:  
Range working.

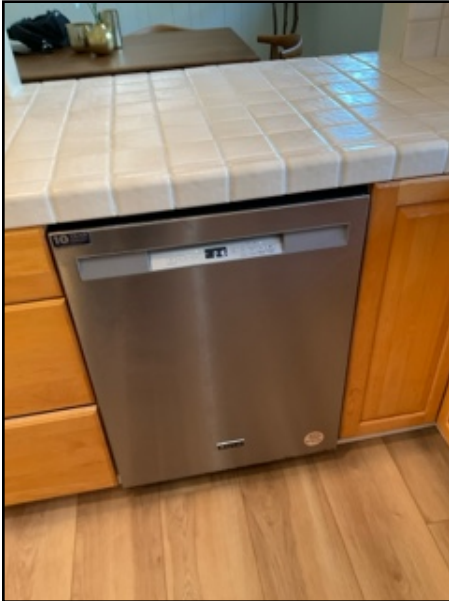
Figure 59-1

Comment 59:  
Dishwasher working.

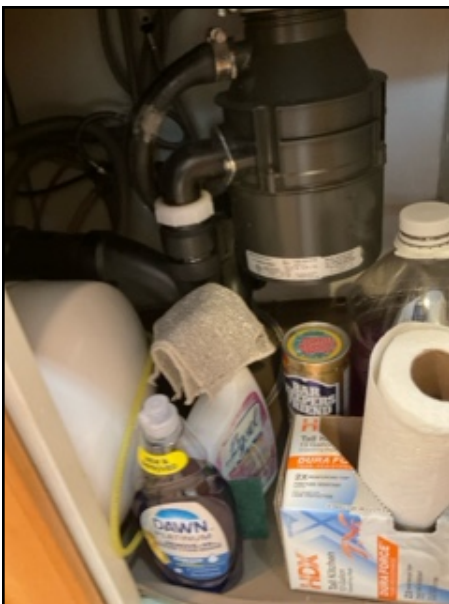
Figure 60-1

Comment 60:  
Garbage disposal working.

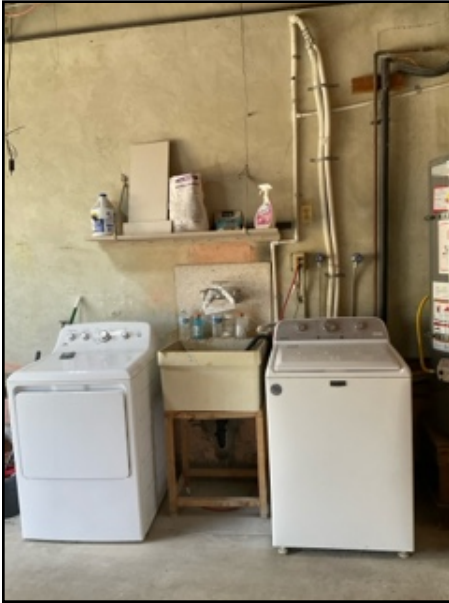
Figure 61-1

Comment 61:  
Laundry in garage.

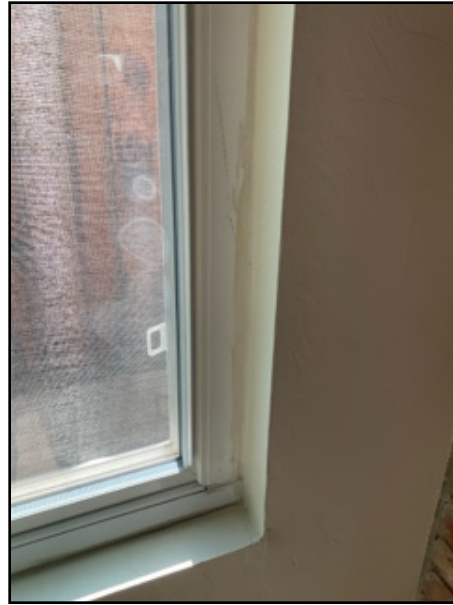
Figure 64-6

Minor paint, drywall damage, burned out bulbs, broken/missing covers and other minor cosmetic defects noted at various locations throughout the home.

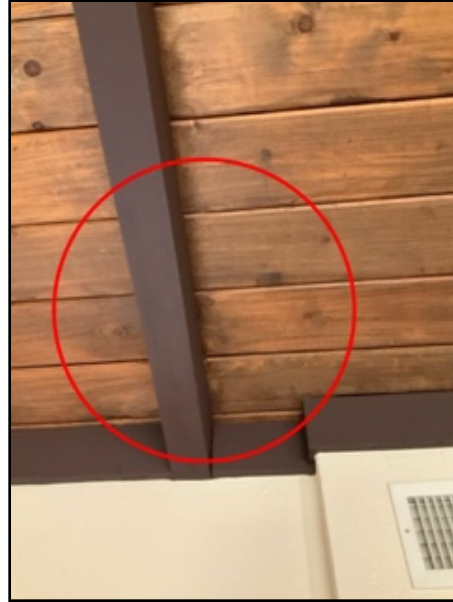
Figure 65-2

**Comment 65:**  
**FURTHER EVALUATION REQUIRED:** Evidence of possible wood destroying organisms noted on interior wood ceiling.
