### *Inspection Report*

Address: 2325 Warm Springs Ln Templeton, CA 93465

10/03/2026

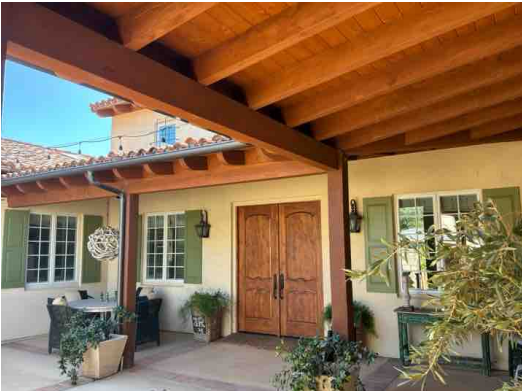
**27: FRONT PORCH COVER:** Appears serviceable and in good condition.

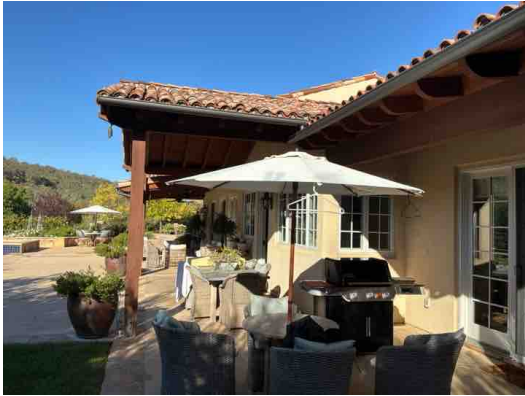
**28: BACKYARD PATIO COVER:** Appears serviceable and in good condition.

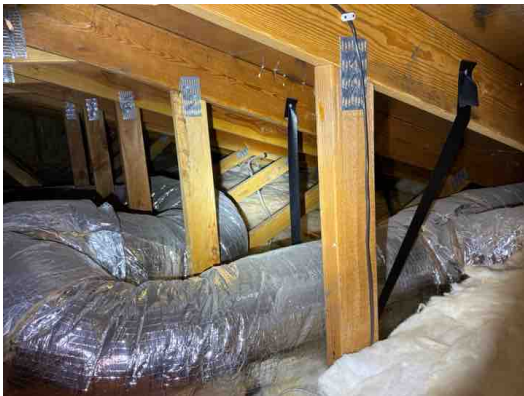
51: **ATTIC ACCESS LOCATION:** Laundry Room, Garage, Primary bedroom closet, and Front entry

52: **VISIBLE ATTIC FRAMING:** No noted framing defects found in the accessible and visible areas of the attic.

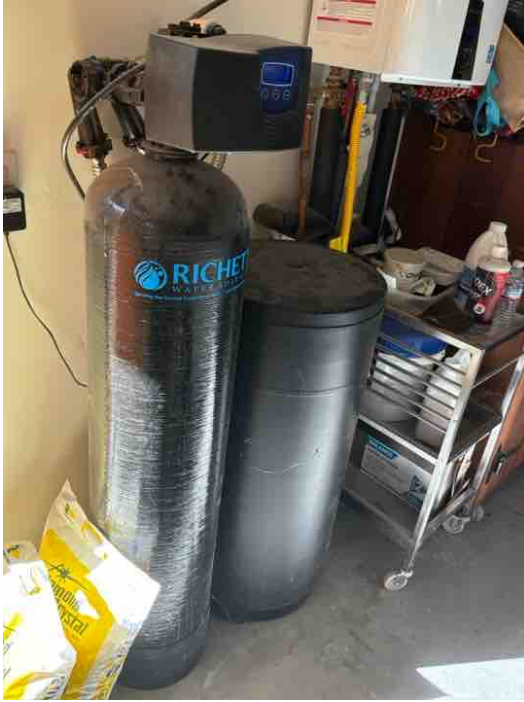
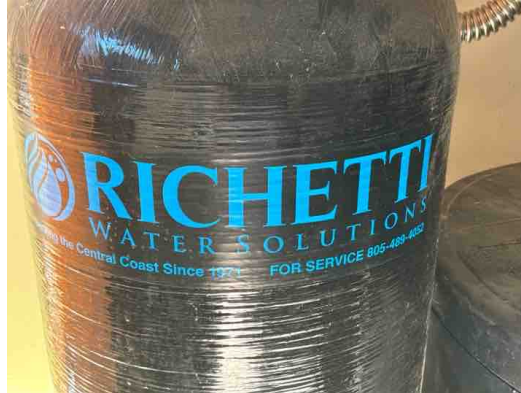
**DS 68:** Water softener installed in the Garage

**MR 69:** Recommend servicing water softener. Water softener found low on salt and dirty.

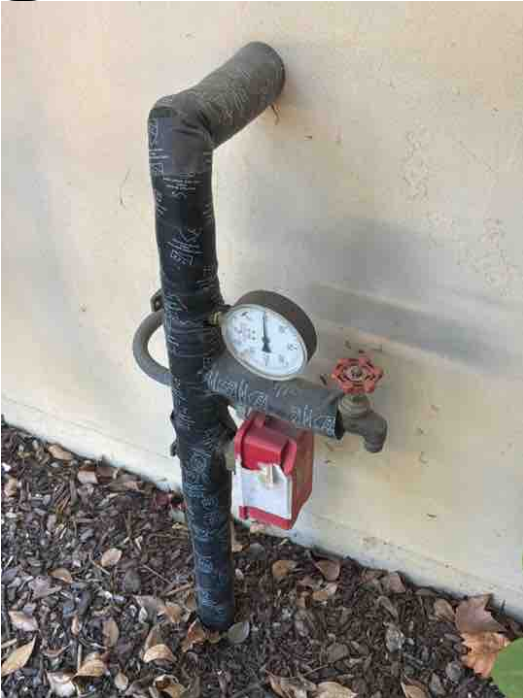
**DS 73:** Fire sprinkler alarm electric bell box, pressure gauge, drain valve are installed on the exterior.

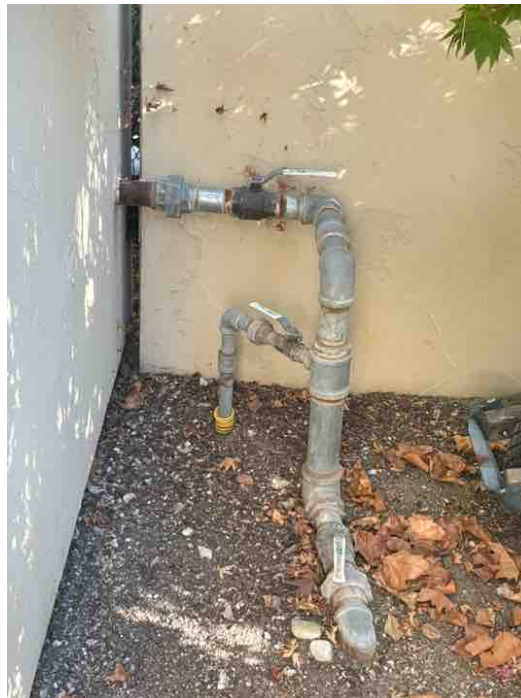
**77:** Gas shut-off appears serviceable.

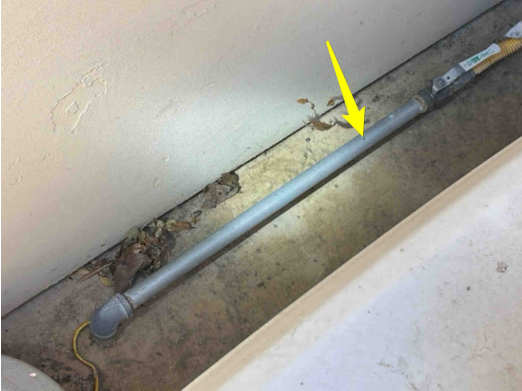
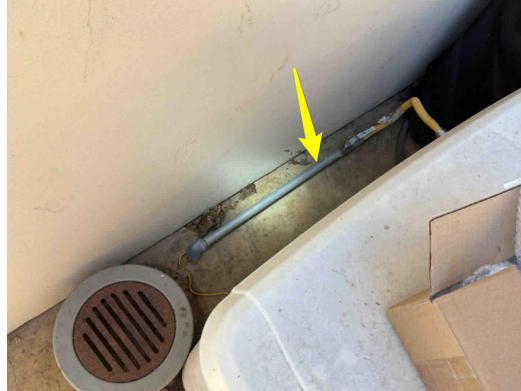
**SU 78:** Gas piping found not properly strapped or supported per standards AT THE HORIZONTAL GAS SUPPLY FOR THE GENERAC GAS ELECTRIC GENERATOR LOCATED ON THE NORTH SIDE OF THE GARAGE. [CPC Table 1210.2.2] California plumbing code requires steel gas piping to be supported at appropriate intervals not exceeding 6 feet. Lack of proper support can result in pipe movement, joint stress, and increased risk of gas leakage.

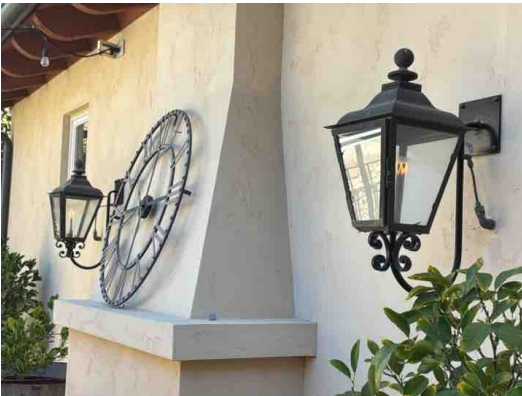
**81:** The TWO exterior wall gas torch lamps at the courtyard fireplace operated when tested.

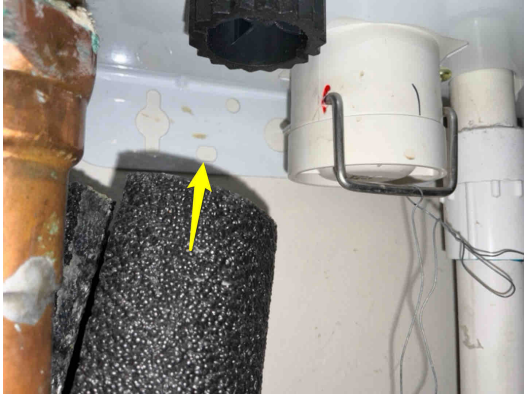
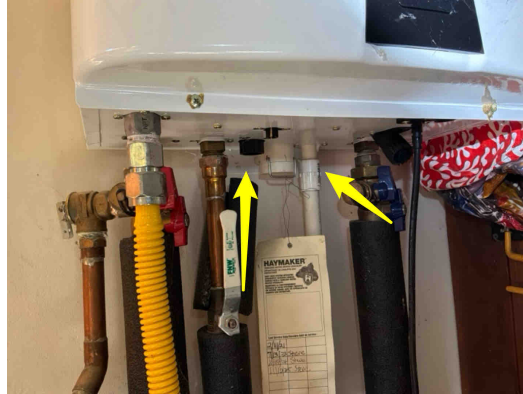
Example

**E&C 85:** The TANKLESS water heater is NOT properly fastened to the wall at the BOTTOM STRAP with the appropriate number and/or type of fasteners. Refer to manufacture's installation requirements for proper fastening.

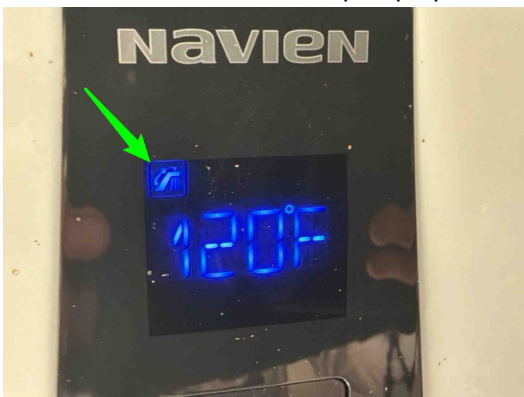
**88:** Water heater circulation pump operated when tested.

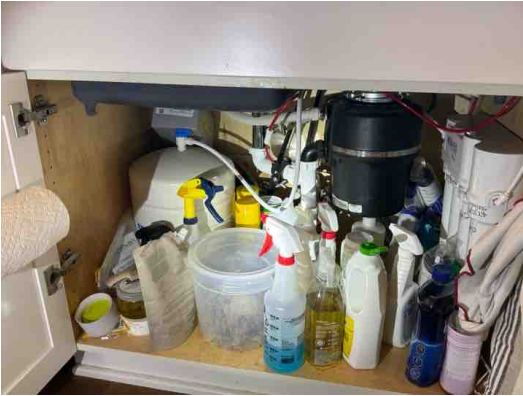
**94:** Plumbing under the kitchen sink appears to be installed correctly and is functioning.

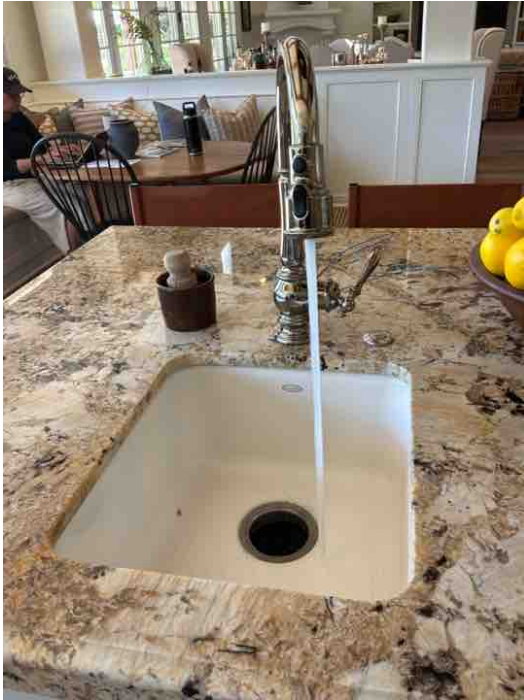
97: The kitchen Island sink appears serviceable with typical wear for its age.

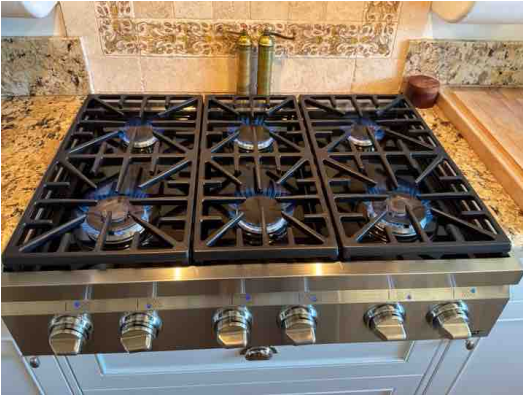
**101:** The cooktop is Natural Gas and operated when tested

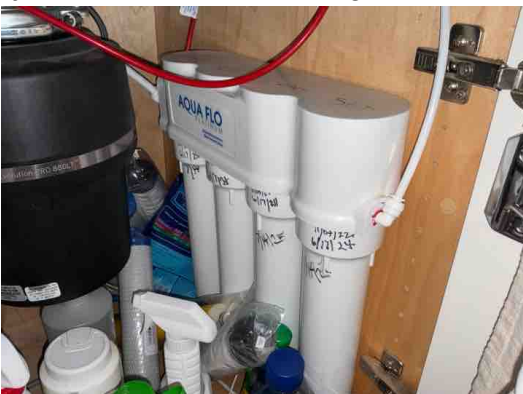
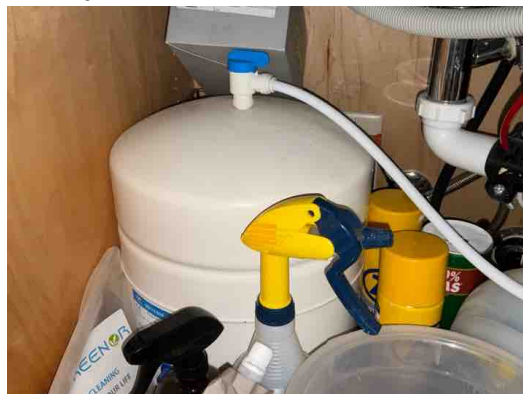
**MR 109:** The kitchen sink water purification system, reverse osmosis, operated when tested. *Reverse osmosis system filters should be changed and serviced annually.*

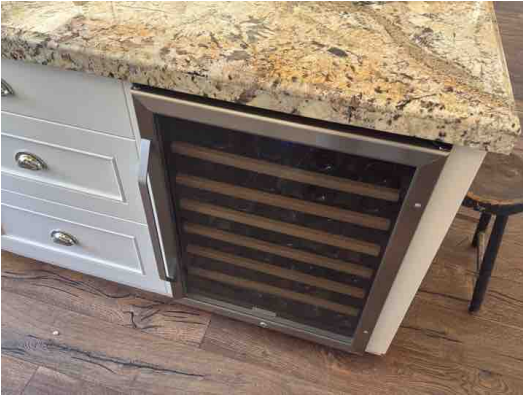
**110:** The WINE REFRIGERATOR installed in the KITCHEN operated when tested.

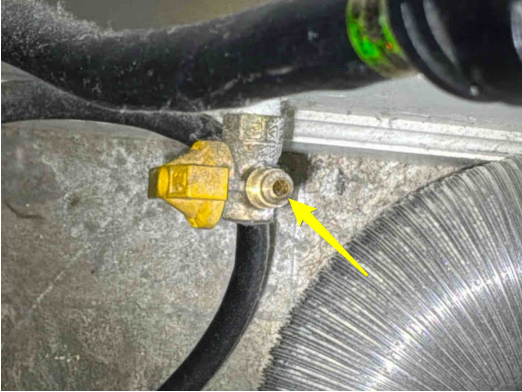
**SC 116:** A proper cap is missing at an unused gas valve per standards at the LAUNDRY. This can allow the gas valve to be accidentally turned on slightly creating a gas leak behind the laundry.

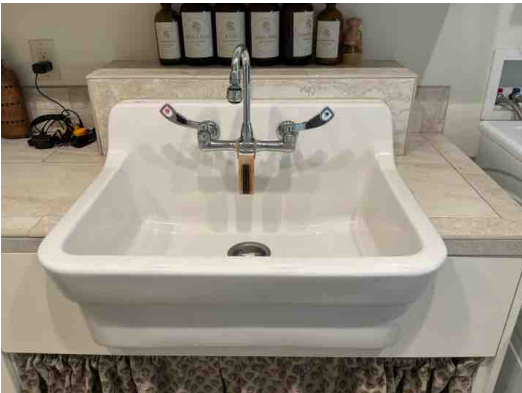
**119:** Laundry Room Utility Sink appears serviceable.

**120:** Plumbing below the utility sink appears serviceable.

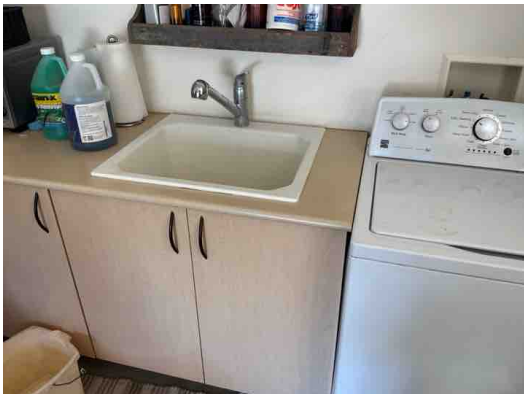
**126:** Garage Utility Sink appears serviceable.

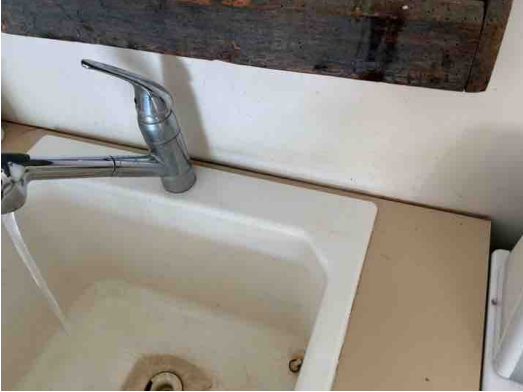
**MR** **UPG** **128:** Recommend sealing the countertop at the GARAGE LAUNDRY SINK to the wall to prevent water intrusion behind the laundry sink cabinets.

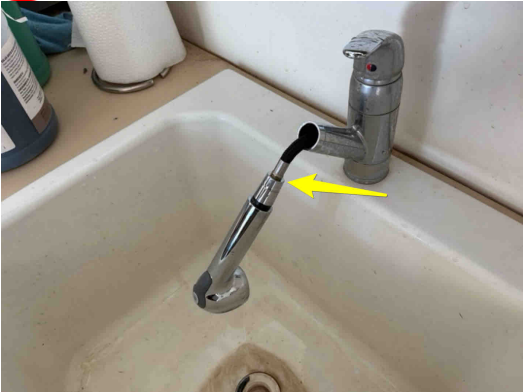
**E&C** **129:** The spray wand leaks at the hose connection at the GARAGE LAUNDRY SINK

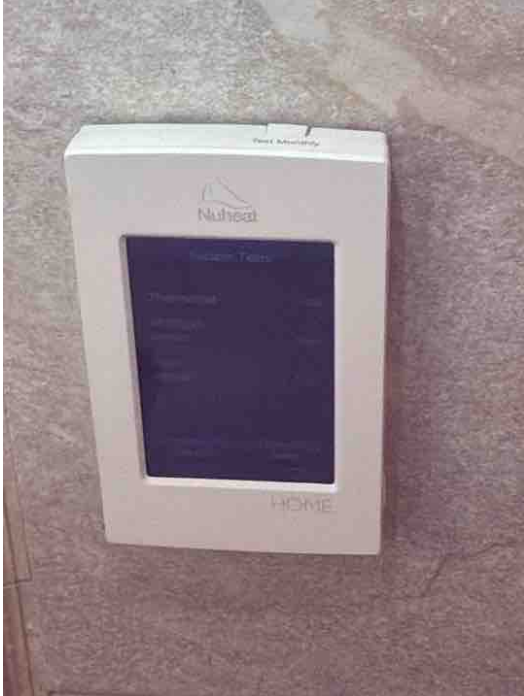
**FI 137:** The electric radiant floor heating system DID NOT OPERATE when tested: PRIMARY BEDROOM BATHROOM

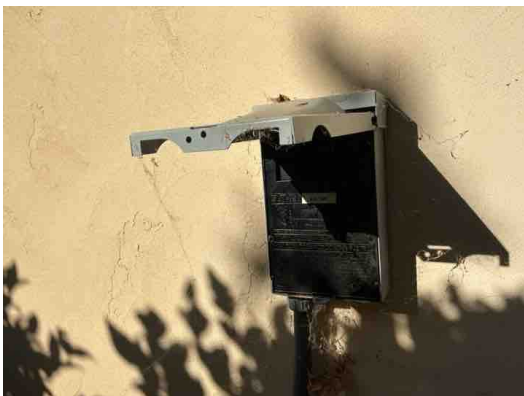
**169:** Electrical Disconnect Provided

**SU 170:** Missing bushing clamp as wires are passing into the AIR CONDITIONER ELECTRICAL SERVICE DISCONNECT PANEL.

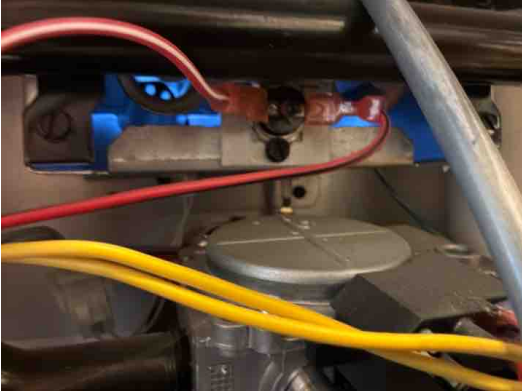
**UPG 194:** Recommend the installation of the sediment trap at the furnace gas piping at flex connection. Upgrades should be performed by a certified or licensed HVAC professional familiar with minimum requirements.

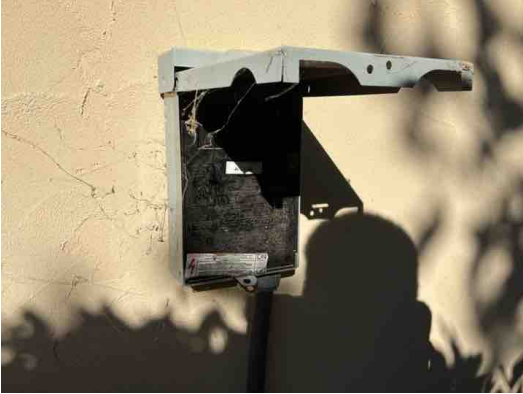
**203:** Electrical Disconnect Provided at or near the Equipment per standards.

**SU 204:** Missing a proper wire bushing clamp where the air conditioners electrical service wires pass into the metal electrical service disconnect box. Upgrades recommended for safety per minimum standards.

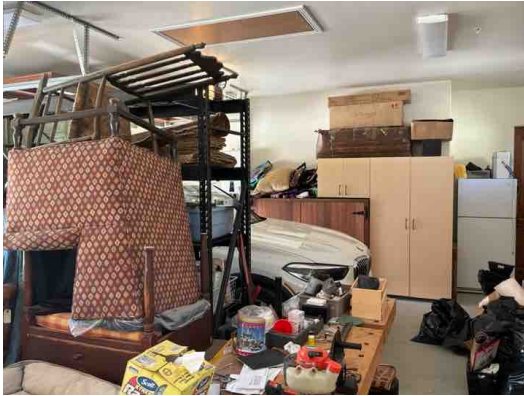
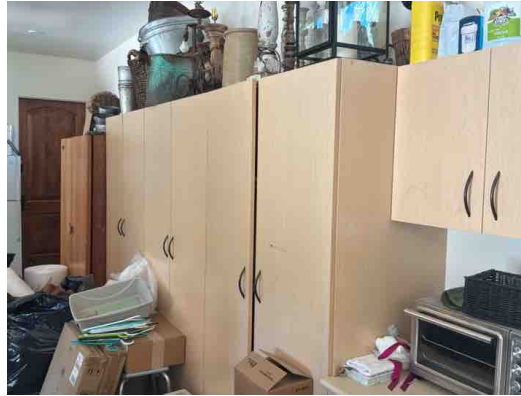
**DS** 233: Common cracks found in the concrete garage floor.

**DS 234:** The garage floor and walls are not fully visible due to occupants' belongings and/or cabinetry. Areas of the garage is not accessible, visible nor inspected. A re-inspection is recommended once full access is made available.

**DS 235:** Due to an excessive amount of stored items and/or cabinetry in the garage, the majority of the garage walls and/or floor, is not accessible, not visible, nor inspected. A re-inspection is recommended once access is made available.

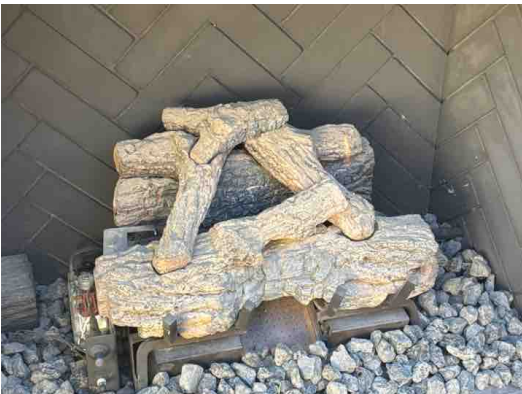
**E&C 250:** THE FIREPLACE CONDITION: The EXTERIOR - FRONT ENTRY COURTYARD GAS Fireplace did not operate when tested and found to be in need of servicing, maintenance and/or repair. Contact the Gas Company for a free evaluation or a qualified gas fireplace service technician to evaluate and correct as needed.

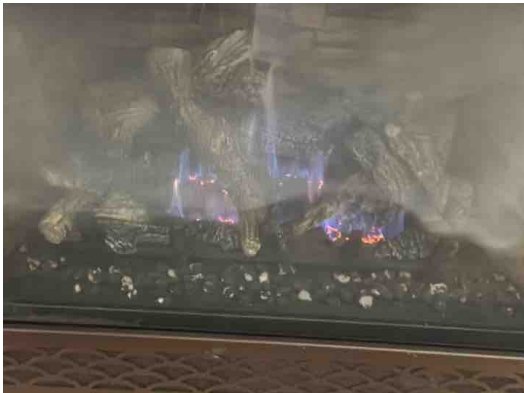
254: **GAS FIREPLACE CONDITION**: The FAMILY ROOM GAS fireplace operated when tested.
