## USA Home Inspectors

## Home Inspection Report

Prepared For:  
**Karen Saske**  
Property Address:  
**4669 Valencia Dr**  
**San Diego, CA 92115**  
Inspected On: Wed, Sep 2 2026 at 8:00AM

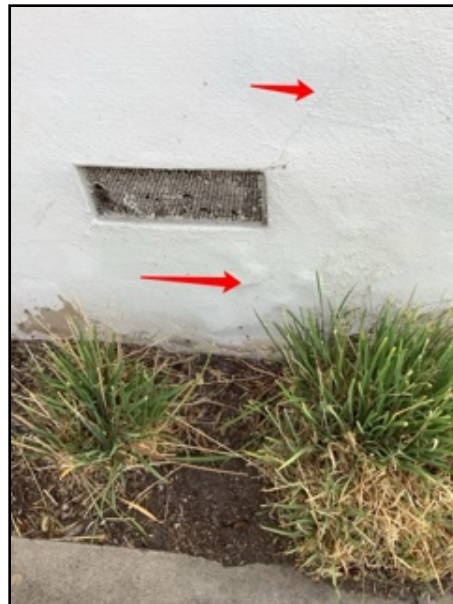
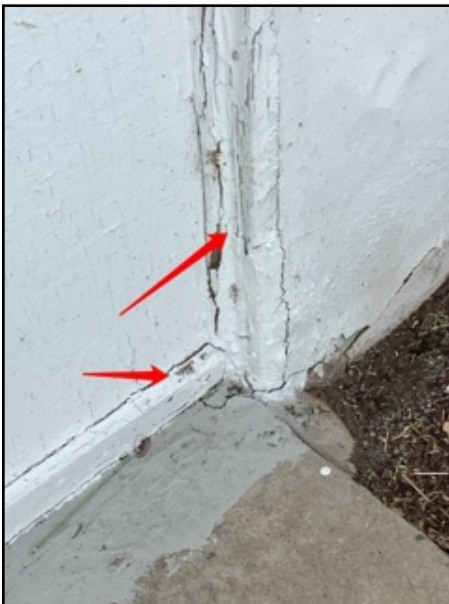
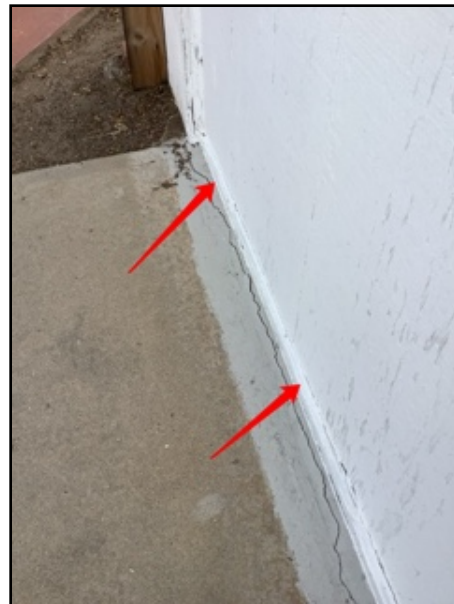
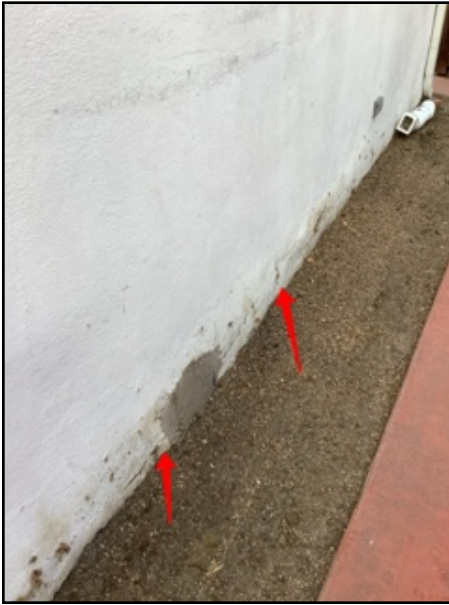
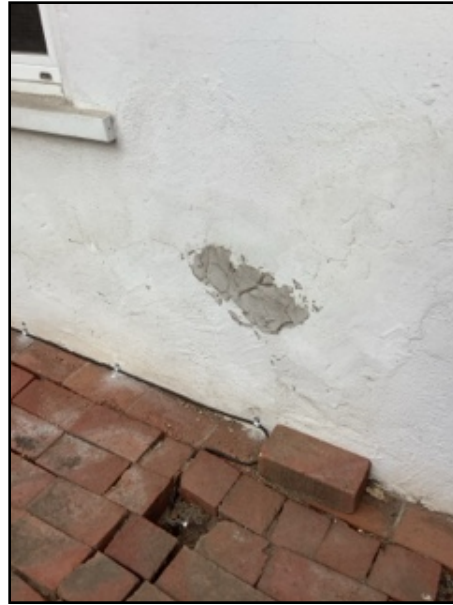
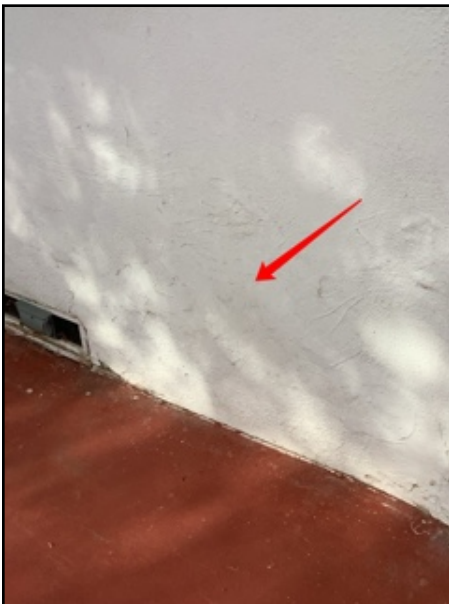
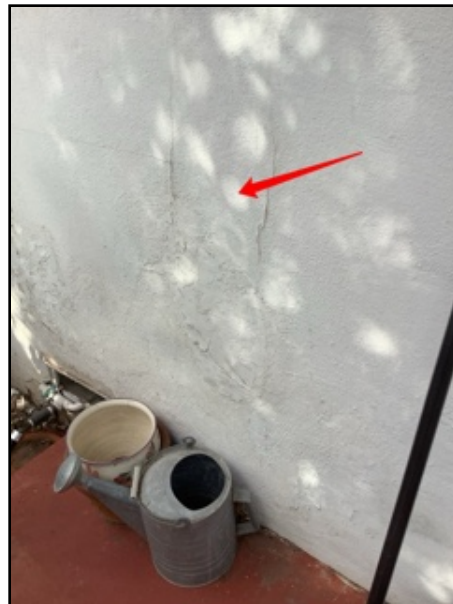
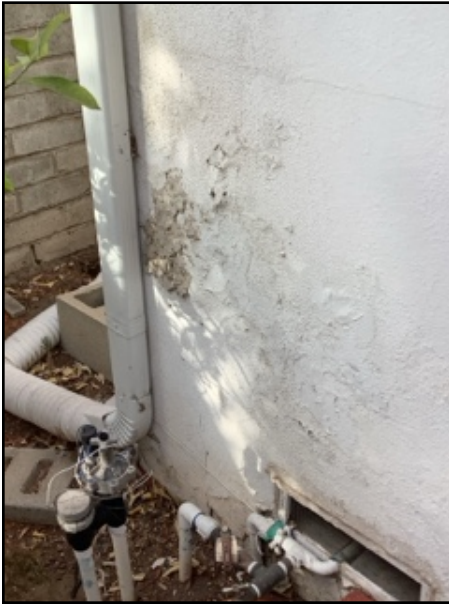
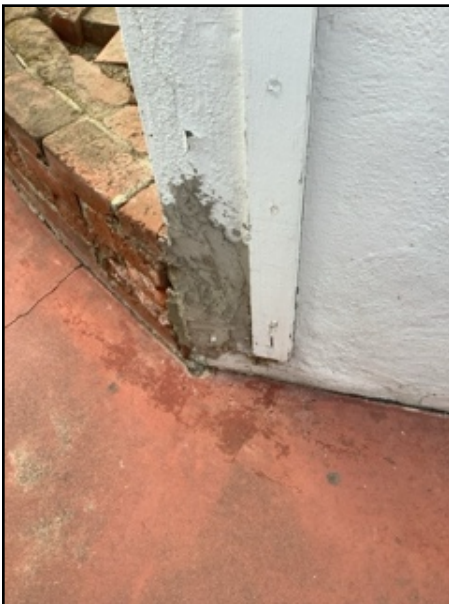
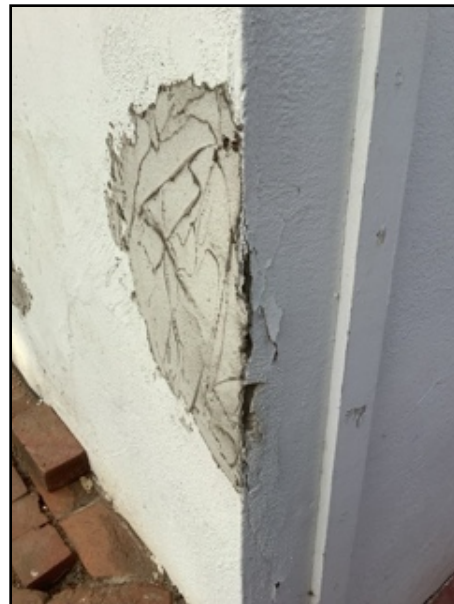
Defects such as peeling, holes, cracks, and patches noted at various places throughout exterior.

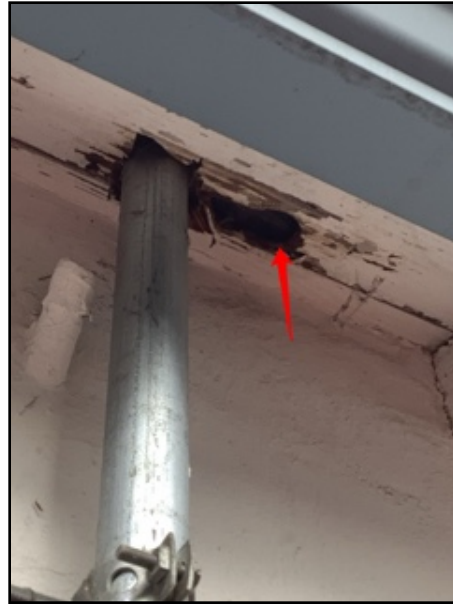
Figure 12-2

Pipes, wiring and holes penetrating exterior wall noted not sealed properly at wall. If penetration to exterior wall not sealed it leaves an opening for water intrusion and or insects.

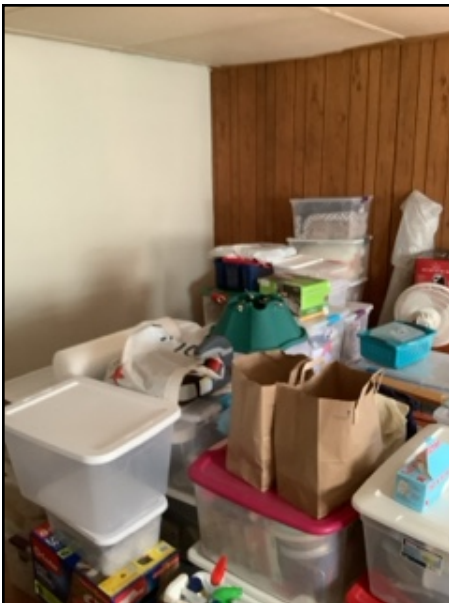
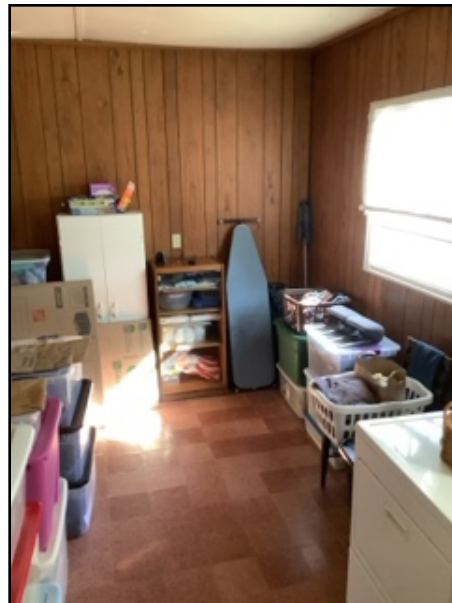
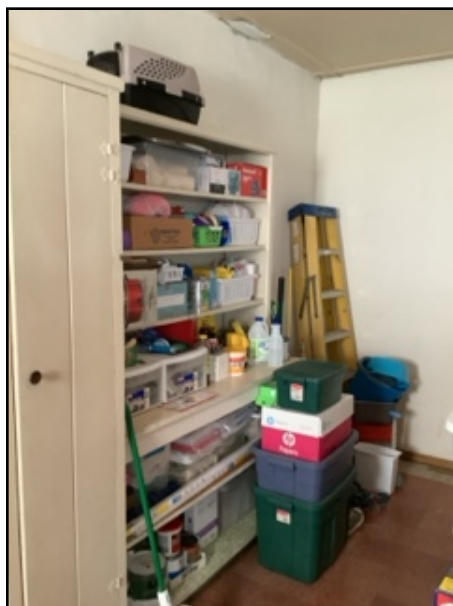
Personal belongings stored in garage prevented inspection of some aspects of the garage.

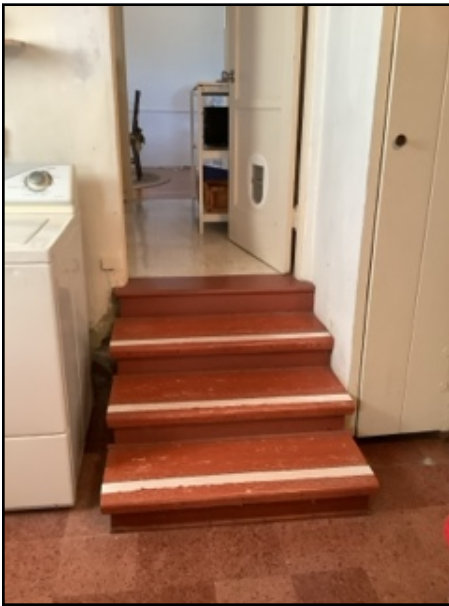
Figure 17-1

Although it may not have been required the time of construction, areas with a drop off greater than 30 inches or having four or more steps are required to have railings installed. Railings are to be non-climbable with balusters no more than 4 inches apart and no gap greater than 6 inches. No known retrofit requirement for this item is known at the time of inspection.

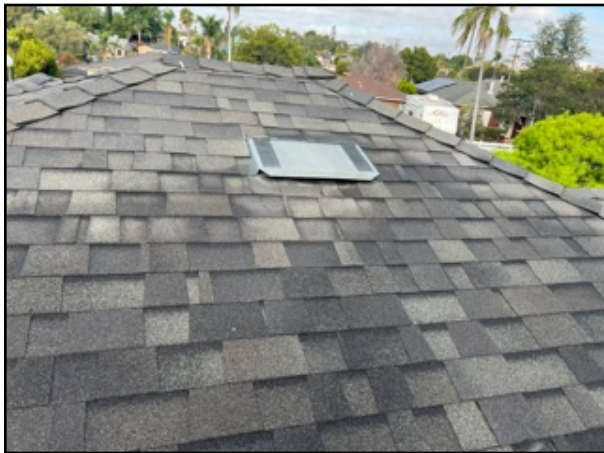
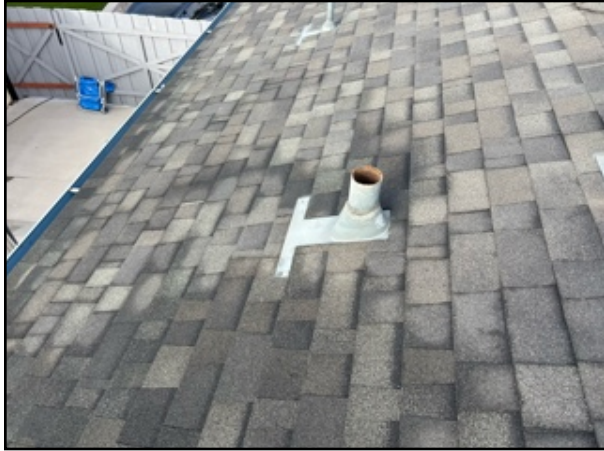
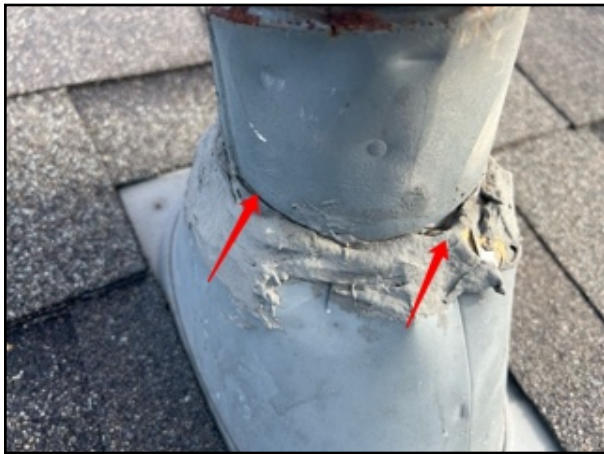
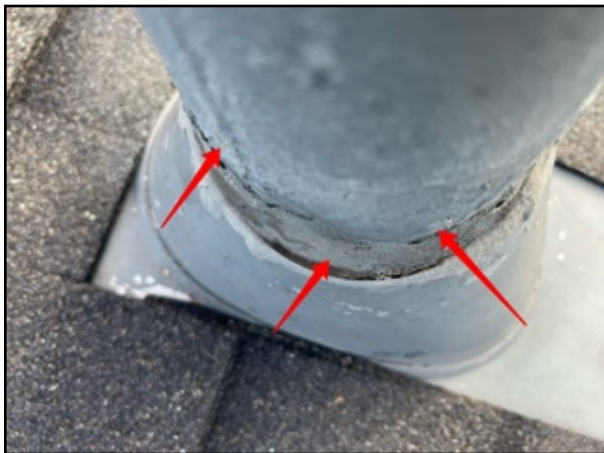
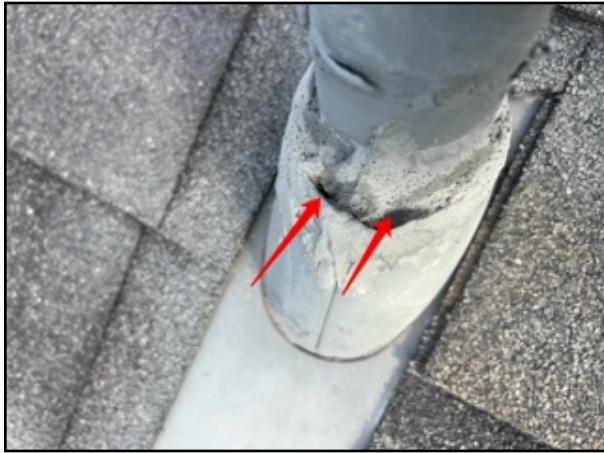
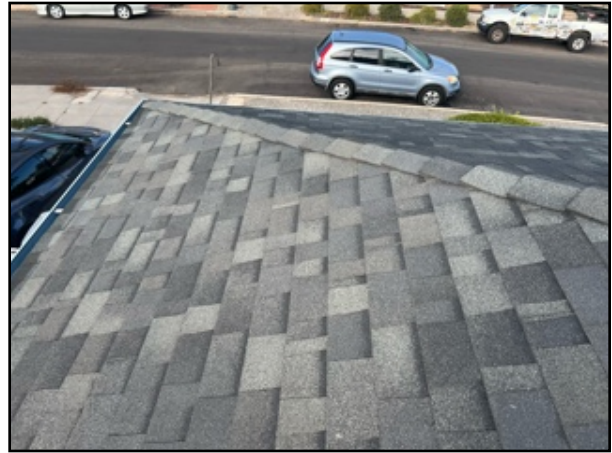
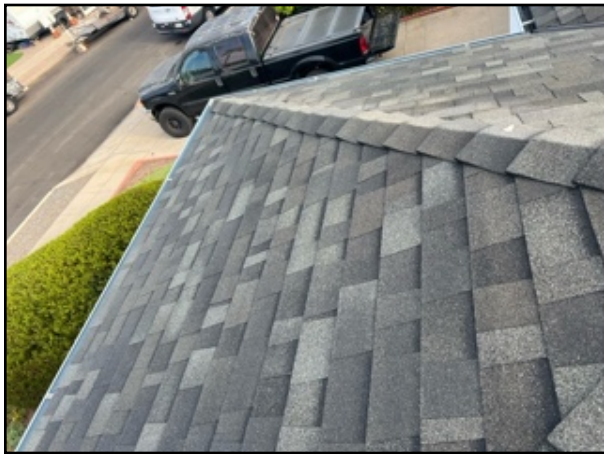
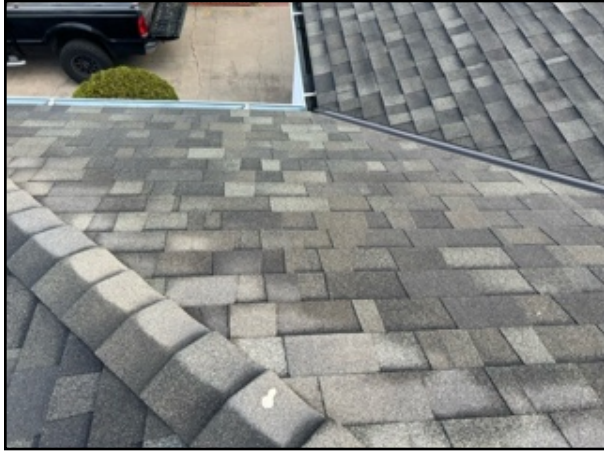
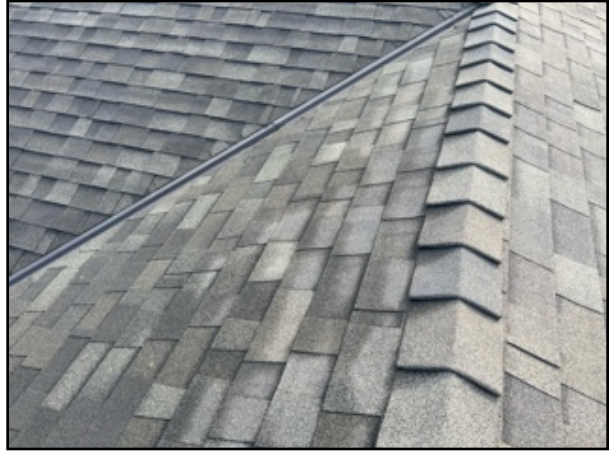
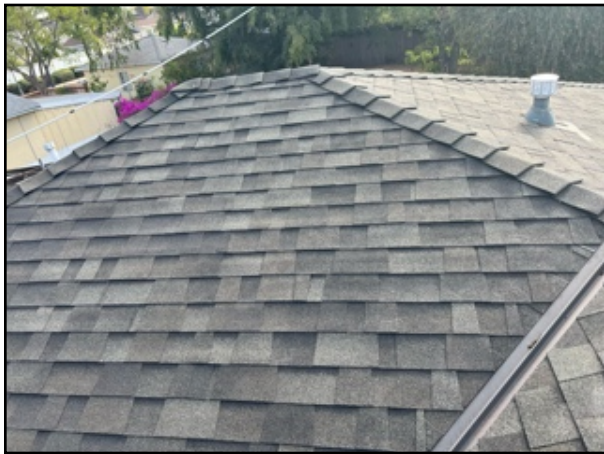
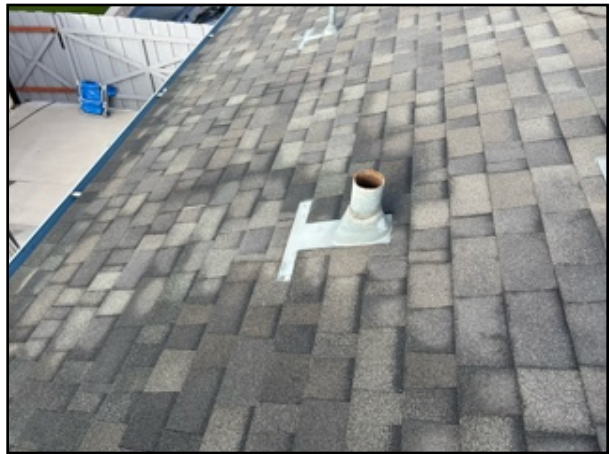
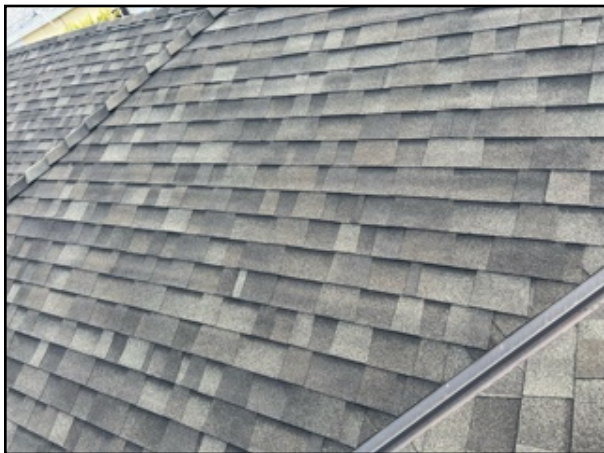
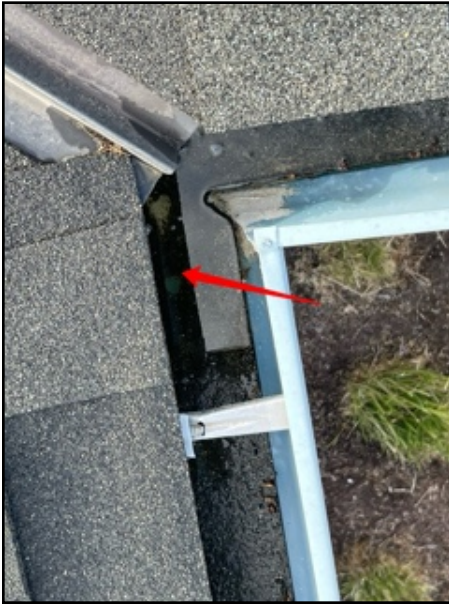
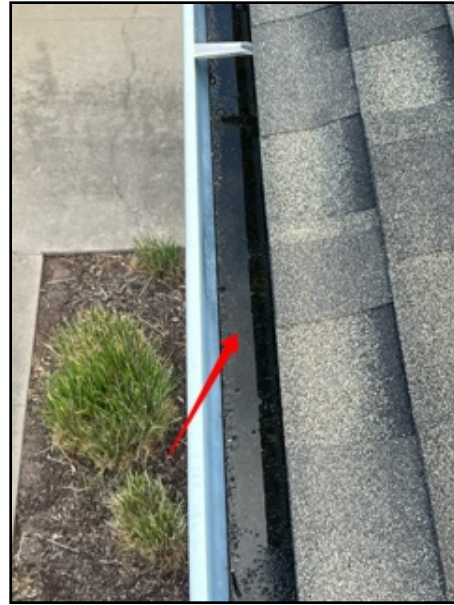
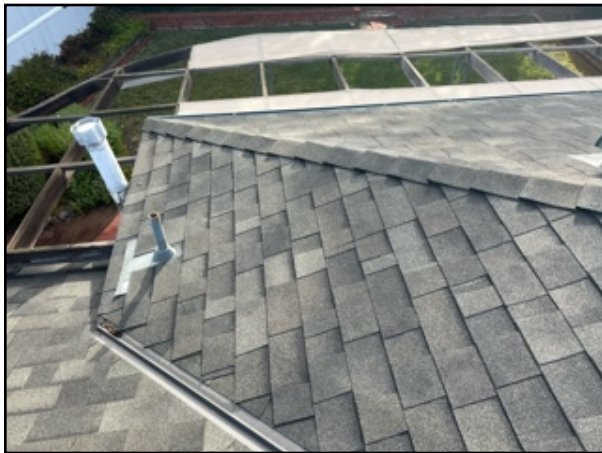
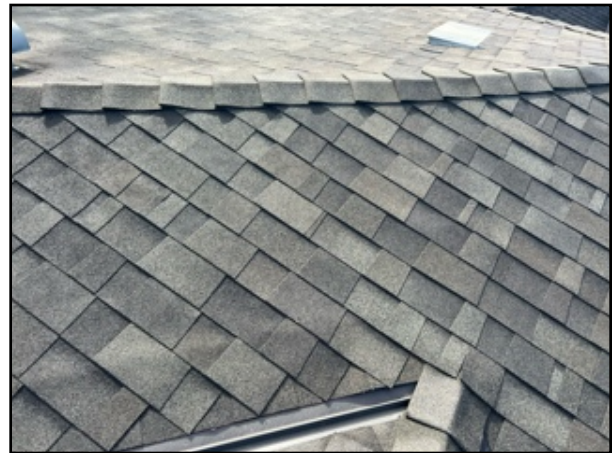
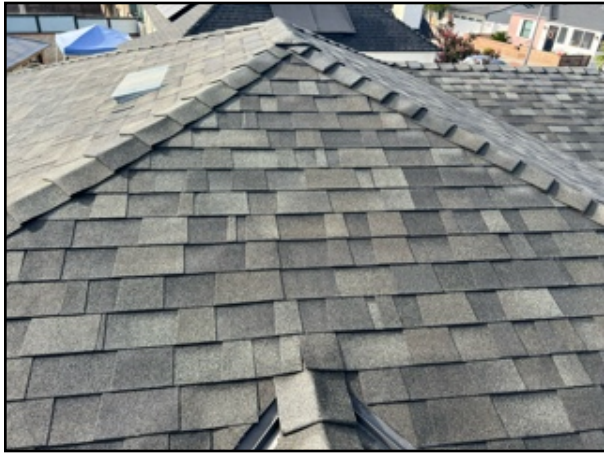
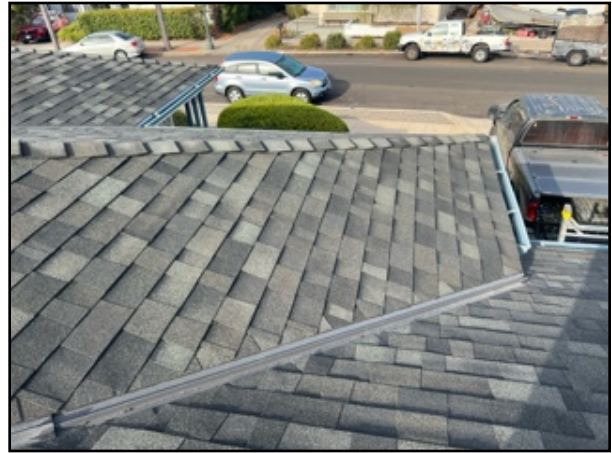
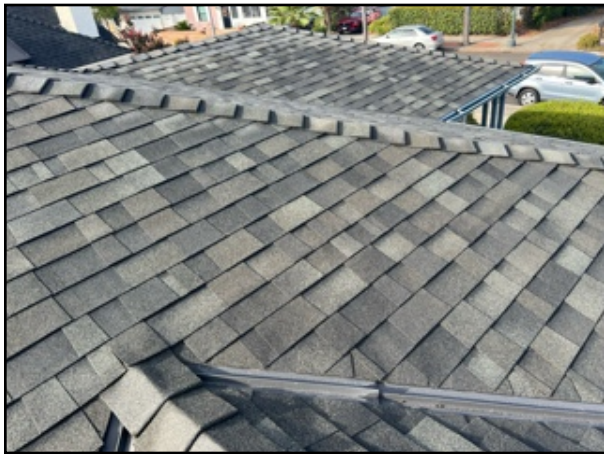
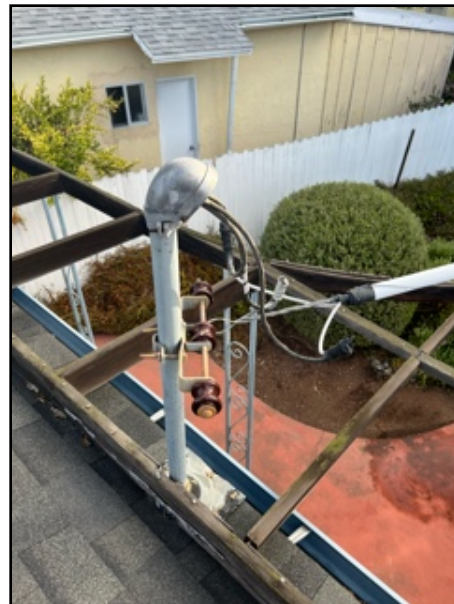
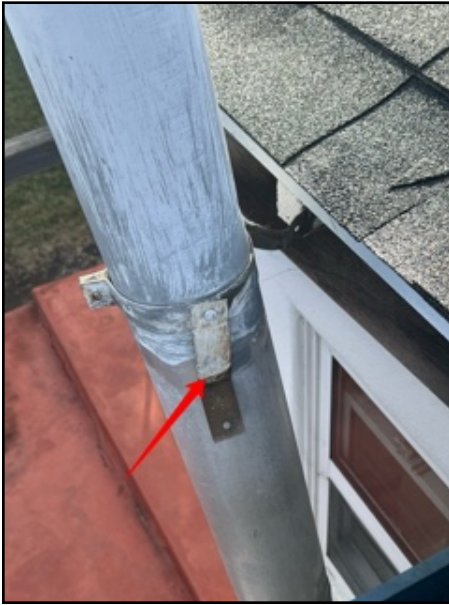
Crack sealant around flashing noted at various places. Standing water noted in gutters in various locations. Facial board near structure side noted opening not properly sealed.

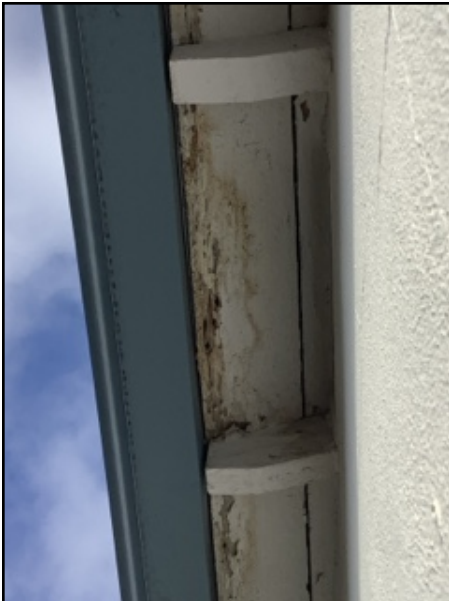
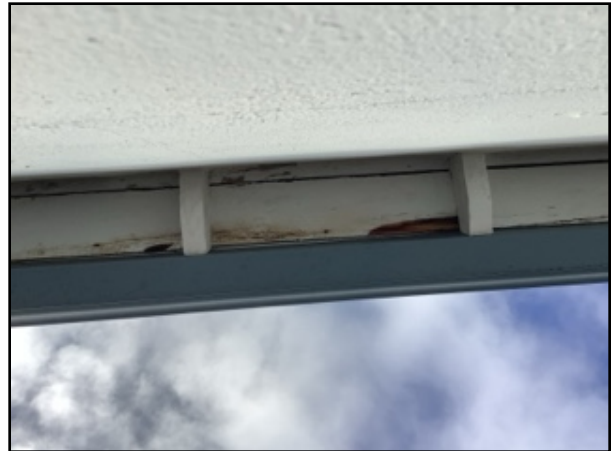
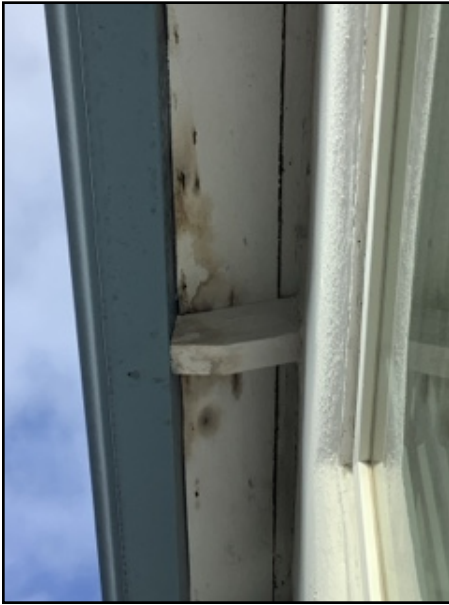
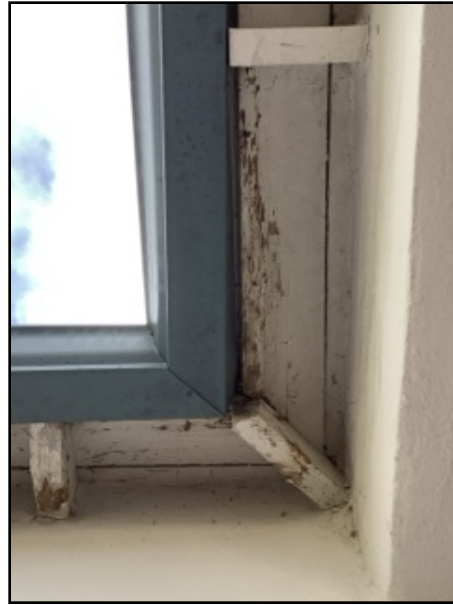
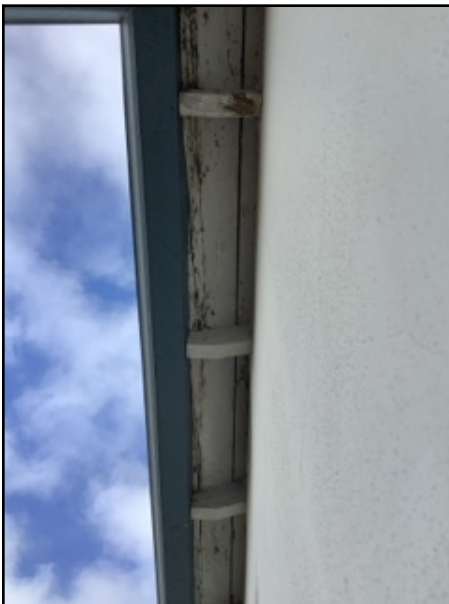
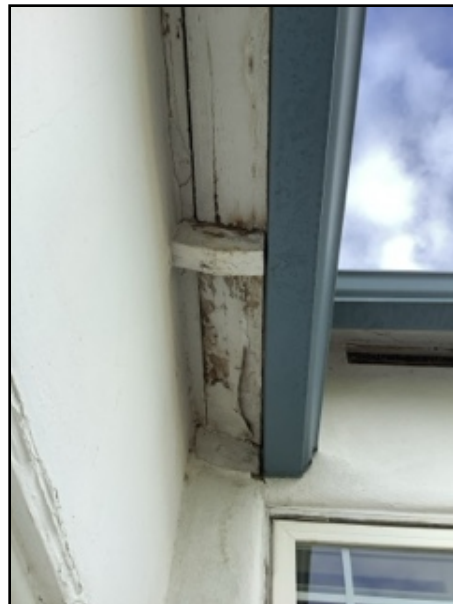
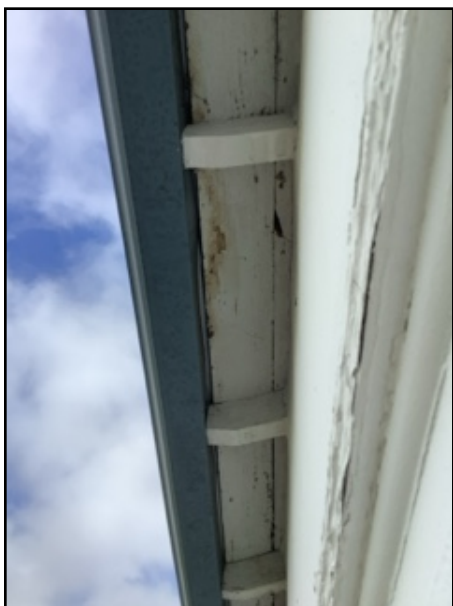
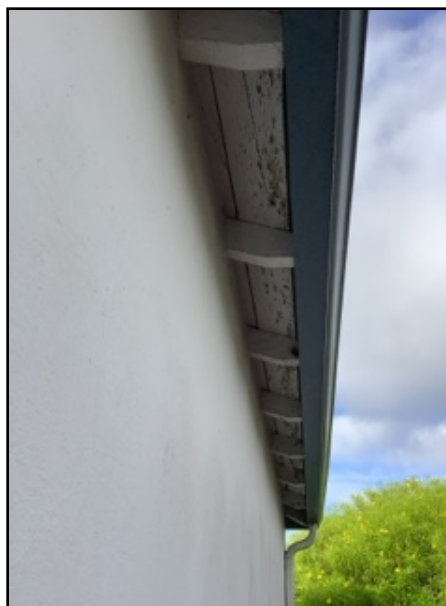
**FURTHER EVALUATION REQUIRED:**

Evidence of possible water intrusion along soffit board near gutters.

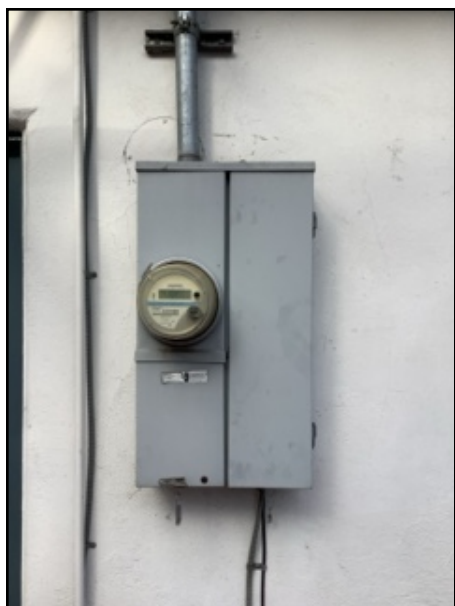
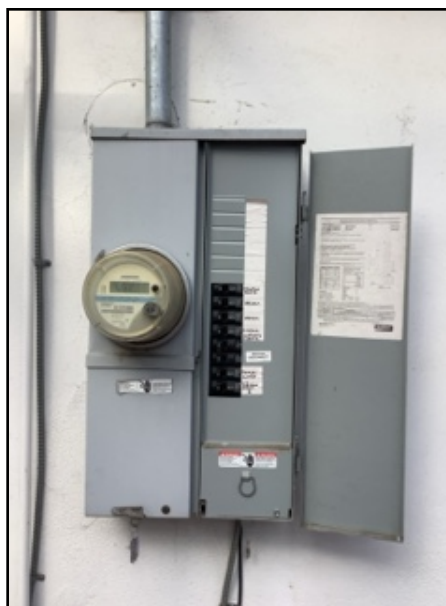
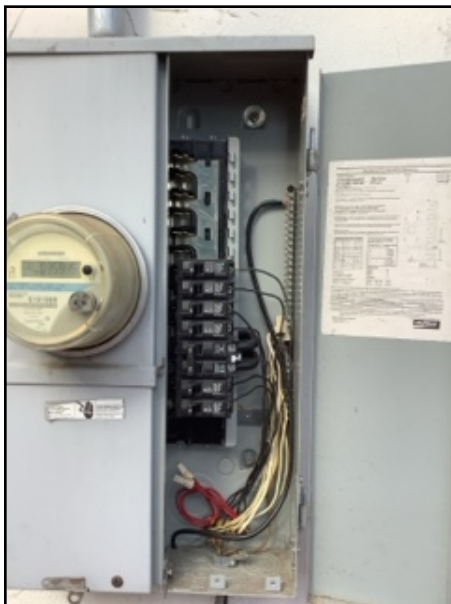
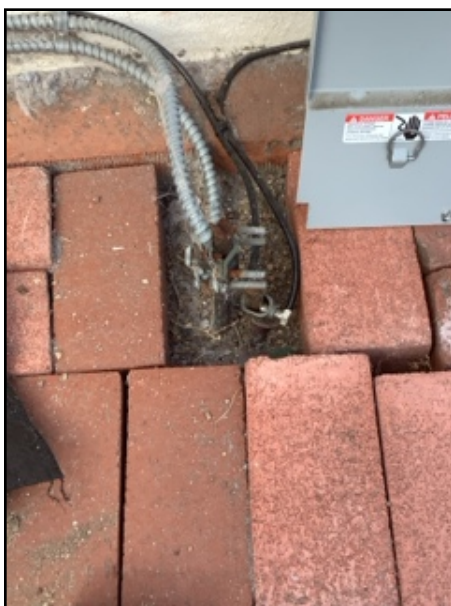
A thermal scan was conducted and no significant hot spots were noted.

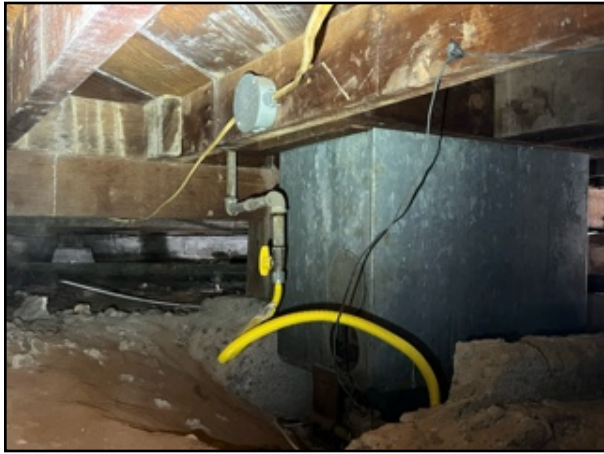
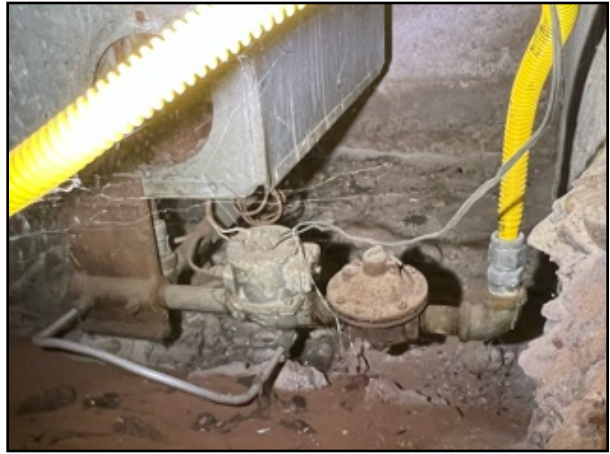
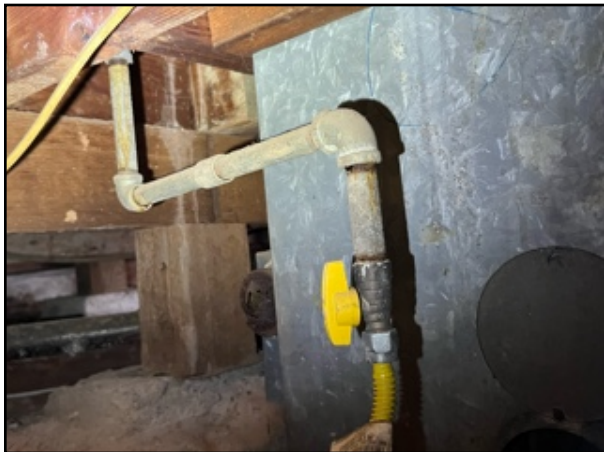
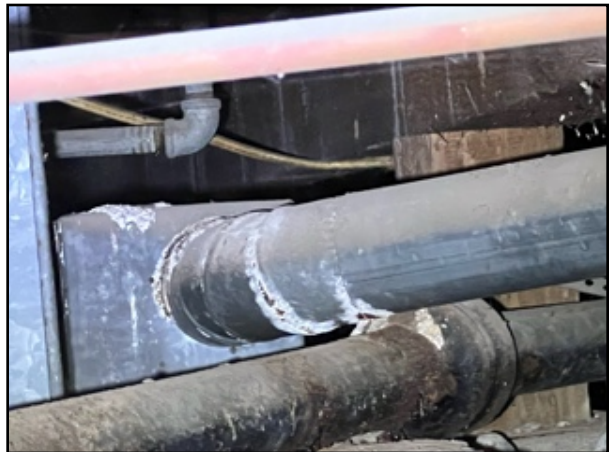
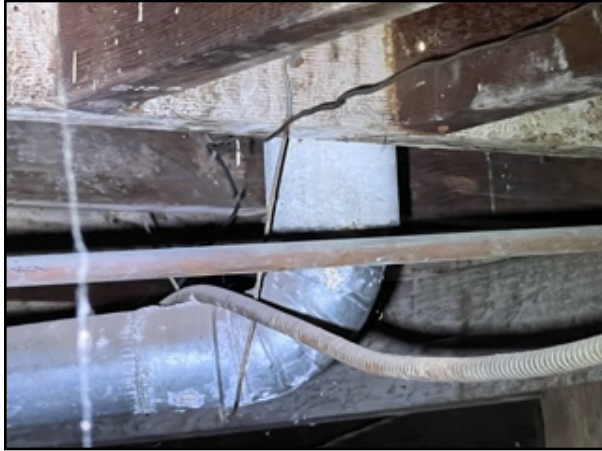
Comment 30:  
Pictures of furnace located in crawlspace.

A licenced contractor should conduct an annual service and maintenance for furnaces over 10 years old.

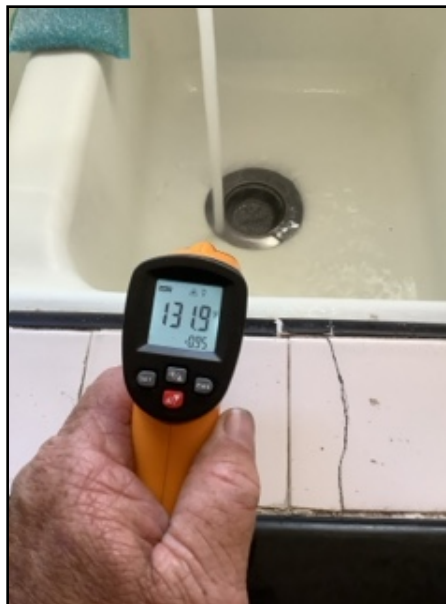
Figure 32-2

Water temperature was 131 degrees Fahrenheit. Most appliance manufacturers recommend a temperature of around 120 degrees Fahrenheit. Generally, temperatures above 130 degrees Fahrenheit are considered unsafe.

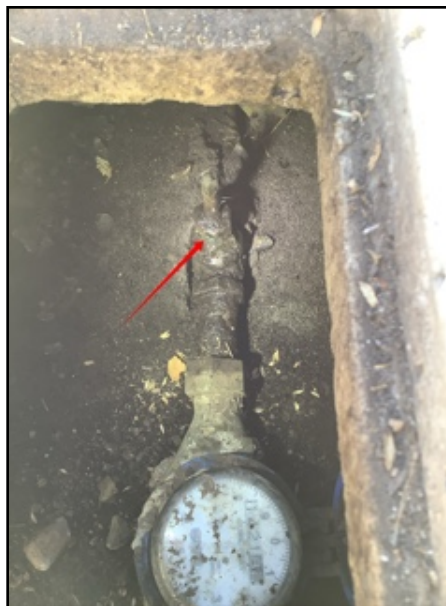
Figure 33-2

Water shutoff valve leading from water meter noted leaking at time of inspection.

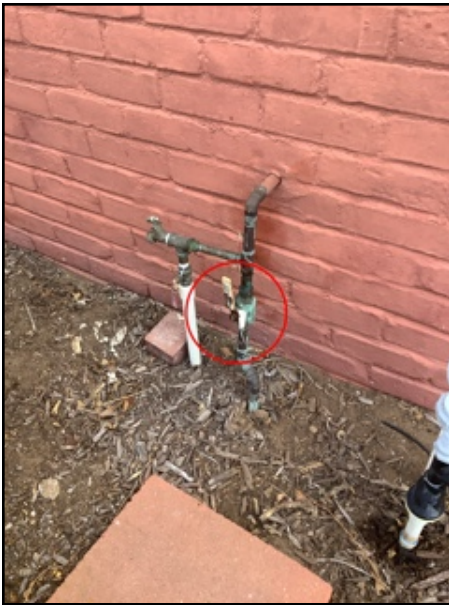
Figure 35-1

Water shut off valve located in front of home.

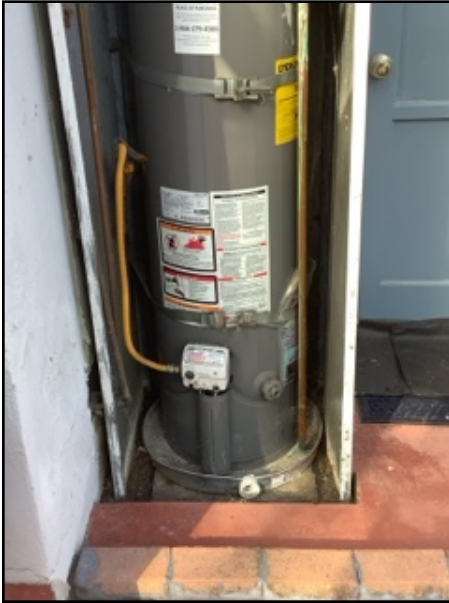
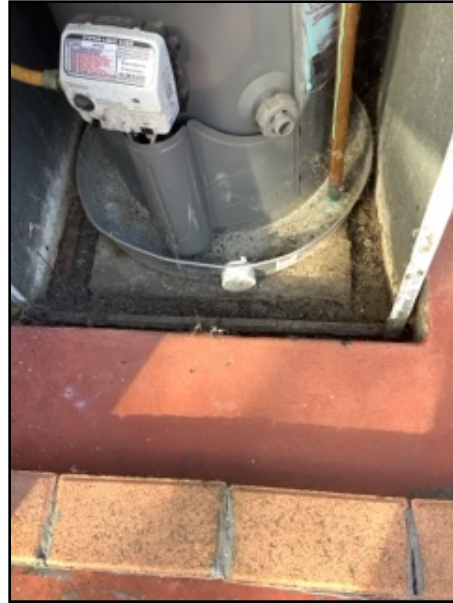
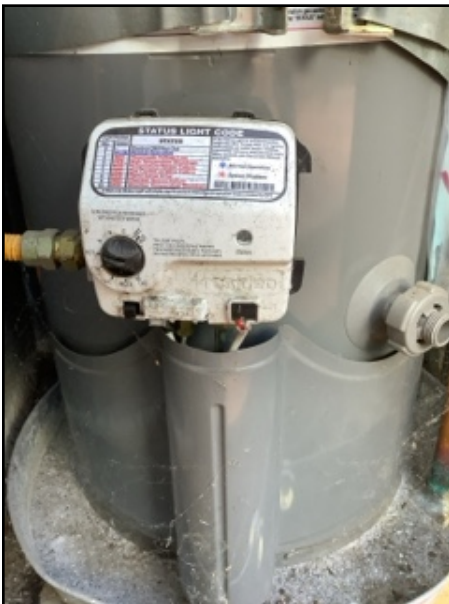
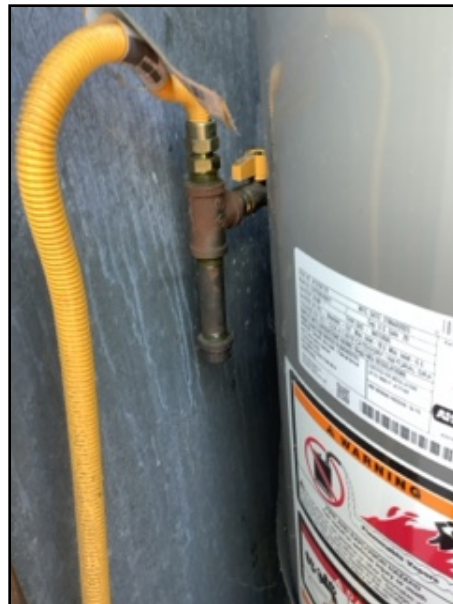
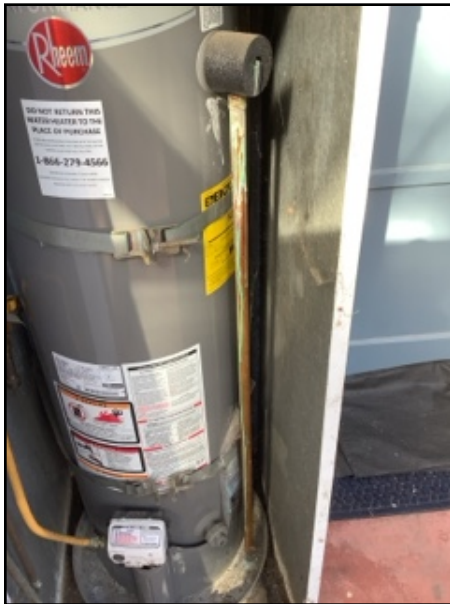
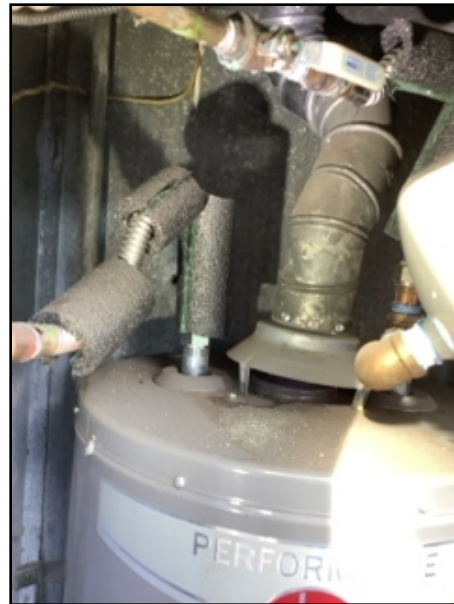
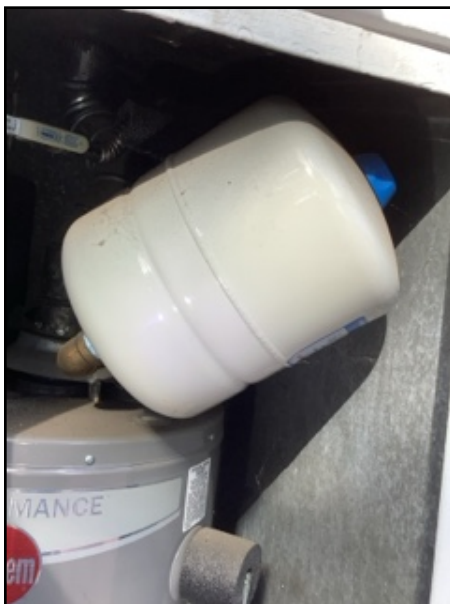
Pictures of water heater located in metal cabinet in backyard.

Water heater noted sitting below concrete slab. Slab slopes towards structure and water heater. Standing water could deteriorate bottom of water heater overtime. Recommend raising water heater up to height or above the concrete pad.

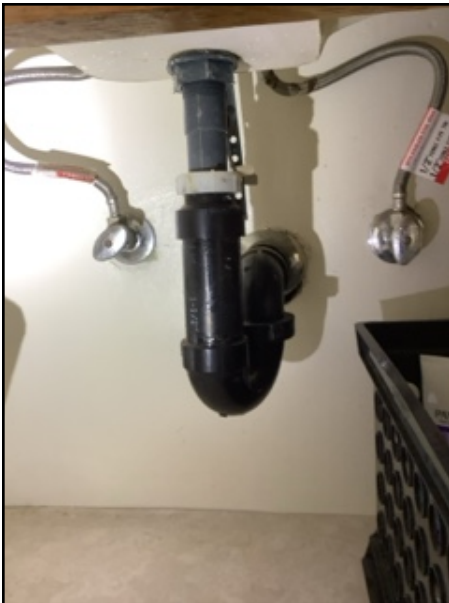
Figure 41-1

Comment 41:  
Picture underneath the sink.

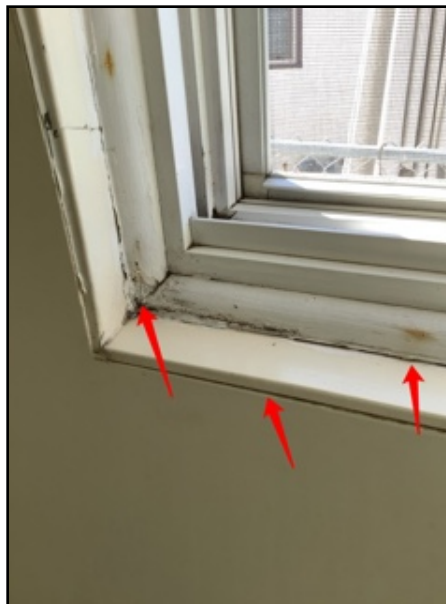
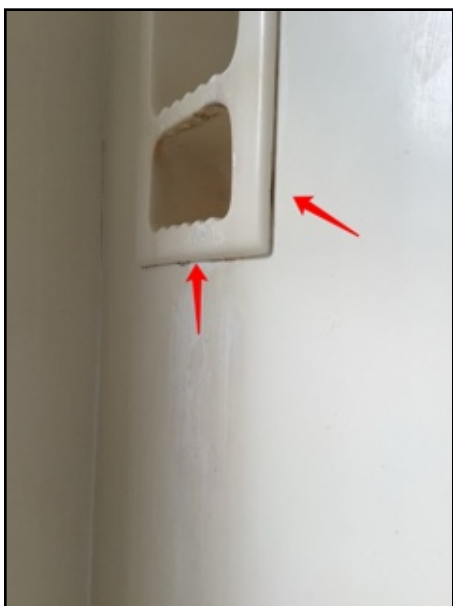
Caulking around windowsill noted cracked deteriorating. caulking in corners of shower stall and sill noted crack or deteriorating.

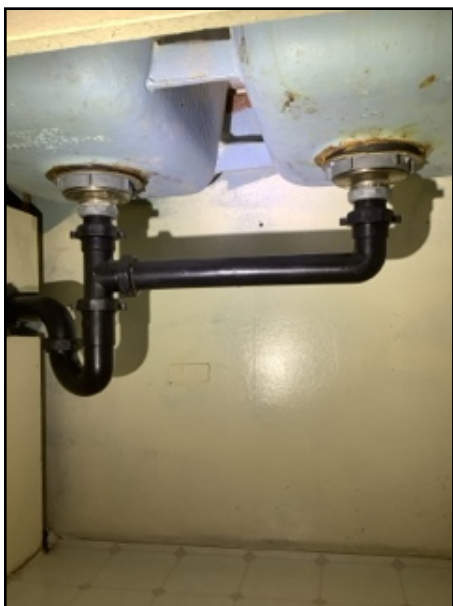
Figure 45-1

Comment 45:  
Picture underneath the sink.

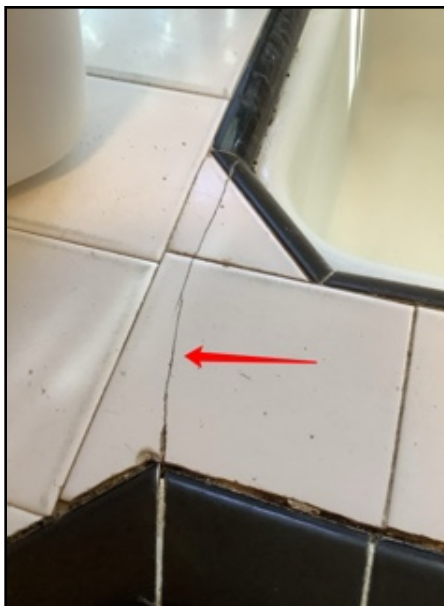
Figure 46-2

Comment 46:  
**REPAIR OR REPLACE:**  
Tile noted cracked in various locations along sink countertop.

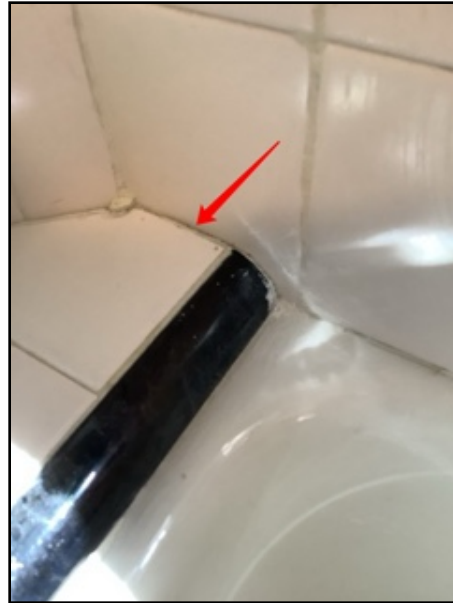
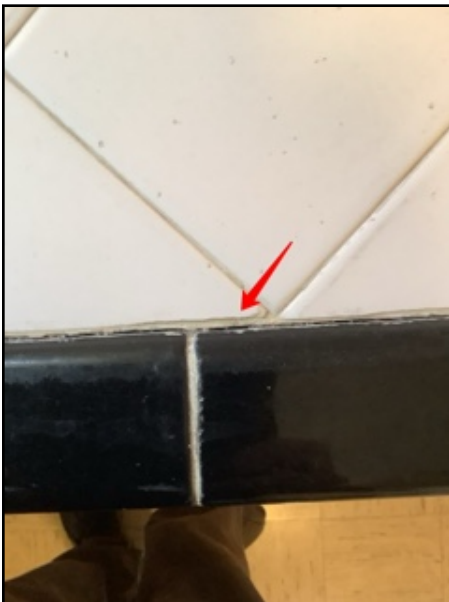
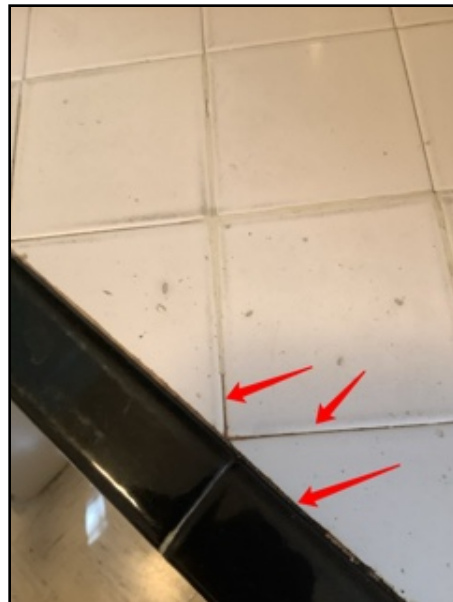
**Comment 47:**  
**REPAIR OR REPLACE:**  
Grout/caulking noted cracker deteriorating and various locations along sink countertop.

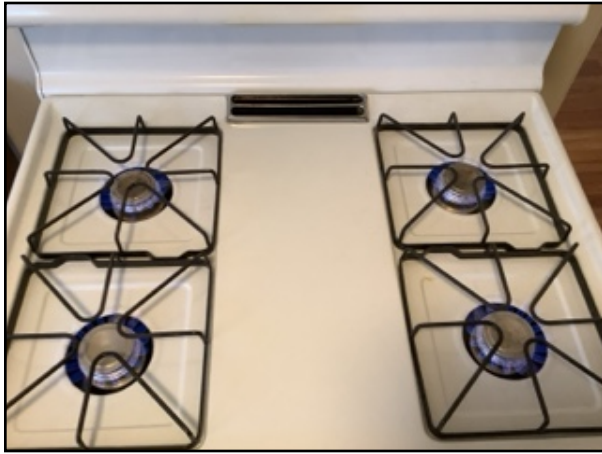
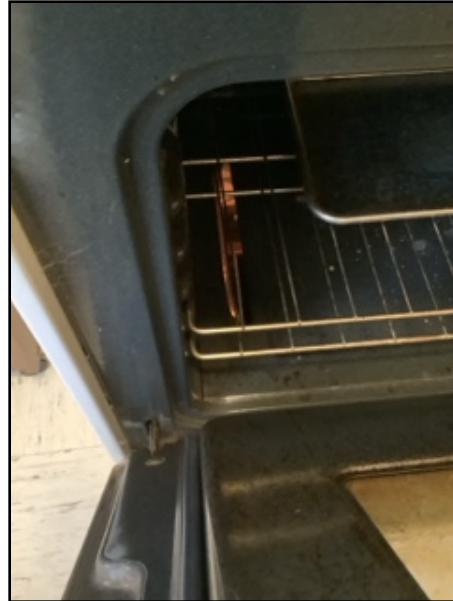
Pictures of burners and oven working at time of inspection.

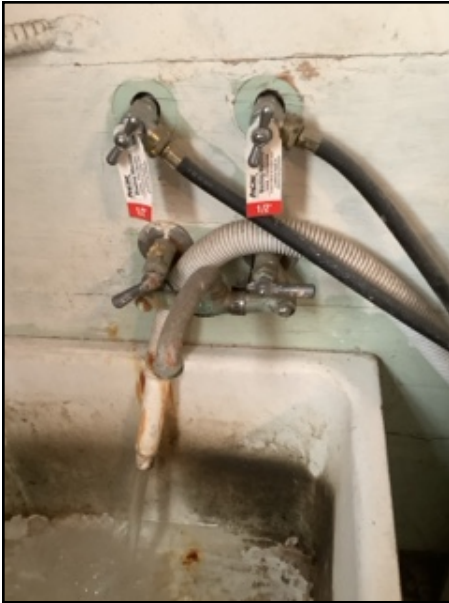
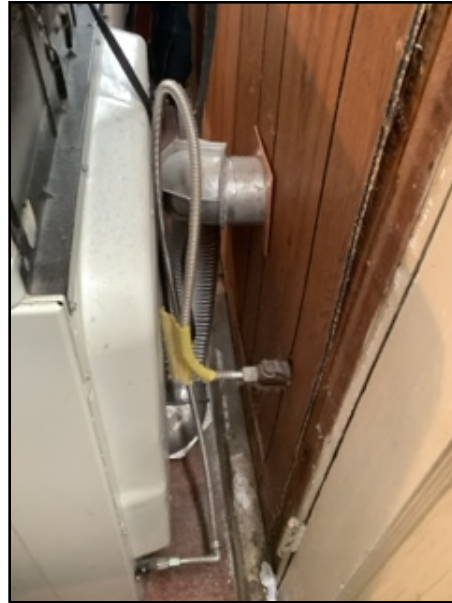
Comment 50:  
Laundry hook ups located in garage.

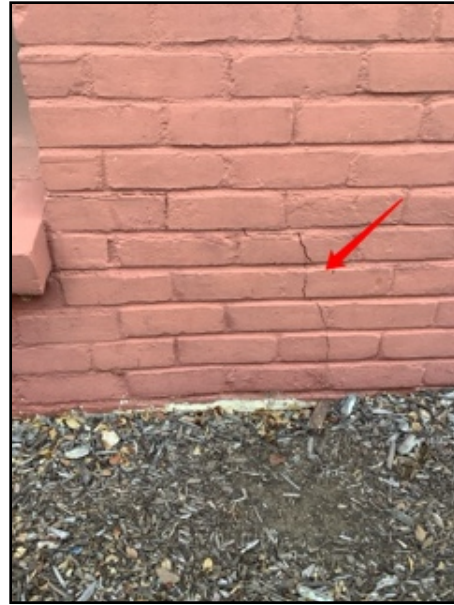
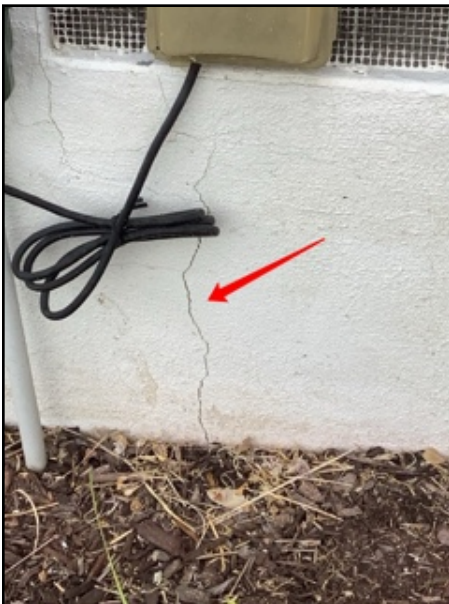
Minor cracking noted at exposed portions of foundation. Generally, cracks of less than ¼ inches and with no deviation are no cause for concern. Questions about structural integrity should be evaluated by a more qualified professional (such as a licensed engineer).

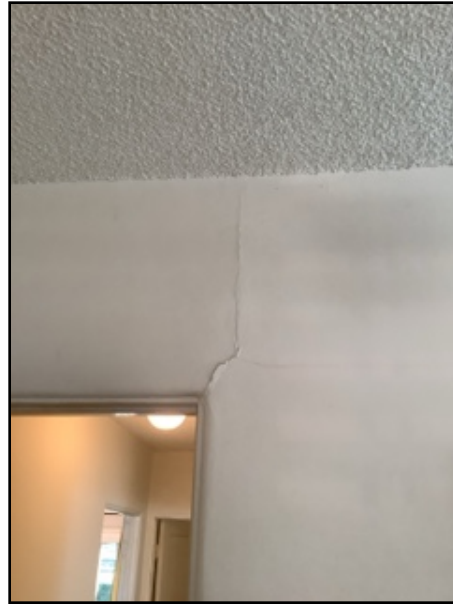
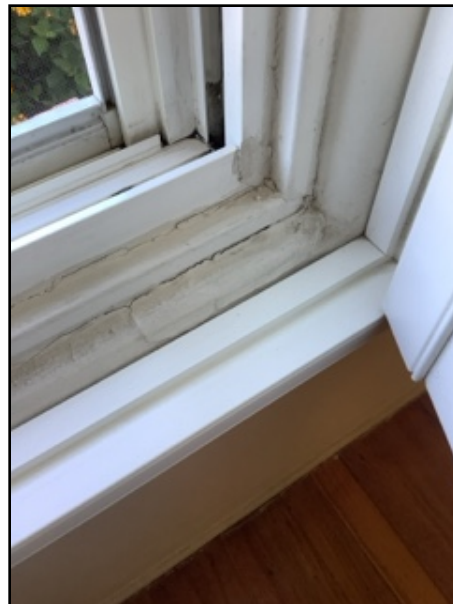
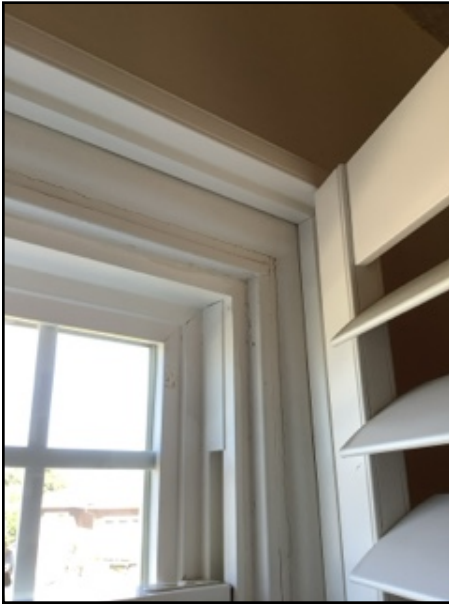
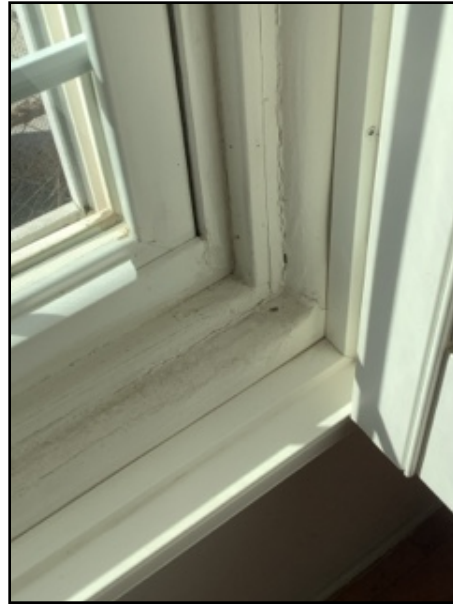
Minor paint, drywall damage, burned out bulbs, broken/missing covers and other minor cosmetic defects noted at various locations throughout the home.
