## USA Home Inspectors

## Home Inspection Report

Prepared For:  
**Karen Saske**  
Property Address:  
**4669 Valencia Dr**  
**San Diego, CA 92115**  
Inspected On: Wed, Sep 2 2026 at 8:00AM

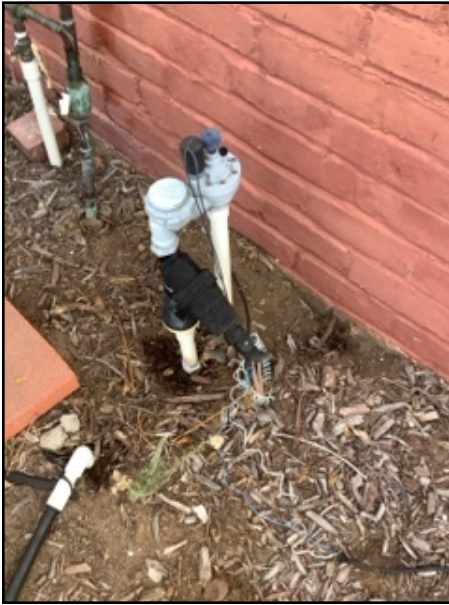
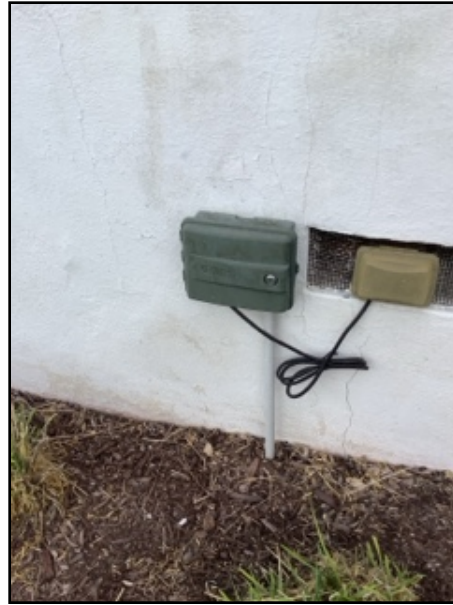
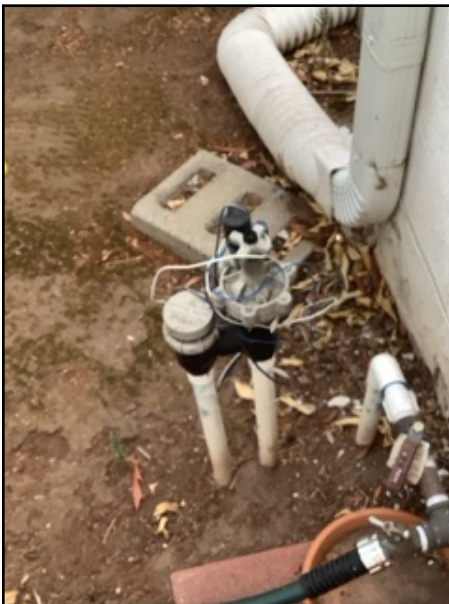
Pictures of mechanical water sprinkler valves located in front yard and backyard.  
Electronic clock located in front yard.
