# **Cornerstone Inspection**

## **Property Inspection Report**

**645 Moss Ave, Paso Robles, CA 93446**

**Date of Inspection: 8/19/2026 Time: 9:00 AM**

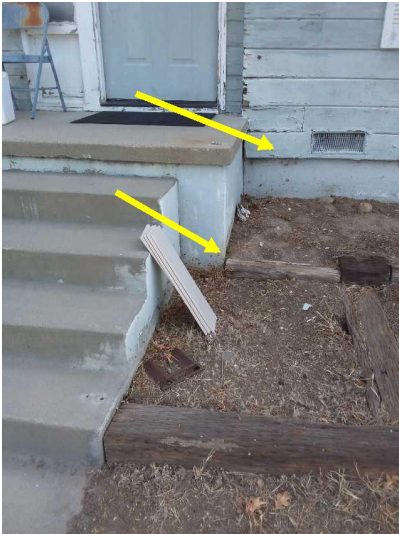
10.4. There are areas of this property that do not have guardrails, which are required for walk-offs greater than thirty inches. While there are walk off's less than 30 inches, appropriate precautions should be taken to safeguard children and the elderly.

There are areas of this property that do not have guardrails, which are required for walk-offs greater than thirty inches. While there are walk off's less than 30 inches, appropriate precautions should be taken to safeguard children and the elderly.

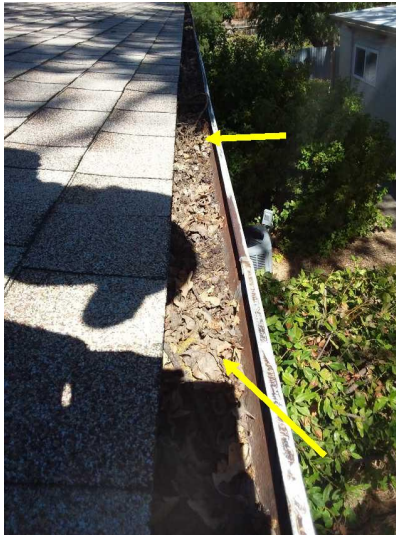
Some of the gutters need to be cleaned to drain properly.

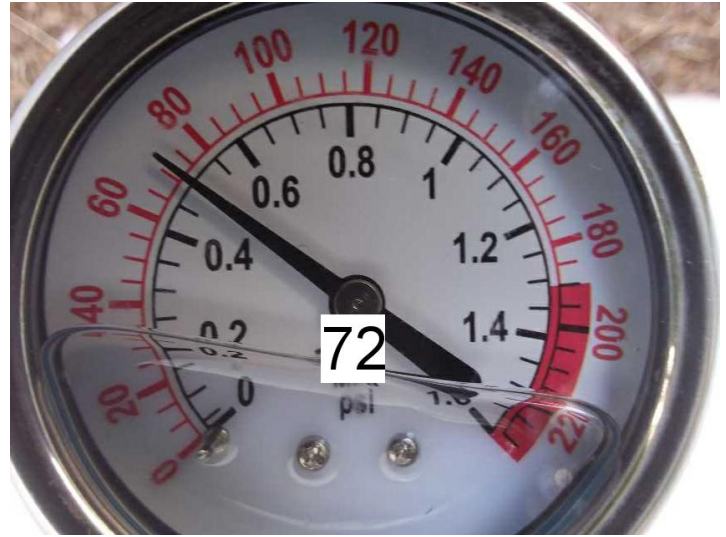
The water pressure entering the residence is under 80psi and a regulator is not required on the plumbing system.

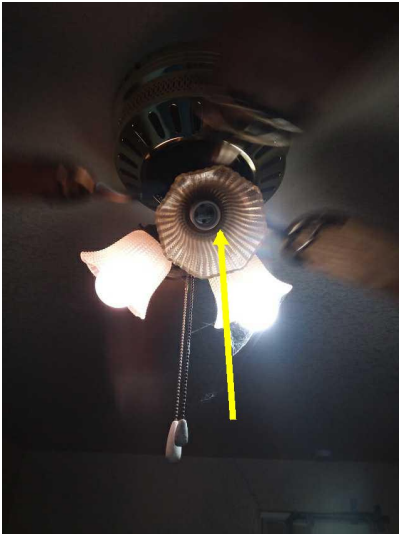
A ceiling light does not respond, and should be serviced.

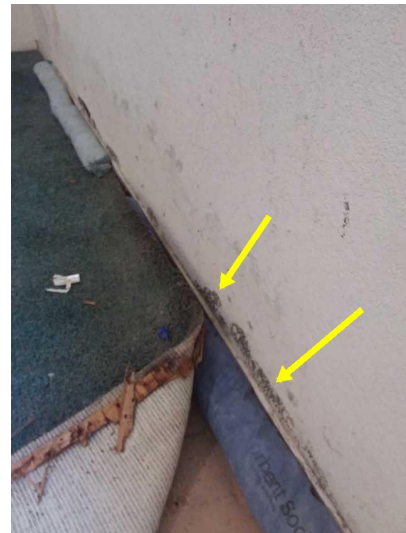
There is a mold-like substance that we will point out, which should be evaluated by a specialist. All molds flourish in a damp environment and many are commonplace, but some are toxic and represent a health threat.

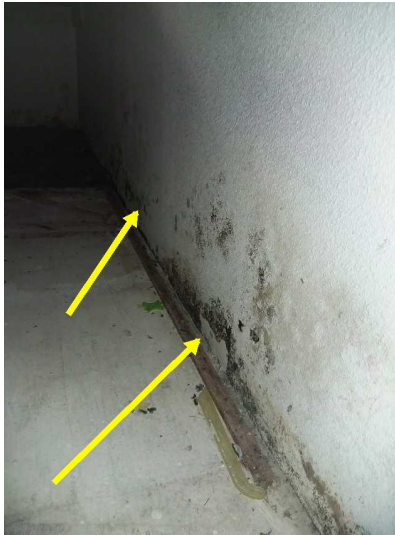
There is a mold-like substance that we will point out, which should be evaluated by a specialist. All molds flourish in a damp environment and many are commonplace, but some are toxic and represent a health threat.
