# 4843 Bricker St

# Houston, Texas 77033

| Type | <b>Home Inspection and Floor<br/>Plan Report - 4843 Bricker St</b> |
| Inspected by | <b>HomeTeam Inspection Service -<br/>North Houston</b> |

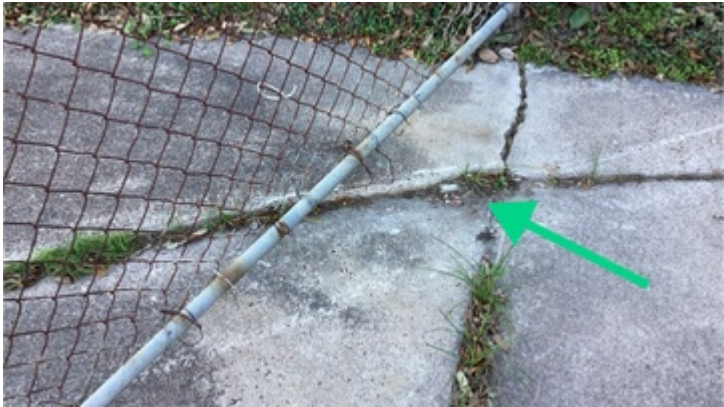
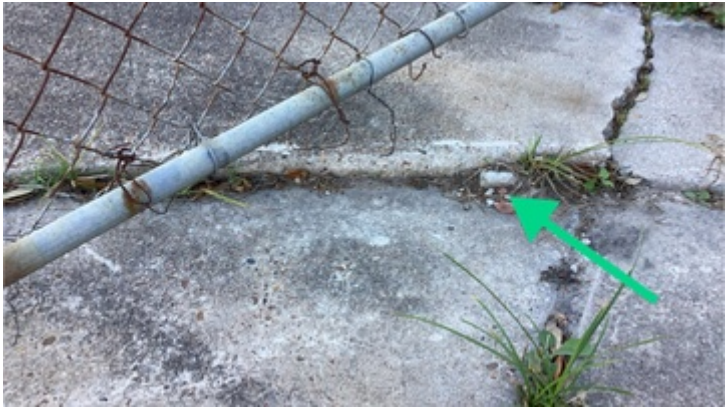
Repair deficiency

### Trip Hazard

The sidewalk, patio, driveway, or walkway is unlevel.

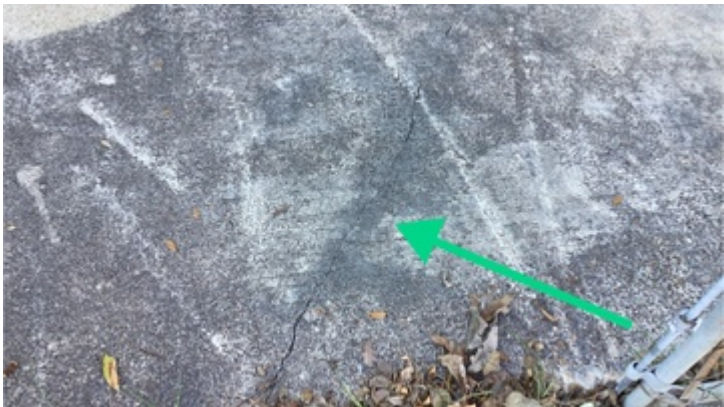
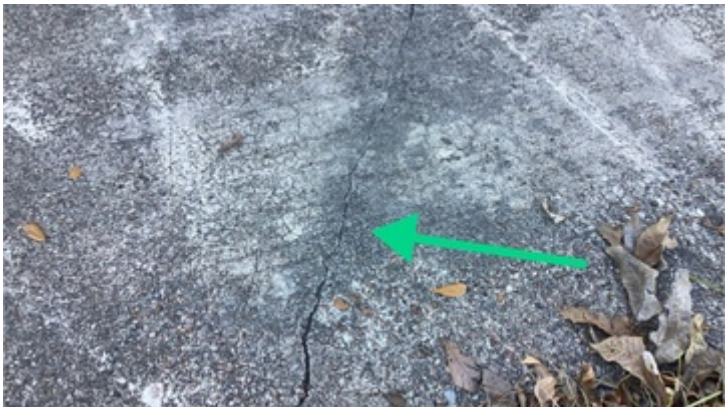
Monitor deficiency

Minor Cracks in the Driveway

The driveway has minor cosmetic cracks.

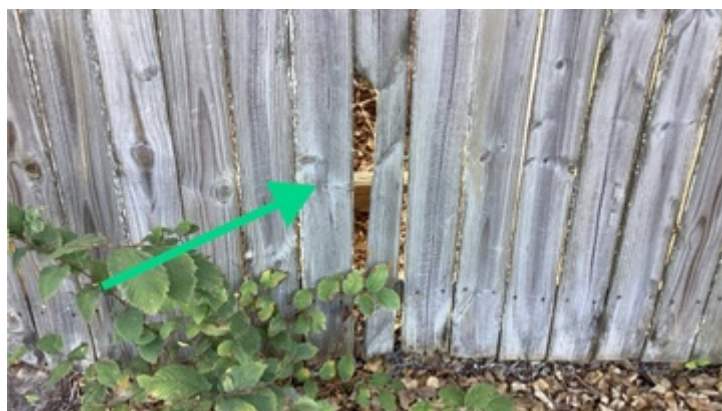
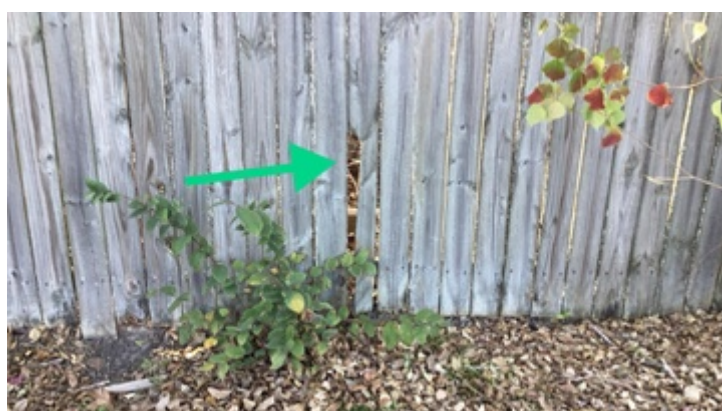
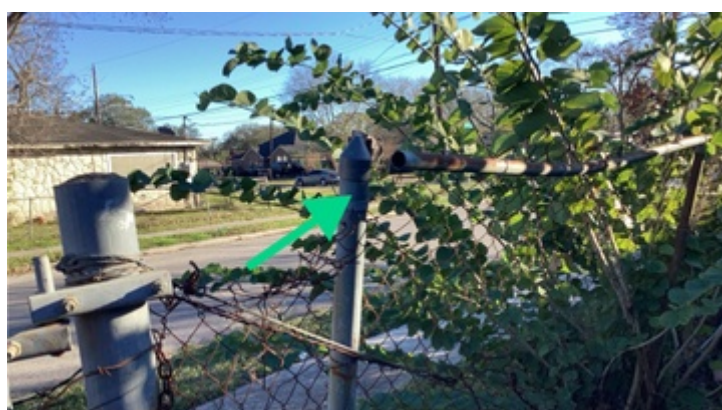
Repair deficiency

Damaged Fence / Gate

The fence or gate is damaged in one or more areas.

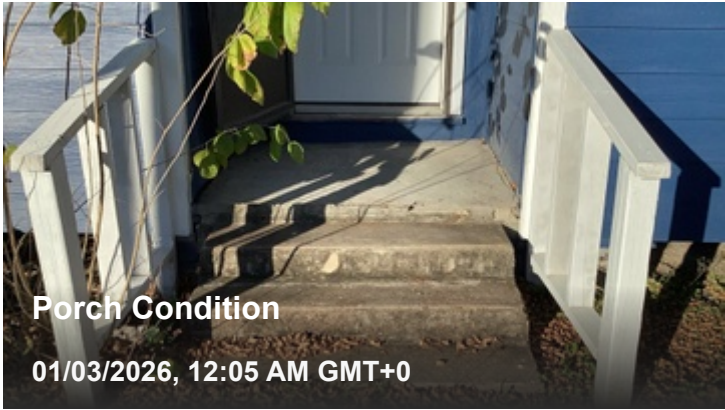
Wood Rot Observed

Wood rot is observed on / in the property.

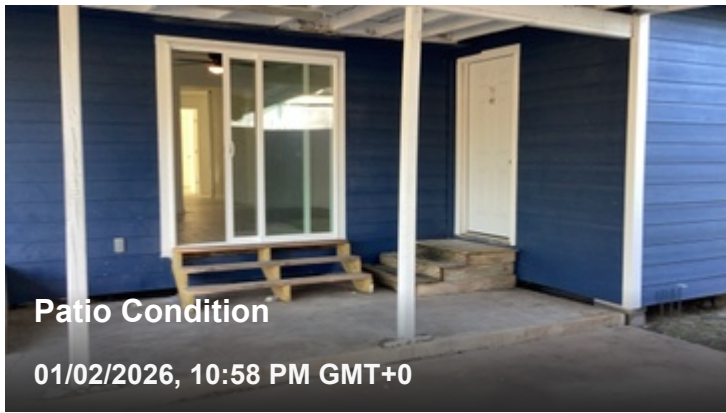
**Wood Rot Observed**

Wood rot is observed on / in the property.

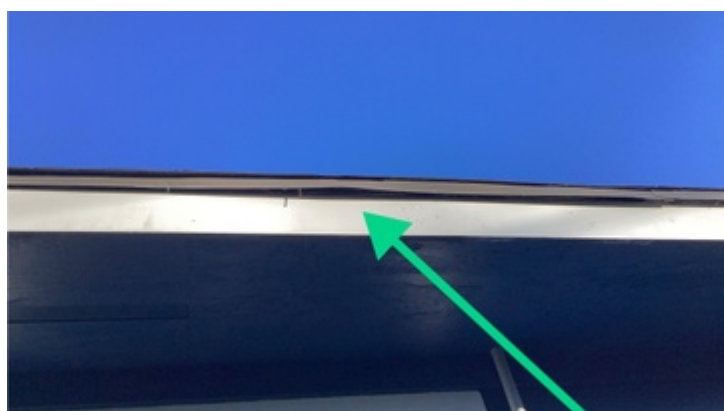
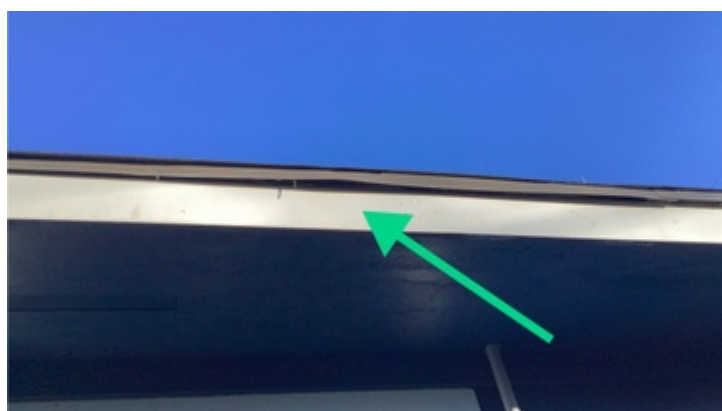
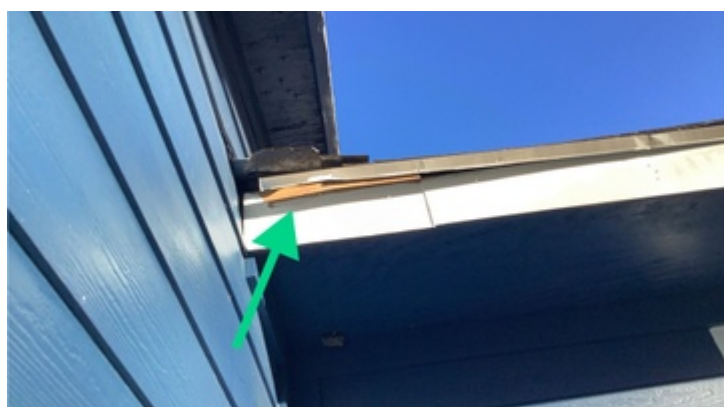
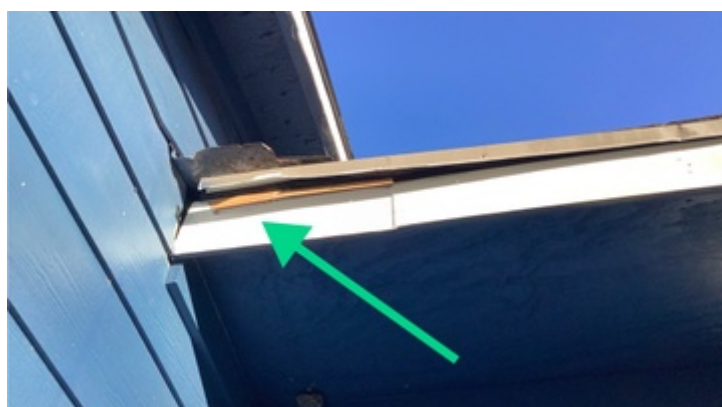
## Damaged Flashing

The flashing is damaged.

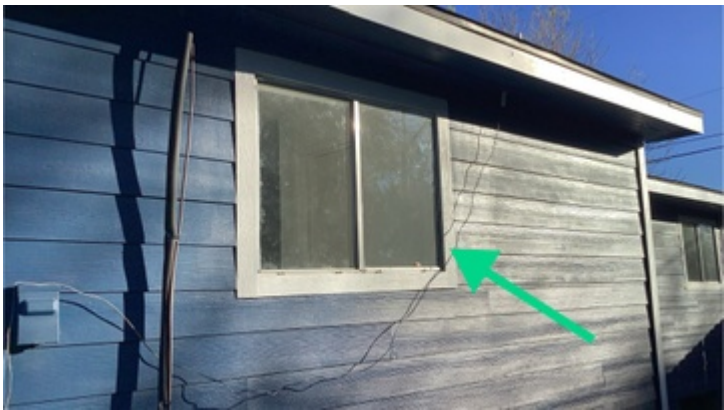
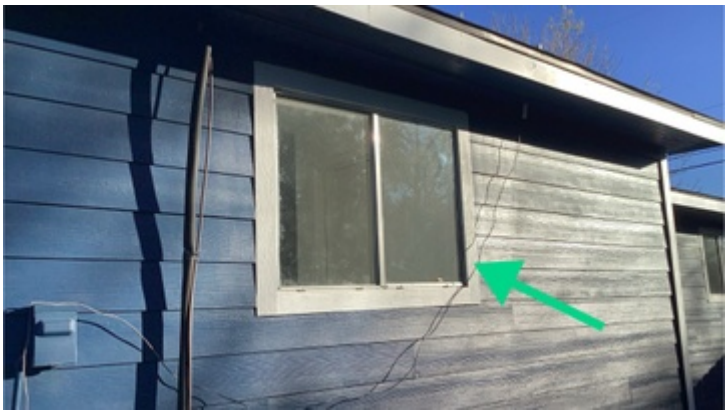
### Missing Window Screen

One or more windows are missing a screen.

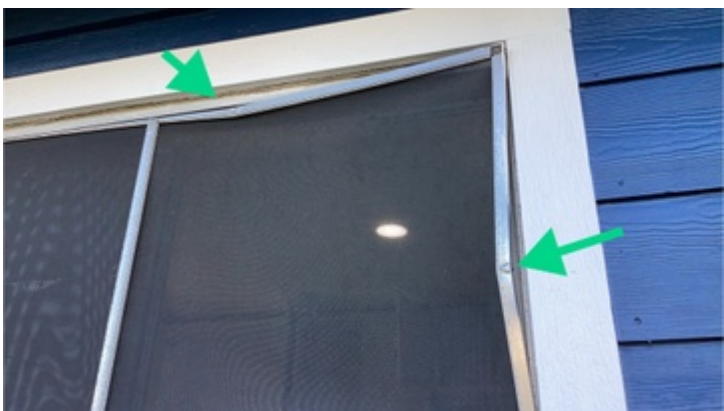
Damaged Screen

One or more window screens are damaged.

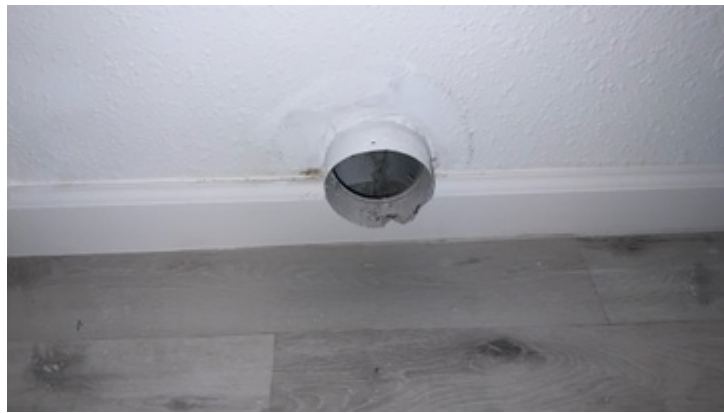
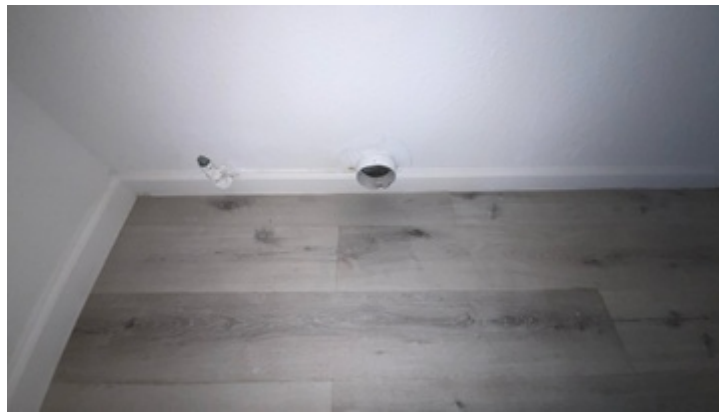
Repair deficiency

Improper Venting

The dryer vent is not terminating to the exterior.

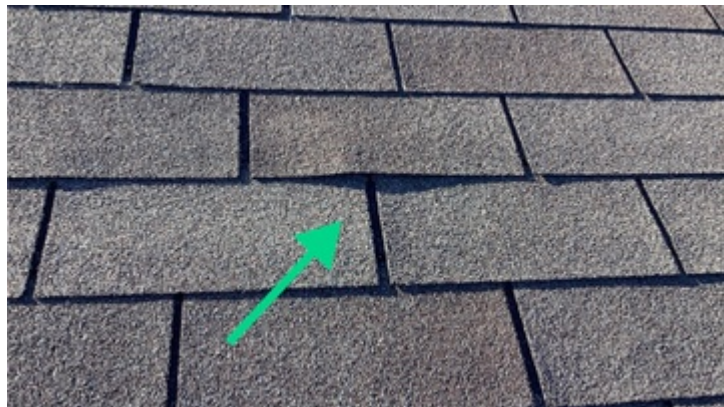
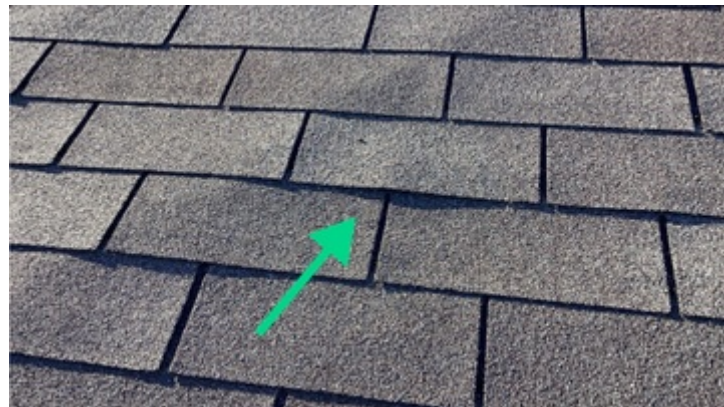
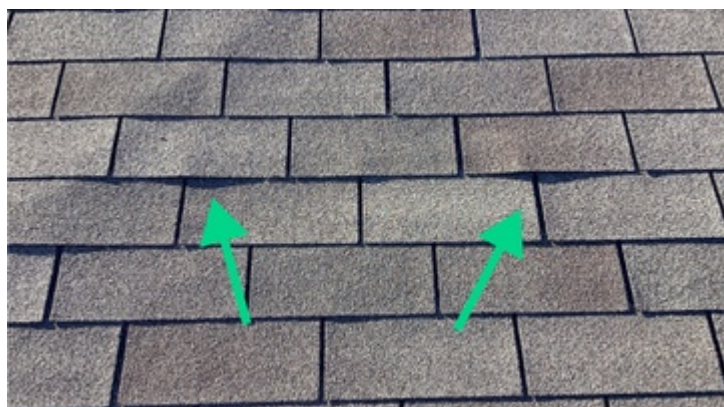
**Repair deficiency**

## Curling / Lifting Shingles

One or more areas of shingles are curling / lifting.

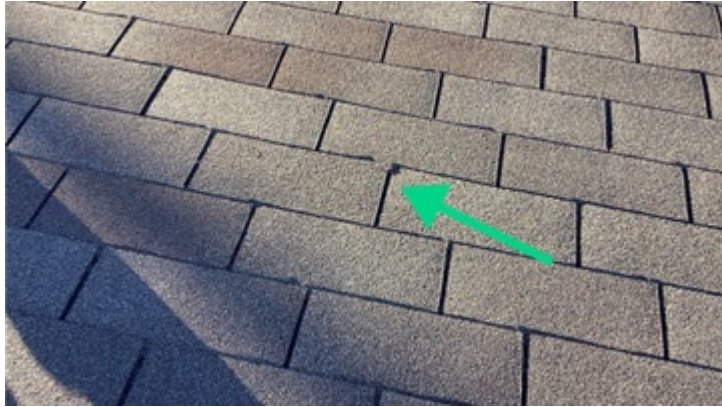
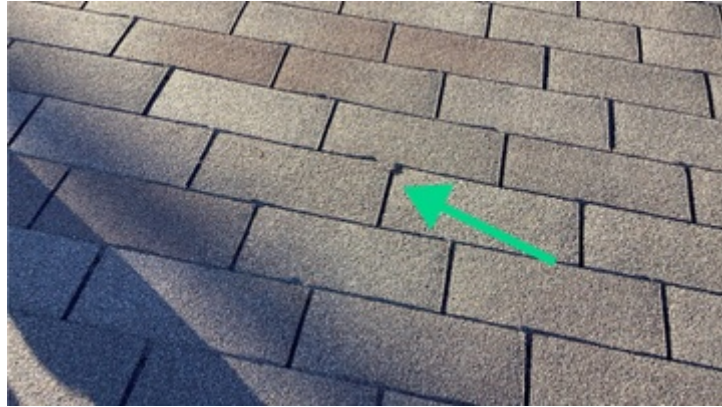
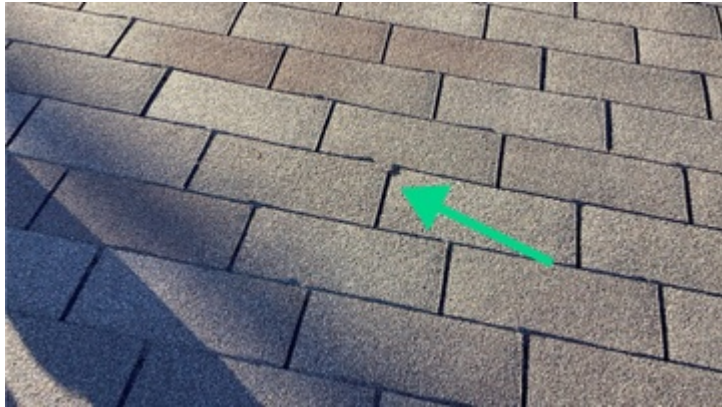
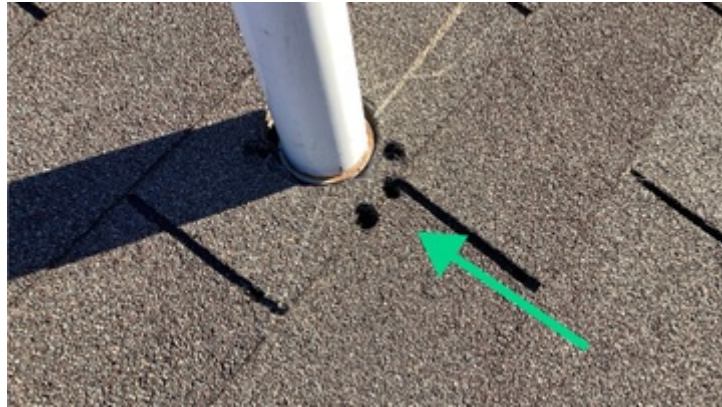
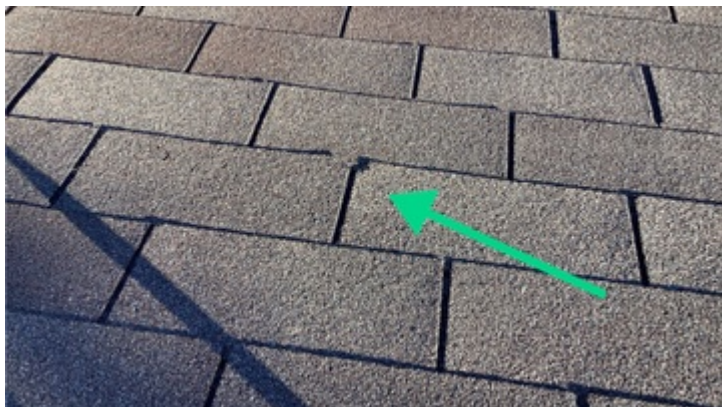
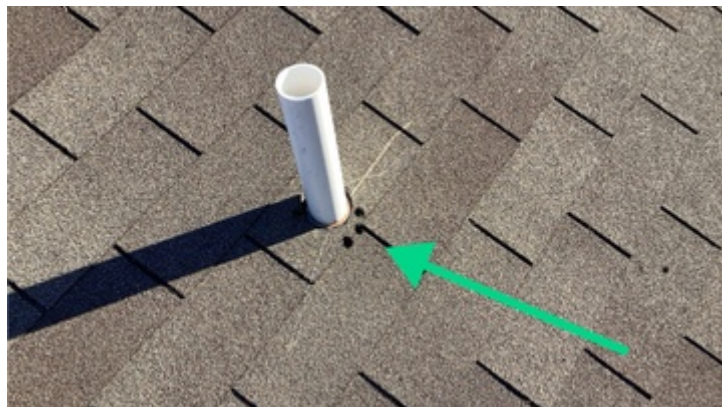
**Repair deficiency****Damaged Roof**

The roof is deteriorated / damaged / warped

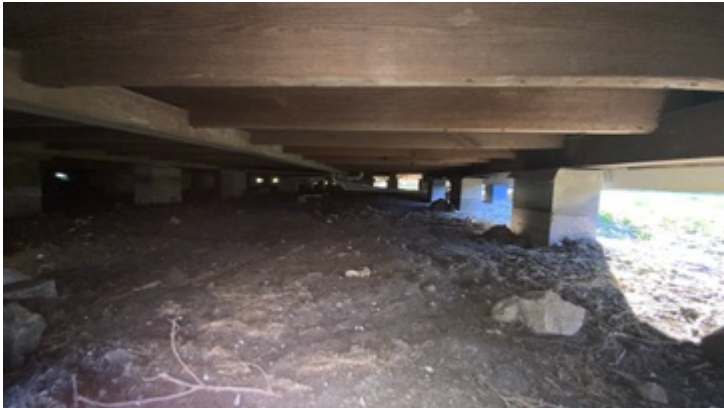
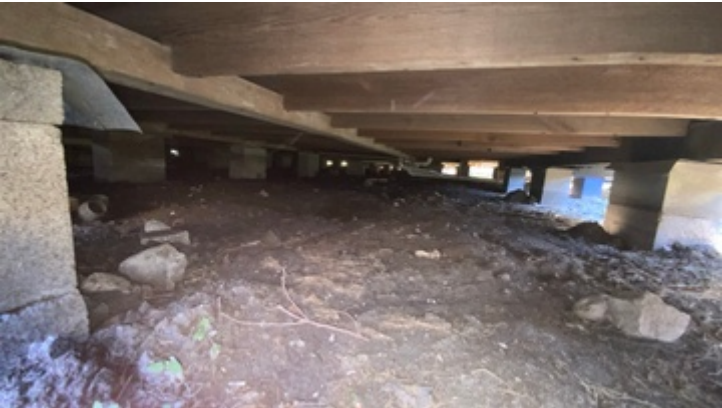
Repair deficiency

Missing Vapor Barrier

The vapor barrier is missing.

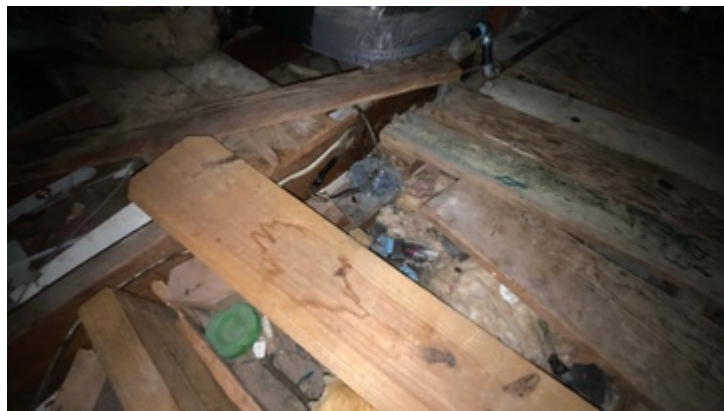
**Safety deficiency**

## Cloth Wiring Present

There is cloth-wrapped wiring present.

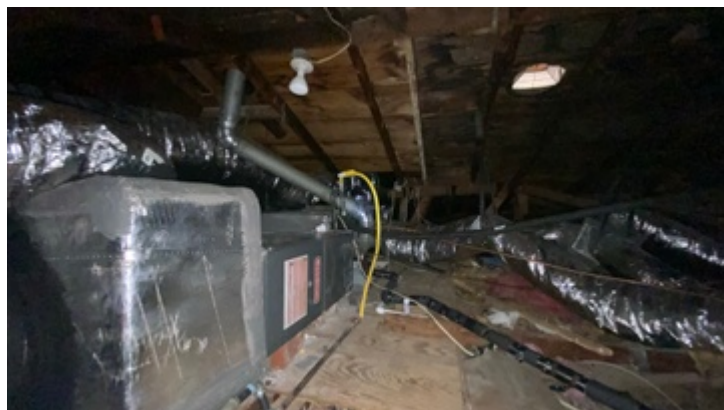
**Safety deficiency**

## Wiring

Wiring in the attic space not protected in junction box

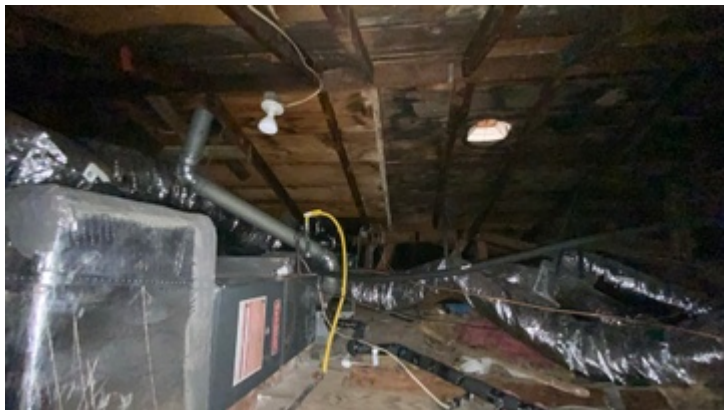
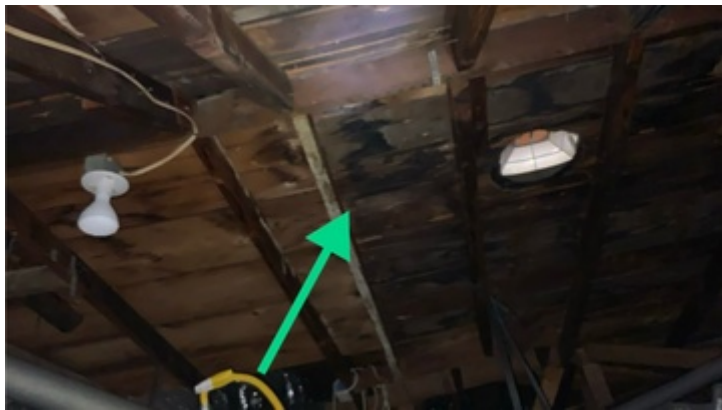
**Monitor deficiency**

## Stains From Previous Water Damage

There are water stains in the attic.

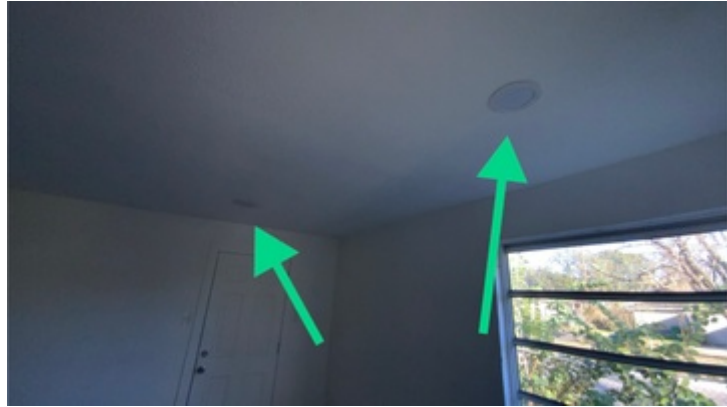
**Monitor deficiency****Inoperable or Missing Light Bulb**

One or more light bulbs have burnt out or are missing.

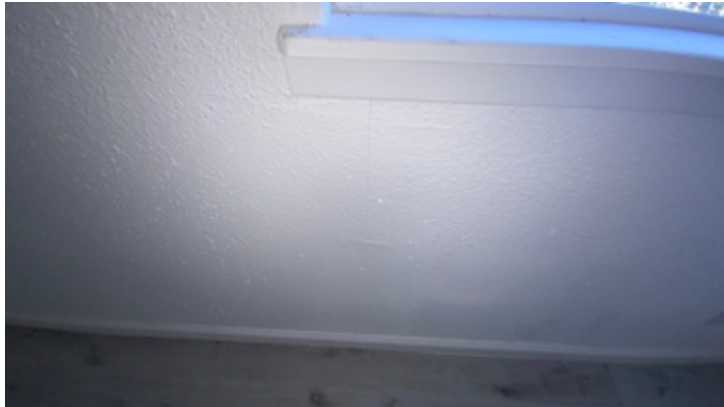
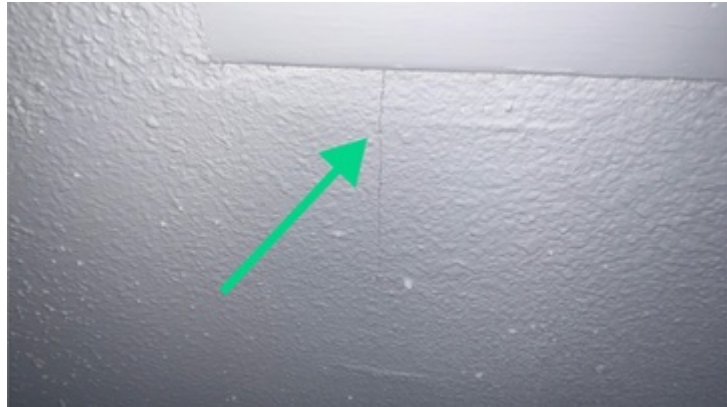
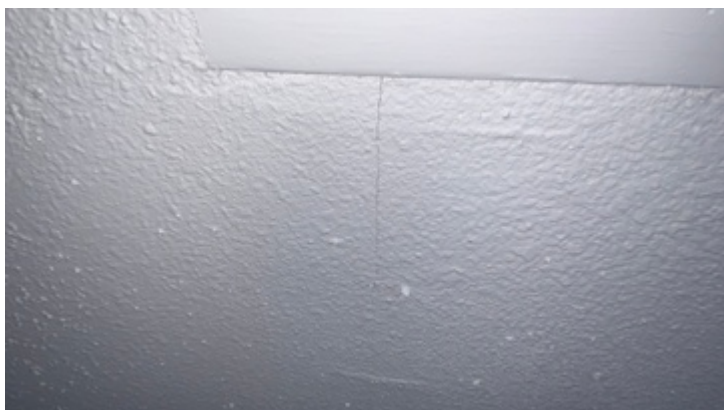
**Monitor deficiency****Minor Wall Cracks**

There is minor cracking on the wall / ceiling.

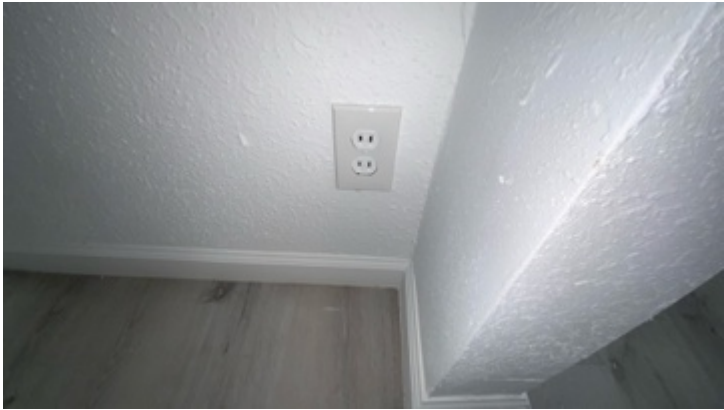
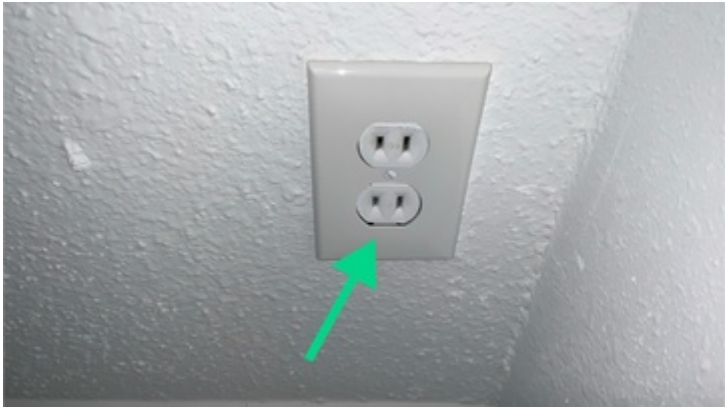
Safety deficiency

Unsafe Two-Prong Outlet

The two-prong outlet is not up to current safety standards.

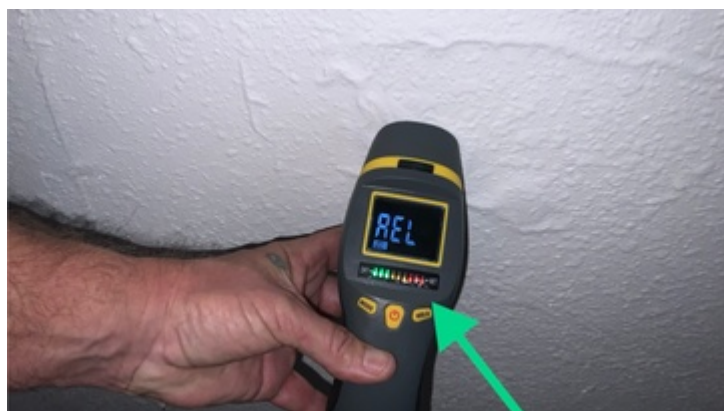
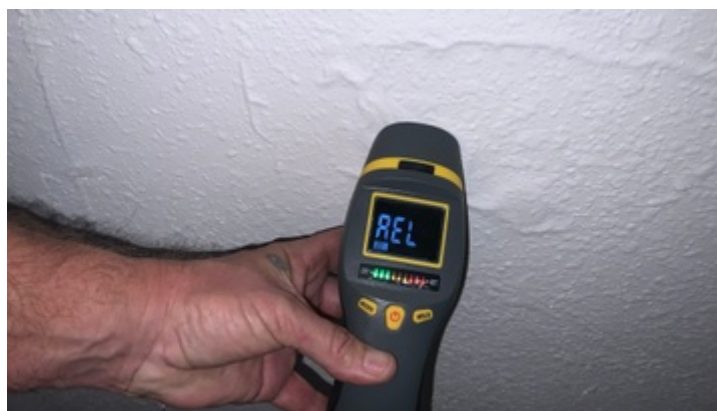
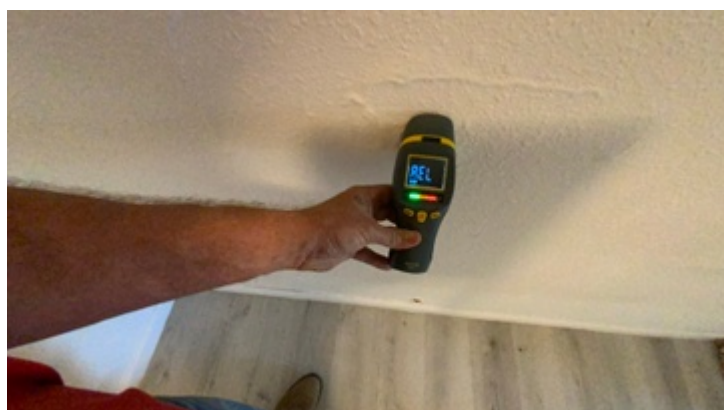
### Repair deficiency

## Moisture Intrusion in Walls / Ceiling

There are signs of moisture intrusion.

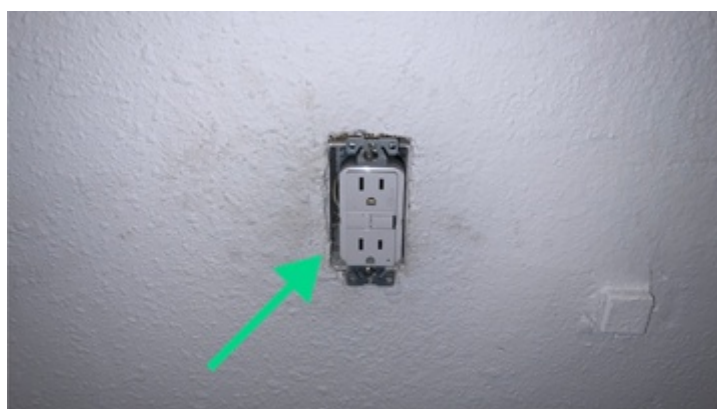
### Repair deficiency

## Missing Cover Plate

One or more switches / outlets / receptacles are missing a cover plate.

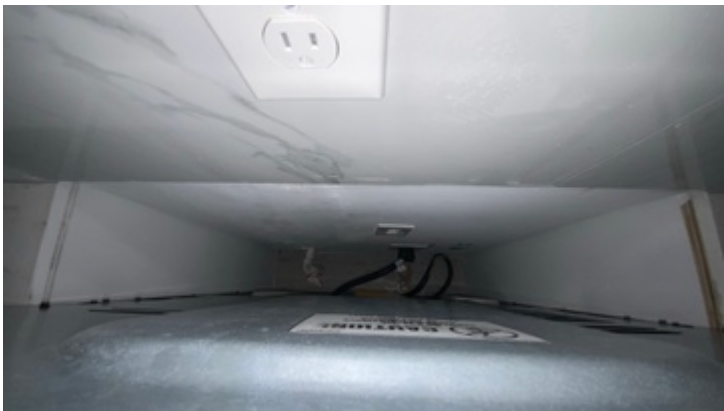
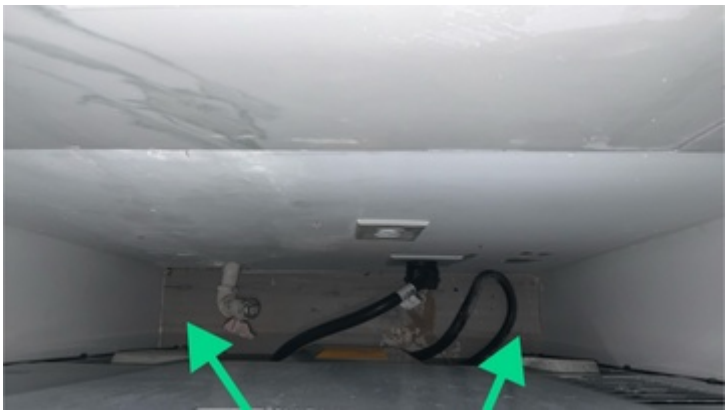
### Missing Range Anti-tip Bracket

The range is not installed with an anti-tip bracket.

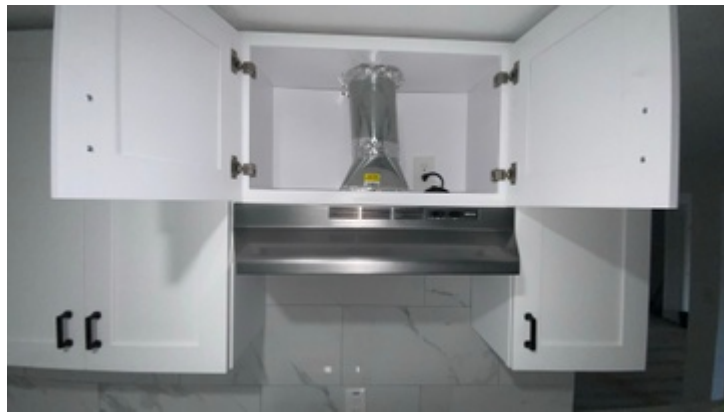
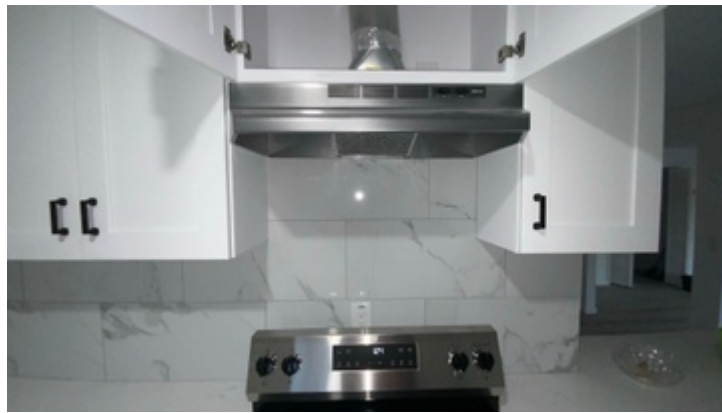
**Non-Functional**

The vent hood is not working.

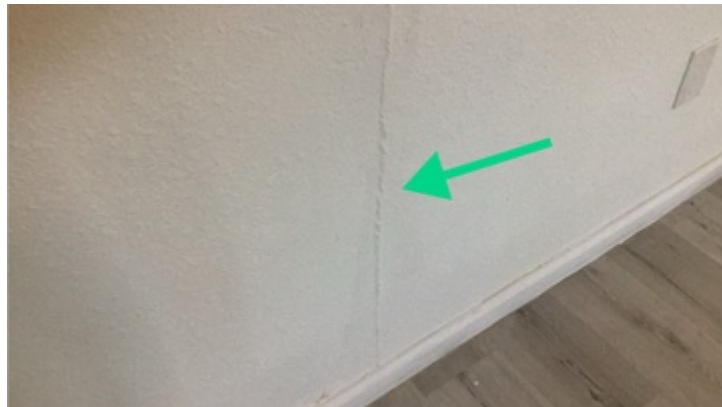
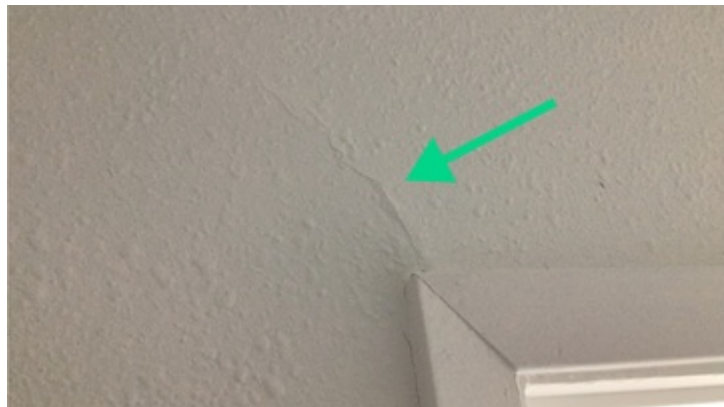
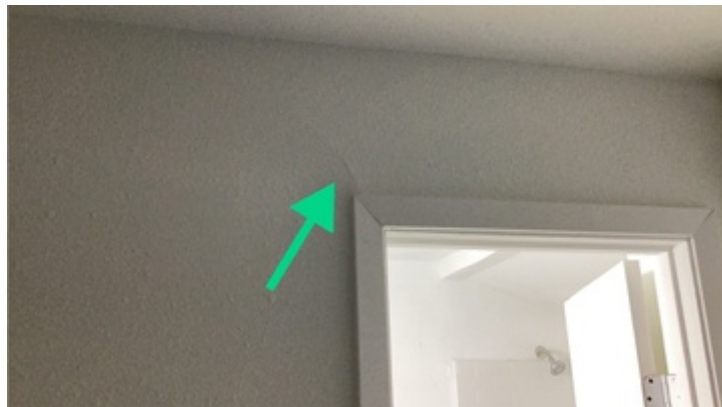
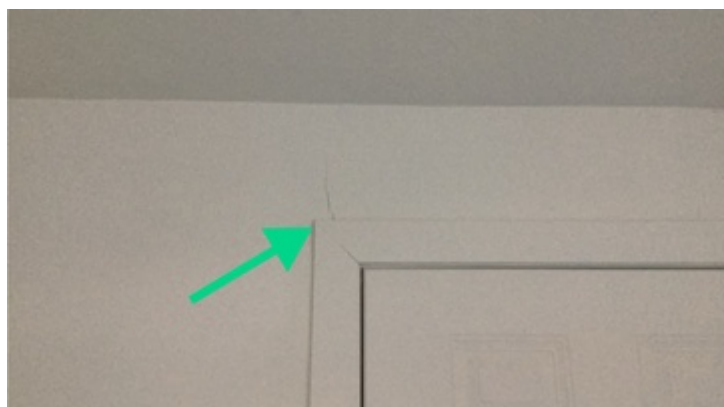
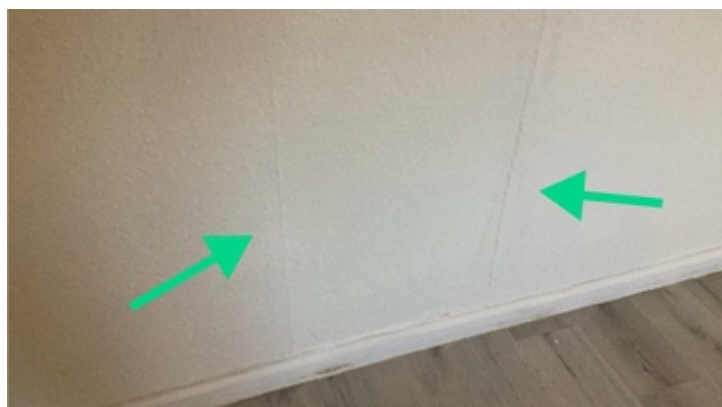
## Crack(s) in Wall(s)

There are one or more cracks in the walls.

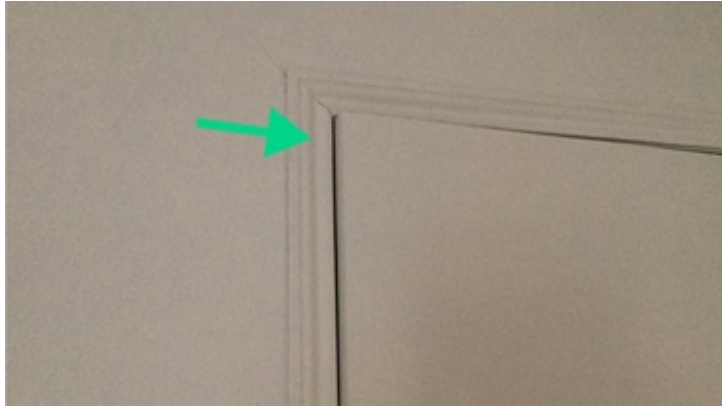
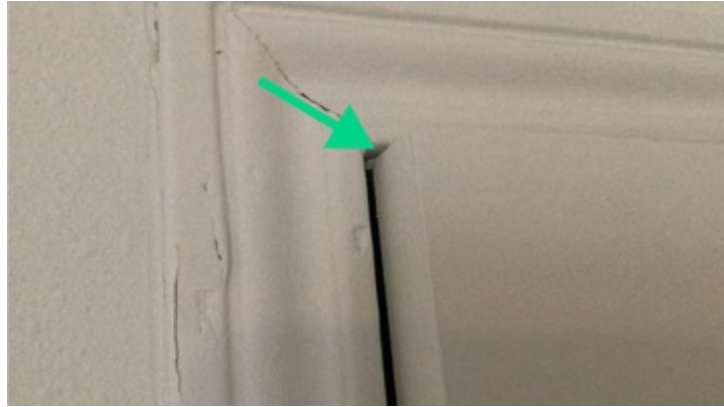
**Repair deficiency****Door Does Not Latch**

The door does not latch properly.

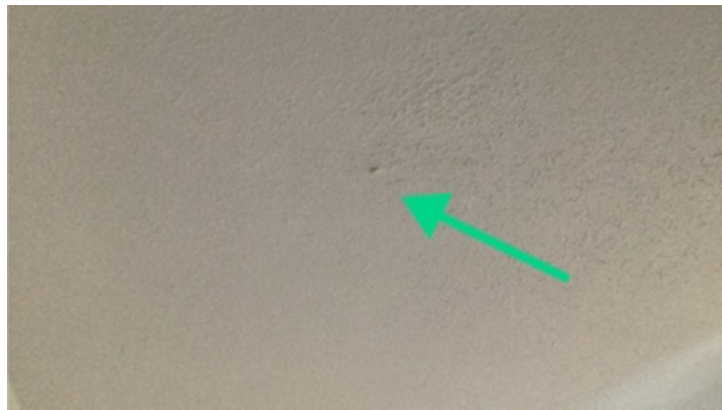
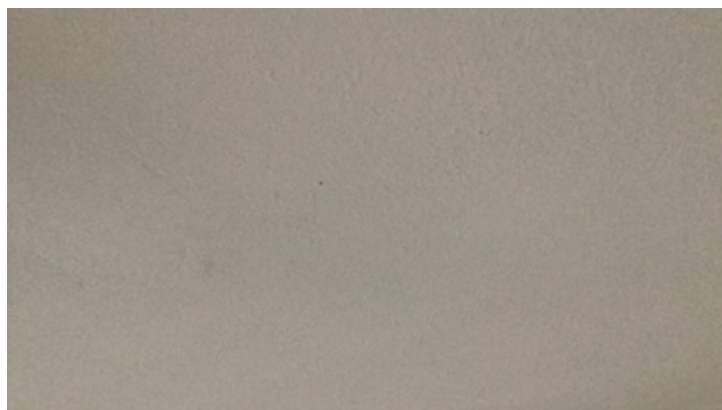
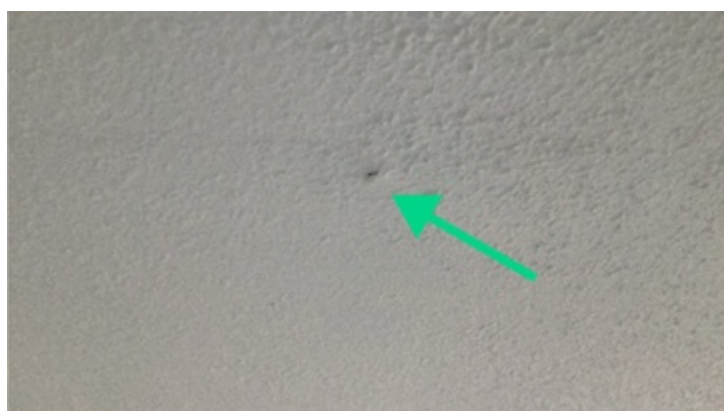
## Bedroom 3 photos / videos

**Monitor deficiency****Nail pops on ceiling**

One or more nail pops on the ceiling

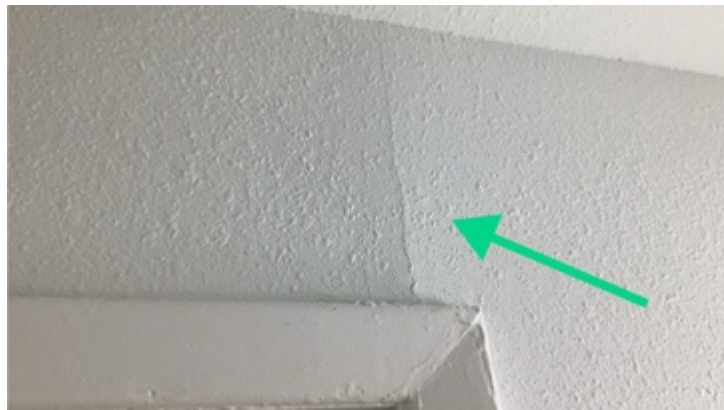
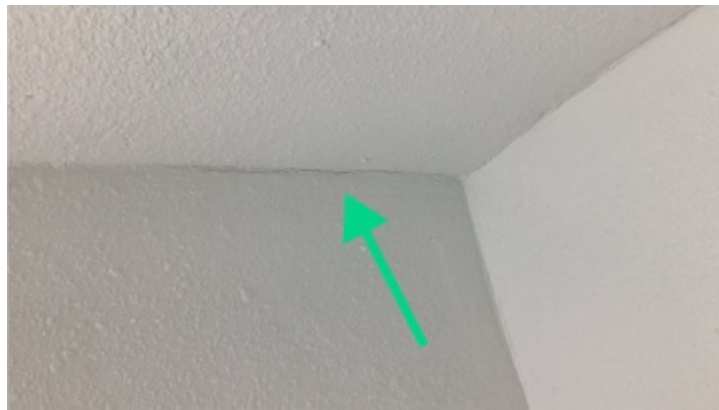
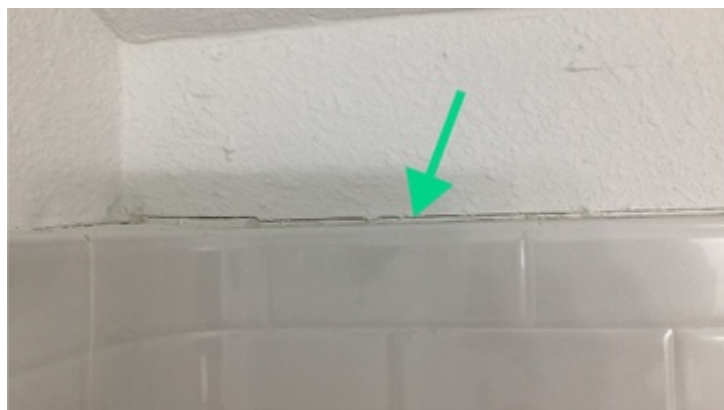
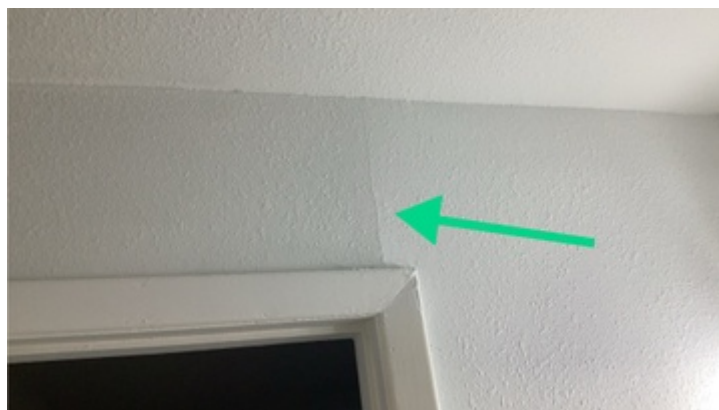
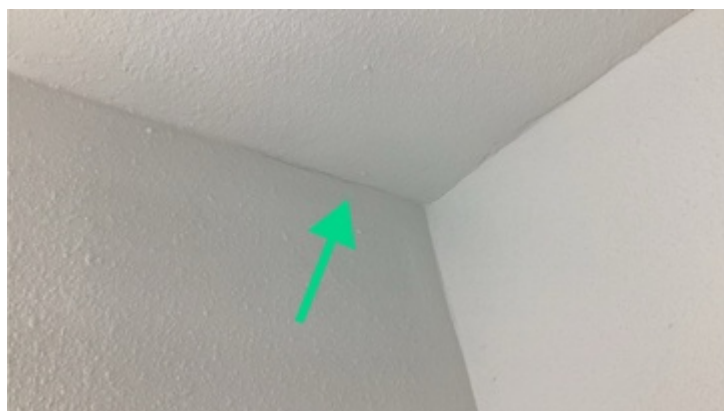
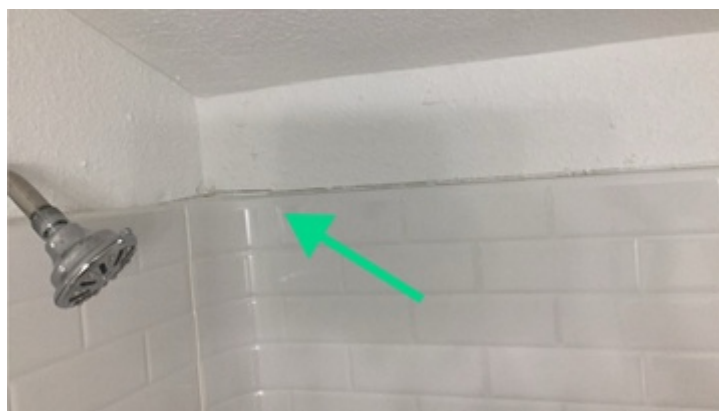
**Repair deficiency**

## Crack(s) in Wall(s)

There are one or more cracks in the walls.

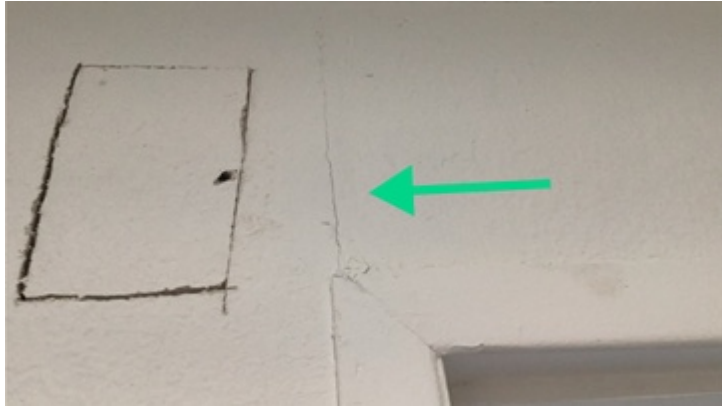
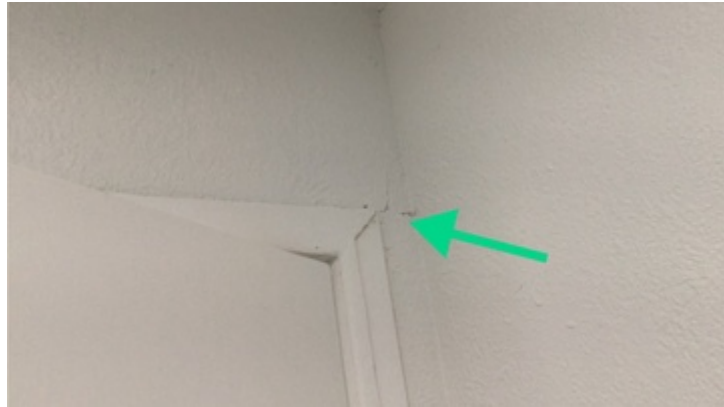
**Repair deficiency**

### Crack(s) in Wall(s)

There are one or more cracks in the walls.

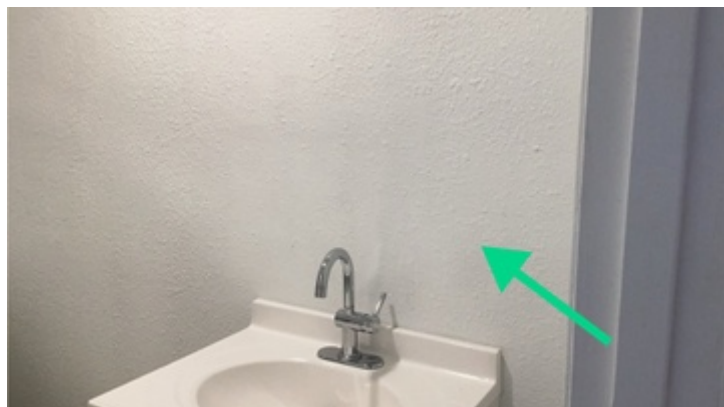
### Missing Bathroom Mirror

The bathroom mirror is missing.

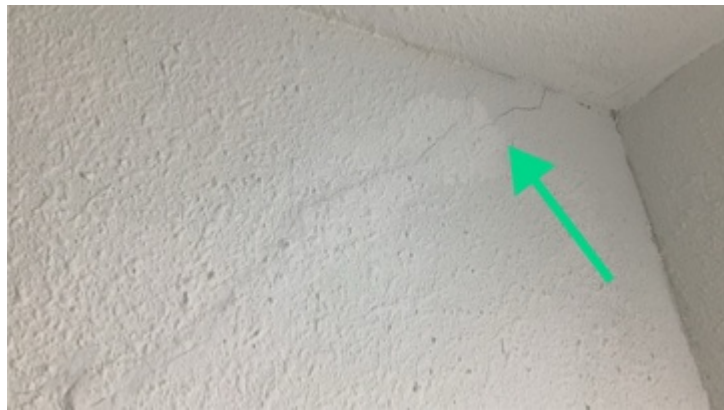
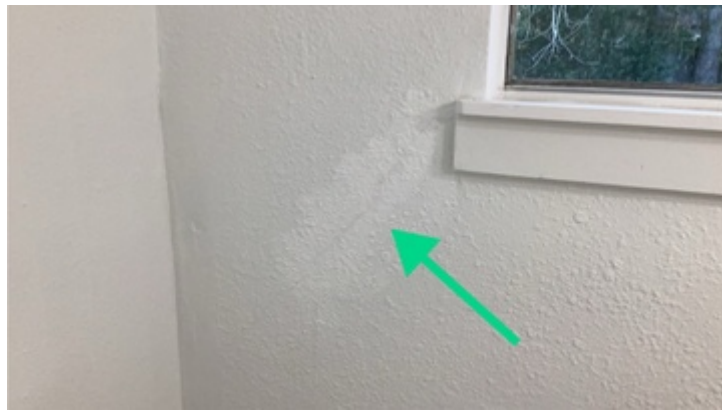
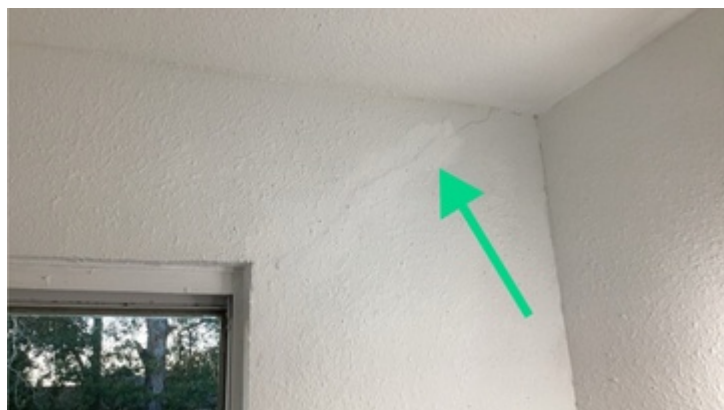
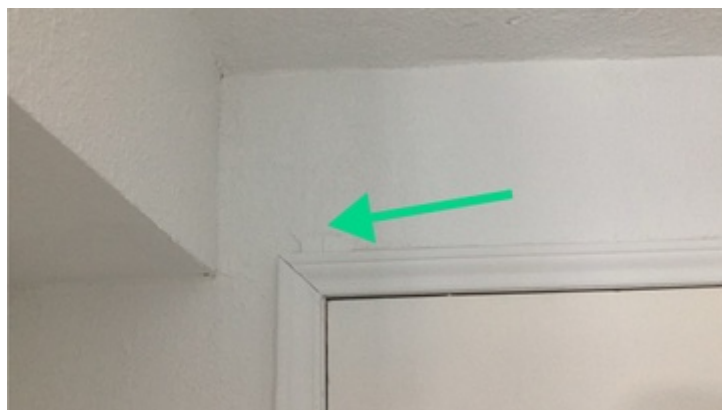
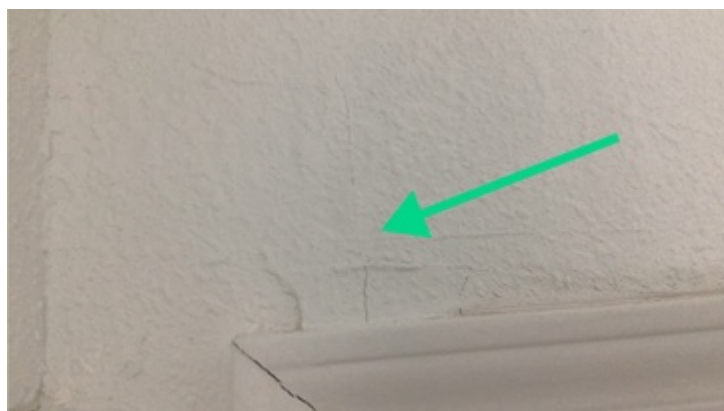
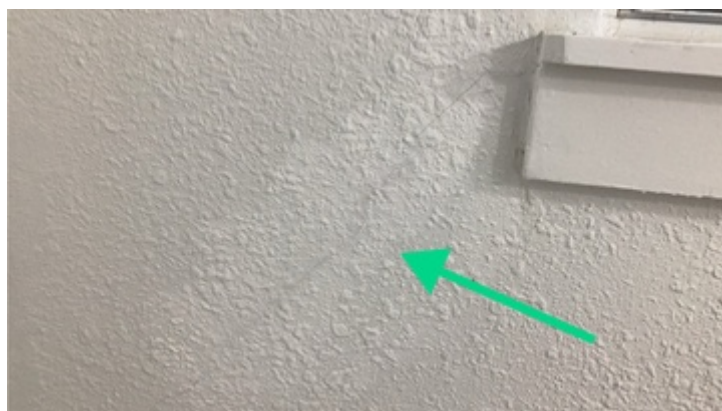
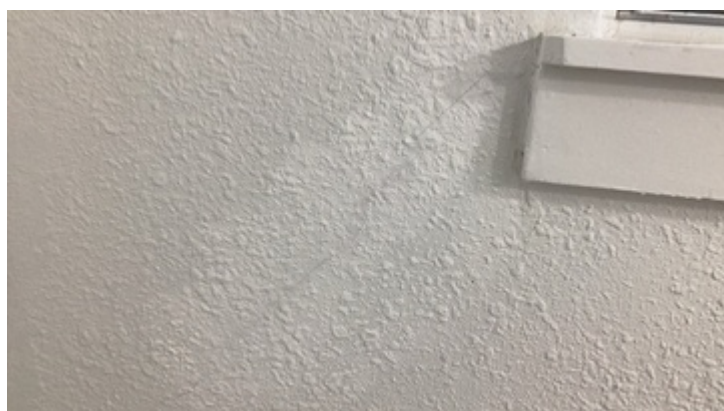
**Crack(s) in Wall(s)**

There are one or more cracks in the walls.

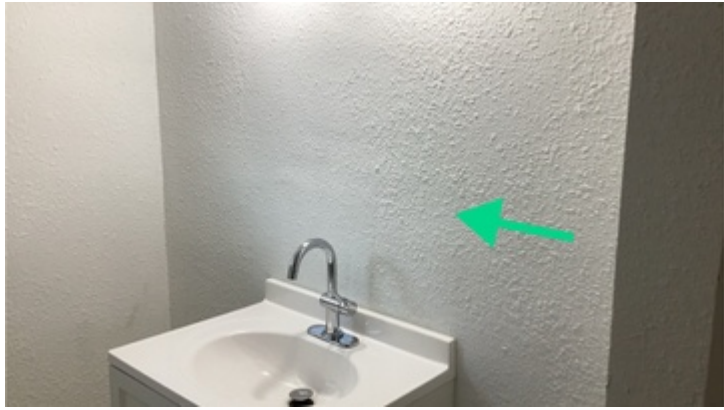
### Missing Bathroom Mirror

The bathroom mirror is missing.

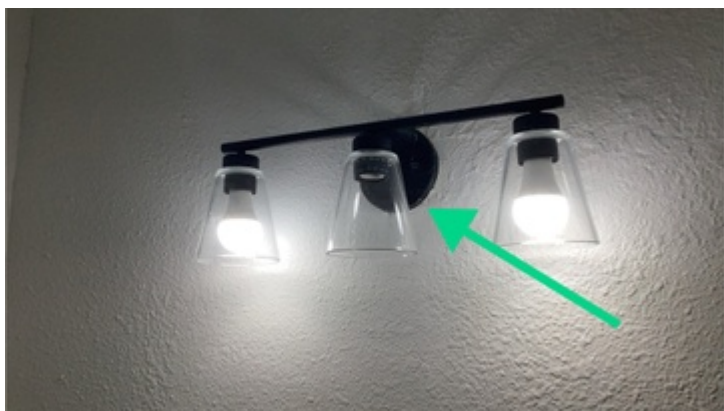
## Inoperable or Missing Light Bulb

One or more light bulbs have burnt out or are missing.
