# 4843 Bricker St

# Houston, Texas 77033

| Type | <b>Home Inspection and Floor<br/>Plan Report - 4843 Bricker St</b> |
| Inspected by | <b>HomeTeam Inspection Service -<br/>North Houston</b> |

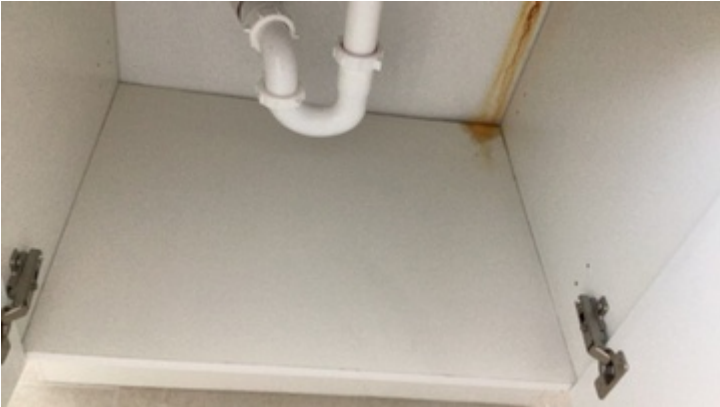
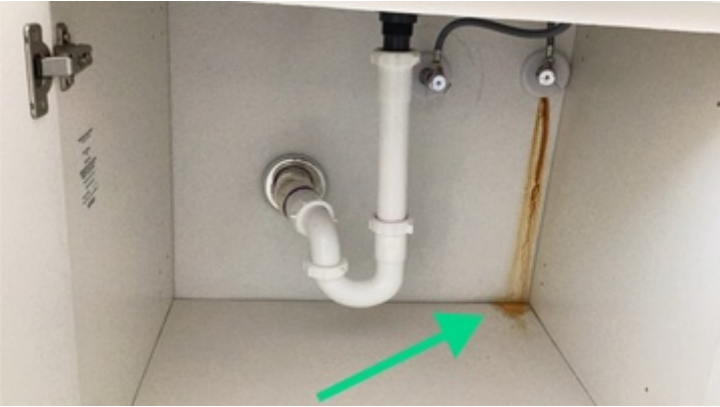
**Leaking Distribution Pipe**

The distribution pipe is leaking.

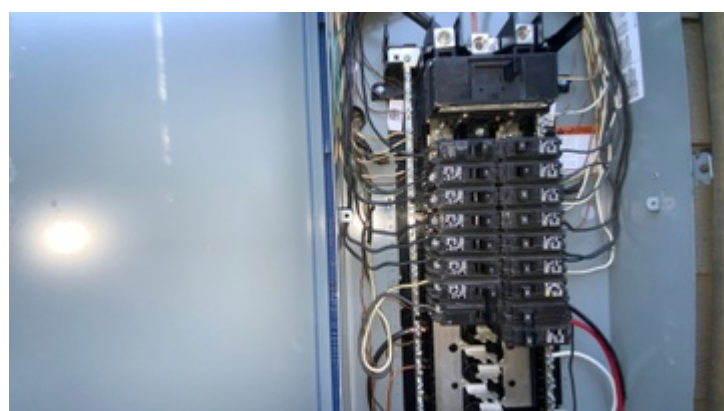
#### Improper Wiring

The wiring has been done improperly.

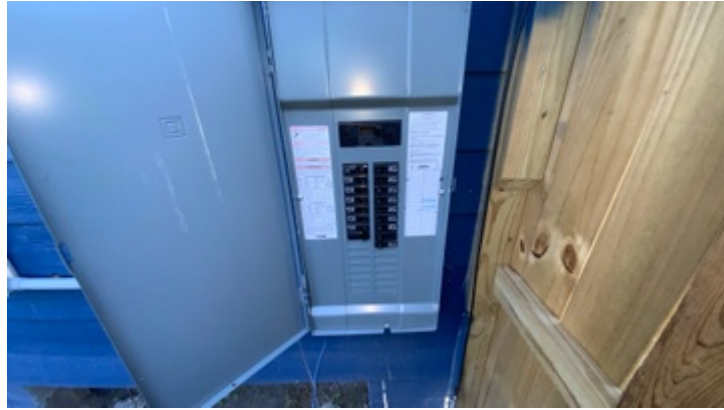
## Missing AFCI Breaker

A required Arc-Fault Circuit Interrupter is missing.

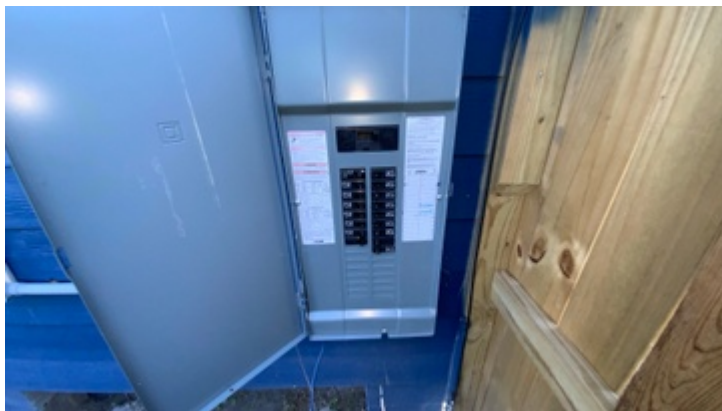
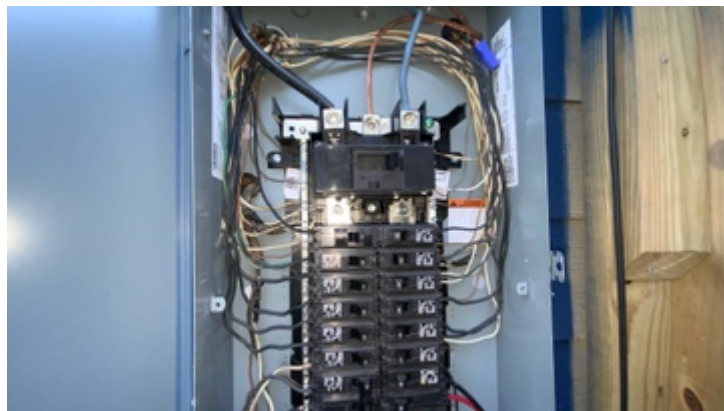
## Missing Surge Protection

There is no whole-house surge protection installed.

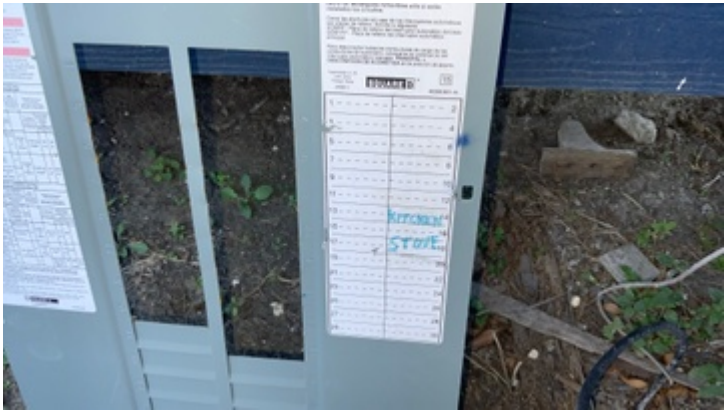
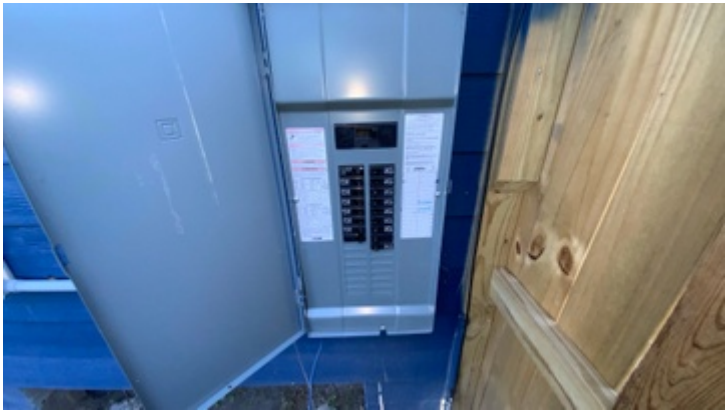
## Missing Labels in Electrical Panel

The electrical panel is missing circuit labeling.

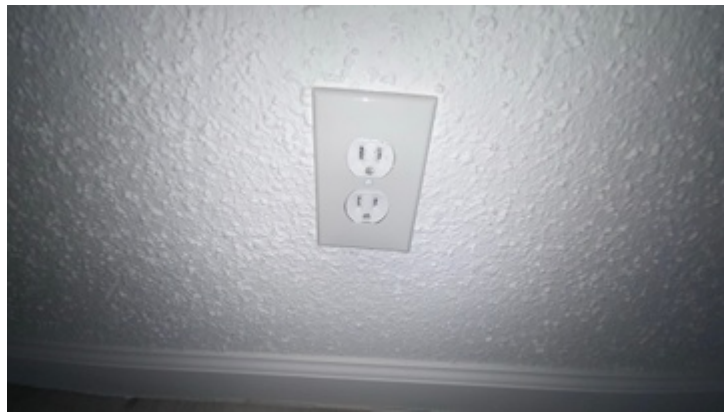
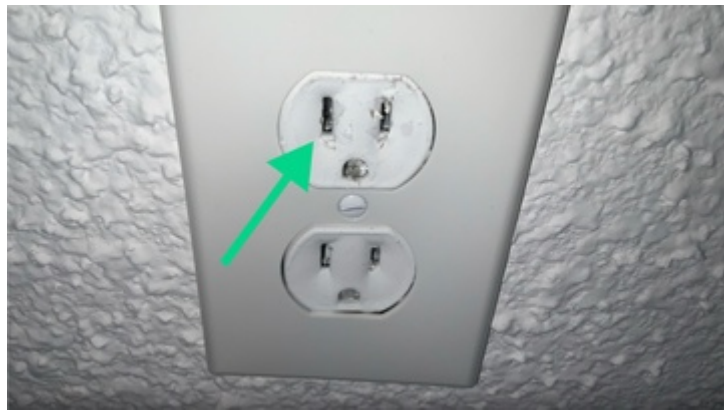
Unsafe Outlets

One or more receptacles / outlets are not tamper resistant.

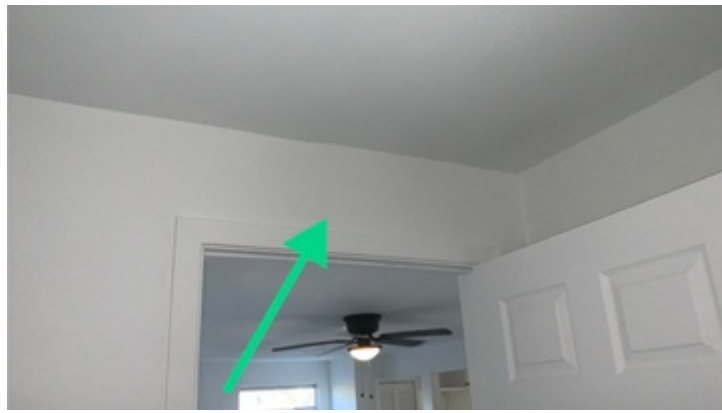
## Missing Smoke Detector(s)

The amount of smoke detectors on the property does not meet the residential requirements.
