Lone Star Stucco, LLC

## Moisture Assessment Report

2409 Langston Street

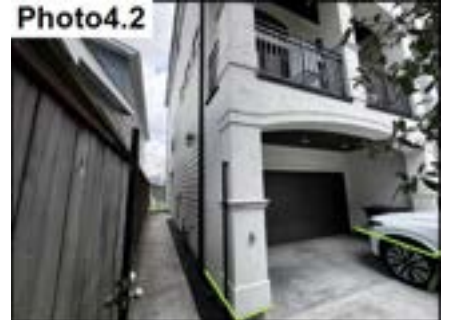
Photo4.2

- Stucco appears to be typically detailed at grade for the time of this construction. The inspector suggests that this is a positive detail and recommends no modification at this time but to always keep soil away from the structure. Please refer to photos #4.2, #4.3, #4.4, #4.5 and #4.6 for more detail.

Proper Grade Termination with Weep Screed / Positive Detail

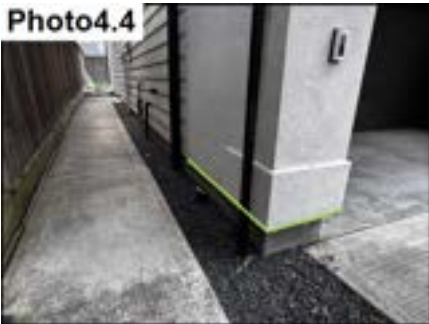
Photo4.4

Proper Grade Termination with Weep Screed / Positive Detail

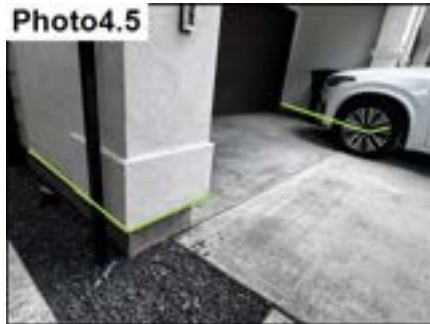
Photo4.5

Proper Grade Termination with Weep Screed / Positive Detail

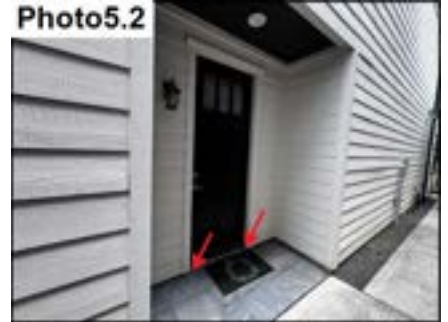
Photo5.2

- The door trim and miter sealants are aged or separated at this location. The inspector suggests to have a qualified waterproofing contractor seal this area with a low modulus sealant in an effort to prevent moisture intrusion. These types of sealants are of high quality and compatible with stucco and other termination points. Please refer to photos #5.2, #5.3, #5.4, #5.5 and #5.6 for more detail.

Door Trim and Miter Sealant / Seal

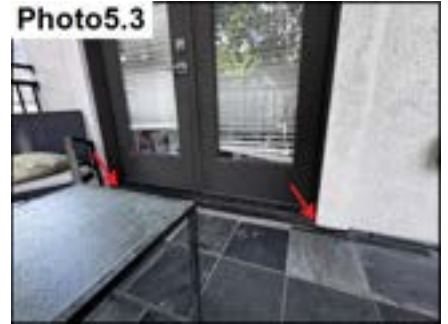
Photo5.3

Door Trim and Miter Sealant / Seal

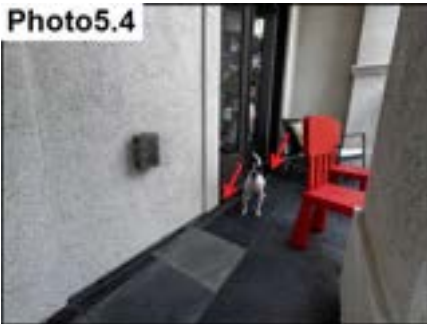
Photo5.4

Door Trim and Miter Sealant / Seal

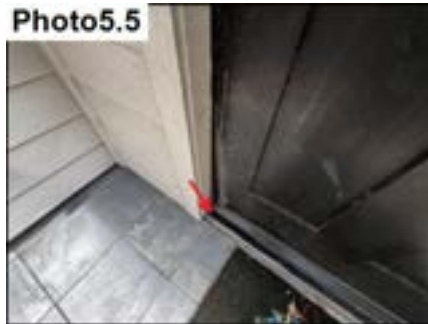
Photo5.5

Door Trim and Miter Sealant / Seal

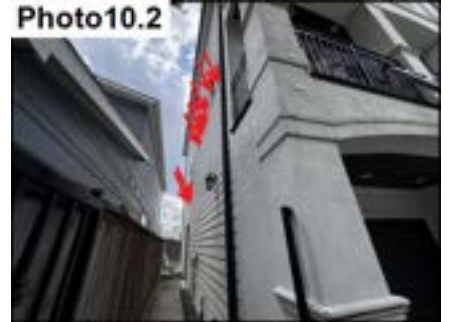
Photo10.2

- The window sealants are aged or separated. The inspector suggests to have a qualified waterproofing contractor further assess and seal this area with a low modulus sealant in an effort to prevent moisture intrusion. These types of sealants are of high quality and compatible with stucco and other termination points. Please refer to photos #10.2, #10.3, #10.4, #10.5, #10.6, #11.1, #11.2, #11.3 and #11.4 for more detail.

Window Sealants / Seal

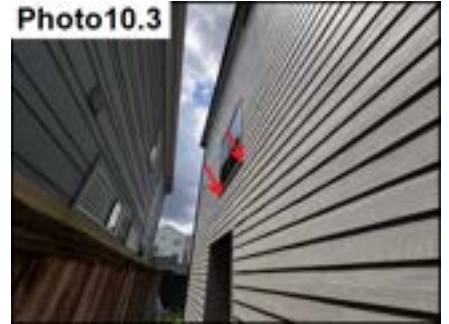
Photo10.3

Window Sealants / Seal

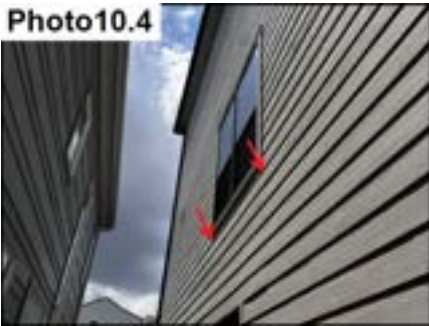
Photo10.4

Window Sealants / Seal

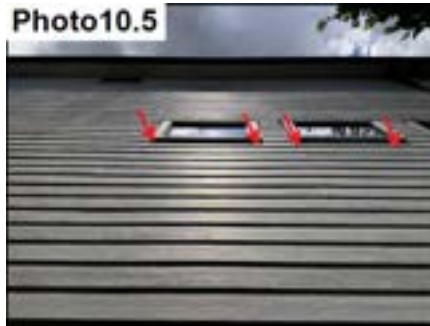
Photo10.5

Window Sealants / Seal

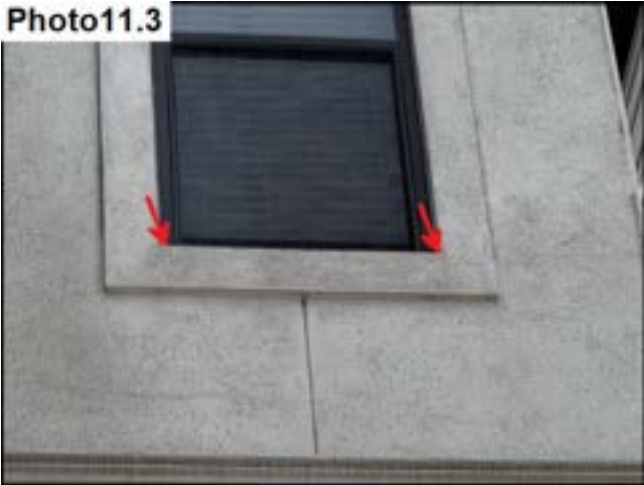
Photo11.3

Window Sealants / Seal

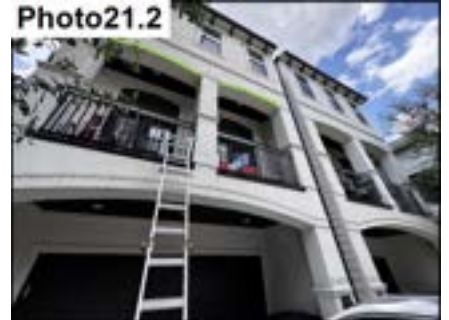
Photo21.2

No Relief Present / No Modification but Maintain Sealants Above

| Grid Location | Item Description | Moisture Readings | Substrate Condition | Observations |
|---|---|---|---|---|
| Green Lines | Relief | | | Although the bottom of the wall noted does not have a proper relief, this was a proper detail at the time of construction. Upon invasive testing at this location, the substrate was firm with low moisture readings. The inspector recommends no modification at this point in time but recommends to maintain all sealants above this location to prevent potential moisture intrusion. Please refer to photos #21.2, #21.3, #21.4 and #21.5 for more detail. |

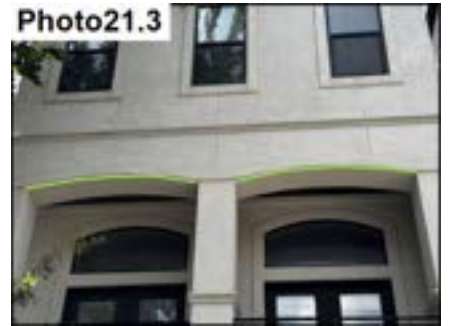
Photo21.3

No Relief Present / No Modification but Maintain Sealants Above

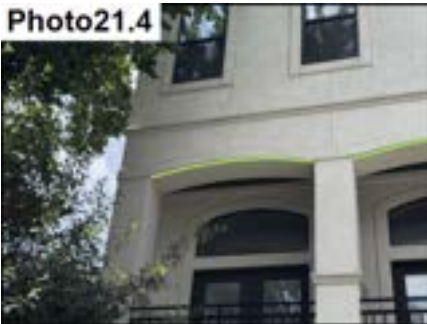
Photo21.4

No Relief Present / No Modification but Maintain Sealants Above

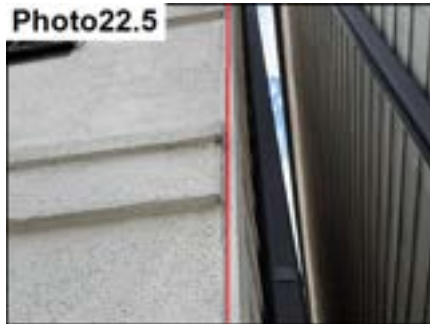
Photo22.5

- Siding/stucco termination sealants are aged or separated at this location. The inspector suggests to have a qualified waterproofing contractor further assess and seal this area with a low modulus sealant in an effort to prevent moisture intrusion. These types of sealants are of high quality and compatible with stucco and other termination points. Please refer to photos #22.2, #22.3, #22.4, #22.5 and #22.6 for more detail.

Siding & Stucco Termination / Seal

| Grid Location | Item Description | Moisture Readings | Substrate Condition | Observations |
|---|---|---|---|---|
| Red Line | Stucco Termination | | | Siding/stucco termination sealants are aged or separated at this location. The inspector suggests to have a qualified waterproofing contractor further assess and seal this area with a low modulus sealant in an effort to prevent moisture intrusion. These types of sealants are of high quality and compatible with stucco and other termination points. Please refer to photos #22.2, #22.3, #22.4, #22.5 and #22.6 for more detail. |

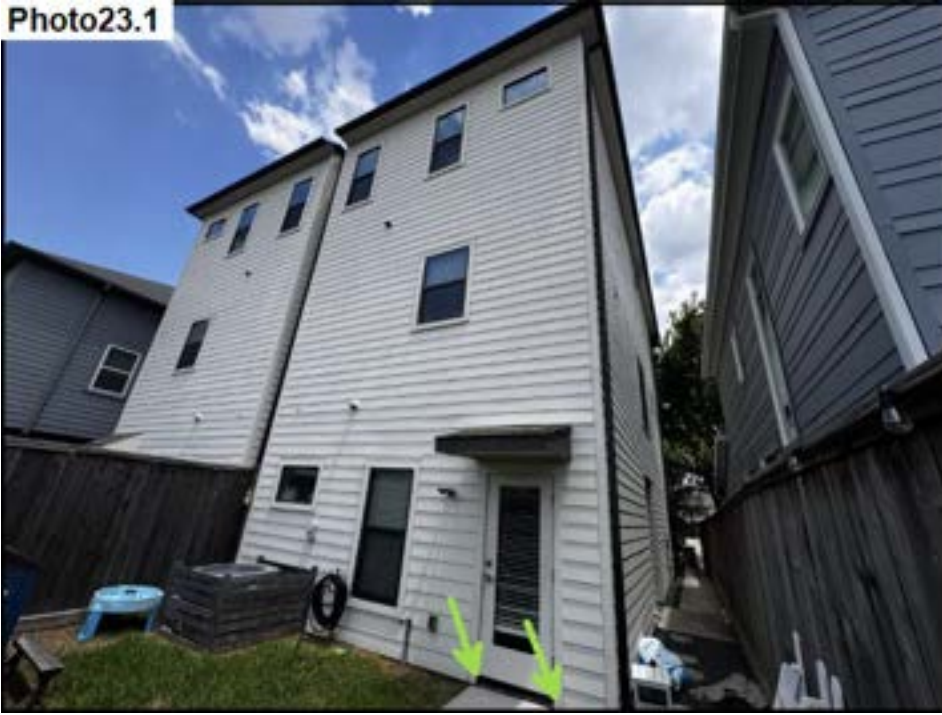
Photo23.1

| Grid Location | Item Description | Moisture Readings | Substrate Condition | Observations |
|---|---|---|---|---|
| Green Arrows | Doors | | | Door trim and miter sealants are present at this location. The inspector states that this is a positive detail and suggests maintaining these sealants in an effort to prevent moisture intrusion. Please refer to photos #23.2, #23.3, #23.4, #23.5 and #23.6 for more detail. |

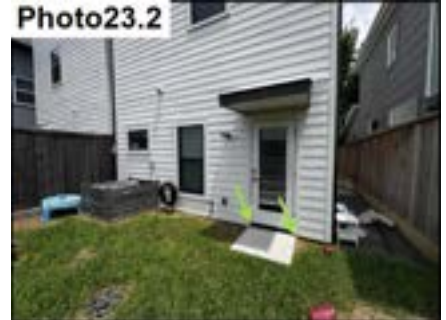
Photo23.2

- Door trim and miter sealants are present at this location. The inspector states that this is a positive detail and suggests maintaining these sealants in an effort to prevent moisture intrusion. Please refer to photos #23.2, #23.3, #23.4, #23.5 and #23.6 for more detail.

Door Trim and Miter Sealant /  
Maintain

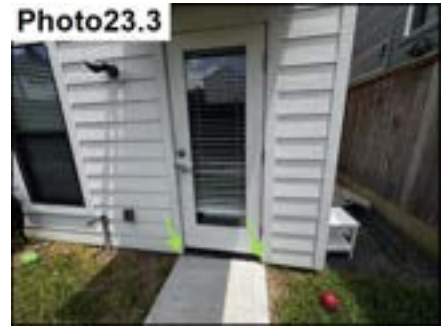
Photo23.3

Door Trim and Miter Sealant /  
Maintain

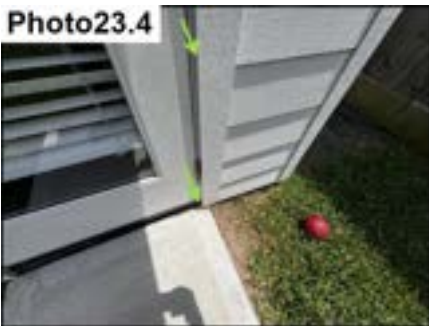
Photo23.4

Door Trim and Miter Sealant /  
Maintain

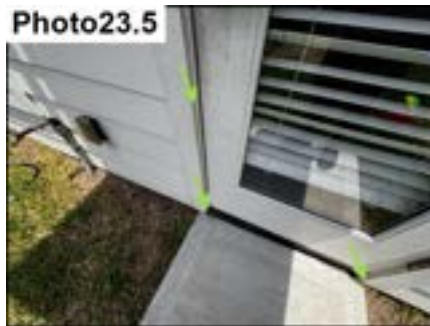
Photo23.5

Door Trim and Miter Sealant /  
Maintain

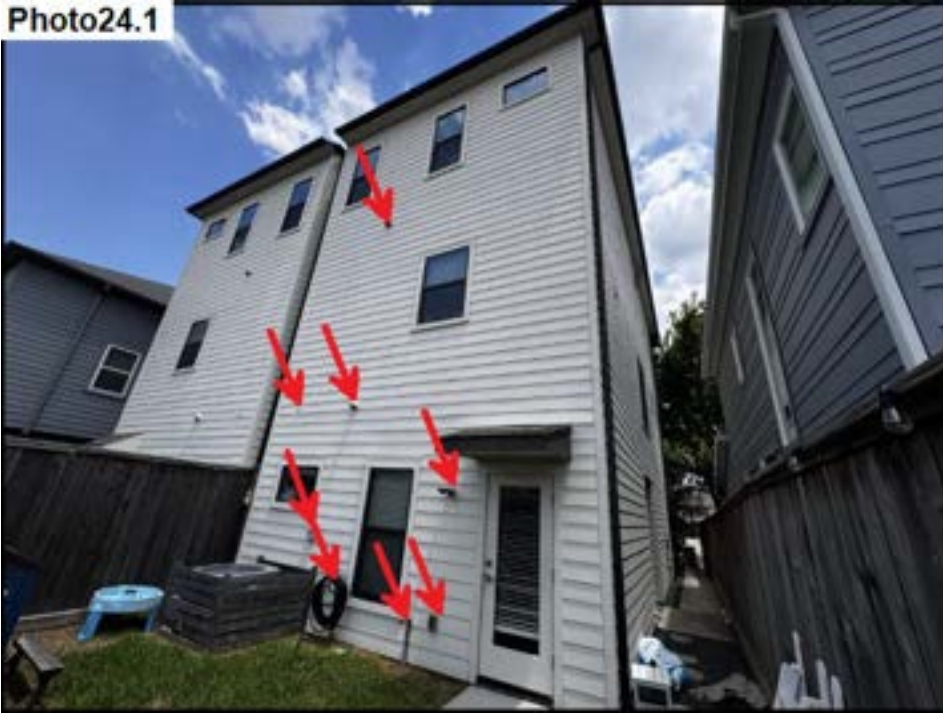
Photo24.1

| Grid Location | Item Description | Moisture Readings | Substrate Condition | Observations |
|---|---|---|---|---|
| Red Arrows | Penetrations | | | The penetration sealants are aged in this location. The inspector suggests to have a qualified waterproofing contractor seal this area in an effort to prevent moisture intrusion. Please refer to photos #24.2, #24.3, #24.4, #24.5 and #24.6 for more detail. |

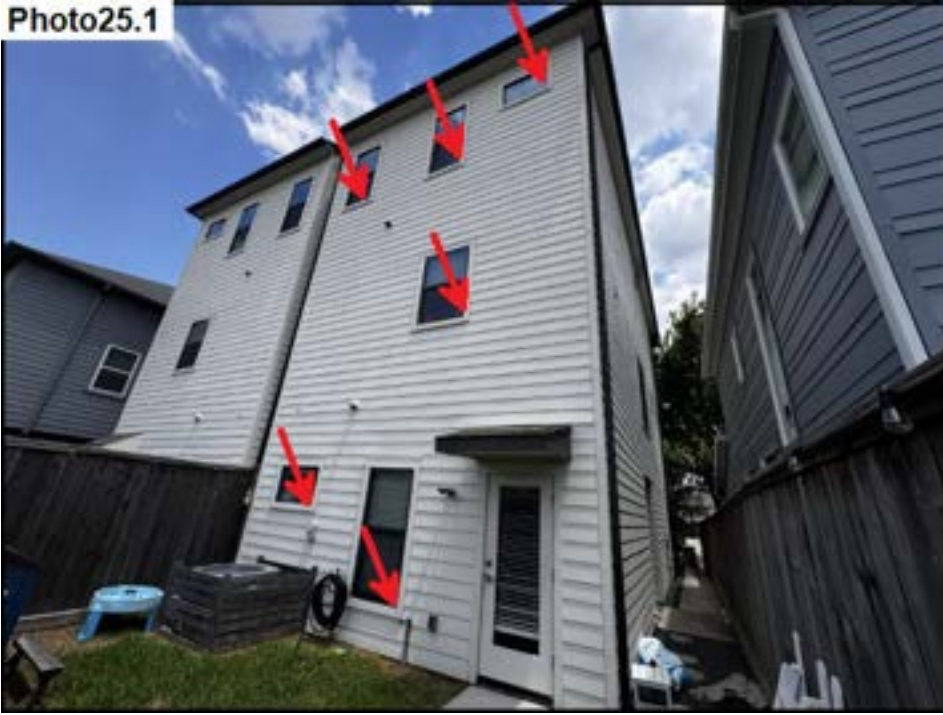
Photo25.1

| Grid Location | Item Description | Moisture Readings | Substrate Condition | Observations |
|---|---|---|---|---|
| Red Arrows | Windows | | | The window sealants are aged. The inspector suggests to have a qualified waterproofing contractor further assess and seal this area in an effort to prevent moisture intrusion. Please refer to photos #25.2, #25.3, #25.4, #25.5 and #25.6 for more detail. |

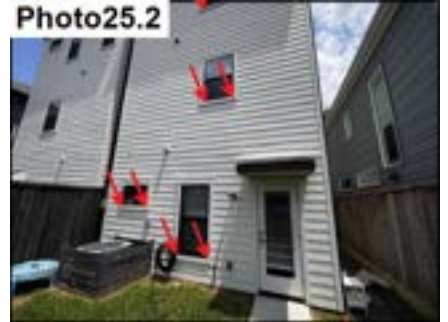
Photo25.2

- The window sealants are aged. The inspector suggests to have a qualified waterproofing contractor further assess and seal this area in an effort to prevent moisture intrusion. Please refer to photos #25.2, #25.3, #25.4, #25.5 and #25.6 for more detail.

Window Sealants / Seal

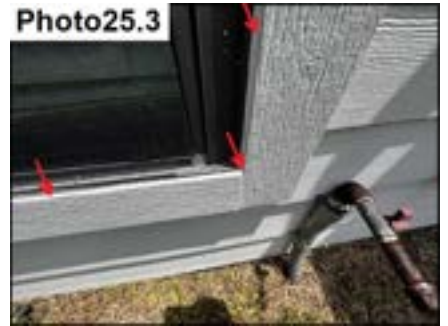
Photo25.3

Window Sealants / Seal

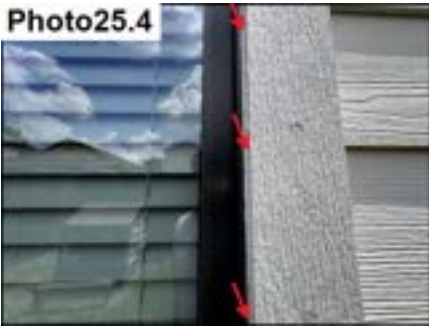
Photo25.4

Window Sealants / Seal

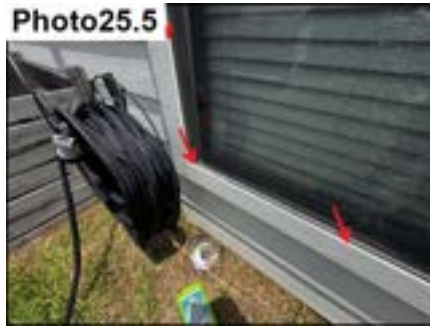
Photo25.5

Window Sealants / Seal

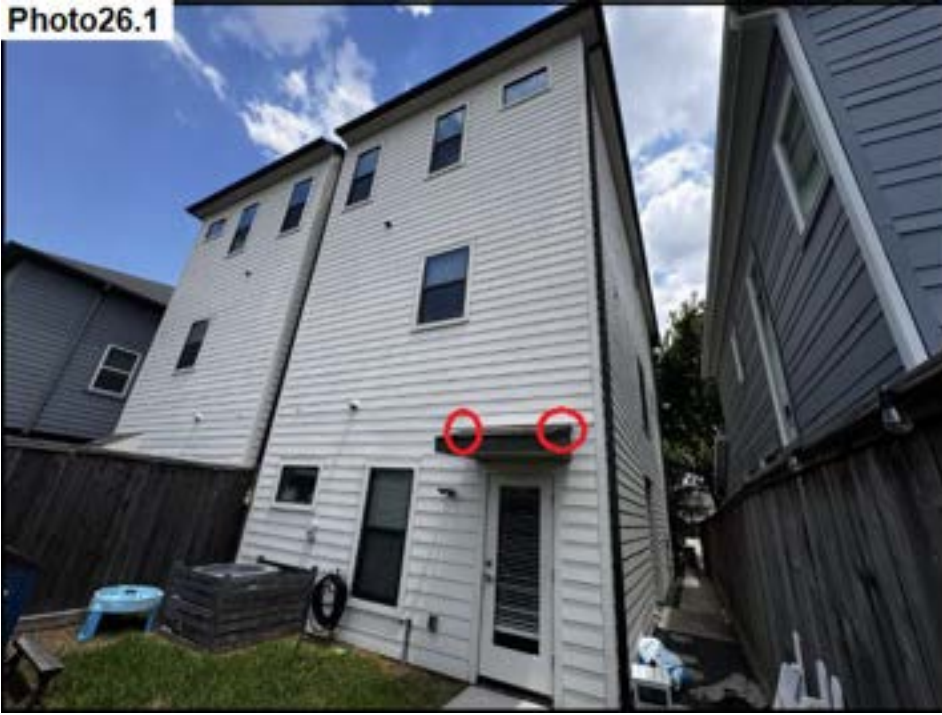
Photo26.1

| Grid Location | Item Description | Moisture Readings | Substrate Condition | Observations |
|---|---|---|---|---|
| Red Circles | Flashing | | | The roof diverter flashing sealants are aged at this location. The inspector suggests to have a qualified waterproofing contractor further assess and seal this area in an effort to prevent moisture intrusion. Please refer to photos #26.2, #26.3, #26.4, #26.5 and #26.6 for more detail. |
