# Home Inspection Report

3202 Mirro Drive, Manitowoc , WI 54220

Halverson Home Inspection LLC  
108 Eaton Court  
Valders , WI 54245  
920-905-5995  
th Alverson4@new.rr.com

073025-147

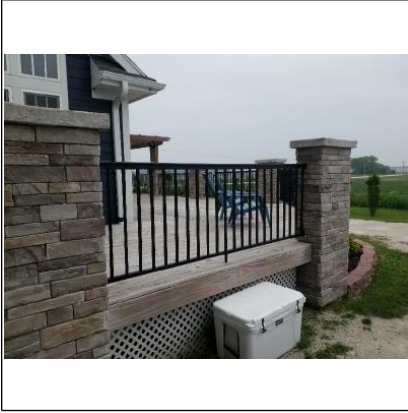
Rubber roof on balcony not visible. Evidence of leaking in house, recommend qualified contractor evaluate

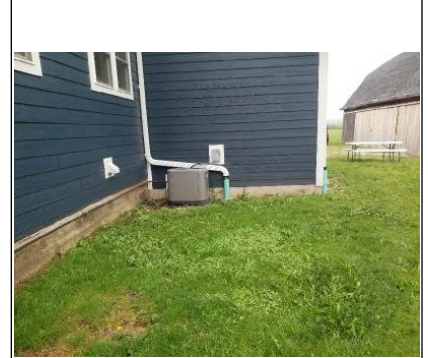
Negative grade North

**Comments** Low areas of grading next to the foundation recommend adding additional soil and slope away from foundation

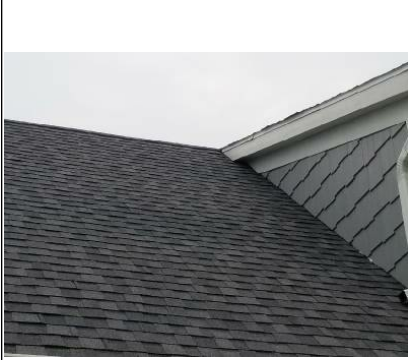
White spots are exposed nails,  
they have been caulked.  
Recommend monitoring

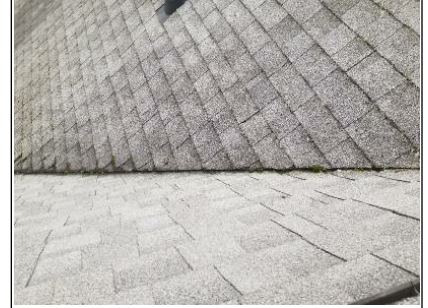
Roof on barn in need of  
replacement

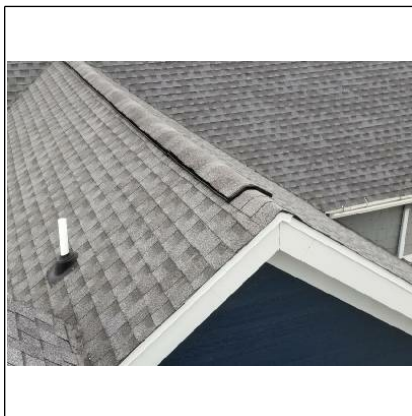
**Comments** Pulled away from chimney - recommend sealing.

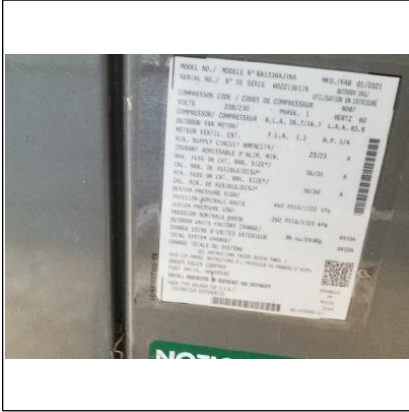
**Comments** Outside condenser unit coils dirty recommend cleaning

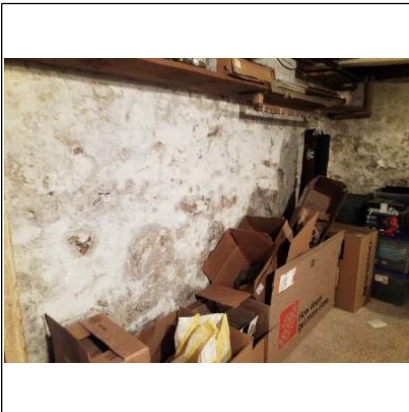
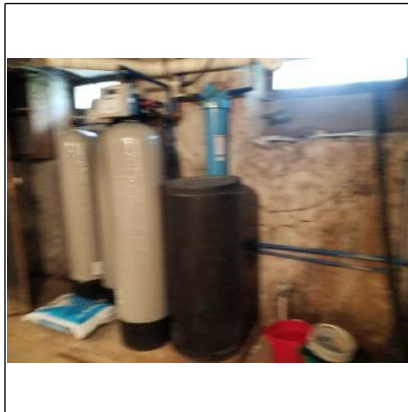
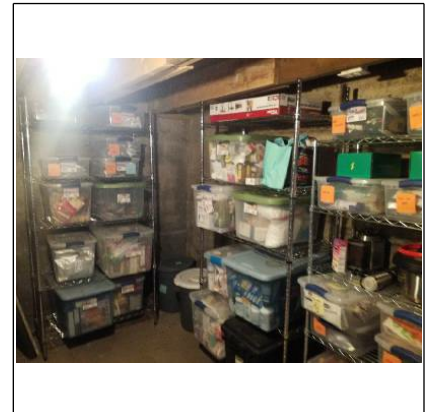
**Comments** Foundation appeared to be in overall satisfactory condition.

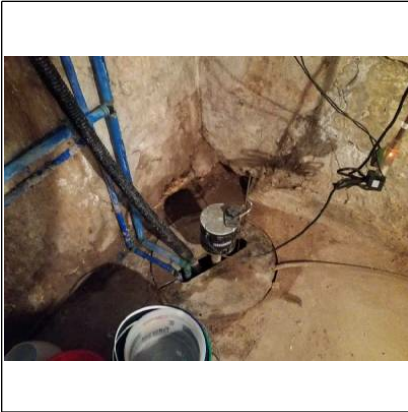
**Comments** Active seepage.  
Continual seepage is likely

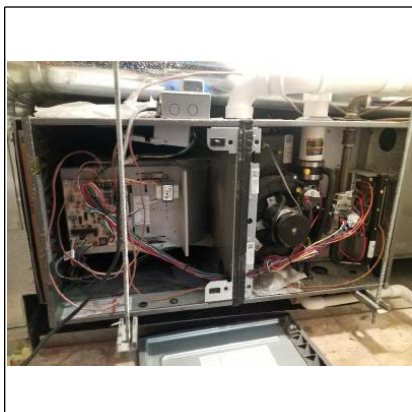
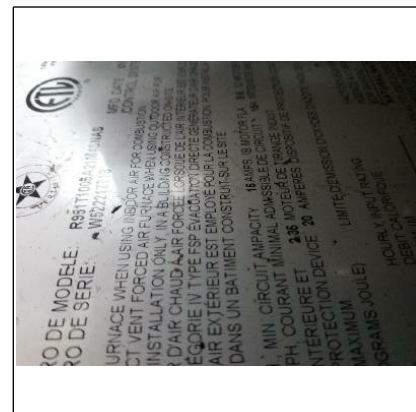
**Comments** H.E.P.A.-paper type filter should be changed once a year.  
 Furnaces were not operated due to exterior temperature

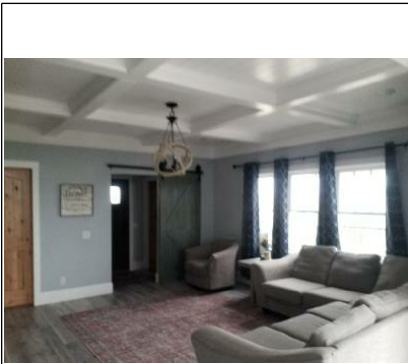
**Doors** ☐ None ☐ Satisfactory ☐ Marginal ☒ Poor ☐ Cracked glass ☐ Broken/Missing hardware

Unable to open door. Deadbolt malfunctioning. Safety Hazard
