Disclosure of Pre-Sale Inspection Report

2220 Stonecroft Dr.

# PROPERTY INSPECTION REPORT

**2220 Stonecroft Dr Grafton WI**  
**Inspection Prepared For: Tracy Prohuska**  
**Agent: Jaime Lubner - Compass**

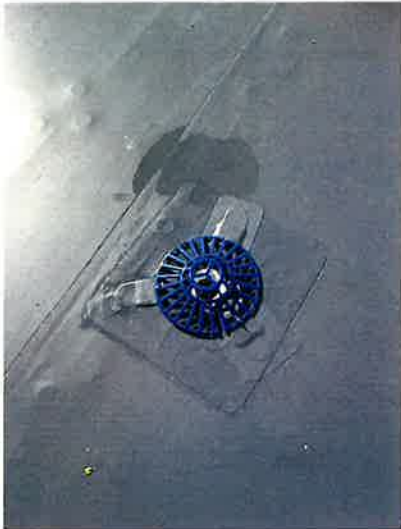
New drains

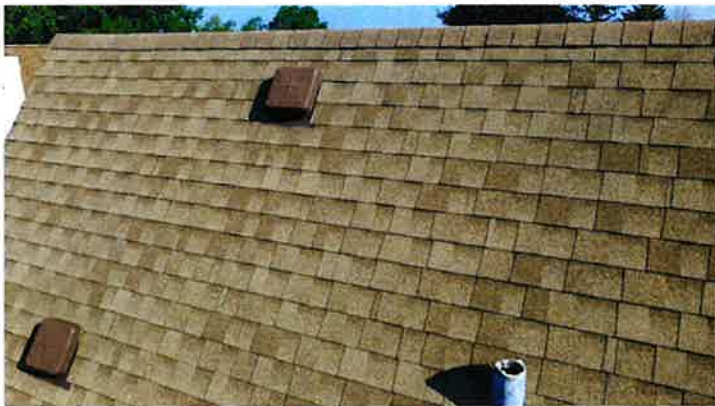
Hail dents vent no notable hail marks

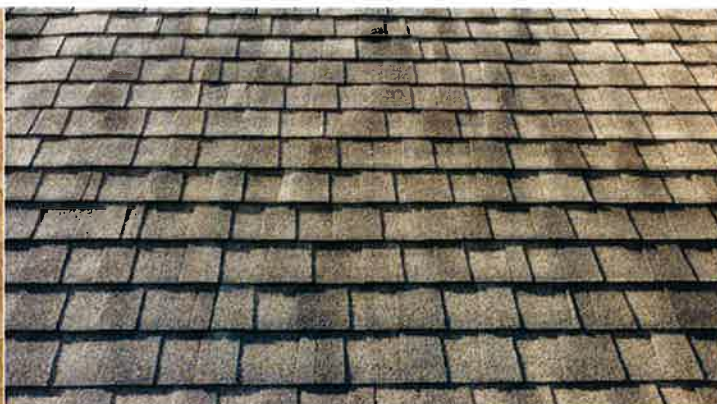
Uneven

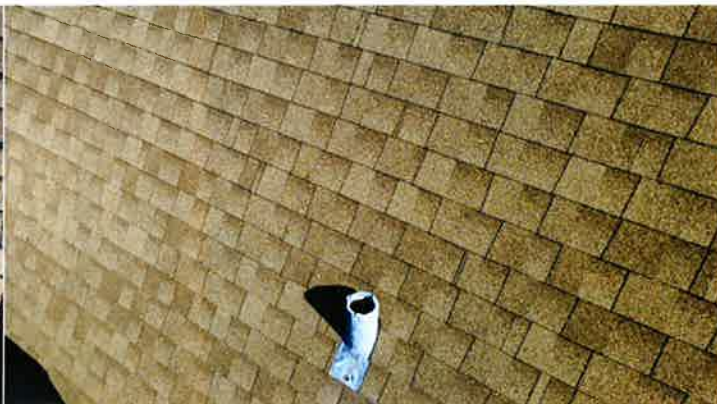
Lead

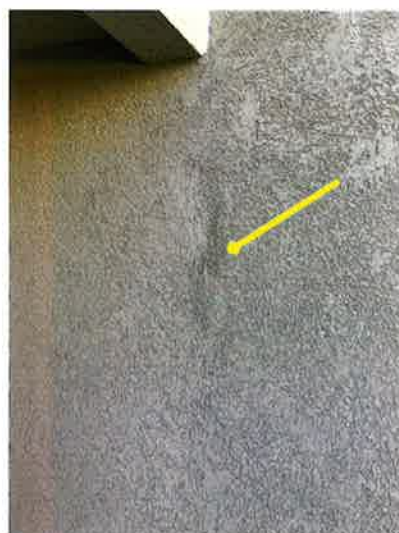
Ripple

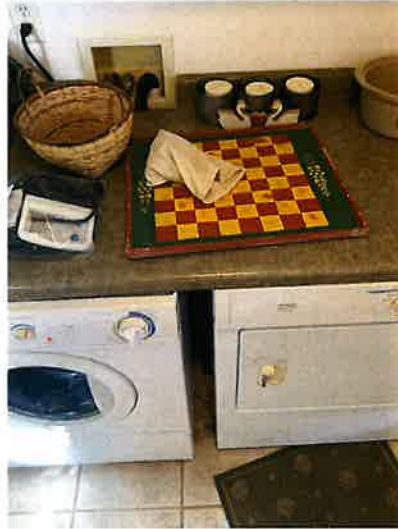
Unable to see behind the washer/dryer. No representations can be made.

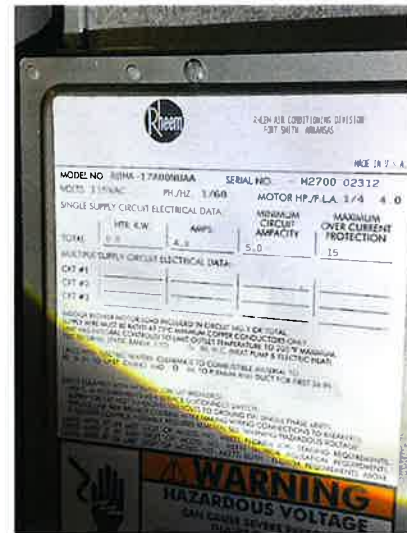
The photo shows furnace model and serial numbers for your information

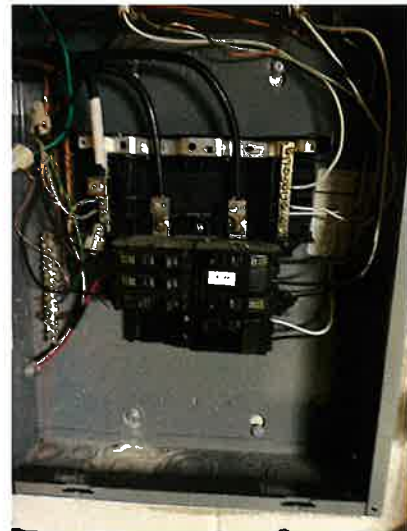
Inside of the panel for your reference
