# INSPECTION REPORT

For the Property at:  
**N6604 MINE RD**  
IRON RIDGE, WI 53035

RE: Report No. 2349  
N6604 Mine Rd  
Iron Ridge, WI  
53035

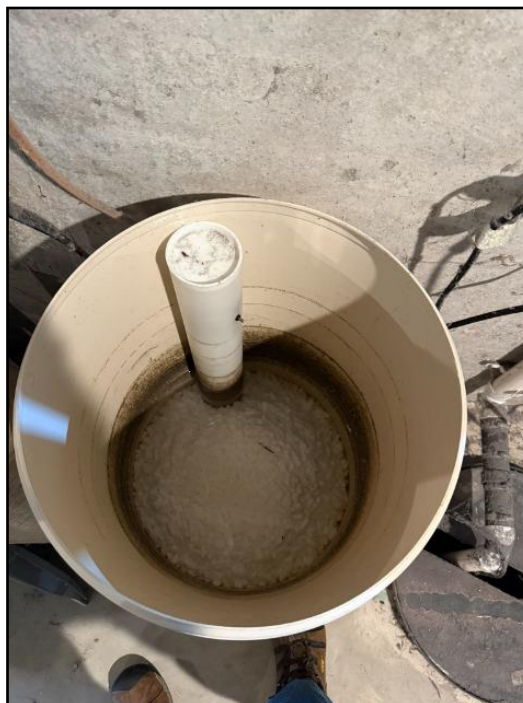
• Water softener

Brine tank low on salt.
