**REAL ESTATE CONDITION REPORT**

THIS CONDITION REPORT CONCERNS THE REAL PROPERTY LOCATED AT 700 Creekwood Drive  
IN THE City  
(CITY) (~~VILLAGE~~) (~~TOWN~~) OF West Bend COUNTY OF  
Washington STATE OF WISCONSIN.

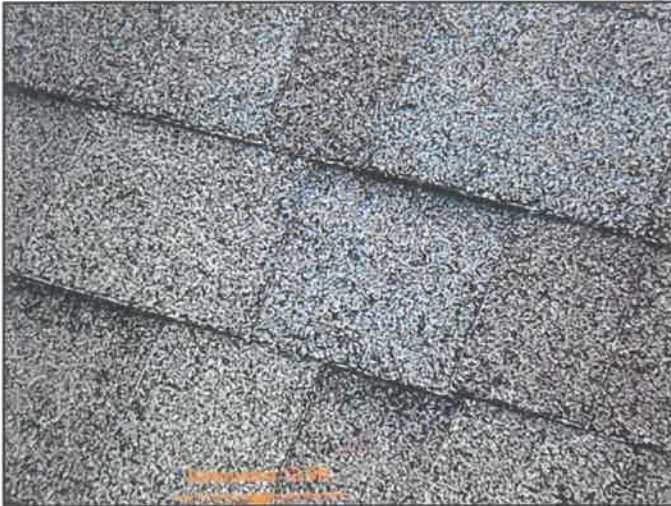
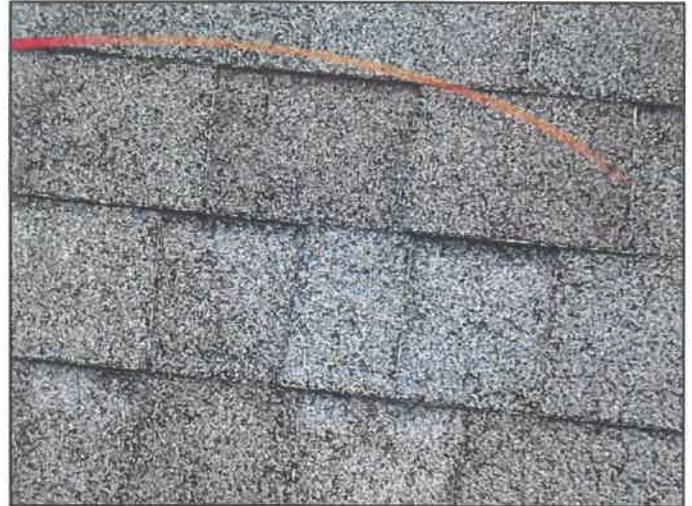
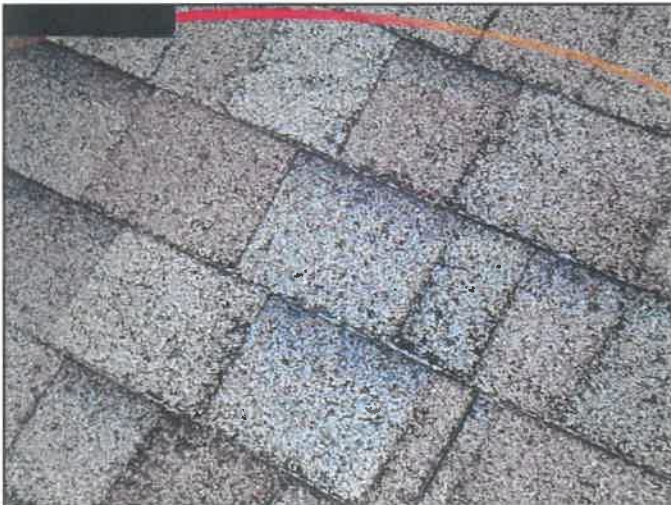
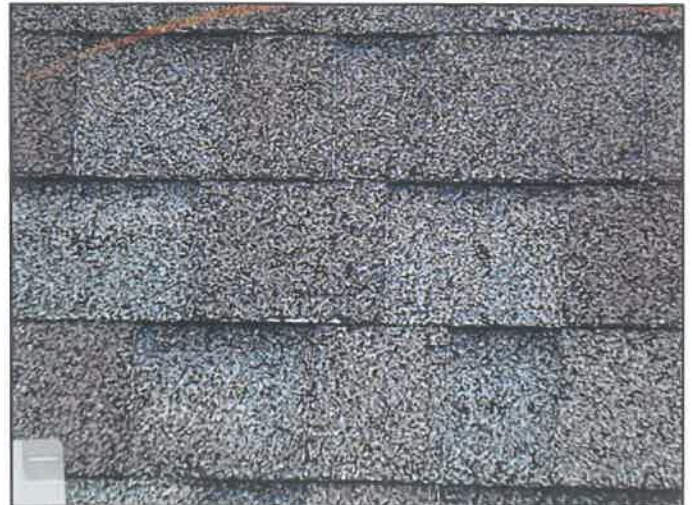
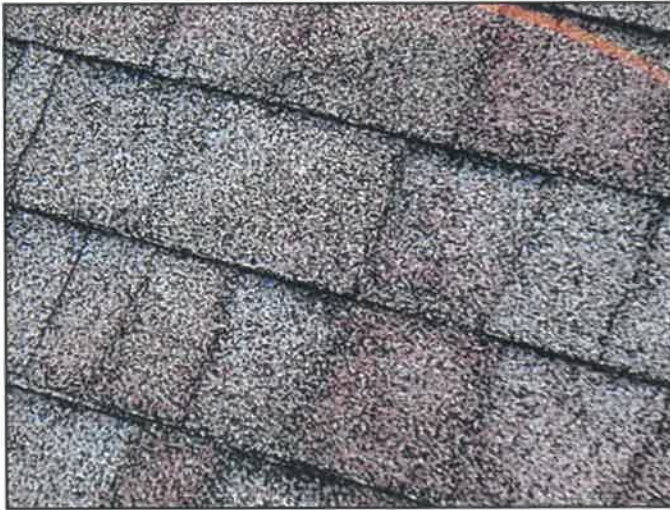
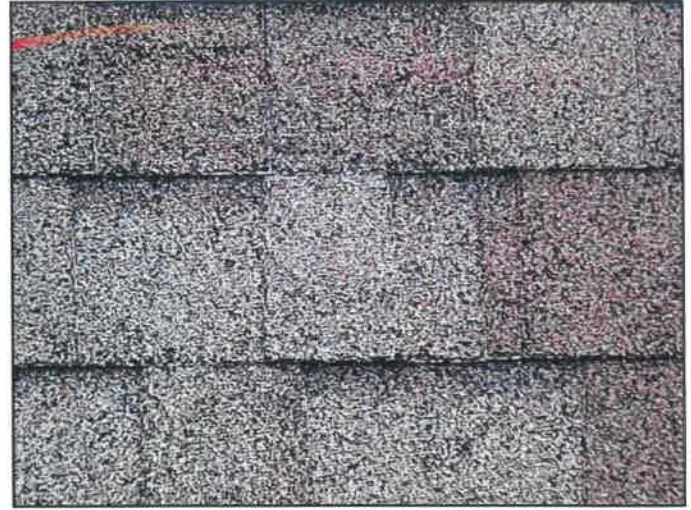
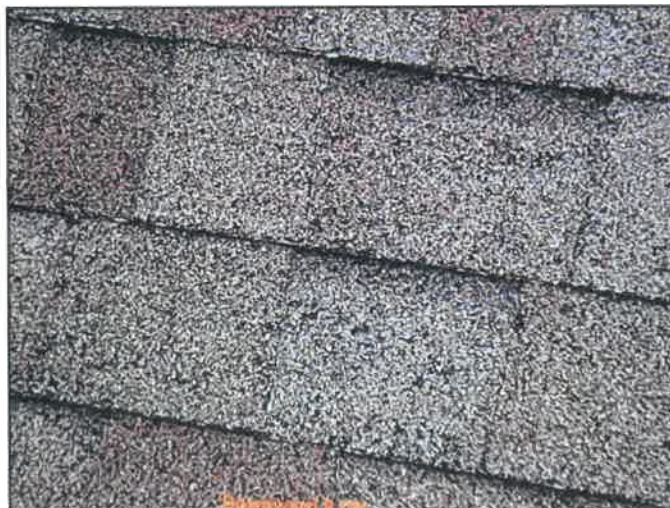
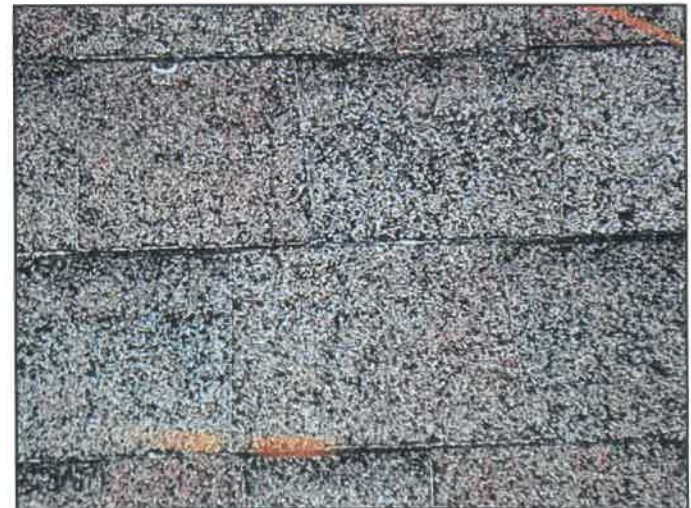
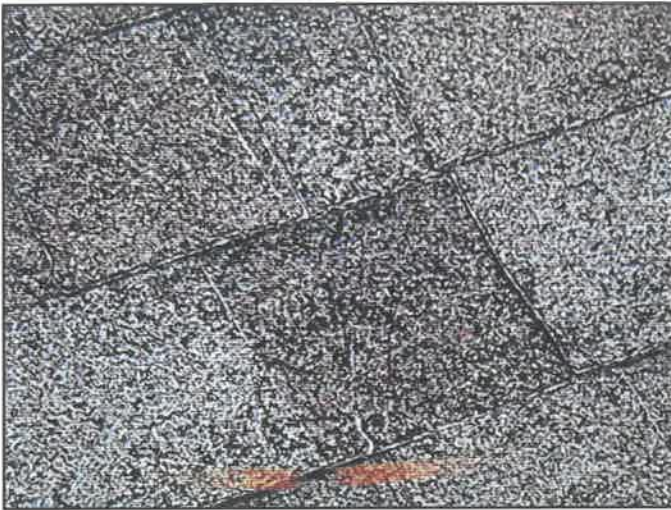
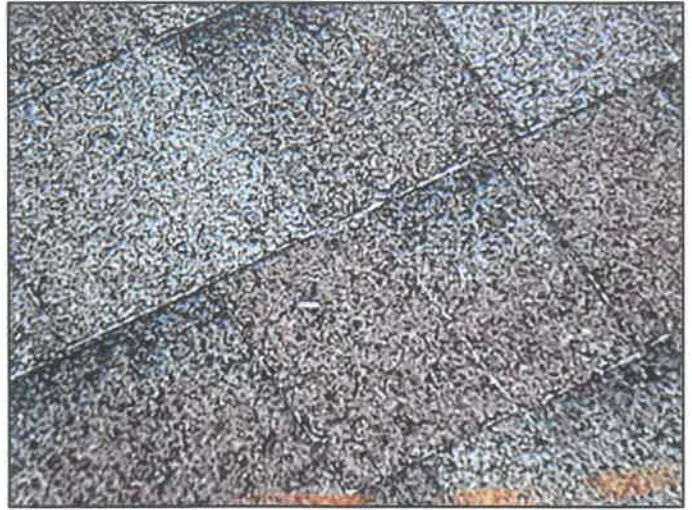
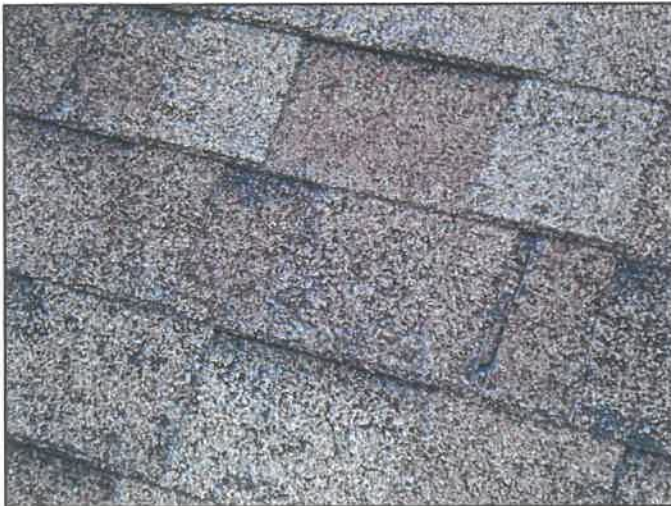
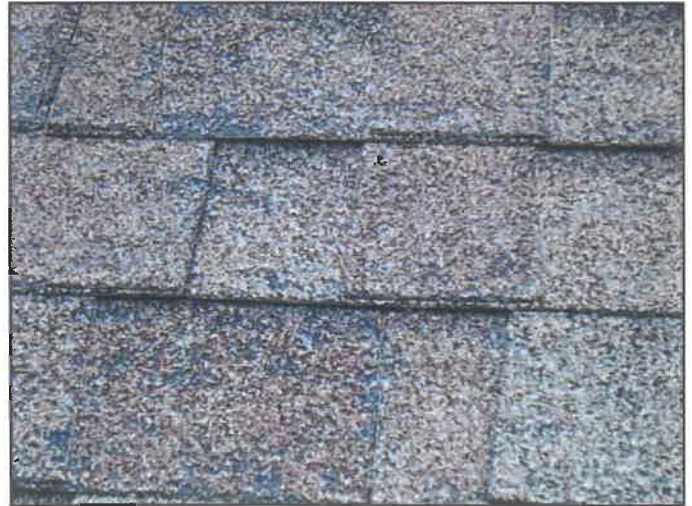
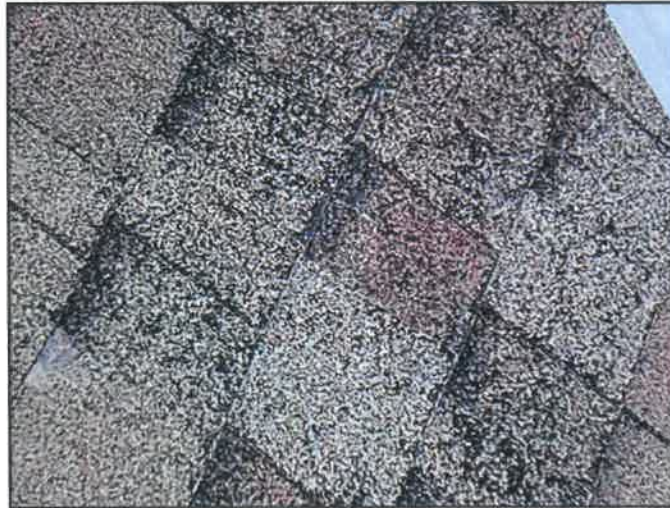
Condition: • [Granule loss](#)

DEFECT - The roofing materials are showing signs of significant granular loss and is likely at the end of its useful life. The roof should be replaced in the near future to prevent property damage and further leaking into the home. there was no evidence of active leaking observed at the time of the inspection.

Replaced  
September  
2026

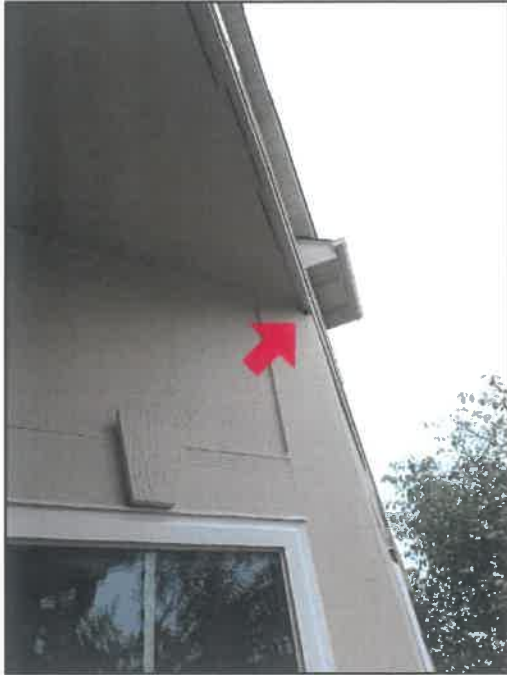
**Condition:** • DEFECT - There are a large number of bees entering the building above the front bay window. The bees need to be removed and then the area should be opened up and any damage should be repaired. There is likely rot in the area, but you won't know how much until the area is opened.

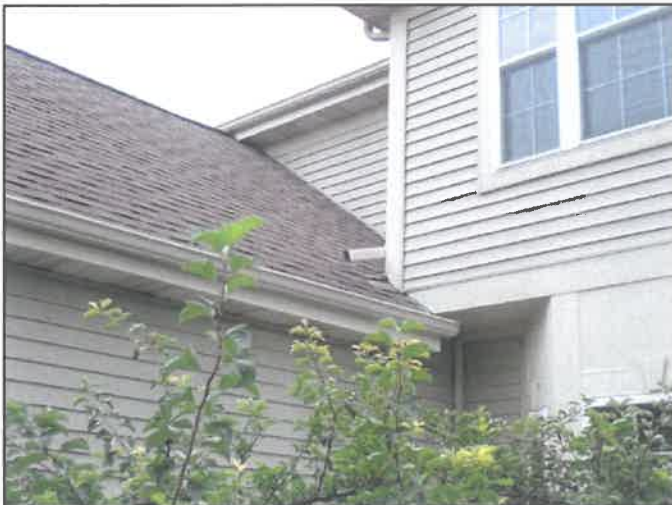
48. Vulnerable areas

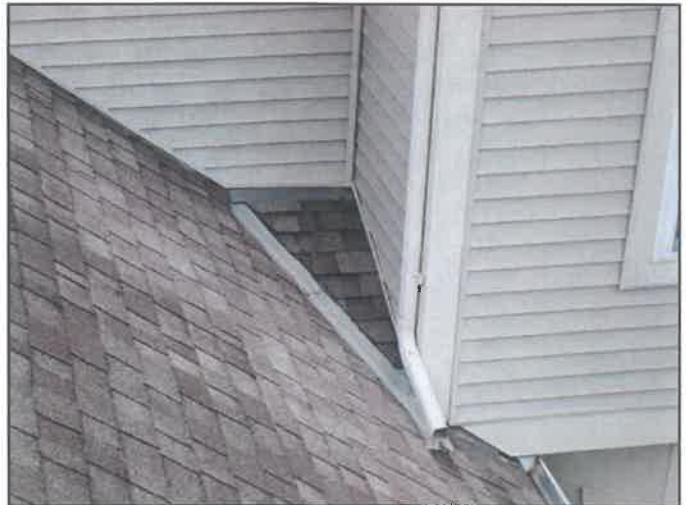
49. Vulnerable areas

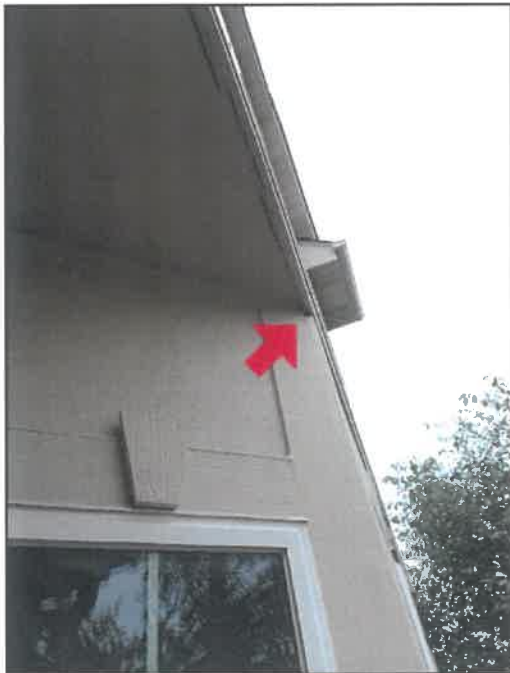
65.

**6. Condition:** • DEFECT - There are a large number of bees entering the building above the front bay window. The bees need to be removed and then the area should be opened up and any damage should be repaired. There is likely rot in the area, but you won't know how much until the area is opened.

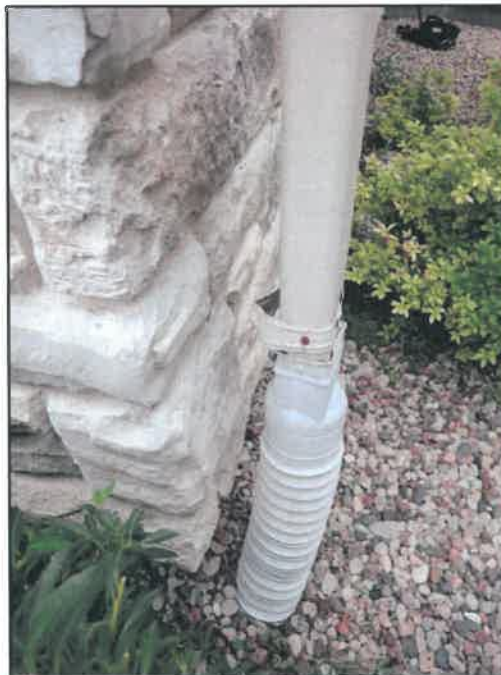
Loose downspouts need to be better secured to the structure.

73. Loose

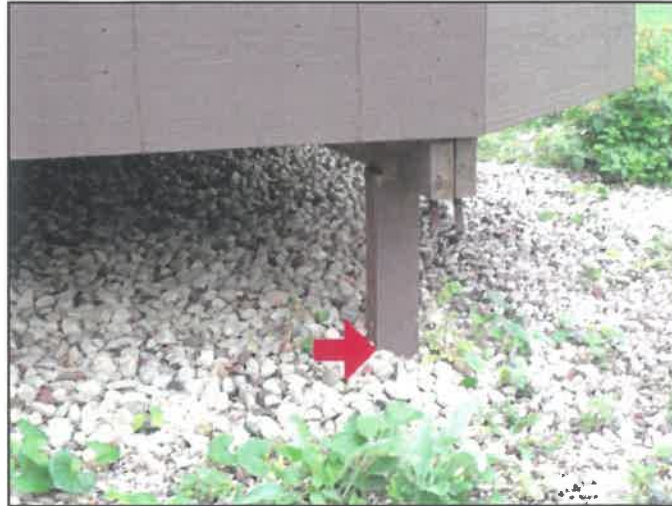
90. Wood/soil contact

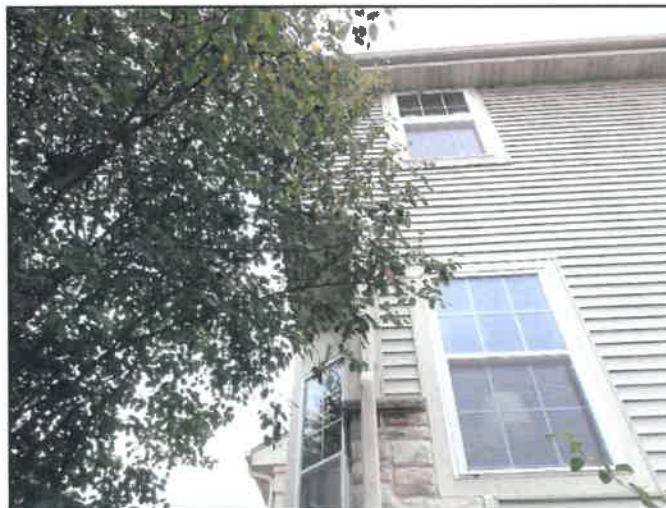
91. trim back foliage

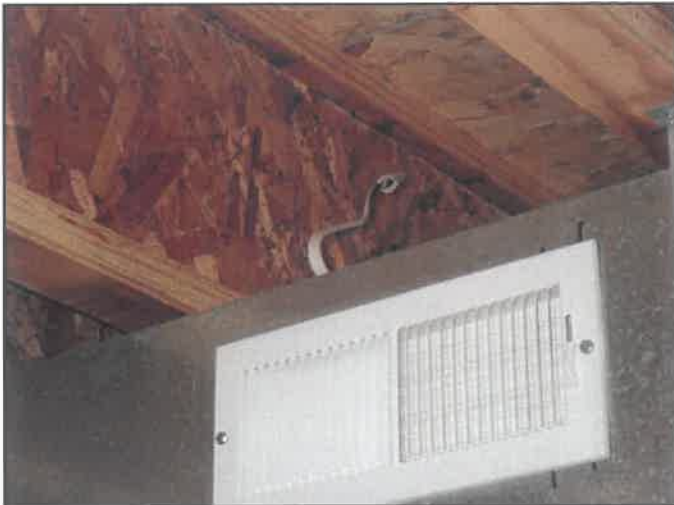
119. Open splices

#### **21. Condition:** • [Open splices](#)

**Implication(s):** Electric shock | Fire hazard

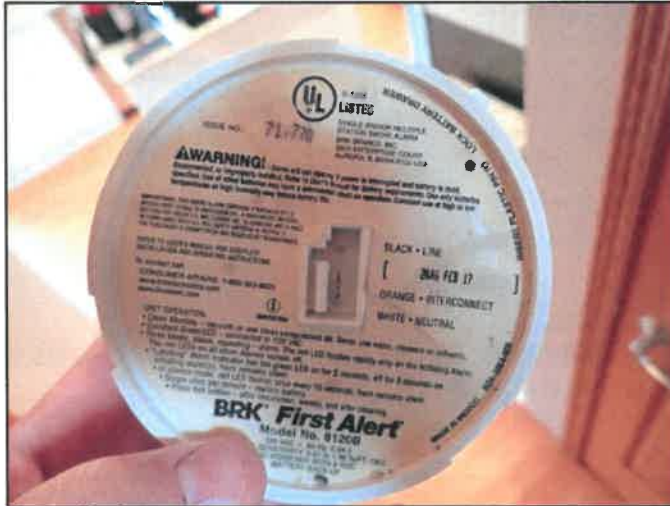
125. More than 10 years old

### 24. Condition: • More than 10 years old

There should be a smoke detector and carbon monoxide detector that is functional and less than 10 years old on every floor. Some are missing and/or are out of date and need to be replaced. The smoke detectors should also not be placed

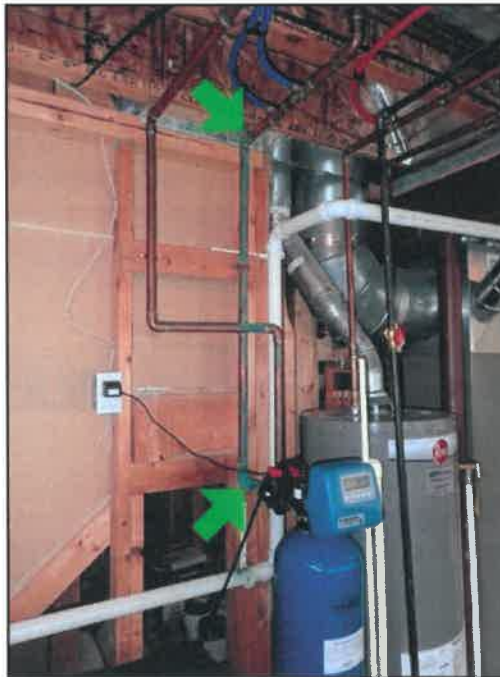
There are a few leaking/corroded plumbing joints that need to be repaired.

215. Leak

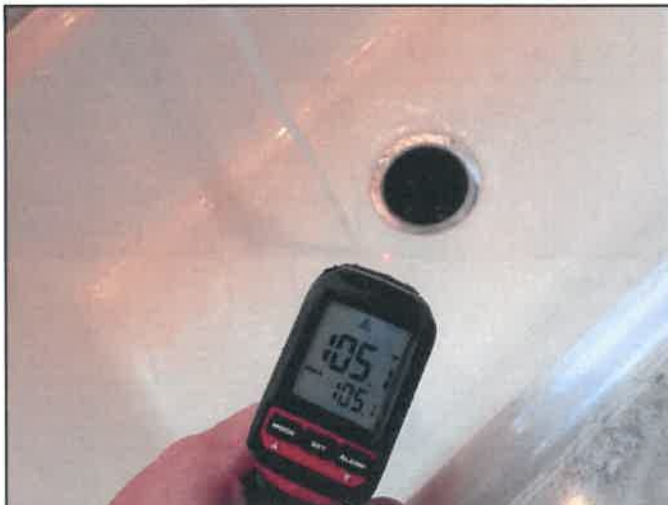
The water heater is slightly under performing and needs to be evaluated and repaired/replaced by a qualified plumber.

216. Rheem

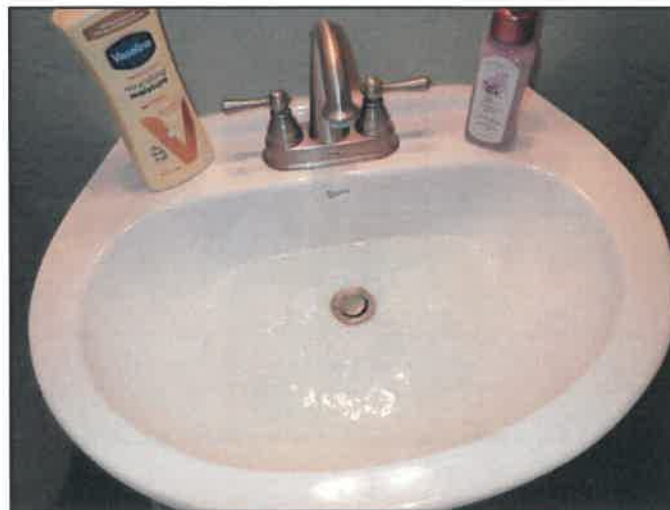
222. Slow drains

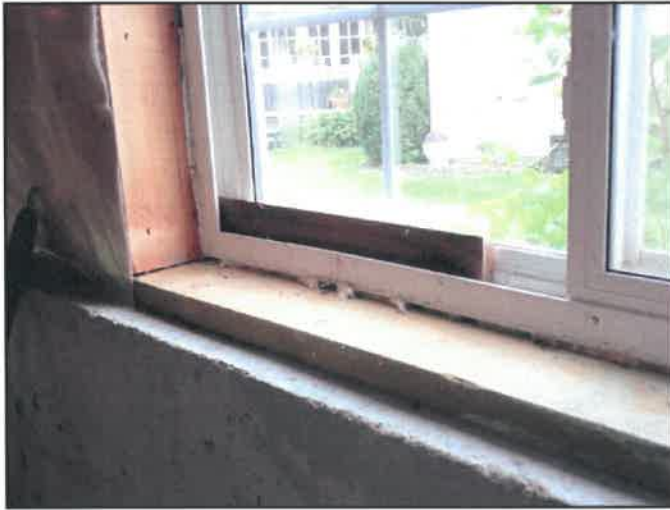
236.

**35. Condition:** • The basement windows in the utility room are poorly flashed and need to be improved before the walls are closed up if you choose to finish the area. The windows interior trim shows stains from moisture and need to be improved. The areas were dry at the time of the inspection.
